SiC MOSFET micro-explosion due to a Single Event Burnout: analysis at the device and die levels

Abstract

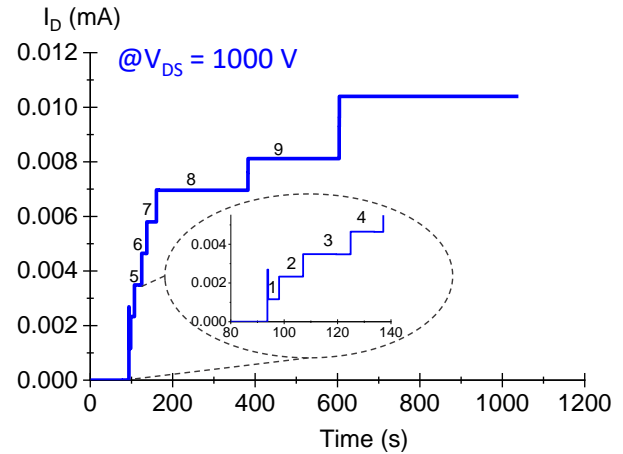
Figure 2: Evolution of the online current I_D during proton irradiation at 53 MeV of all ten SiC MOSFET DUTs in parallel.

A SEB event is detected by the sudden increase of the current. Notes that for isolation, a current-limiting resistance is used for each MOSFET. Fig. 2. shows the current change as a function of the irradiation time, related to the fluence of protons. The monitoring of the drain current I_D during the irradiation showed that nine devices have suffered from probable catastrophic SEB-type degradation. Four of these SiC MOSFETs were randomly selected for the further failure analysis. An analysis of the statistical properties of the SEB mechanism by applying Weibull statistics is presented in [19] indicating random failure over time, for this device irradiated with 53 MeV protons.

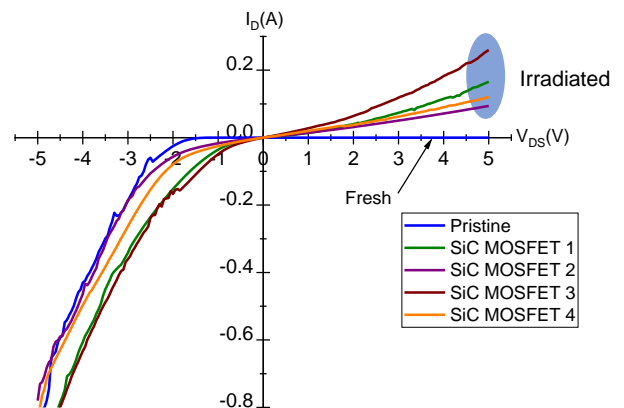
Figure 3: I_D - V_{DS} characteristics of the irradiated and failed devices. Characteristic are compared with a fresh device.

As expected, a conductive trend (I_D - V_{DS}) is measured after SEB. The electrical signature of the catastrophic SEB is then, the presence of a non-negligible current in direct polarization, even under small polarization from 500 mV. A variability between the four devices is measured. By comparing with the pristine device, the MOSFET channel control of the failed devices is lost. This result indicates catastrophic damage at the device gate. At $V_{DS} = 4$ V (Fig. 3), the current exceeds 0.1 A for all damaged DUTs after the irradiation. This strongly suggests that at the SiC die level, the degradation of the material produces a conductive pathway through the MOSFET structure and leads to a high leakage current in forward mode. Since the SiC MOSFET has internal diode formed by the P-I-N layers, this device presents the capacity to have reverse conduction. Interestingly, in reverse voltage I_D - V_{DS} characteristics, a survival of the diode characteristics of the SiC MOSFET is observed. The semi-log plot (Fig.4) shows that for $V_{DS} = -0.6$ V, the average measured leakage current is 14 mA for the degraded devices instead of 1.1 nA for the pristine one.

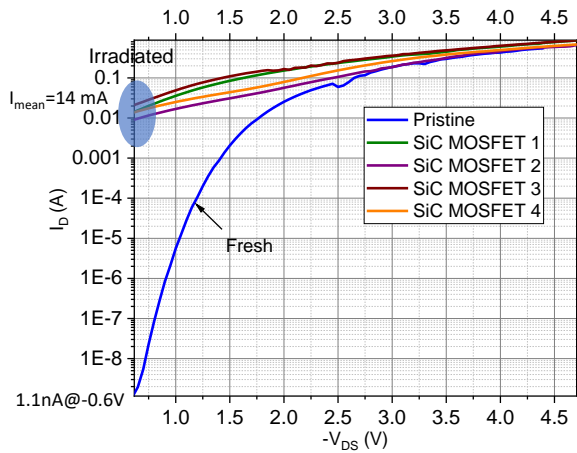
Figure 4: Reverse characterization at $V_{GS}=0V$ of four failed MOSFETs compared to the pristine device, for reverse bias.

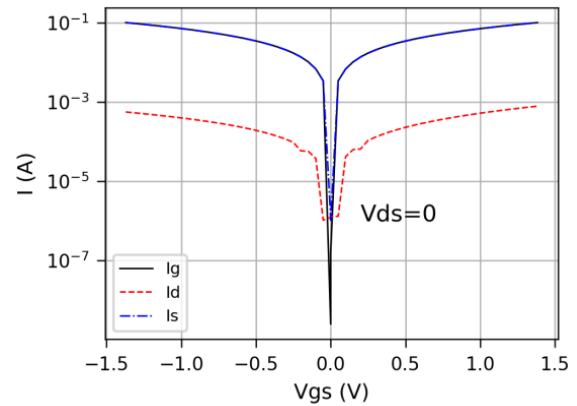
Furthermore, measurements of the drain, source and gate currents as a function of gate bias (V_{GS} with relative low values) for $V_{DS}=0V$, after irradiation (Fig.5), confirm the gate rupture: the gate current is high for forward and reverse V_{GS} bias. Comparing to the drain current, this characteristic shows that the I_D current flows mainly horizontally through the source and not through the epitaxial layer and the substrate (drain contact). After SEB a conductive patch is created locally between the gate and source contacts.

Figure 5: I_G , I_D and I_S as a function of gate bias for the irradiated device. A leakage has been triggered between Gate and Source.

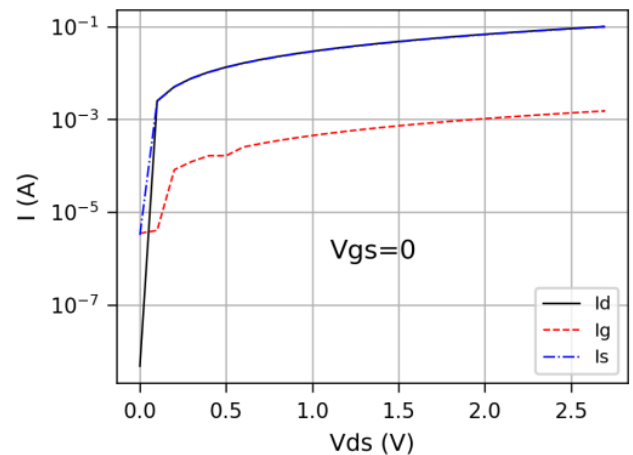
In addition, the same currents were measured as a function of drain bias after irradiation (Fig.6). The current flowing from drain to source shows that the p-type area below the gate has also been destroyed.

Figure 6: I_G , I_D and I_S as a function of drain bias for the irradiated device. A leakage has been triggered between drain and source.

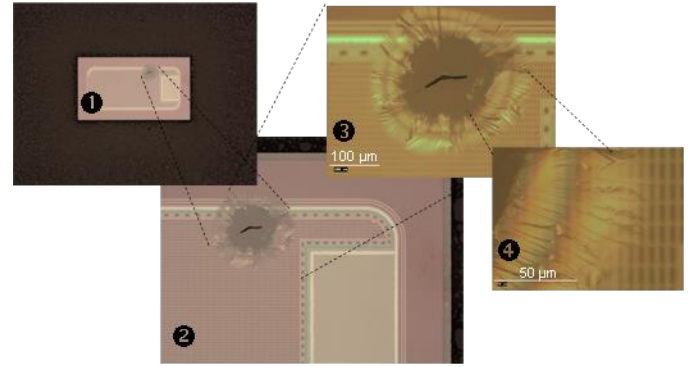
From the back-side, the thinning of the SiC chip face allows to locate the area of the defect through the transparency of the thin SiC die. This step represents a high risk, since SiC material is a rigid but brittle material. Its mechanical behavior is close to that of glass. Three of the four devices were broken at this stage of the sample preparation. SiC thinning from a thickness of $170\ \mu\text{m}$ to about $30\ \mu\text{m}$ was necessary to allow a good optical inspection through the SiC die. Fig.9 represents the optical inspection of a failed die. The die is isolated from the copper base plate (1). The damage consists of a longitudinal crack in the middle surrounding an area with multiple radial cracks (2). The defect occupies a circular area with a diameter of more than $280\ \mu\text{m}$ (3). Through the thinned SiC, a first black crown at the center and radial propagation traces can be observed (4).

Figure 9: Optical inspection of the failed die after thinning

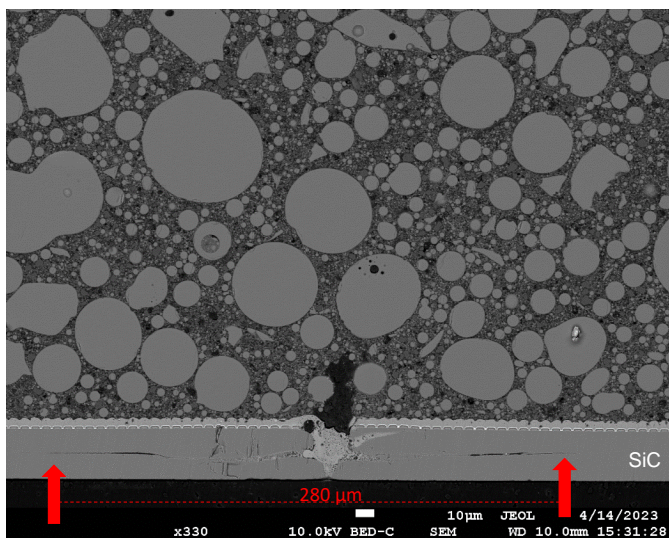
A mechanical cross section was prepared at the end of the sample preparation. Backscattered electron (BSE) imaging and energy dispersive X-ray spectroscopy (EDX) mapping were performed using a scanning electron microscope (SEM, JSM-7200F JEOL). A large view (with a relative magnification of 330, for a size of $360\ \mu\text{m} \times 280\ \mu\text{m}$) of the cross-section surface is reported in Fig. 10. At the interface between the EMC and the SiC die a cavity (area dark on Fig.10) is identified. Just below, the row of SiC MOSFETs is completely destroyed. In addition, a round-shaped area (which seems to have been melted) is observed in the SiC material. The observation of the large crack ($280\ \mu\text{m}$, indicated by the red arrows) inside the SiC semiconductor confirms that during the cross-sectional preparation, the cross-sectional stage has not caused any additional damage. This is the area shown on the backside on the Fig.9. A close up of the defect at the SiC die level is reported in Fig.11 a). At the top of the image, the mold EMC, the SiC MOSFET structure and the large crack in the SiC material can be observed. The outline image (Fig. 11b)), generated from the SEM view, allows to highlight the areas with strong deformation and therefore the collapse of the contact metal.

Figure 10: SEM view of the obtained cross section with backscattered electron detector.

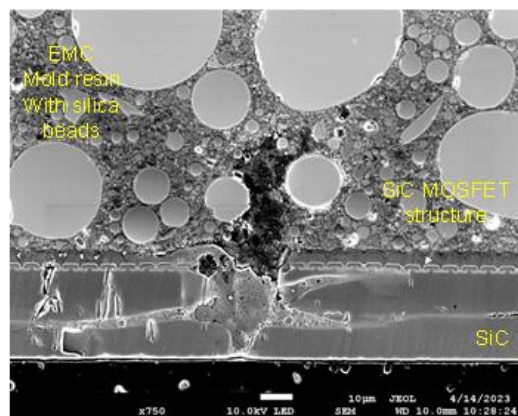
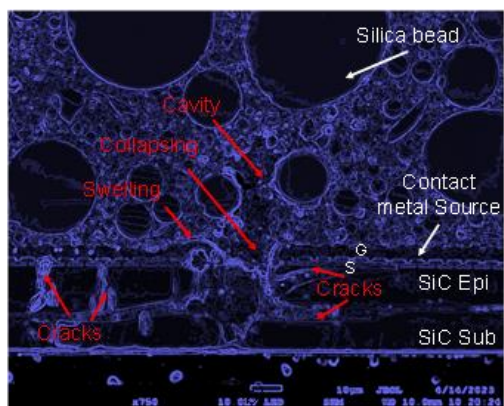
Under of the observed cavity, the different functional parts of the MOSFET structure are indicated in Fig. 11 b). The crack is located in the SiC substrate. The metallic source contact, just on top of the epilayer, is collapsed under the cavity, while at the left side, a swelling is observed.

Figure 11: (a) SEM view of the catastrophic degradation induced by the proton at the SiC die level, the SEM observation is zoomed on the damage in the gates region, at the center of the Fig.10 and (b) the generated contours image used for the analysis.

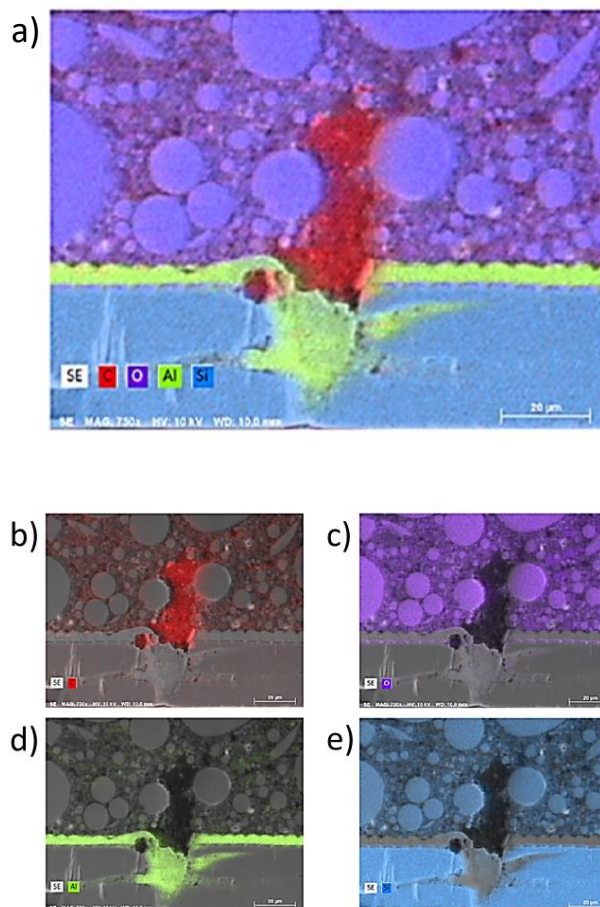
Figure 12: EDX measurements superimposed to the SEM view of the SiC cross section after the proton SEB. (a) the combined image for C (red), O (violet), Al (green), and Si (blue) (b) EDX mapping of C. (c) EDX mapping of Si. (d) EDX mapping of O. (e) EDX mapping of Al.

The location, isolation and analysis of the damage reveals the destruction of the SiC MOSFET and the defect inside the SiC semiconductor structure. EDX analysis reveals traces of carbon like a fire-place, indicating the occurrence of a micro-explosion. To better understand this micro-explosion, the local failure mechanism is correlated with the fire triangle. Indeed, in order to have combustion, it is necessary to have fuel, one oxidant (such as oxygen) and enough energy to initiate the reaction of combustion. In our present case, the proton SEB event generates in the SiC structure a high increase of local

temperature conducting to thermal decomposition of the SiC element. As oxygen is trapped in the MOSFET structure and EMC micro-pores, the energy transferred by the irradiation is sufficient, so combustion and thus explosion can take place. This is clearly visible in Fig. 12. High temperatures are reached, during the blast, when the local temperature exceeds the sublimation temperature of the SiC (> 2100 °C). The SiC epitaxial layer explodes, a cavity is created and is filled with the fusion of the aluminum layer (Fig. 12-f). The evidence of the combustion gas emissions is found in Fig.12-a) where a large concentration of Carbon is measured in the EMC packaging above the location of the SEB event. Failure analysis at the die level of a failed device after proton irradiation indicates micro-explosion like a thermal blast occurring during the SEB. The molten aluminum fills the cavity and creates new conductive path within the device, which is validated by the observed leakage current in the I-V characteristics.
