SiC MOSFET micro-explosion due to a single event burnout: analysis at the device and die levels

Rosine Coq Germanicus, Tanguy Phulpin, Thomas Rogaume, Kimmo Niskanen, Sandrine Froissart, O. Latry, Alain Michez, Ulrike Lüders

Rosine Coq Germanicus, Tanguy Phulpin, Thomas Rogaume, Kimmo Niskanen, Sandrine Froissart, et al.. SiC MOSFET micro-explosion due to a single event burnout: analysis at the device and die levels. ISTFA 2023 - the 49th International Symposium for Testing and Failure Analysis Conference, Nov 2023, Phoenix, United States. pp.483-490, 10.31399/asm.cp.istfa2023p0483 . hal-04285320

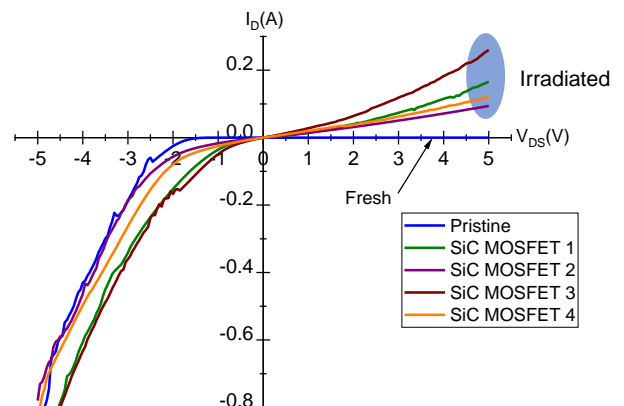
Figure 3: I_D - V_{DS} characteristics of the irradiated and failed devices. Characteristic are compared with a fresh device.

As expected, a conductive trend (I_D - V_{DS}) is measured after SEB. The electrical signature of the catastrophic SEB is then, the presence of a non-negligible current in direct polarization, even under small polarization from 500 mV. A variability between the four devices is measured. By comparing with the pristine device, the MOSFET channel control of the failed devices is lost. This result indicates catastrophic damage at the device gate. At $V_{DS} = 4$ V (Fig. 3), the current exceeds 0.1 A for all damaged DUTs after the irradiation. This strongly suggests that at the SiC die level, the degradation of the material produces a conductive pathway through the MOSFET structure and leads to a high leakage current in forward mode. Since the SiC MOSFET has internal diode formed by the P-I-N layers, this device presents the capacity to have reverse conduction. Interestingly, in reverse voltage I_D - V_{DS} characteristics, a survival of the diode characteristics of the SiC MOSFET is observed. The semi-log plot (Fig.4) shows that for $V_{DS} = -0.6$ V, the average measured leakage current is 14 mA for the degraded devices instead of 1.1 nA for the pristine one.
