Backside Fault Localization and Defect Physical Analysis of Degraded Power HEMT p-GaN Transistors Stressed in DC and AC Switching Modes

Backside fault localization and defect physical analysis of degraded power HEMT p-GaN transistors stressed in DC and AC switching modes

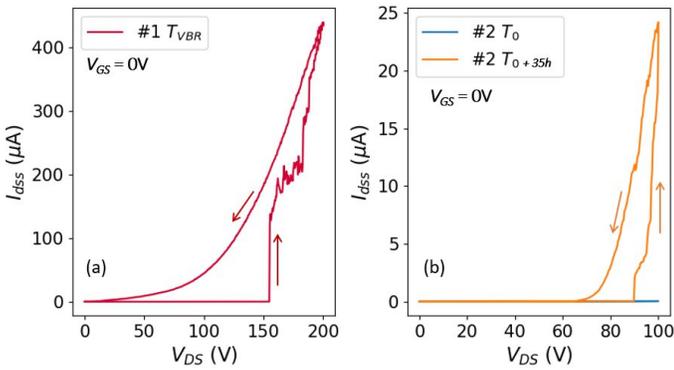
Characterization curves of the leakage current $I_{dss} = f(V_{DS})$ are shown in figure 1b at T_0 in blue and post stress at T_{0+35h} in orange. An abrupt current leakage at T_{0+35h} appears over 90V only, the transistor is still functional after the aging despite this current leakage change. Failure analysis was conducted in

Figure 1: (a) Electrical signature of breakdown voltage of transistor #1, the curves are similar for transistor #3, a steep increase of current I_D between drain and source occurs at 155V. (b) Electrical characterization of the aged transistor #2 of the leakage current I_{dss} under V_{DS} at T_0 in blue and after 35 hours of electrical stress at T_{0+35h} in orange. A high leakage current appears only after 90V. Forward and backward sweeps are performed to take into account a possible hysteresis (arrows close to curves). #3 has similar I_{dss} curve than #2.

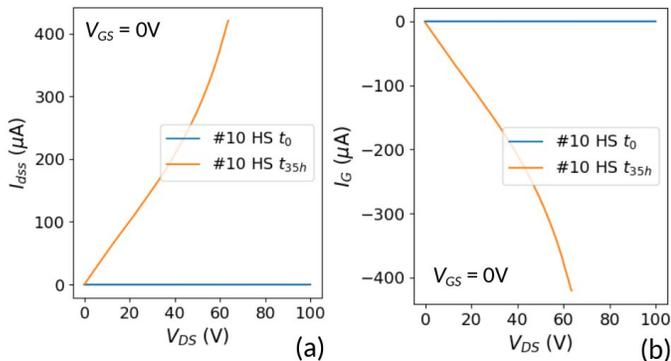
Figure 2: Drain leakage current $I_{dss} = f(V_{DS})$ at $V_{GS} = 0V$ of transistor #10 before stress (at t_0) and after stress at t_{35h} (stress under switched voltage of 67V). (a) Drain current (b) gate current during this characterization measurement. The degradation observed is a leakage current between the drain and the gate of the transistor.

For the GD leakage current case, as the layer (AlGaN) that contains the leakage path is rather thin (15 nm) (Fig15), the conductive path through dislocations can easily conduct the leakage current (fig 2) compared to the dislocations paths in the DS current leakage case through GaN layers (1 to 2 μm) under the drain electrode that need a higher polarization (90V, fig 1b) to be activated.

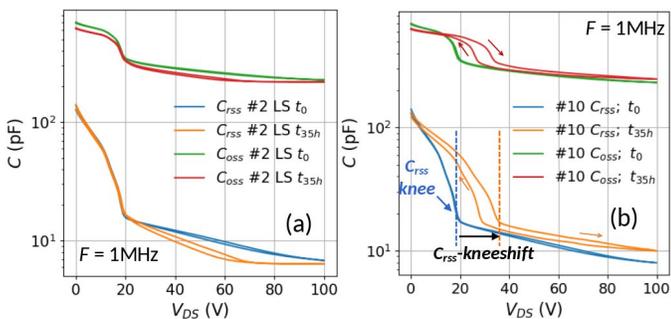
Figure 3: C_{oss} and $C_{rss} = f(V_{DS})$ capacitance measurement with Keysight B1505A before and after stress for (a) transistor #2 (for #3 the curves are similar) (120V) and (b) transistor #10 (67V). The main change for #2 and #3 is observable in the higher voltage values where the capacitance value becomes constant. For transistor #10 the capacitance knee is shifted to higher V_{DS} values and the hysteresis increases.

The change of capacitance of transistor #2 (and for #3 stressed in AC switching mode at 120V) is seen approximately between 70V and 100V Fig.3a which means the depletion stops or is complete at 70V. The zone near the drain electrode is degraded which changes the polarization of the 2DEG in this region. As the leakage current is only visible for a high enough electric field only (ie high V_{DS}) a thick isolating layer can be suspected, in this case the leakage current can be expected to be vertically through the GaN layer.

The transistor AC stressed at 67V shows a capacitance shift to higher V_{DS} voltage values (Fig.3b). The knee observed is caused by the metal field plate which depletes more easily the 2DEG to move away the electric field peak from the gate stack in order to protect it and increase gate reliability. The shift traduces the fact that the 2DEG is depleted under the field plate at higher voltage than at t_0 . This shift shows that the field plate effect is less significant which shows that degradations have appeared beneath it. Now as the current leakage is between gate and drain as visible in figure 2 the layer of interest is expected to be the AlGaIn barrier. This layer is supposed to electrically isolate the gate and the drain. A defect in the dielectric layer would have create an electrical contact between the 2DEG (the drain) and the source (the field plate) and the

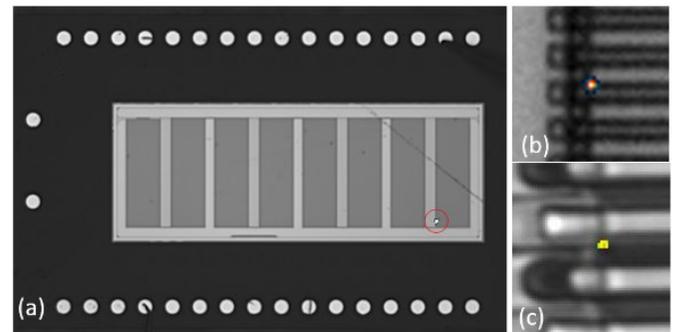
Figure 4: (a) LIT Amplitude signal of the prepared transistor #1 with a 5x magnification (lock-in frequency 25Hz), polarized at 2V with probes landed on the electrical vias. (b) LIT at 10x magnification focused on the hot spot (c) InGaAs camera PEM image with a 71x magnification focused on the emission spot (good correlation with LIT hot spot position)

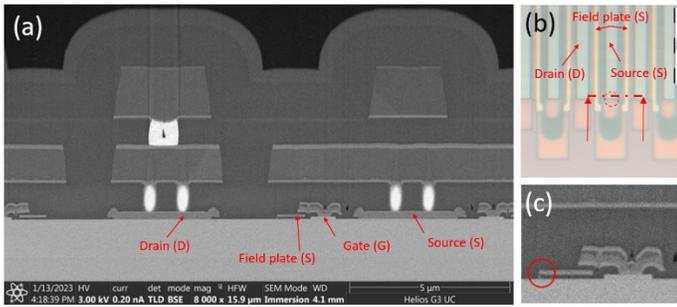
The FIB Slice&View cross section is positioned 2 μm beside the hot spot (figure 5a) and a small pitch (50nm) is needed (figure 5b) regarding the defect size: a filamentary breakdown defect is revealed only on one image of the Slice & View (zoom in figure 5c). As expected, it is situated in the Si_xO_y layer where the electric field is maximal *ie* between the 2D electron gas (2DEG) connected to the drain electrode and the drain-side corner of the field plate (FP) connected to the source. This defect seems to be a metal filament obtained with the localized fusion of the FP metal through Si_xO_y and probably AlGaIn to reach the 2DEG. Due to its very small dimensions (a few tenths of nanometers), FIB slice&view cross section resolution is not sufficient and TEM observation is needed to analyze more precisely this defect type.

Figure 5: (a) FIB slice&view cross section in the defect zone of #1 transistor, the section axis observed is indicated by the red arrows in (b) the zoom in (c) shows at the corner of the source field plate the leakage path formed at the breakdown voltage in figure 1(a). This zone is where the electrical field is locally the most significant.

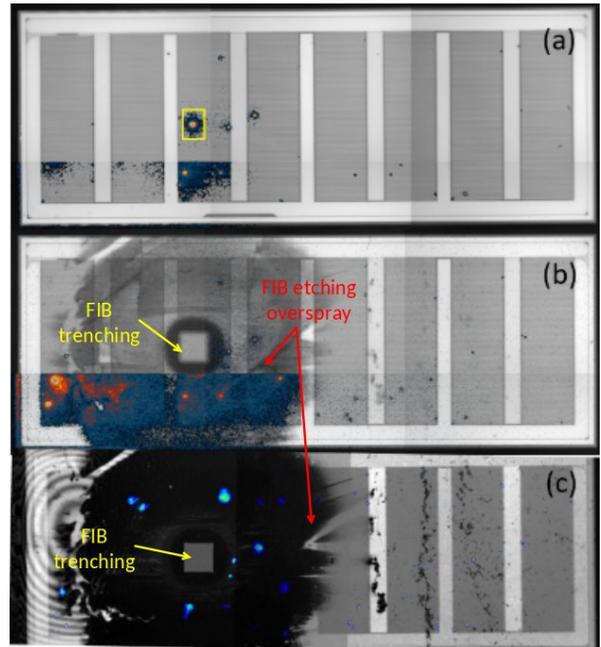
For the transistor #2, as the transistor is stressed in permanent switching mode on a long duration, more hotspots are visible during the LIT backside analysis (figure 6a) done after backside parallel lapping (silicon substrate was thinned to a thickness of 100 μm as for transistor #1). These hot spots are only visible for an electric polarization above 90V on a stressed transistor and corresponds to the high leakage of figure 1b. There is still a quite good correlation with PEM analysis despite some spots appears more or less intense with one technique or the other. If we apply the same backside ultimate trenching method as for transistor #1 above a selected hot spot, no more spot is detected at this position with LIT and PEM in this zone (figures 6b and 6c).

Figure 6: (a) superimposed LIT of #2 with polarization between 75V and 95V, more than 20 hot spots are visible, a brighter hot spot is visible in the yellow square (b) LIT after FIB silicon trenching locally above the brightest hot spot that has disappeared (c) InGaAs camera PEM image after FIB silicon trenching, emission spot has also disappeared.

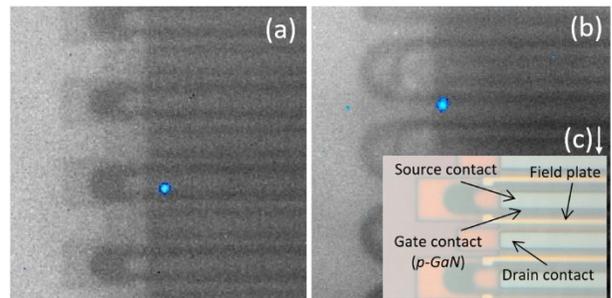
The hotspots and emission spots localization on transistor #2 are mainly near the drain edge electrode as visible in figure 7b. However some points are visible near the gate region area. The spots in the case of transistor #3 are similar to #2 (#3 will be used for other measurements that will be presented in the end of this paper). For the transistor #10 the hotspots are only located in the gate regions as it can be seen in figure 7a.

Figure 7: InGaAs camera PEM image of the emission spots. (a) Defect near the gate that might be a GD leakage current through the AlGaIn barrier (#10 transistor) (b) defect near the drain metal that is expected to be a DS leakage current through the GaN layer (#2 transistor). (c) optical zoom of the metal structure seen from the backside.

These results are in accordance with the approximate localization of the emission spots over the metal deposition pattern observed in figure 7a. Regarding the attended very small size of the defect (a few nms), knowing exactly which part of the transistor must be inspected during the defect physical analysis (FIB slice&view and/or TEM cross-section) will increase the chances of success.

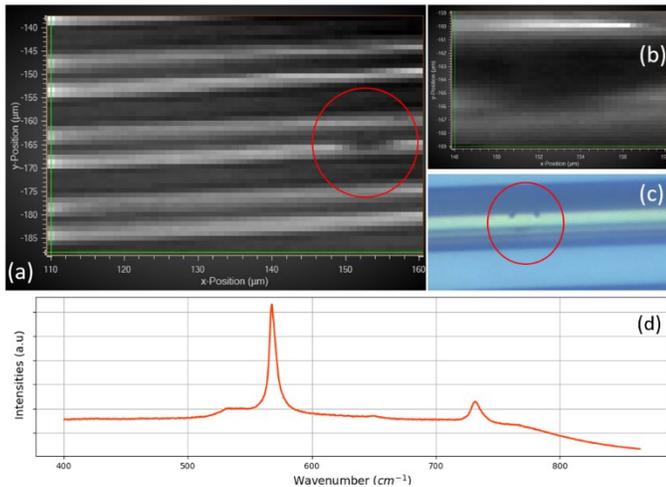
The variation of the principal peak of the Raman shift in figure 8d was mapped in the silicon trenching area (figure 8a, 8b) without any polarization of the transistor. A darker spot is visible over the luminescence pattern of metal lines (Drain, Source, Field Plate) exactly where the localization of the defect was revealed by LIT and PEM.

Figure 8: Raman spectroscopy using 532-nm laser beam diameter 300nm. (a) Mapping of the principal Raman peak (1 μ m scanning step). (b) Higher resolution mapping (300nm scanning step) focused on the defect zone. Optical view of the defect at 100x at the coordinates given by (b). (d) Long exposure Raman spectrum associated with (a,b) acquired for one pixel.

A 100x optical view is shown in figure 8c: dark spots in the GaN layer have now appeared (they were not observed just after FIB trenching). Raman spectroscopy allowed to localize the defect post silicon substrate trenching however this measurement and probably the laser power seems to have aggravated the defect. Indeed, the hotspot that had disappeared after Si trenching is visible once again with LIT and PEM conducted after Raman spectroscopy (figures 9a, 9b).

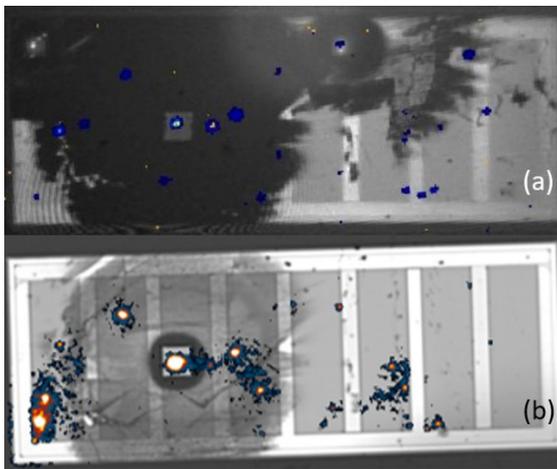
Figure 9: (a) PEM after Raman analysis, the brightest emission spot that disappeared after trenching has now signal. (b) LIT amplitude after Raman analysis, like with PEM, the hot spot reappeared after the Raman analysis.

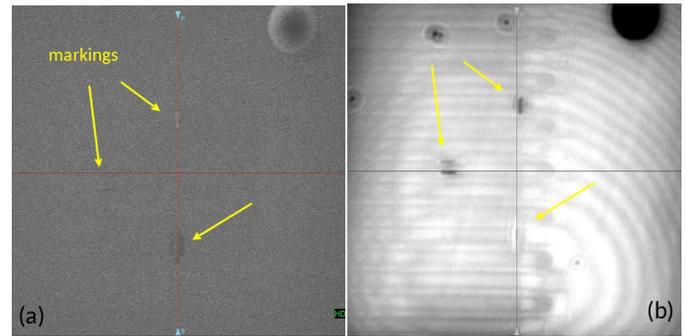
Figure 10: (a) ionic image of the trenching with 10 μ m of remaining silicon and marking. (b) In-situ IR camera image through the remaining silicon and view of the etched lines marking the hot spot position for TEM lamella extraction.

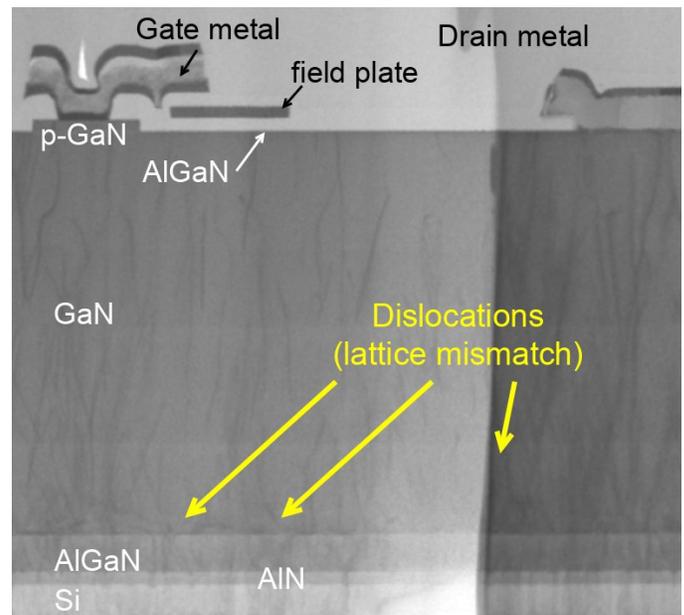
Figure 13: TEM lamella observation of the reference device in the gate-drain region. Dislocation starting from the lower part of the device can be observed. These dislocations can be generated by the lattice mismatch between Si and GaN.

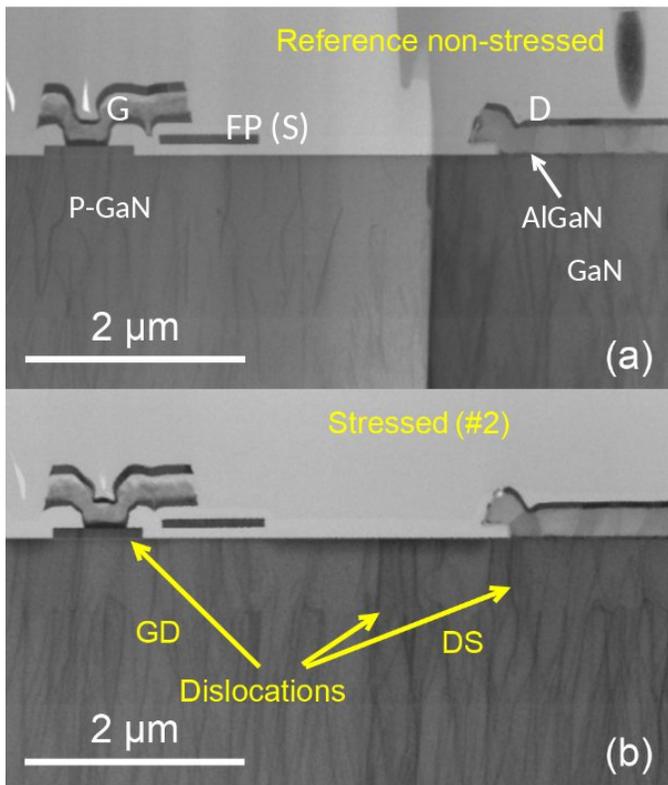
Figure 14: (a) TEM lamella observation of our reference device that was not stressed (b) TEM observation of the GD region of device two #2 (stressed in AC at 120V in cross-conduction switching mode).

For the DS leakage defect case in Figure 14b, the leakage current might go through a parasitic 2DEG at one the AlGaN/GaN interface of epitaxial stack to reach the source [4] or reach a conductive GaN layer (doped layer) connected to the source electrode. Our hypothesis is that when the silicon is entirely removed by the FIB trenching it could change the overall electrostatic polarization around the leakage path which makes it disappear locally with the same polarization parameters.

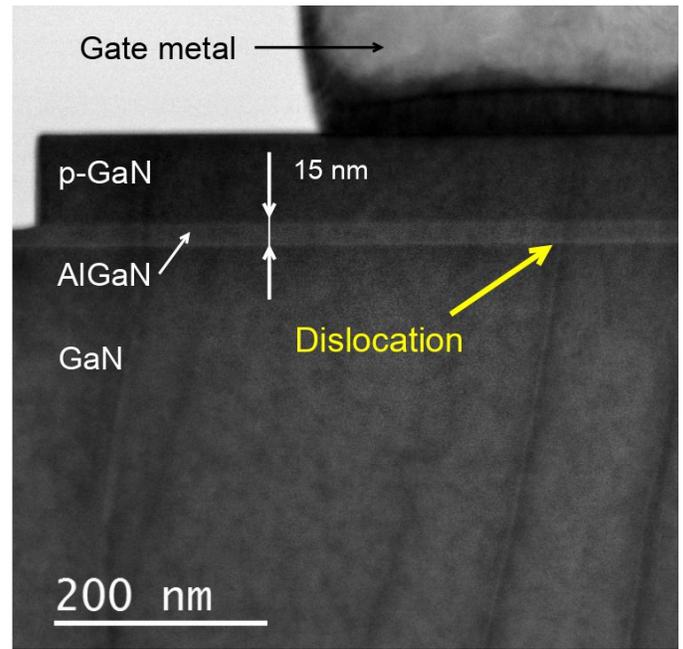
Figure 15: (a) TEM lamella observation in the region illustrated in figure 7a that corresponds with a gate drain leakage such as transistor #10. The leakage is through the AlGaN barrier through one of the dislocations observed such as the one showed by the yellow arrow in the figure.

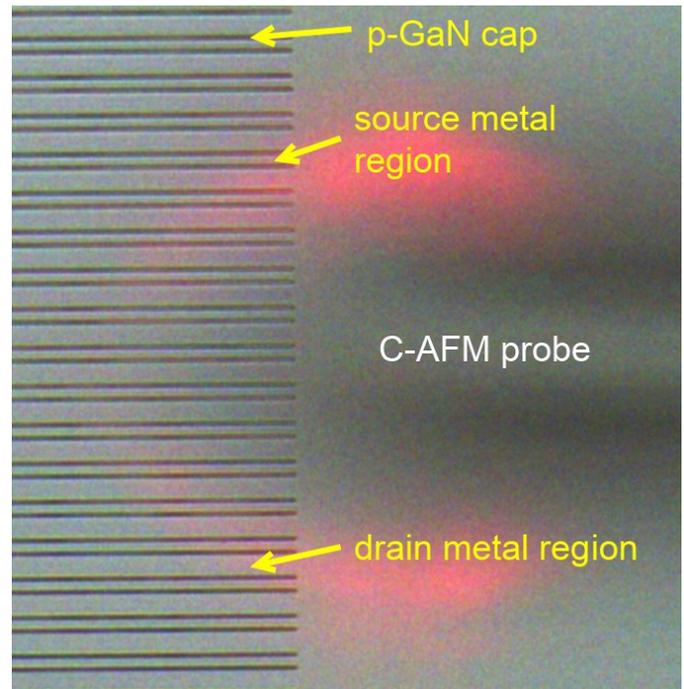
Figure 16: Optical observation of the frontside surface after deep HF, the double lines patterns observed are p-GaN caps, the rest of the observed surface is AlGaN except in the previous source and drain metals the two p-GaN caps and location (see figure 7c and 17) where the surface is the GaN layer.

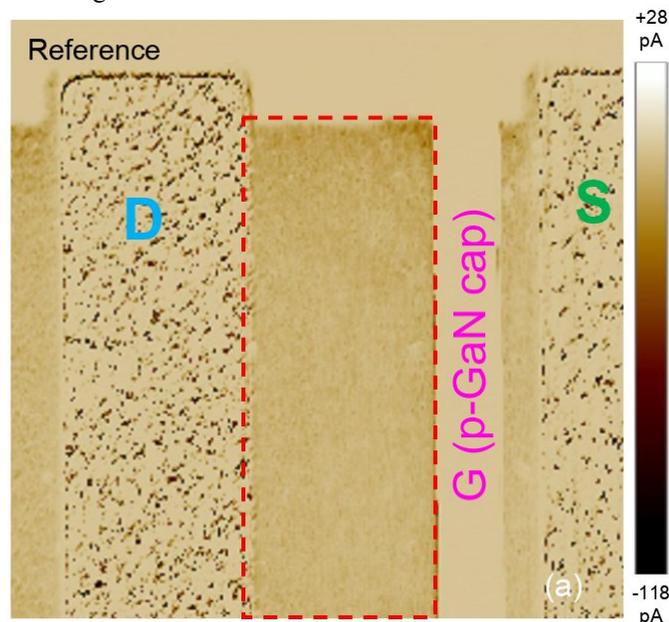
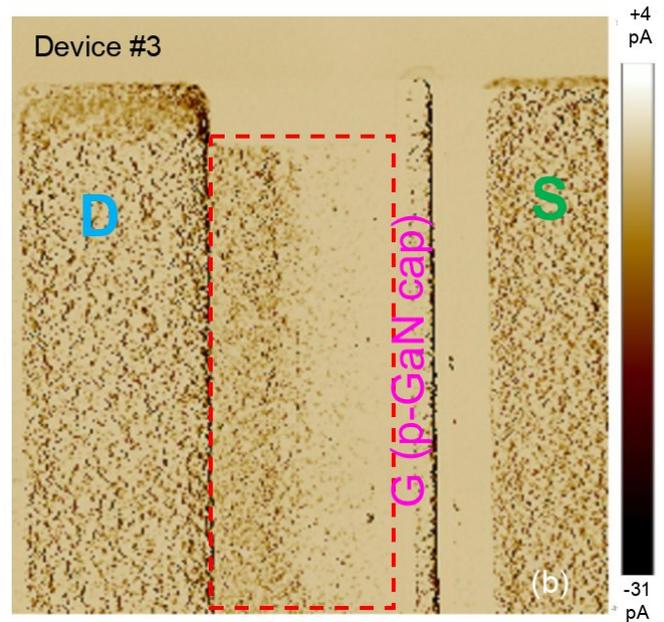
The metal regions (GaN surface) are more conductive due to the surface quality and the fact that there is not the AlGaN layer to isolate the 2DEG compared to the region of interest. The higher roughness probably also affects the measurement in electrical mode.

However even if the comparison is hard, an overall comparison of the current leakage mappings (in all scan directions) shows some difference that might be the result of the stress. A first observation is the comparison for a same device of the leakage current in the zone of interest and in the zone between the p-GaN and the source metal (GS region). For the unstressed device the leakage current is very similar in the two regions. Yet for device #3 the zone delimited by the red lines in figure 18b seems to be more conductive than the GS region (not particularly stressed as the 2DEG always lies in this region which reduce locally hot electron effects and the electric field value). Moreover the leakage current for the stressed device (#3) is less uniformly spread over the interest region like the reference device. Indeed the leakage is higher in many precise locations that form black dots in the C-AFM scan of figure 18b. Some of these dots could be the leakage current through the threading dislocations observed in the TEM lamellae.

Figure 18: Current leakage mapping obtained with conductive AFM, the black dots are the current leakage paths. The zones were the metal contacts were previously are always more conductive due to their proximity with the 2DEG that facilitates surface leakage currents.
