# Fretting Wear Anomaly of Final CubeSat Ejection Tests: Expertise, Solution Testing, and Lessons Learnt

# FRETTING WEAR ANOMALY OF FINAL CUBESAT EJECTION TESTS: EXPERTISE, SOLUTION TESTING, AND LESSONS LEARNT

## ABSTRACT

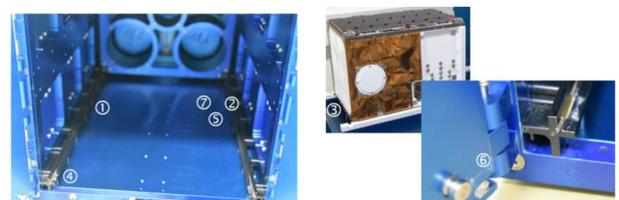
Figure 2: Sampling areas

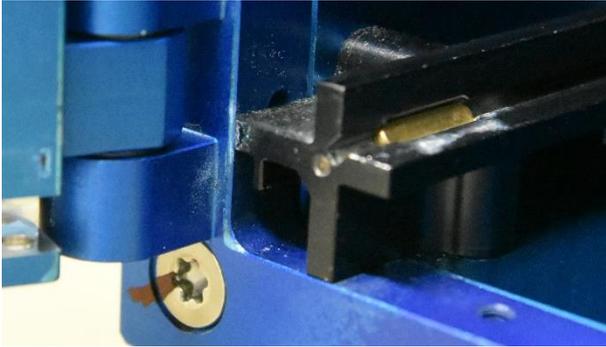
During visual inspections, we noticed that at least 3 areas were subjected to abnormal wear and a lot of particles were present. Two of these areas are located near

switches of the deployer rails. The corresponding areas on the satellites rails exhibits also a lot of wear.

Figure 3: Wear and particles near a switch

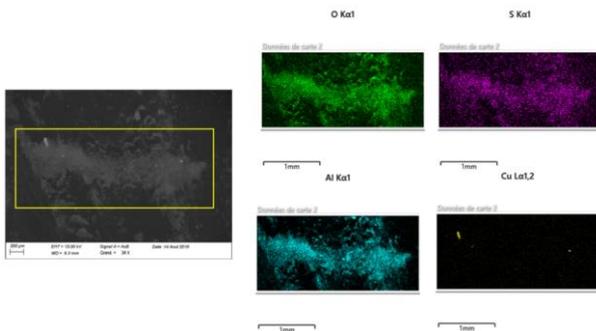
Particles were sampled using carbon adhesive on SEM stubs and were analysed using SEM and EDX. The results showed that the particles were mainly composed of alumina. Traces of Zirconium, Titanium and fluor were also found. On satellite side the rails are made of Al7075 treated by hard anodic oxidation and surtec 650. On the deployer side the rails are made of Al7021 treated by Hard anodic oxidation and interflon. The composition of the particles is thus consistent with the materials in contact.

Figure 4: Example of an EDX analysis

At this stage, the hypothesis of an external contamination acting like a third body in the contact and increasing the wear was excluded. All the particles came from the contact itself and the third body is not an external contamination but the product of the wear itself.

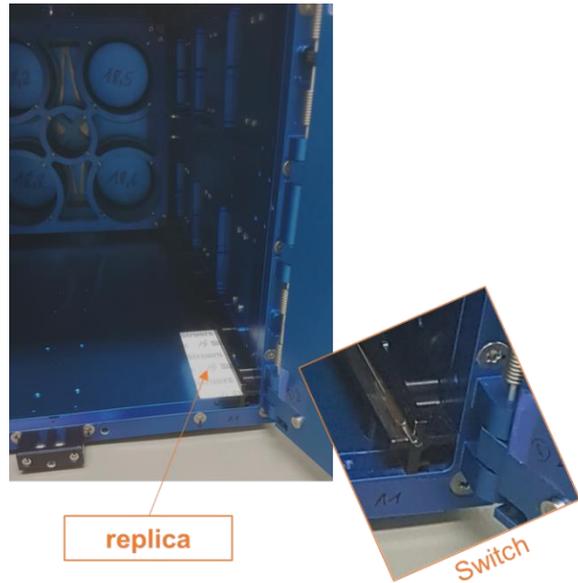
Figure 5: Example of a silicone replica on the deployer rail

The wear area on the Figure 5 shows almost no wear. The mean surface in the area is 800nm above the original mean surface. We also notice that the surface in the wear area is smoother than the original surface.

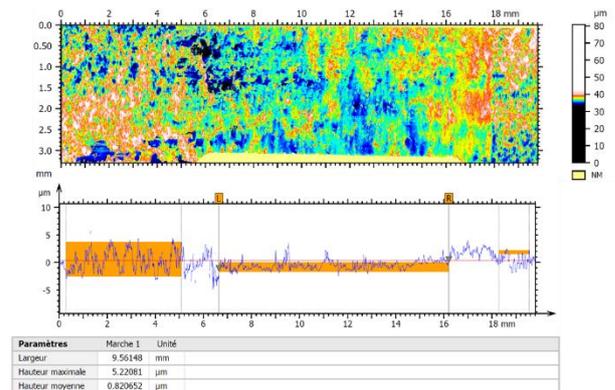
Figure 6: Profilometry on the deployer rail

With a closer look on this surface we were able to see that the worned surface could be locally 5 to 6µm above the original surface.

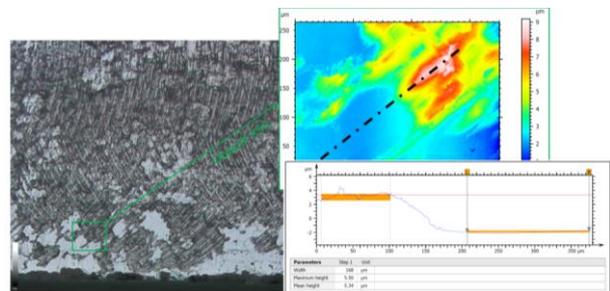
Figure 7: Material trapped in the roughness of the deployer rails

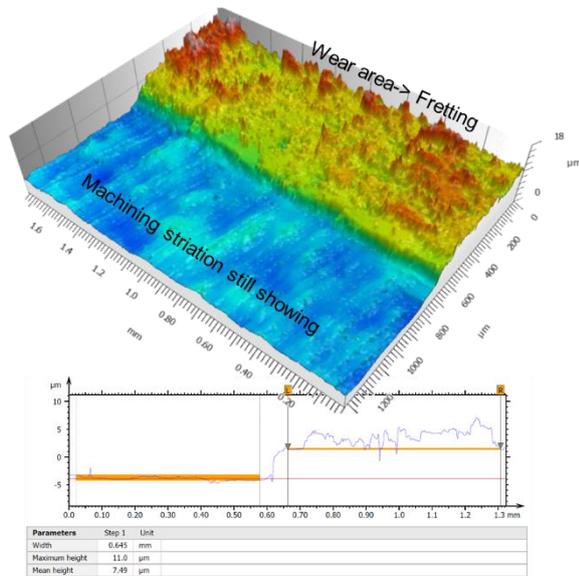
Figure 8: Profilometry on a wear zone of the satellite rail

The same analysis performed on the satellite rails exhibited more than  $7\mu\text{m}$  of wear in average. Wear areas are well defined and it is not hard at all to define a frontier between the wear and the original surface. Moreover the bearing surface at  $7\mu\text{m}$  of the satellite tracks if 100%. Meaning that the bearing surface can no longer increase with wear (locally at least) and that the wear phenomenon is not behaving like a run-in but will continue without any counter-measures.

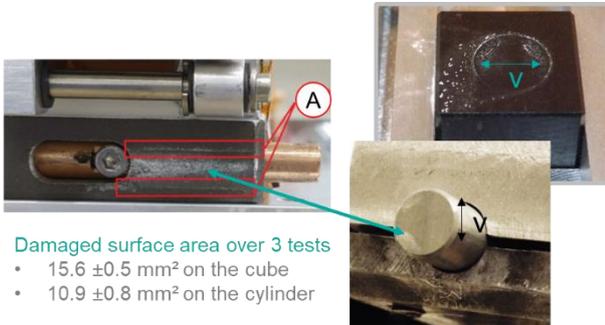
samples, after tests in dry conditions. Features, morphology (surfaces and debris) are successfully reproduced. Contact effectively occurs over few large spots. Over the 3 unlubricated test samples, the damaged area remains quite constant and varies little from one test to another.

Figure 9 - Comparison of damaged areas from satellite and from tribometer tests samples. The arrow v displays the sliding direction during the friction tests

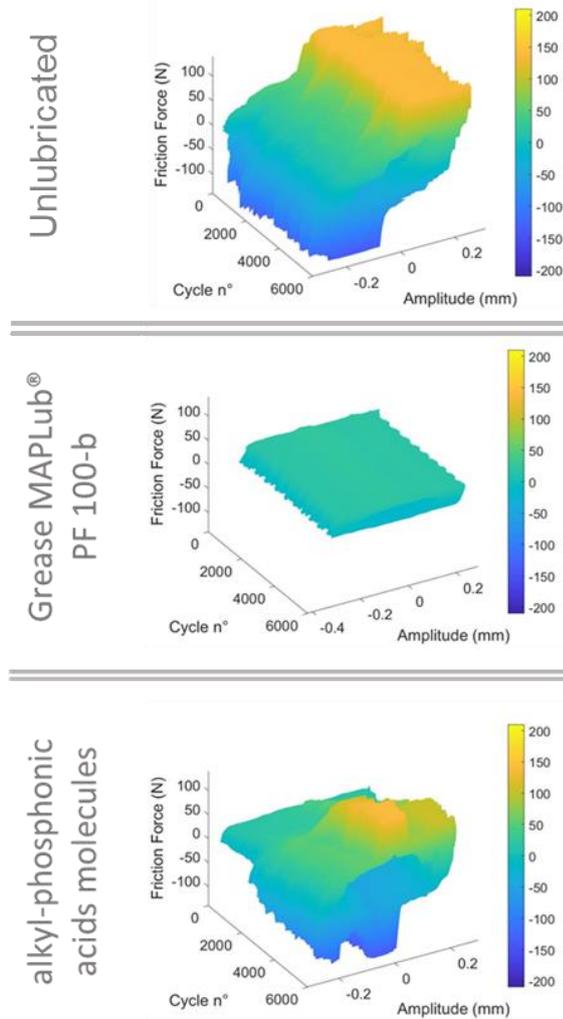
Figure 10 - Fretting loops of the fretting unlubricated and lubricated tests. The loop shape, with curvy sides, is typical of high adhesion fretting in sinusoidal displacement

Figure 10 is showing the fretting loop obtained during the fretting test in unlubricated condition, and in lubricated conditions after lubricant is applied on the damaged surfaces. It can be seen that in the unlubricated case, the friction demonstrates partial slip and very high amplitude of friction force, up to 100N in average (0.7 friction coefficient), pic at 140N (1 friction coefficient). During the test, particles are rapidly created and ejected continuously outside the contact, as evidenced on the cubic sample in Figure 9. White debris are indeed observed in the left side of the contact area. White 3<sup>rd</sup> body patches, are observed inside the friction tracks, in the mostly loaded areas. amount may have not been sufficient to sustain lubrication over the full test.

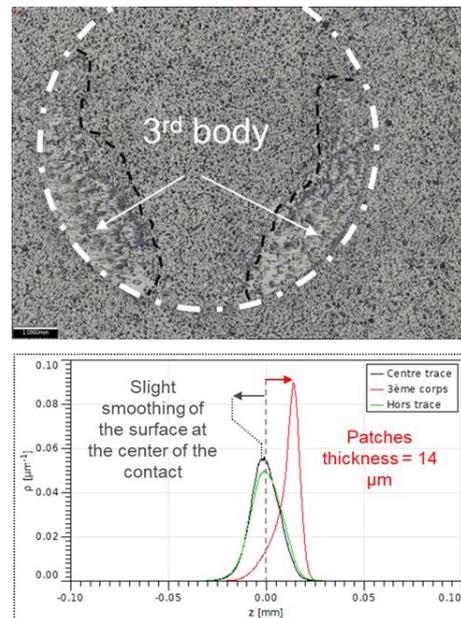
The optical analysis of the unlubricated samples shows that the worn samples is mainly the samples emulating the satellite. It also and that the 3<sup>rd</sup> body accumulate to form thick 3<sup>rd</sup> body patches. Figure 11 indeed shows that the cubic sample is not demonstrating significant wear, the surface at the centre of the contact is slightly smoother than the pristine surface. At the mostly loaded areas, 3<sup>rd</sup> body accumulates to create patches reaching a thickness of 14 µm above the overall sample surface. The cylinder surface (not shown) demonstrate mostly few microns deep worn region. Areas with accumulated 3<sup>rd</sup> body demonstrate 3<sup>rd</sup> body whose thickness may locally reach 2 µm. EDS analysis shows that debris and 3<sup>rd</sup> body are only coming from the cylinder (satellite-based material)[1]. Note that no fluorine is detected on the cubic samples (layer too thin?) but it on the cylinder material. Surtec650 is indeed containing fluorine [4]. The oxygen content is however significantly higher than what it is detected on the pristine materials, which is typical of tribo-oxidation seen during fretting tests in air [2,5].

Figure 11 - Optical topography image and height distribution of the 3<sup>rd</sup> body.

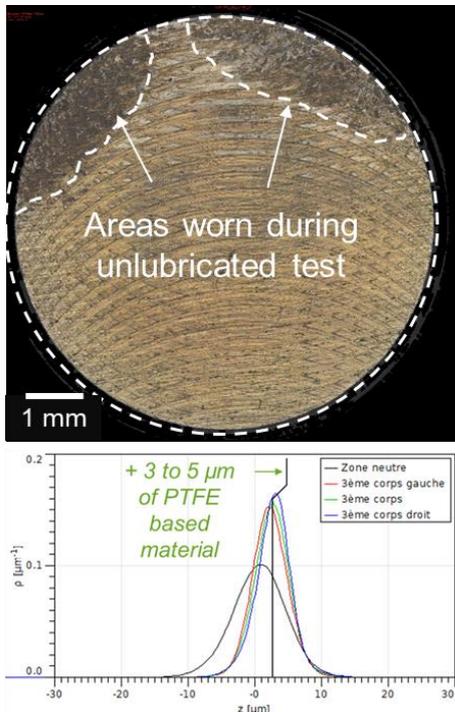
Figure 12 - Optical topography image of the cylinder sample demonstrating large accumulation of PTFE based lubricious material in previously worn areas

The grease lubricated test sequence demonstrates very stable pure sliding friction with a friction force of 15N in average (0.1 friction coefficient). The optical topography shows accumulation of 3<sup>rd</sup> body from coming from the grease and remaining rigidly bounded to the initially worn areas of the surfaces. This demonstrated on the mostly worn samples, the cylinder (Figure 12). Such PTFE layer formation behaviour has been shown to happen with grease containing PTFE particles [6]. While PTFE appears to bind only on the initially worn areas on the cylinder (i.e. on the satellite material), it is found everywhere in the contact on the cubic samples (i.e. deployer material), with slightly thickest patches in initially worn areas.

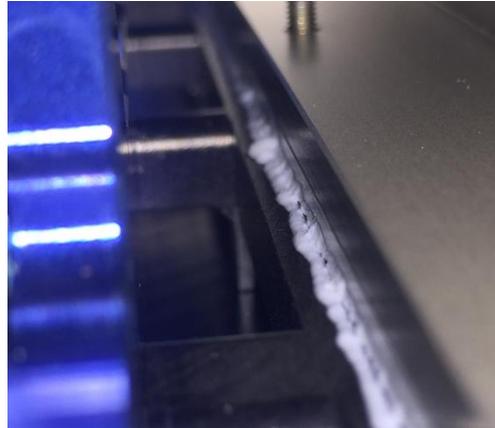
Both satellite dummy and deployer QM were submitted to a full mechanical vibrations qualification sequence (@qual level for 2 minutes, cf. Figure 15). Grease behaviour was observed during vibrations on bottom rails through an opening in the deployer. A grease bulge was observed and confirmed a satisfying grease circulation in the contact (cf. Figure 16).

Figure 16 Grease bulge showing grease circulation on bottom rails

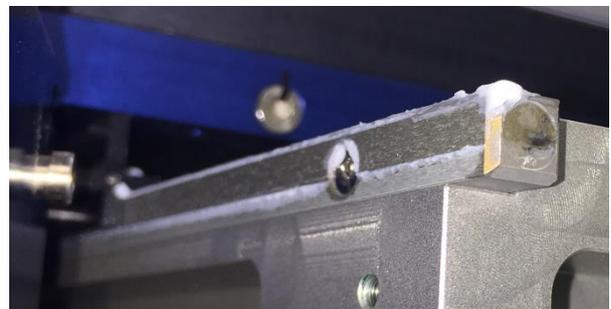
An ejection test was then performed at 75° (cf. Figure 17) in order to limit gravity effect on friction (with 1g compensation). A particular care has been paid in transporting the deployer on the ejection test GSE to avoid “unsticking” the satellite from the rails. Satellite dummy was successfully ejected from the deployer with satisfying margin. In addition, no wear or fretting marks

were observed on both the satellite dummy and the deployer rails (cf. Figure 18). Grease was indeed observed on all sliding surfaces as expected. This successful test confirmed the choice of the corrective actions to solve ejection anomaly.

Figure 18 Satellite dummy rail after ejection test : no fretting marks were observed
