# Hydrological & geomorphological analysis of the Upper Trusan River to assess remediation for riverbank integrity. WWF-Malaysia Project Report

**WWF-Malaysia Project Report**

Report Produced Under Project SW010603-831-CORP SCP-CIMB

Long Semadoh Riverbank Instability and Erosion Project

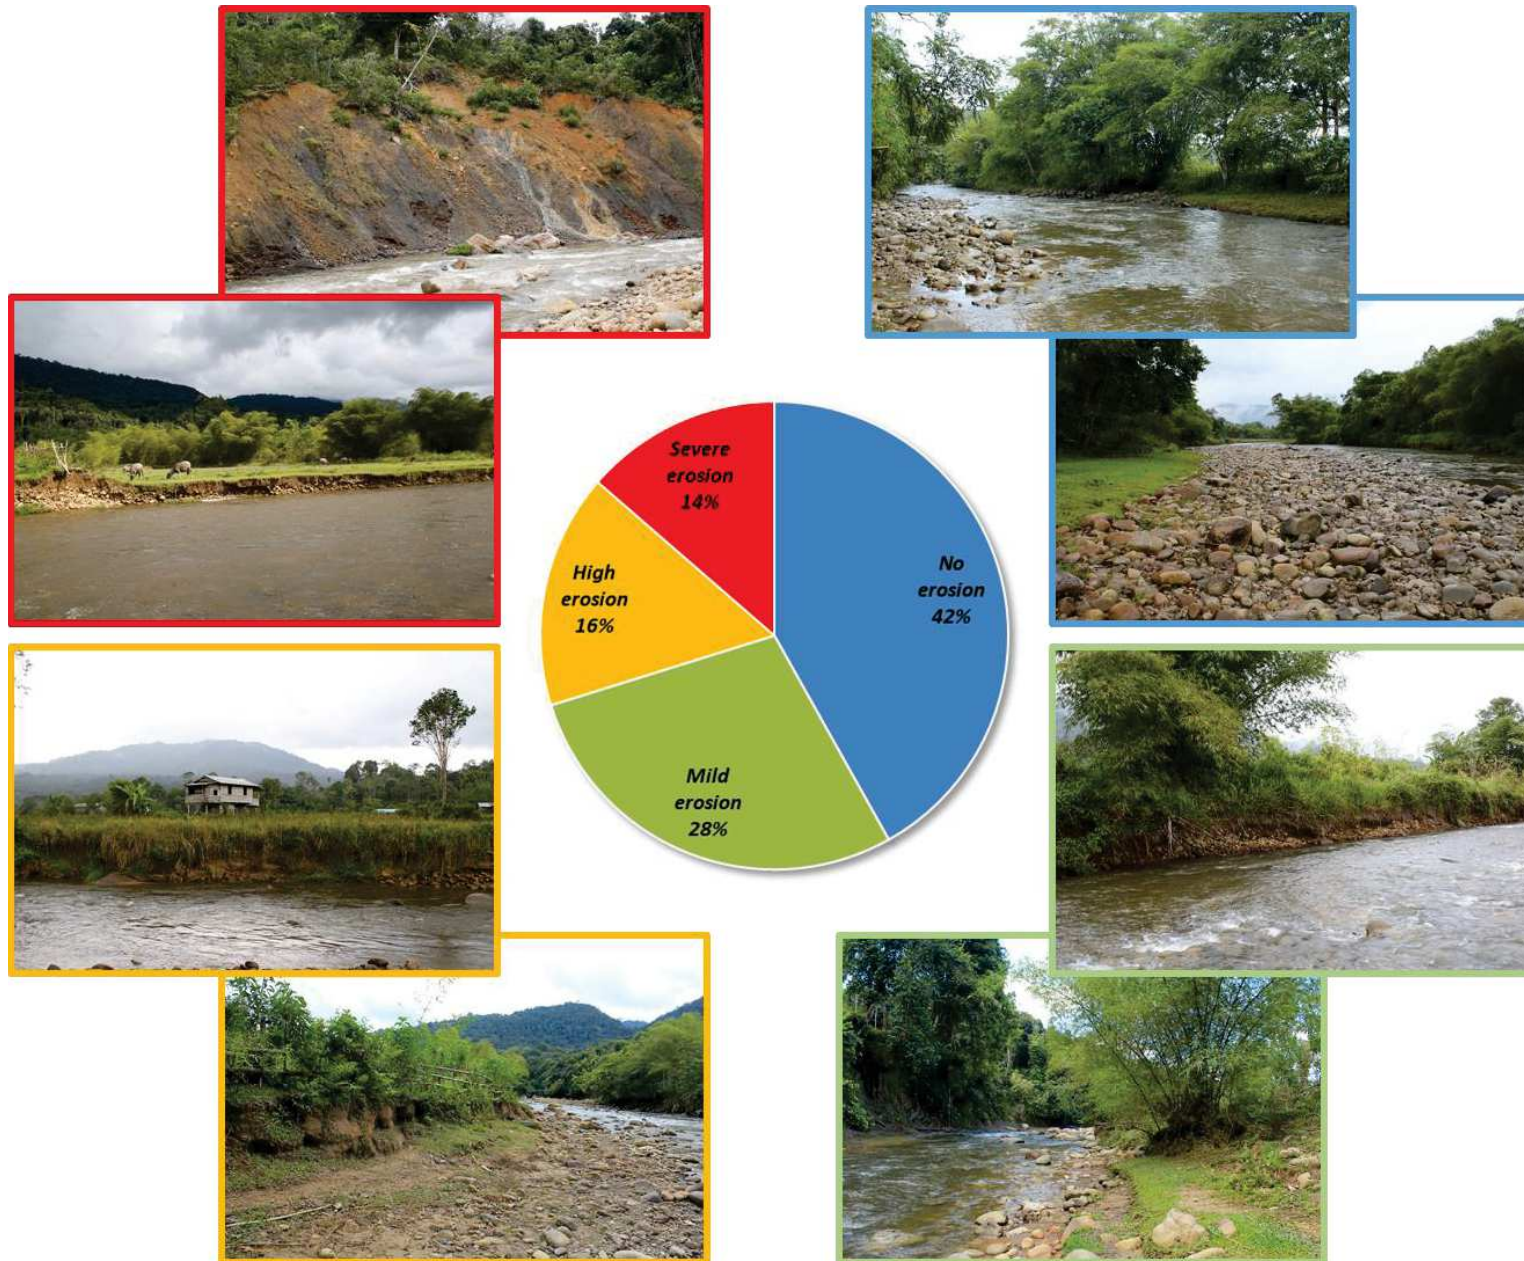
Figure 16. Proportion of the different categories of bank erosion observed in the upper Trusan (see also Figure 17).

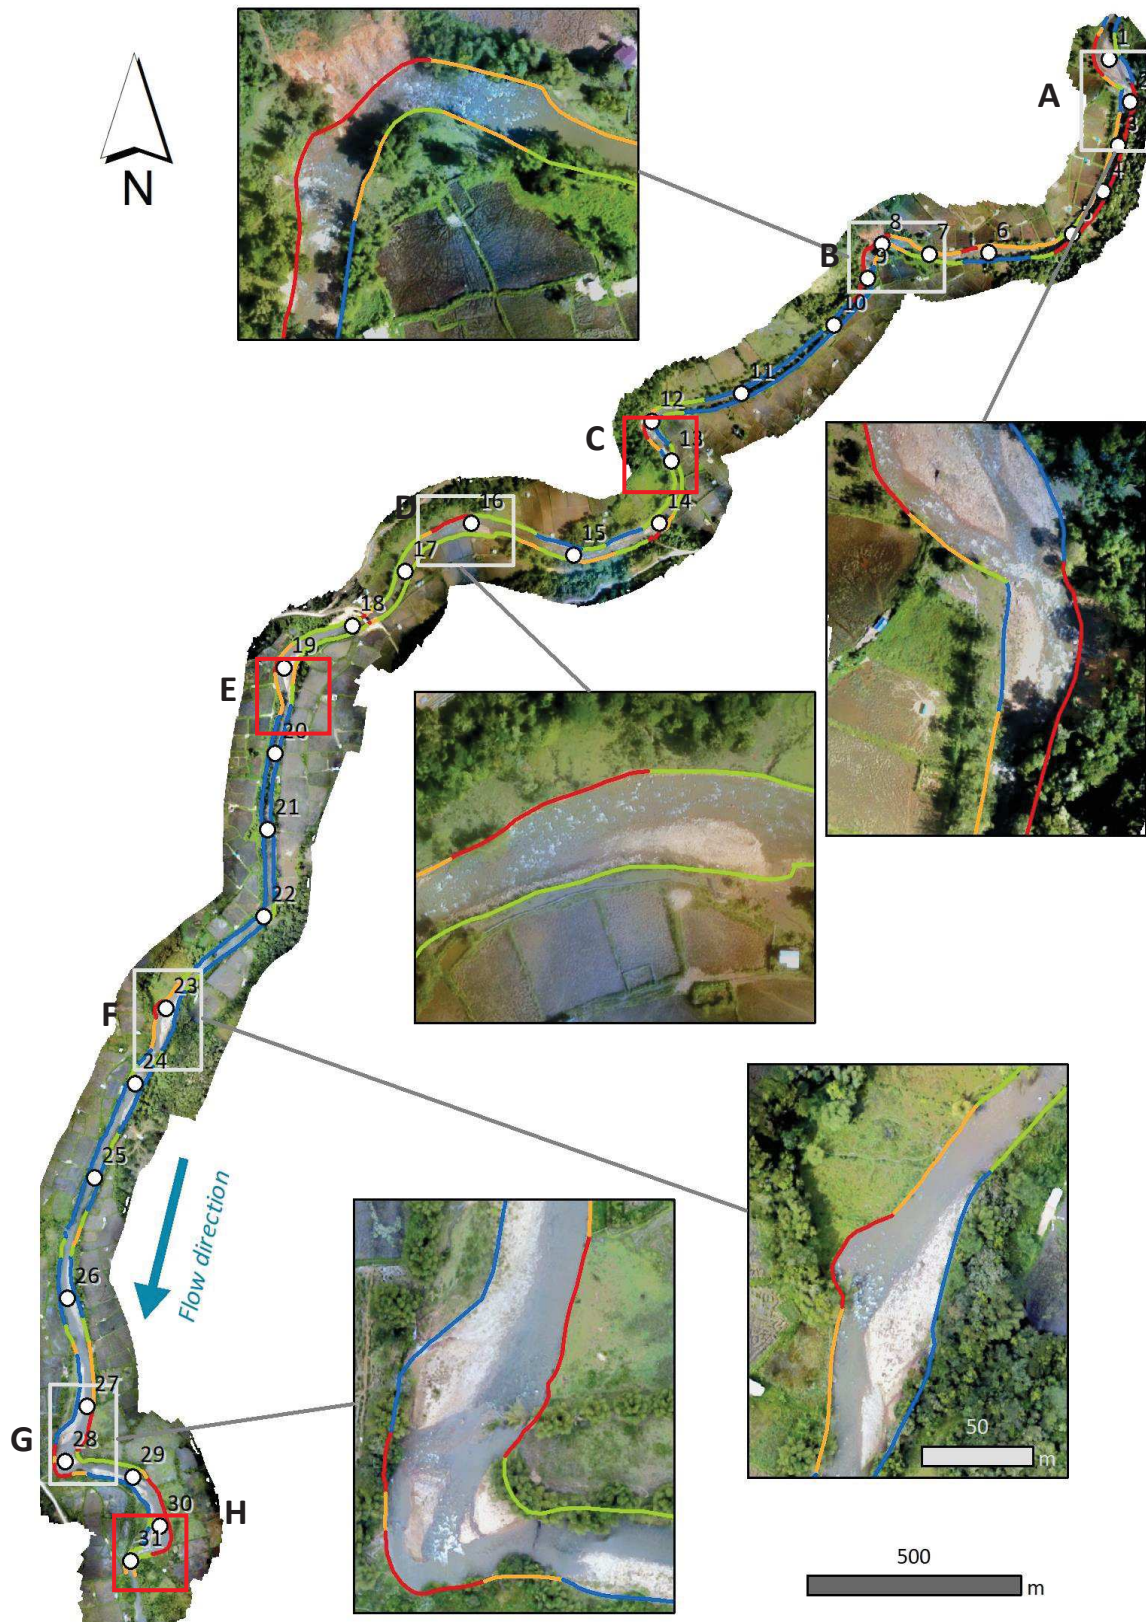
Using a combination aerial and ground photographs, as well as notes from the walk-over survey, a map of erosion was produced (Figure 17). This used a simple classification and basic colour-coding, running from no erosion (0, blue) to severe erosion (3, red), and based on visual assessment of bank stability, height and extent of bank failure and estimated risks of further increase in erosion (considering channel geometry and position of the bank relative to main flow veins). This task was undertaken to provide a primary understanding of erosional issues observed in the field, in order to prioritise the subsequent surveys and modelling exercises. Figure 18 illustrates some of the types and magnitude of erosional issues observed during the survey.

Most of the more extensive problematic areas (red and orange) are located in three main areas: the uppermost 1 km, the lowermost 0.5 km of the study section, and approximately 0.5 km on each side of the road bridge location about half-way through the study section (Figure 17). Between here there are some isolated pressure points, but much of channel has little or no erosion (green and blue). When looking at the total length of banks (i.e. both left and right banks of the study section), the majority (70%, 7.8 km) suffer no or only mild erosion (Figure 16); these could be considered as non-problematic under natural conditions. A remaining 3.3 km of bank was classified as either suffering high or severe erosion. These primarily concern areas with no riparian vegetation, although 2 different conditions were identified; cases where the absence of trees renders riverbanks highly erodible and exposed, and cases where land clearance (usually on slightly higher ground) has caused landslides which are now being eroded by the river, causing important deposition of fine sediments further downstream. These different scenarios are further detailed in the sections below.

Figure 17. Map of erosion in the study section of the Upper Trusan. Red and white boxes show areas of particular concern. Red = severe erosion, orange = high erosion, green = mild erosion, blue = no erosion. Examples of areas of concern (the white boxes) are shown in the zoom-ins; areas in red are not shown as zoom-ins simply due to space, but are discussed the main text.

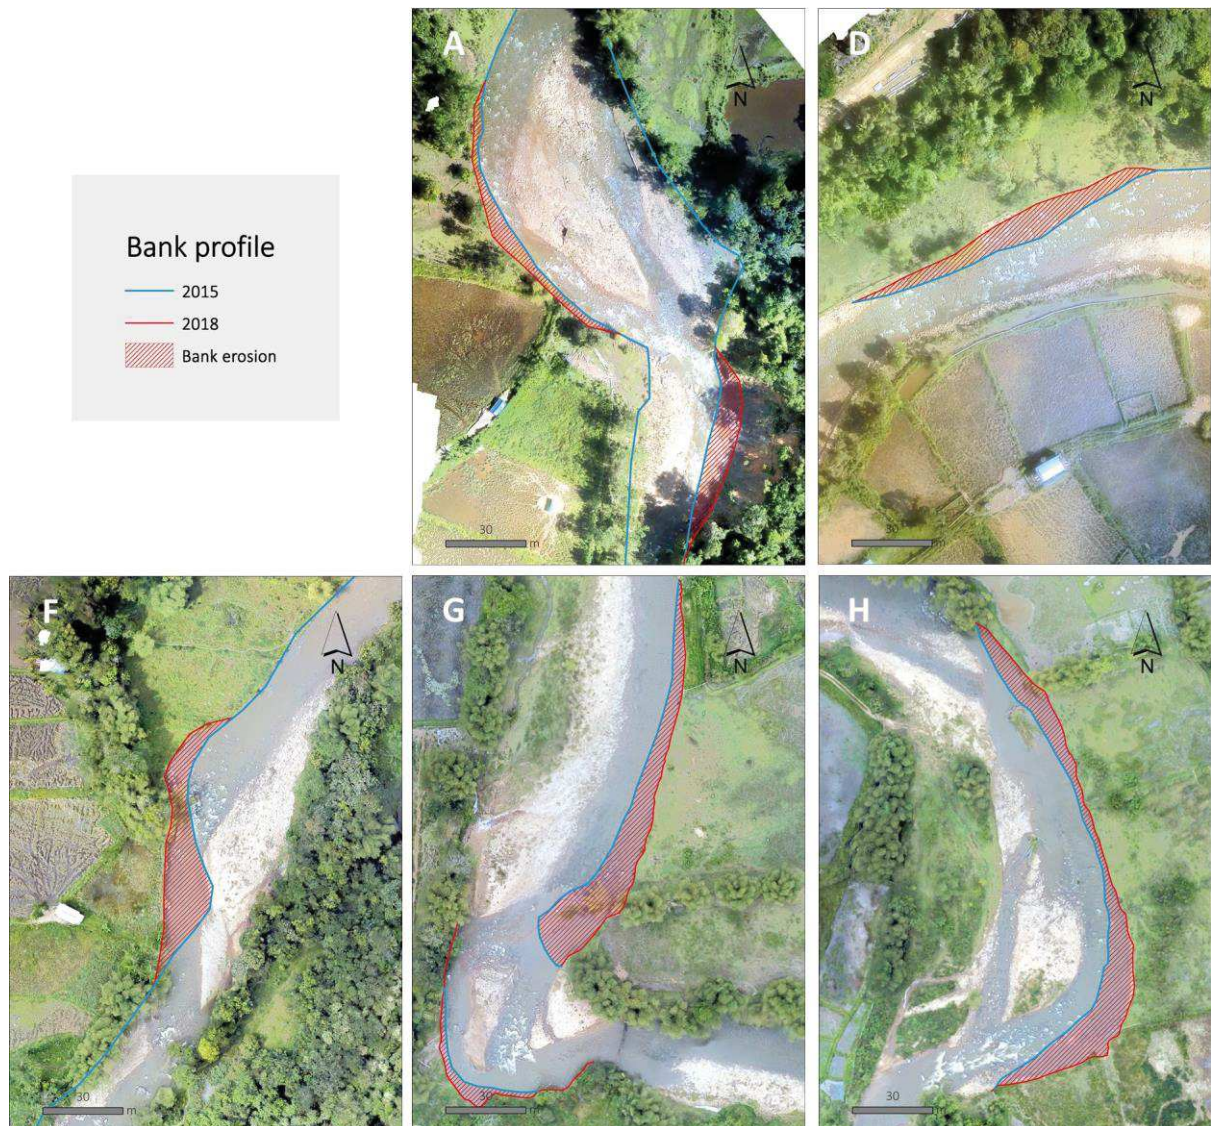
1. The uppermost section (A) shows some erosion on the right bank adjacent to the gravel bar, with bank retreat of 3 to 7 m estimated for the period 2015-18 (Figure 18e; based on Landsat images for the two years). Also, the river here is slowly eroding the forested left bank, with an estimated 10 m bank retreat; appendix Km0.1 and Figure 18e). There is also a major landslide on the left bank, caused by forest clearance on the valley side. Due to the location of this section, there is no direct impact on human settlement. Downstream, between sections A and B, the entire left bank is subject to severe erosion. This is due to intervention in the channel - large boulders have been moved from the right bank towards the centre of the channel in order to prevent erosion of rice paddies, influencing flow hydraulics and conveyance. The consequences are limited by the high resistance of the left bank, although these are likely to remain for a long period (appendices Km0.2 & Km0.4). This area is also subject to trampling by buffalos (appendices 6 & 8) which compact and facilitate erosion of already exposed banks.

7. In Section E, the acceleration of flows caused by the canalised section, together with the presence of a well-developed gravel bar on the left-hand side of the channel, has generated important erosion on the meander (Figure 18e and appendix Km2.8). Although the banks have remained rather stable, much reworking of the previously existing gravel bars has occurred in the last 3 years and may have an impact locally in the future.

Figure 18. Zoom-ins of the main erosional areas; blue lines represent the position of the bank in 2015, and red lines the position of the banks in 2018.

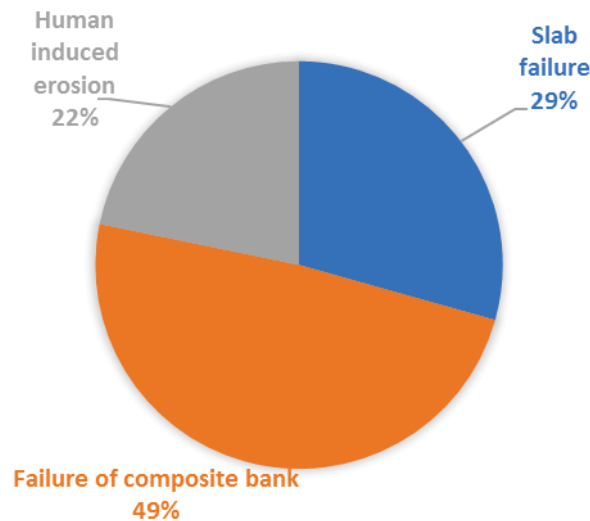
Figure 19. Categories of erosion observed in areas suffering from high or severe erosion. Human induced erosion involves the direct damage caused by diggers or trampling by buffalo. Results indicate that the majority of erosion is caused by the failure of composite banks. This category is often associated with fluvial processes - flow fluctuations, flow competence and bed scouring.

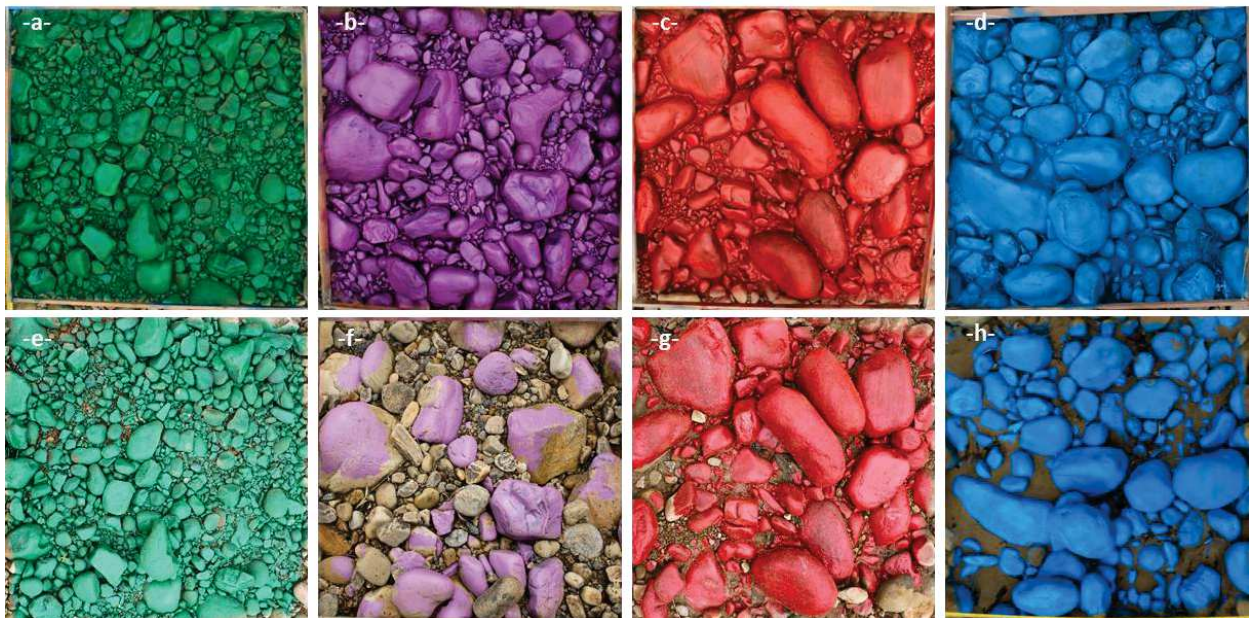
A flood event (or maybe several) occurred between the two field visits (estimated from flood marks as lower than bankfull stage) and some changes were observed on some of the painted patches (Figure 23). These changes were of different nature and reveal the different dynamics at play in different parts of the river. Patches on two bars (bars 3 and 5) showed no clear signs of change (=stability), or at least no change that could be attributed to flow (i.e. there was evidence of just a very small number of small clasts being displaced, but this was so limited that it could have been the result of the action of invertebrates or birds). Several particles of the patch painted on bar 7 were displaced and some were recovered at distances between 0.1 and 25 m downstream. It is important to highlight that some may have moved further but were not found (e.g. displaced out of the bar and/or in the wetted channel). In addition, unpainted sediments were found on top of the patch, showing that particle movement was not limited to the patch itself but likely occurred over much of the bar.

Finally, no particle movement was observed on the bar 9, but the patch was densely covered with sand. Here although the flood event was of the same magnitude as the other locations, sediment dynamics were more depositional than erosional.

Figure 23. Illustration of the different processes observed from painted patches, located on different gravel bars of the River Trusan; bar 3 (-a- & -e-), bar 5 (-b- & -f-), bar 7 (-c- & -g-) and bar 9 (-d- & -h-).

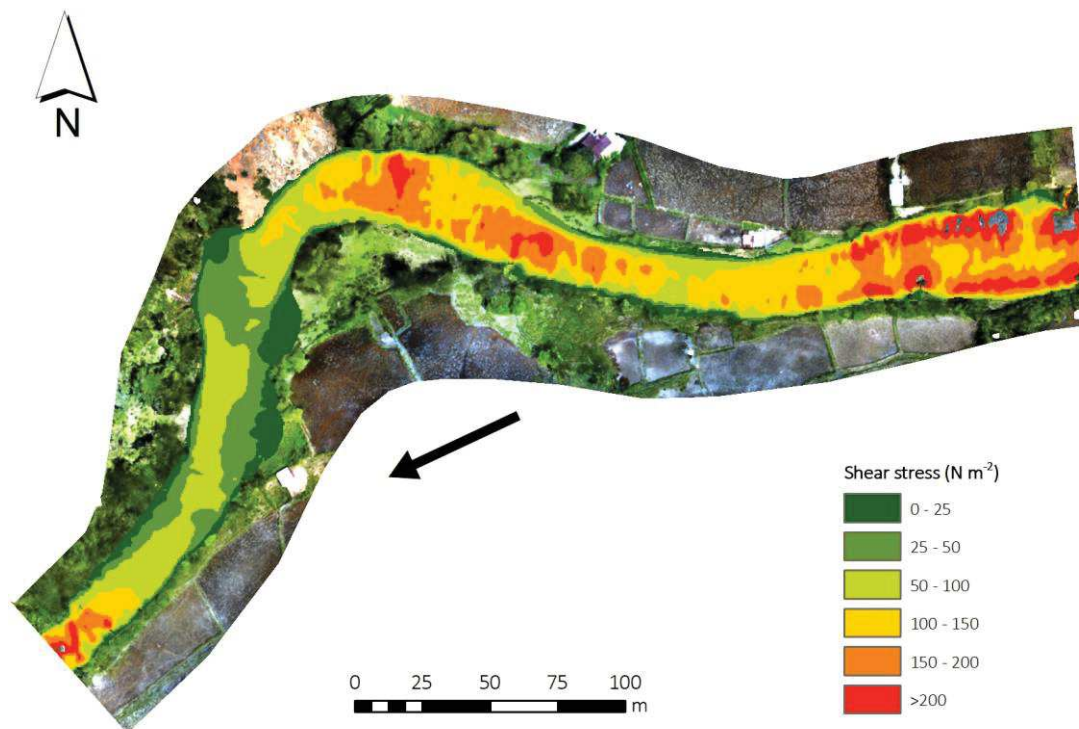
The upper reach (Figure 25; Reach 1 in Figure 3) shows high shear stresses in places where depth is low to moderate as flows are turbulent. The entrance of the bend, where the right bank is clearly exposed (i.e. land cleared and high sediment delivery into the channel), shear stresses are also very high and so water hits the banks at high velocity and force. The energy is then rather well dissipated, with the section directly downstream from the bend being very deep and having low shear stresses (i.e. low velocities) and easily subject to deposition of finer particles (such as the ones eroded from the exposed bank upstream). This is supported by field observations of fine material accumulating on the surface of the bar in this area.

Figure 25. Shear stresses estimates from the 2D model at bankfull discharge ( $Q = 75 \text{ m}^3 \text{ s}^{-1}$ ) for the upper reach (Reach 1 in Figure 3).

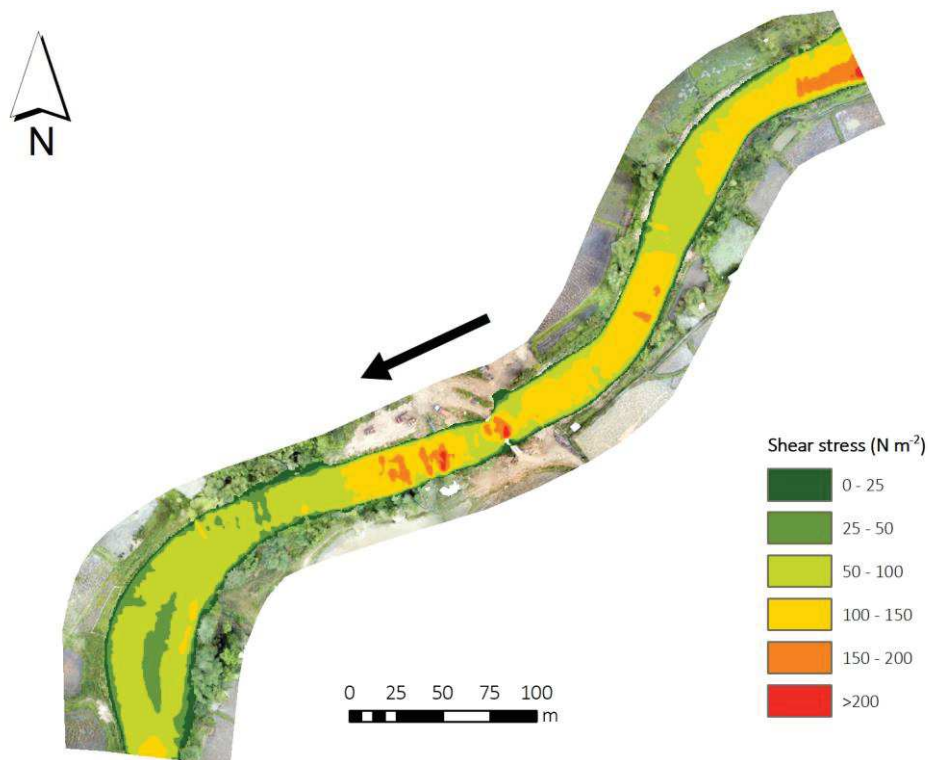
The model output for the middle reach (Reach 4 in Figure 3) is shown in Figure 26. This reach was fully channelized upstream from the road bridge (located approximately in the middle of Figure 26, adjacent to the flow direction arrow). At bankfull, the channelized section is clearly homogeneous with high shear stresses ( $>100 \text{ N m}^{-2}$ ) over the entire width of the channel, initiating an accelerated area of flows concentrated under the bridge that generate very high shear stresses in the vicinity of the bridge as well as further downstream. As the water moves downstream, it appears that shear stresses are not particularly high on the outside the bend. Stresses are higher on the inside; this corresponds with field observation of rather intense erosion of exposed banks in these areas, despite them being outside the wetted channel at low flows.

Figure 26. Shear stresses estimates from the 2D model at bankfull discharge ( $Q = 75 \text{ m}^3 \text{ s}^{-1}$ ) for the middle reach.

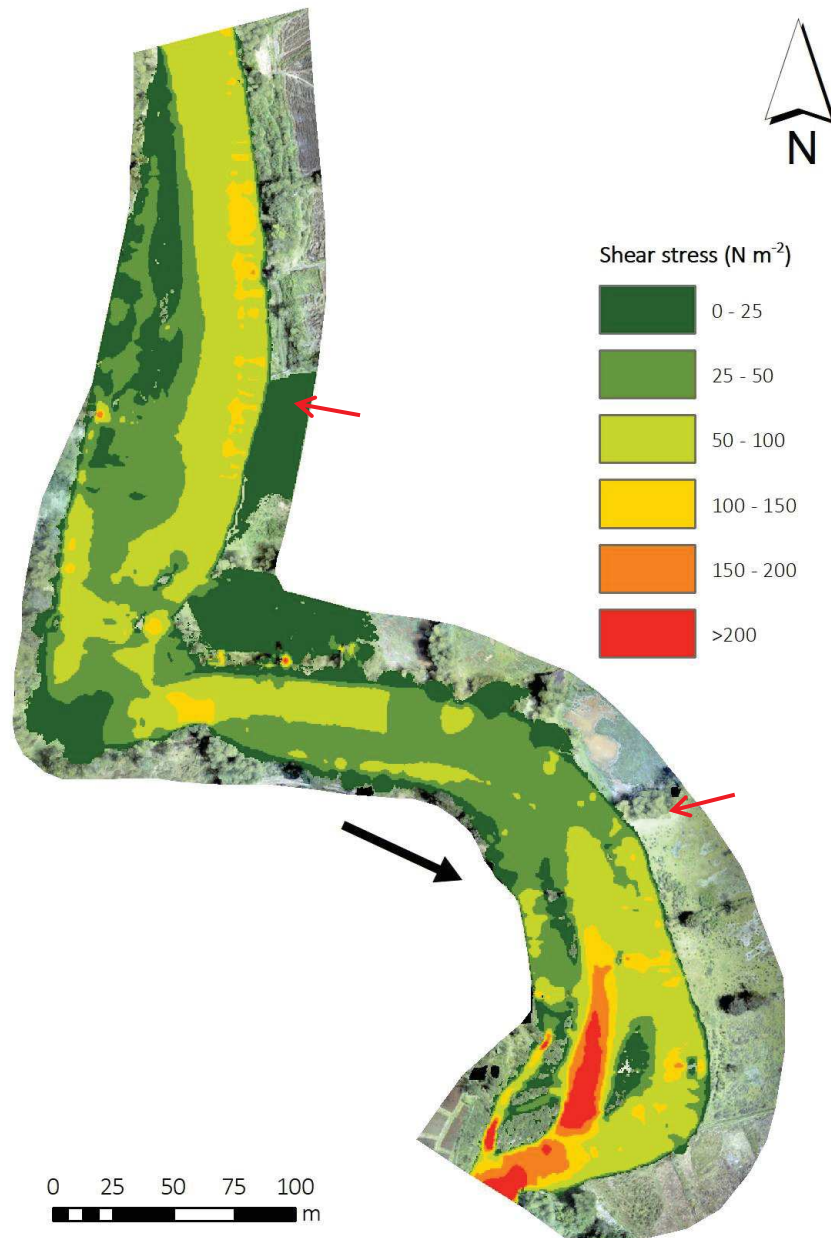
in locations suffering from severe erosion (see arrows). This, along with the observations made earlier about the importance of the absence of vegetation, illustrates that hydraulics is not directly responsible for the occurrence of severe erosion along these banks. A combination of bank material properties (i.e. loose fluvial material) and the lack of trees rendered these areas sensitive to erosion even for the moderate shear stresses that occur during bankfull discharges.

Figure 27. Shear stresses estimates from the 2D model at bankfull discharge ( $Q = 75\ m^3\ s^{-1}$ ) for the lower reach.

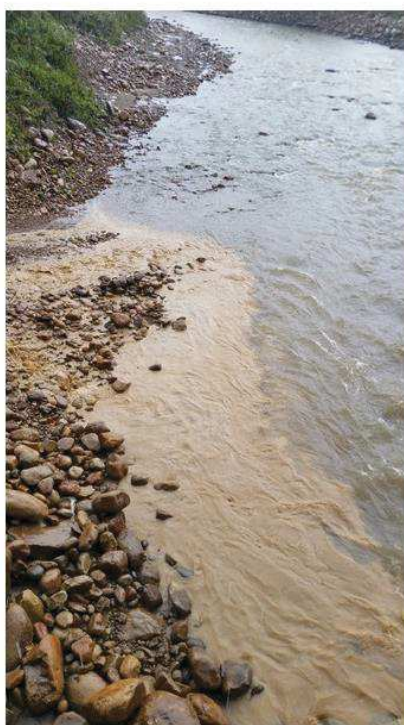
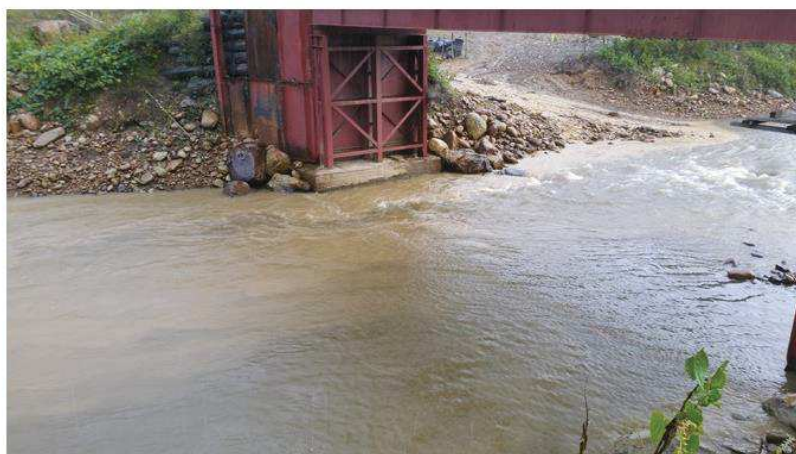
*Plate 2. Bridge at Punan Trusan. These images show water entering the river from an access track (left), and how the plume of fine sediment is conveyed downstream, resulting in a visible increase in turbidity across the channel. March 2018.*

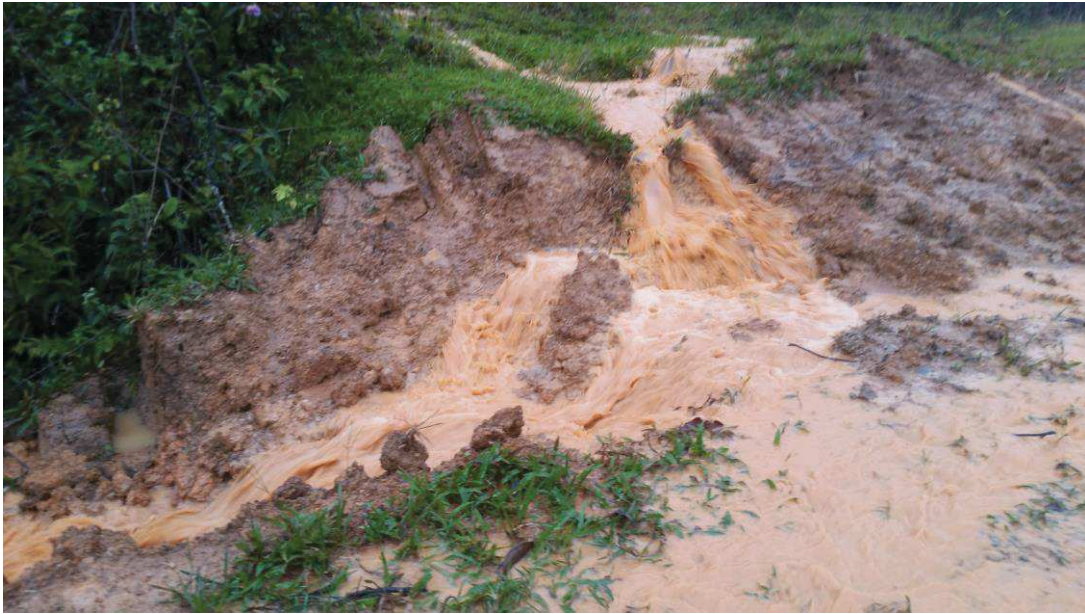
*Plate 3. Track on hillslope approximately 1 km above Punan Trusan. This image was taken during a late afternoon thunderstorm. March 2018.*

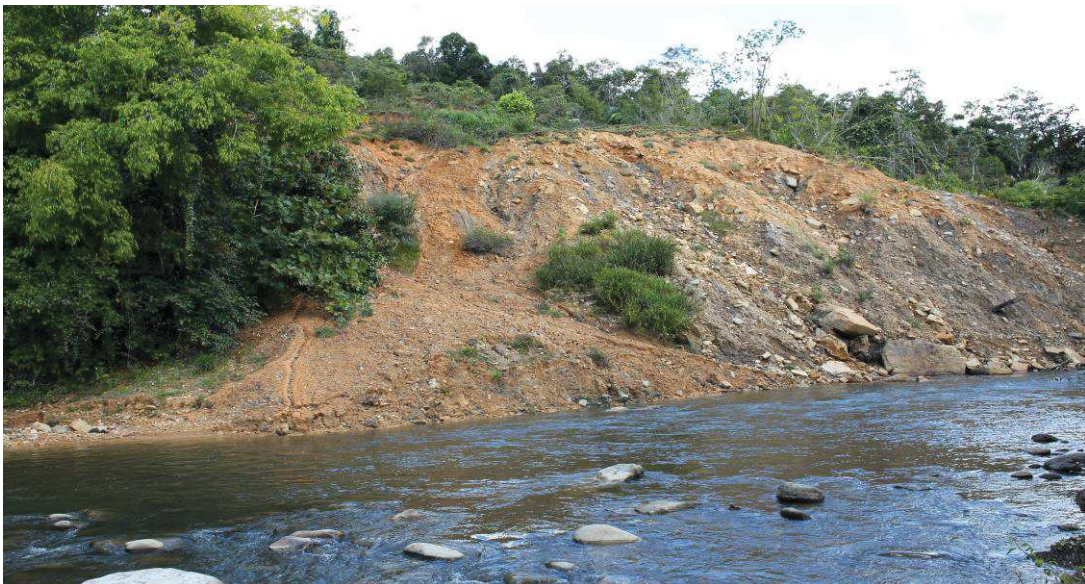
*Plate 4. An example of a major landslide associated with localised forest clearance.*

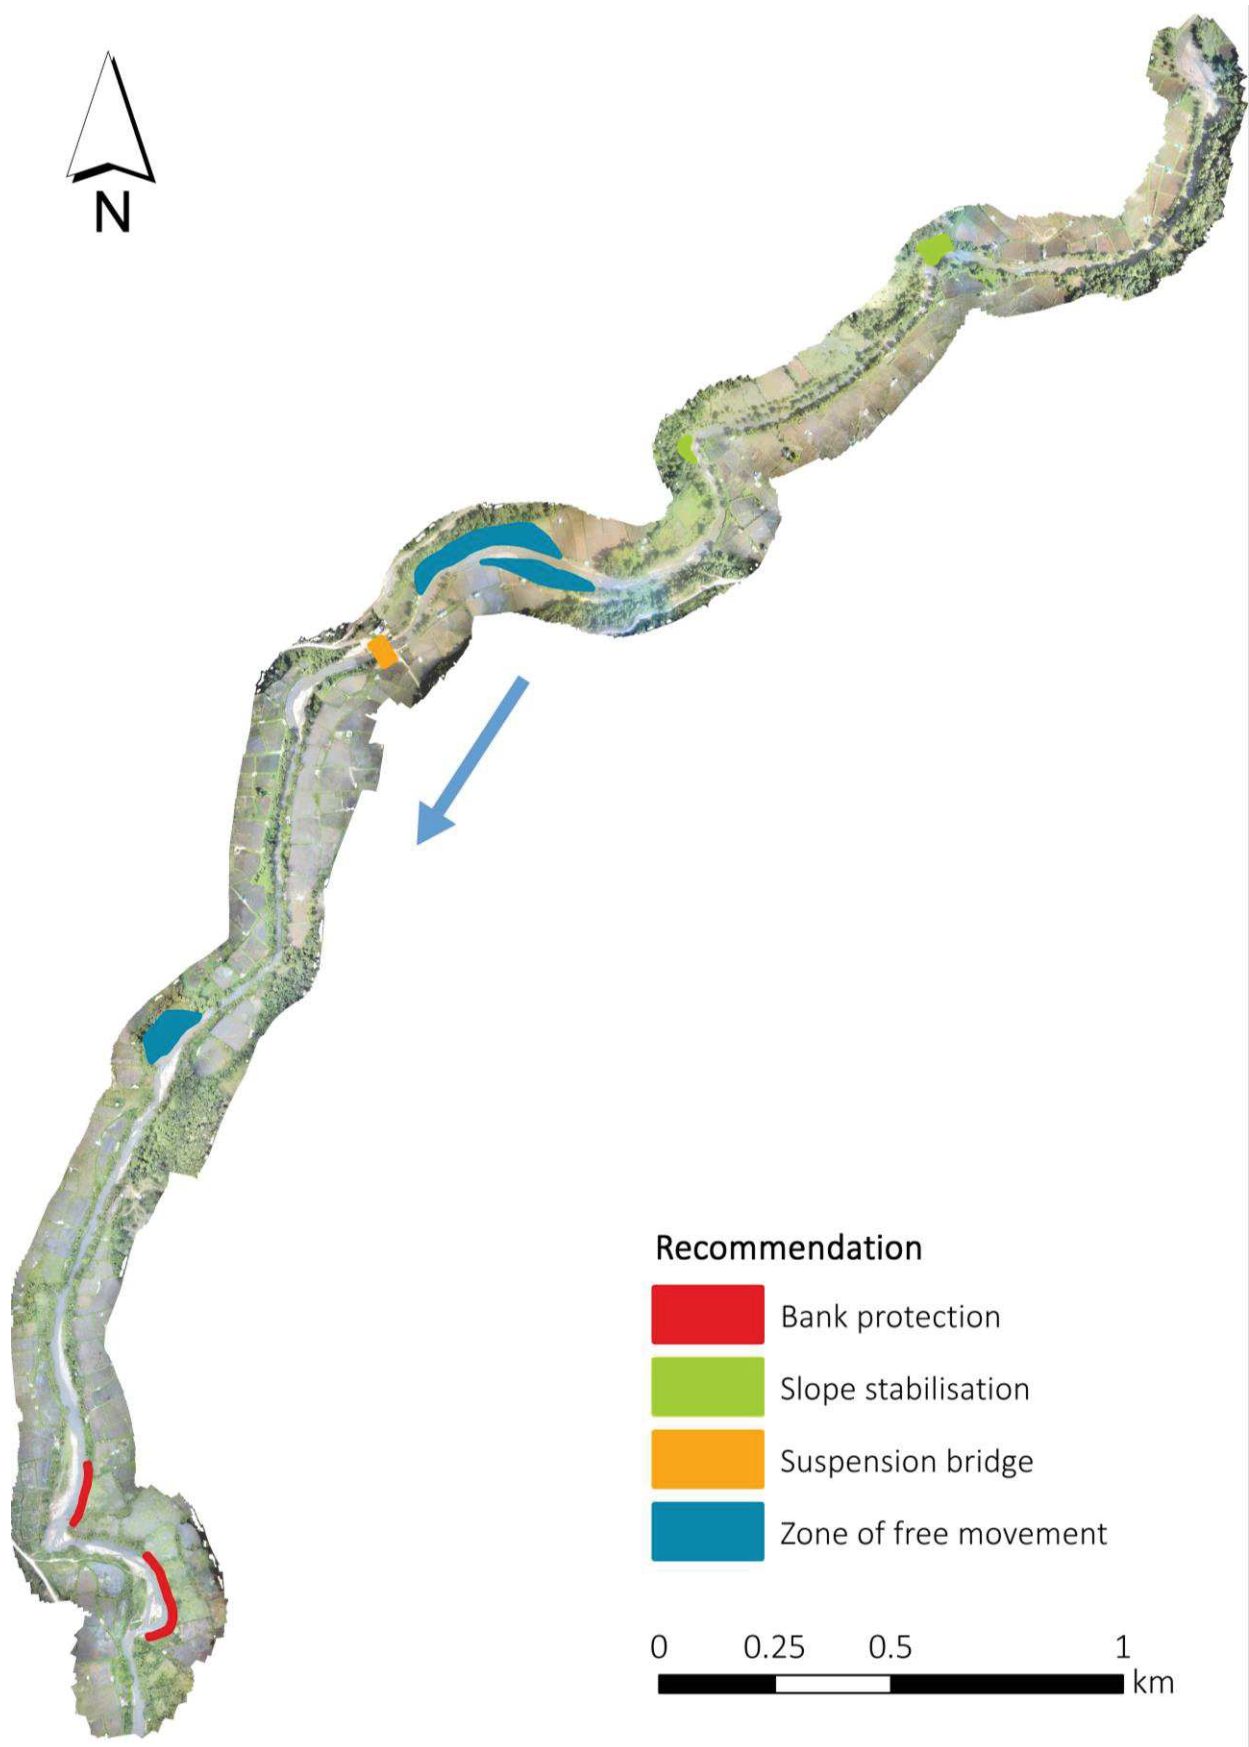
Figure 28. Map of recommendations proposed at the corridor scale for the Upper Trusan River.

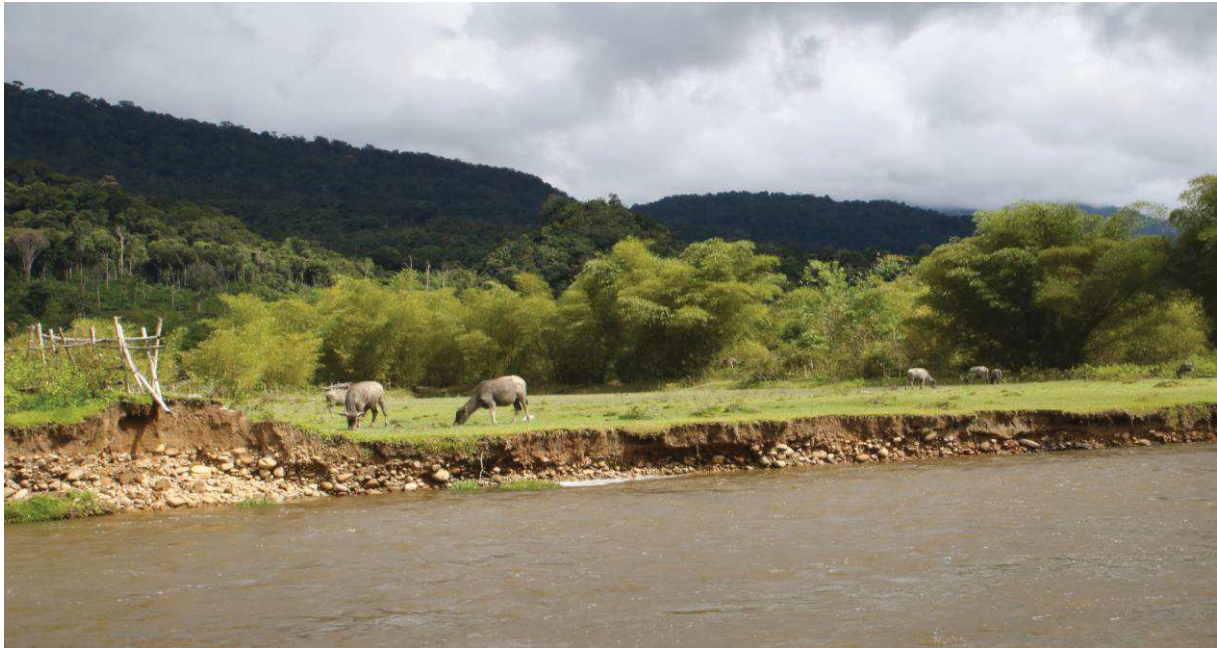
*Plate 5. Example of a cleared riparian area, with pasture land extending all the way to the riverbank. Not only are the banks unprotected (i.e. no binding tree roots), but they have the additional pressure of being trampled by buffalo. The bank is undermined over a distance of approximately 100 m, with retreat in this area estimated from aerial images to have been in the order of 18 m in the last three years (March 2018).*

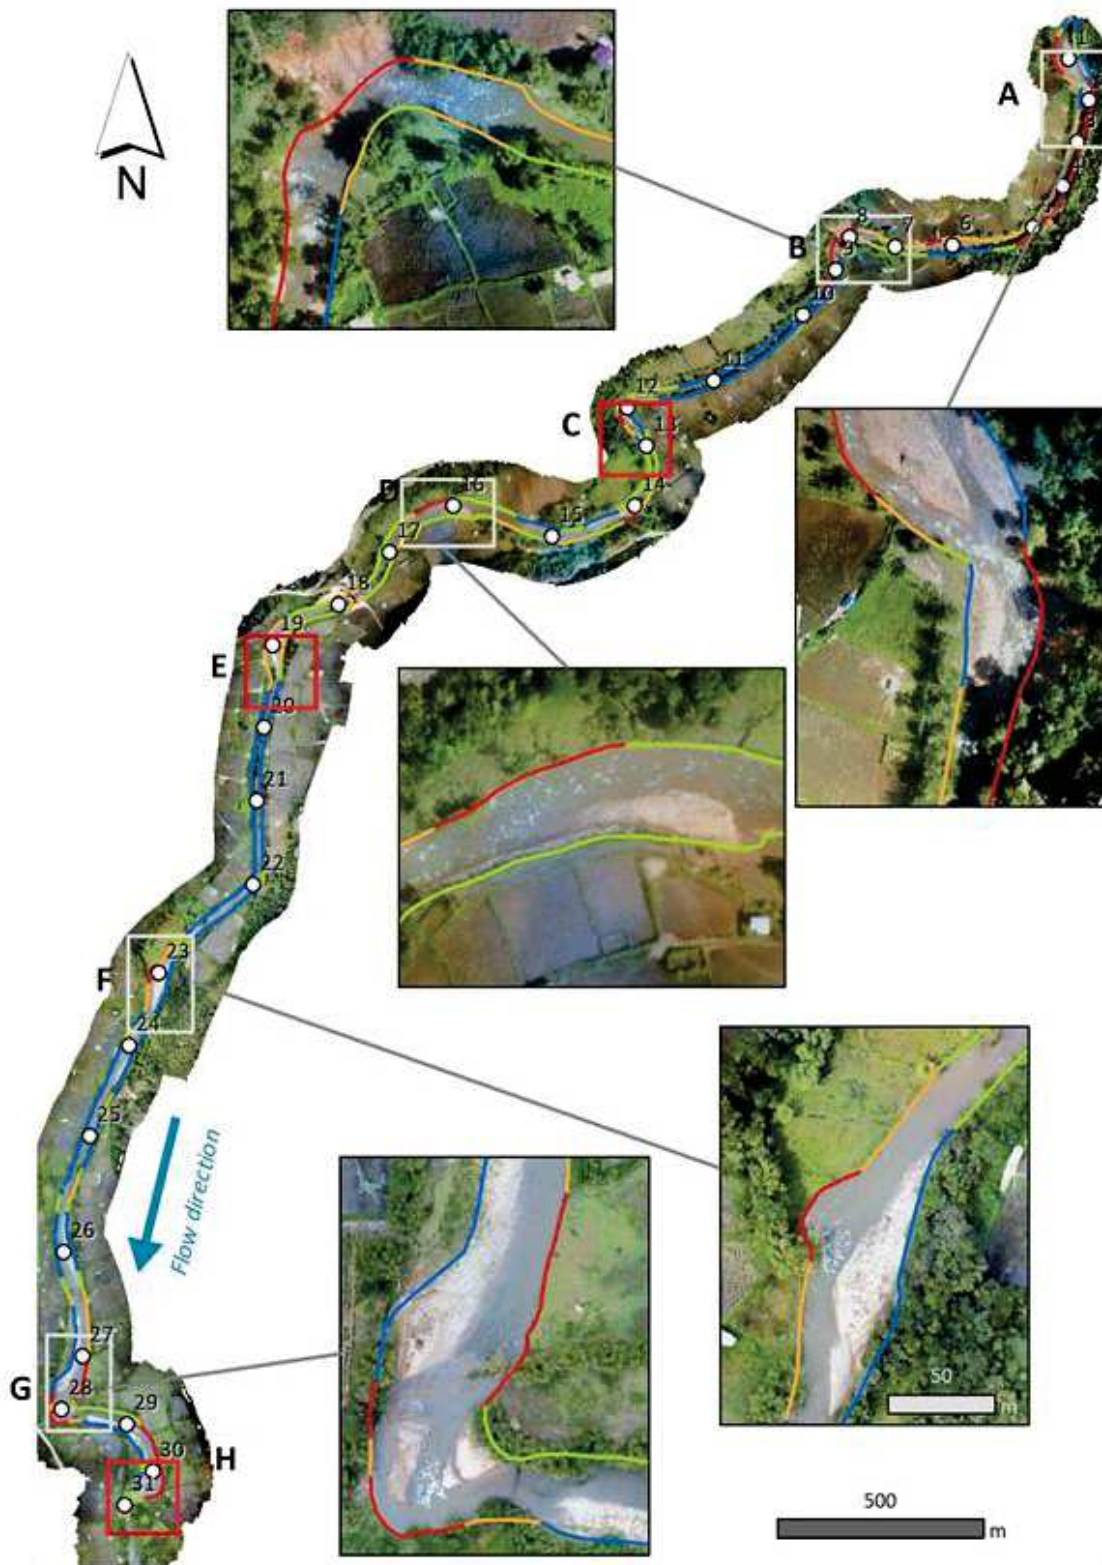
Figure 29. Map of erosion within the study section. Areas where localised measured may be considered are labelled A-F.

There is a small number of places where local intervention may be needed to avoid further deterioration of channel conditions. ‘Soft’ or ‘bio-engineering’ approaches should be adopted – these are less expensive than traditional or hard engineering solutions and offer greater prospects for long term success. To aid discussion of these, Figure 17 is repeated below. The key point to stress is that these interventions should be implemented alongside the catchment and corridor scale management outlined above.

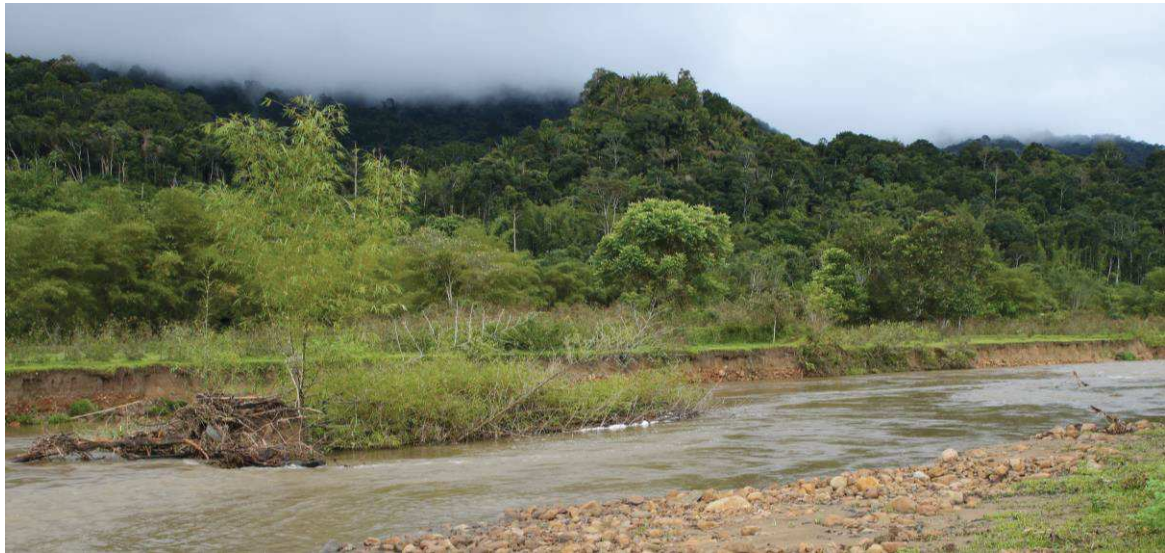
Plate 6. Erosion in the most downstream part of the study section (March 2018).

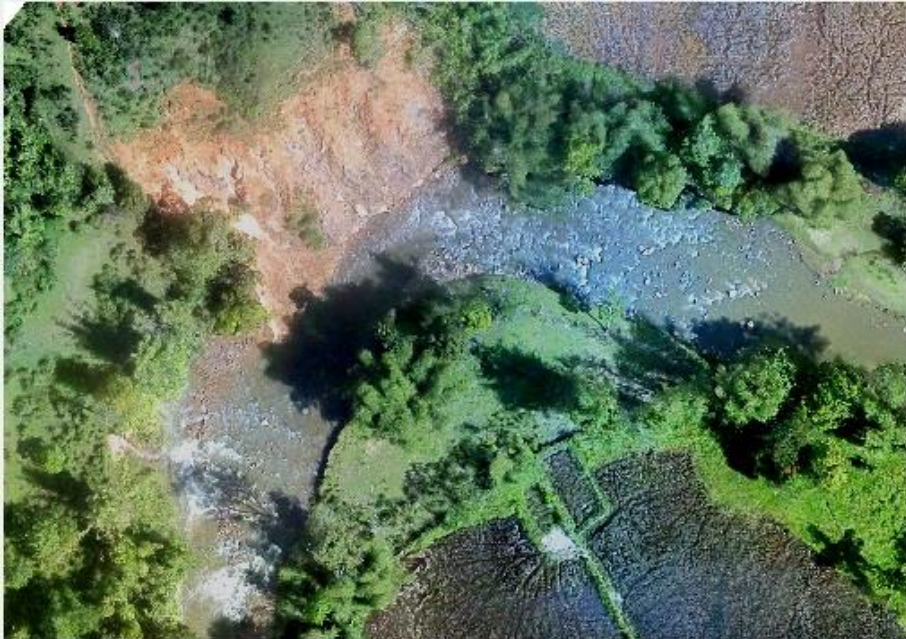
Appendix Km0.9 (continued).

2. Section B shows a large landslide on the right bank due to land clearance (appendix Km0.9). The area subject to slope degradation increased by 50% (from 1000 m<sup>2</sup> to 1500 m<sup>2</sup>) between 2015 and 2018 (based on analysis of aerial images). The consequences of this landslide are directly visible on the gravel bars immediately downstream, with large lenses of sand and fine deposits observed on top of coarser material.

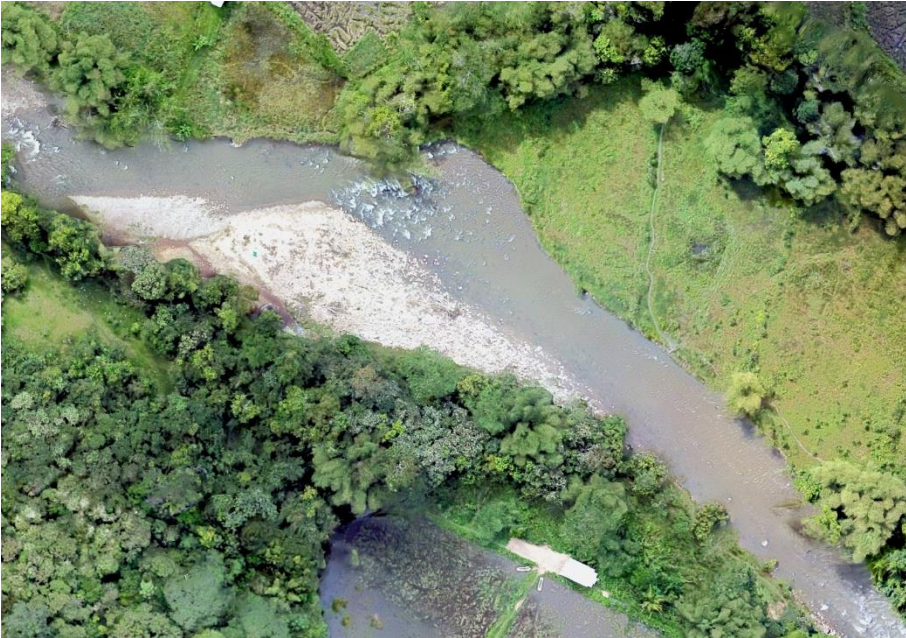
Appendix Km3.7 (continued).

8. In Section F, the absence of riparian vegetation (Figure 17 inset and appendix Km3.7) is responsible for the erosion observed on the right bank. Up to 18 m of bank (i.e. estimated 980 m<sup>2</sup> of land) has disappeared in this bend since 2015 (Figure 14c). At the moment this does not directly threaten valuable land, but if erosion continues it is likely that some rice paddies on the right side of the channel will be lost to the river.
