# Hydrological & geomorphological analysis of the Upper Trusan River to assess remediation for riverbank integrity. WWF-Malaysia Project Report

Baptiste Marteau, Chris Gibbins, Ramon J. Batalla, Damià Vericat

Report Produced Under Project SW010603-831-CORP SCP-CIMB

Long Semadoh Riverbank Instability and Erosion Project

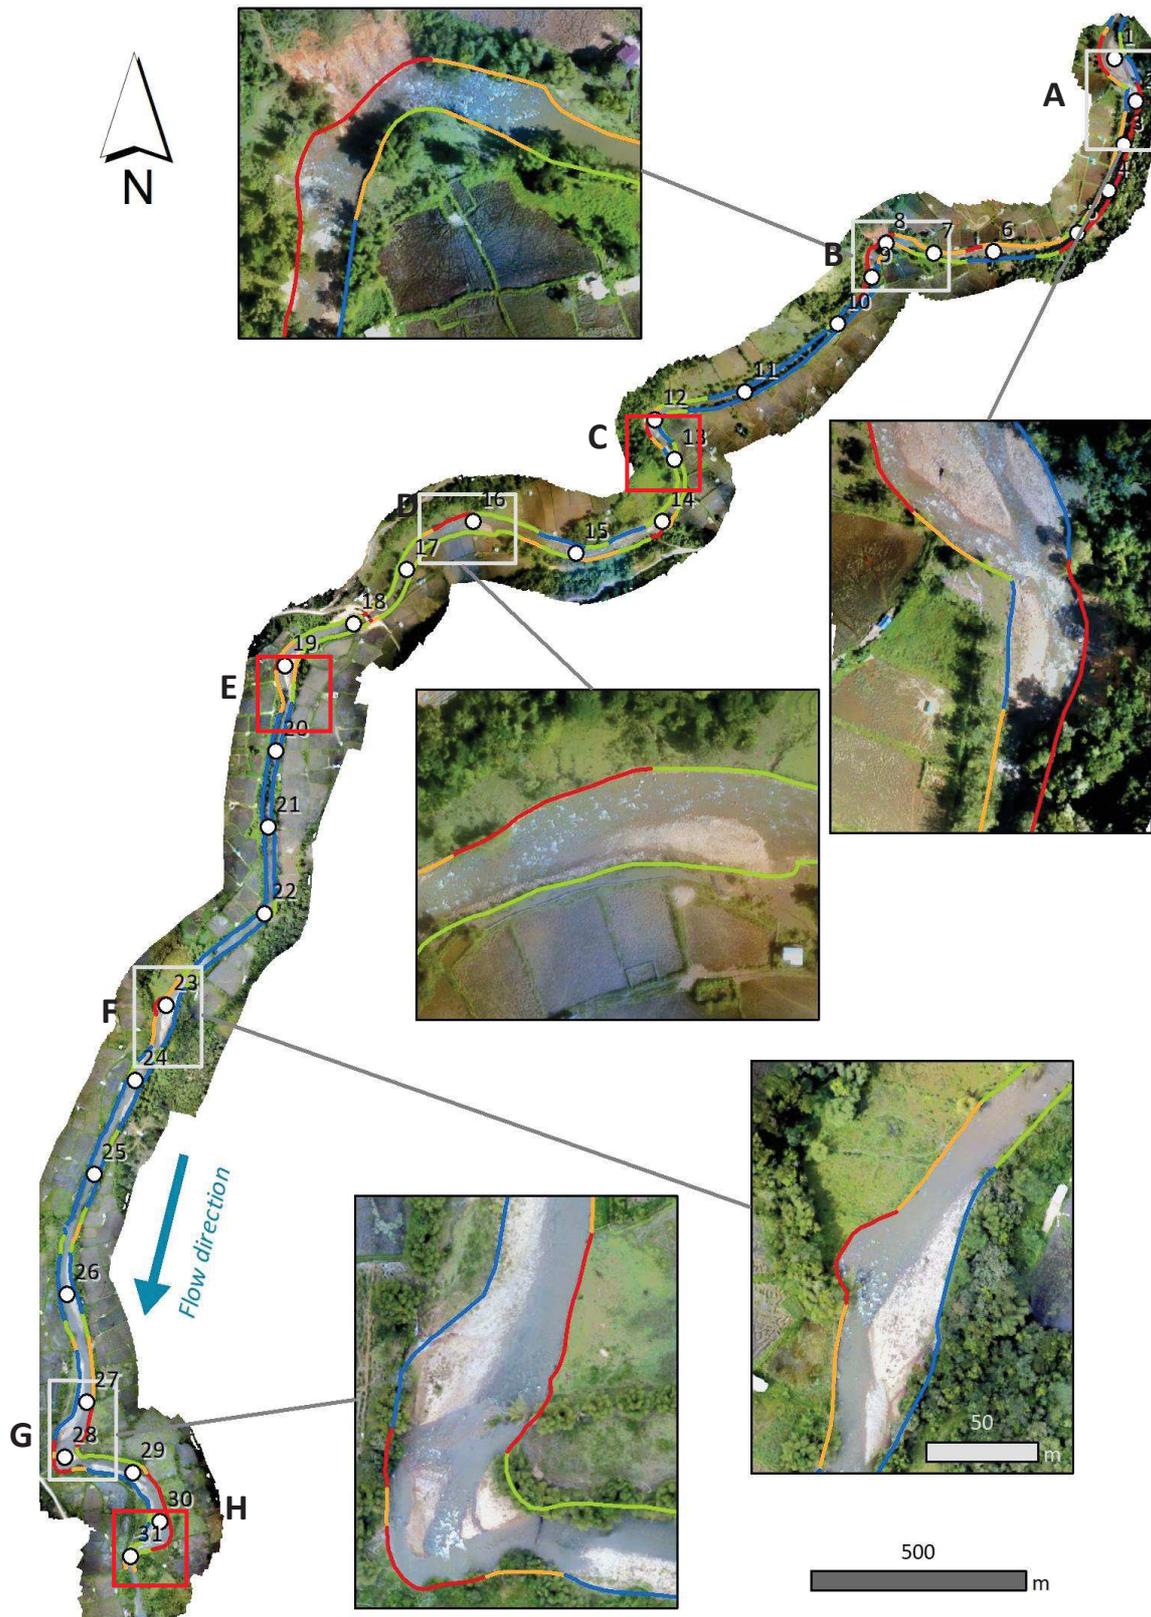
Using a combination aerial and ground photographs, as well as notes from the walk-over survey, a map of erosion was produced (Figure 17). This used a simple classification and basic colour-coding, running from no erosion (0, blue) to severe erosion (3, red), and based on visual assessment of bank stability, height and extent of bank failure and estimated risks of further increase in erosion (considering channel geometry and position of the bank relative to main flow veins). This task was undertaken to provide a primary understanding of erosional issues observed in the field, in order to prioritise the subsequent surveys and modelling exercises. Figure 18 illustrates some of the types and magnitude of erosional issues observed during the survey.

Most of the more extensive problematic areas (red and orange) are located in three main areas: the uppermost 1 km, the lowermost 0.5 km of the study section, and approximately 0.5 km on each side of the road bridge location about half-way through the study section (Figure 17). Between here there are some isolated pressure points, but much of channel has little or no erosion (green and blue). When looking at the total length of banks (i.e. both left and right banks of the study section), the majority (70%, 7.8 km) suffer no or only mild erosion (Figure 16); these could be considered as non-problematic under natural conditions. A remaining 3.3 km of bank was classified as either suffering high or severe erosion. These primarily concern areas with no riparian vegetation, although 2 different conditions were identified; cases where the absence of trees renders riverbanks highly erodible and exposed, and cases where land clearance (usually on slightly higher ground) has caused landslides which are now being eroded by the river, causing important deposition of fine sediments further downstream. These different scenarios are further detailed in the sections below.

Figure 17. Map of erosion in the study section of the Upper Trusan. Red and white boxes show areas of particular concern. Red = severe erosion, orange = high erosion, green = mild erosion, blue = no erosion. Examples of areas of concern (the white boxes) are shown in the zoom-ins; areas in red are not shown as zoom-ins simply due to space, but are discussed the main text.

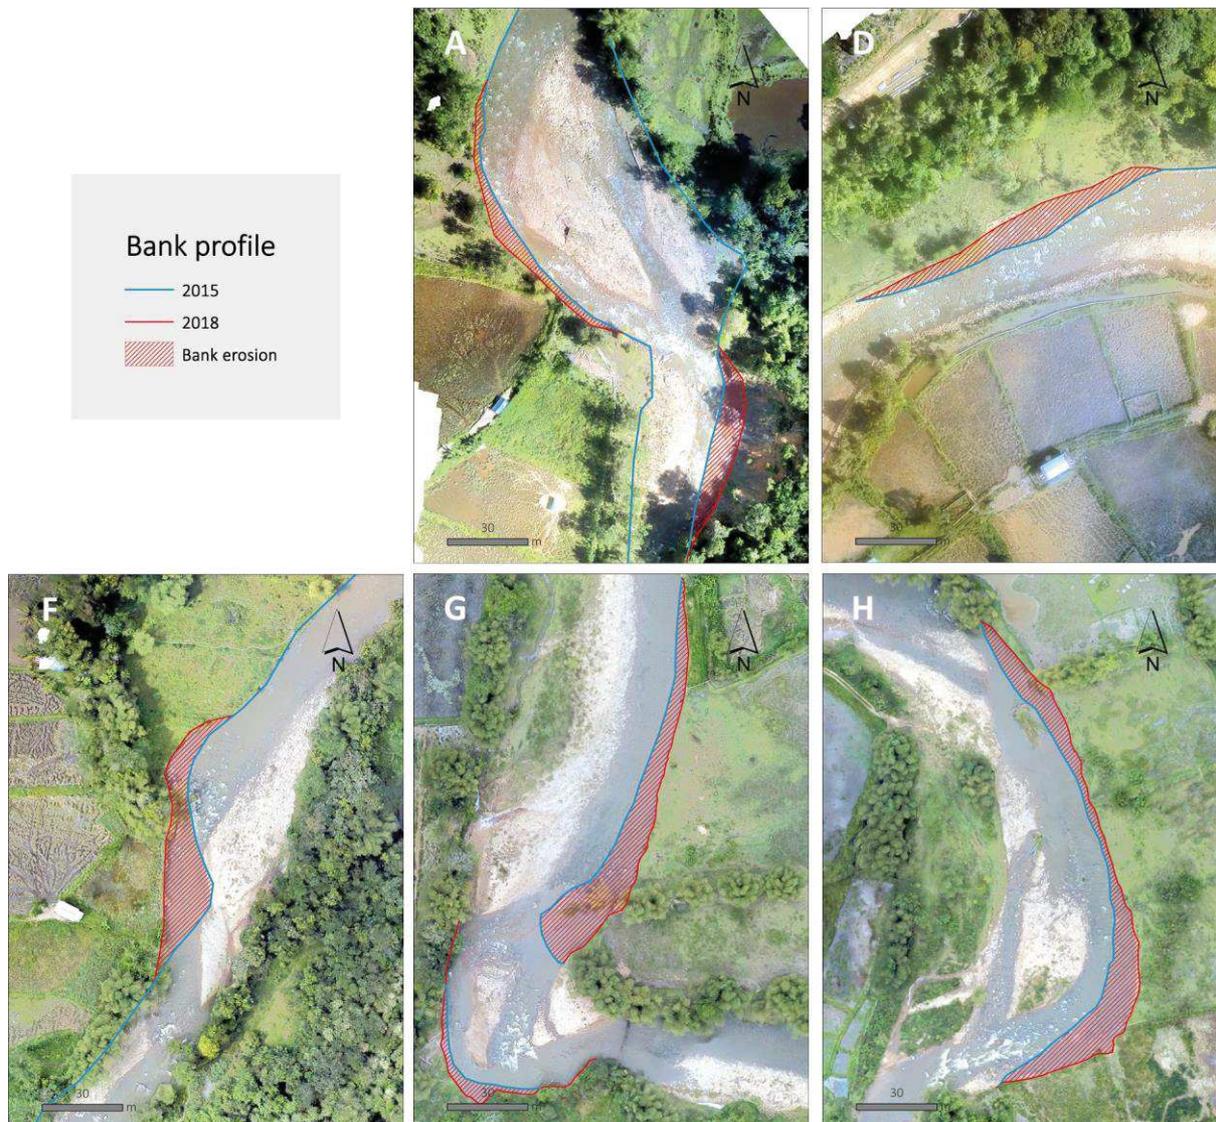
1. The uppermost section (A) shows some erosion on the right bank adjacent to the gravel bar, with bank retreat of 3 to 7 m estimated for the period 2015-18 (Figure 18e; based on Landsat images for the two years). Also, the river here is slowly eroding the forested left bank, with an estimated 10 m bank retreat; appendix Km0.1 and Figure 18e). There is also a major landslide on the left bank, caused by forest clearance on the valley side. Due to the location of this section, there is no direct impact on human settlement. Downstream, between sections A and B, the entire left bank is subject to severe erosion. This is due to intervention in the channel - large boulders have been moved from the right bank towards the centre of the channel in order to prevent erosion of rice paddies, influencing flow hydraulics and conveyance. The consequences are limited by the high resistance of the left bank, although these are likely to remain for a long period (appendices Km0.2 & Km0.4). This area is also subject to trampling by buffalos (appendices 6 & 8) which compact and facilitate erosion of already exposed banks.

7. In Section E, the acceleration of flows caused by the canalised section, together with the presence of a well-developed gravel bar on the left-hand side of the channel, has generated important erosion on the meander (Figure 18e and appendix Km2.8). Although the banks have remained rather stable, much reworking of the previously existing gravel bars has occurred in the last 3 years and may have an impact locally in the future.

Figure 18. Zoom-ins of the main erosional areas; blue lines represent the position of the bank in 2015, and red lines the position of the banks in 2018.

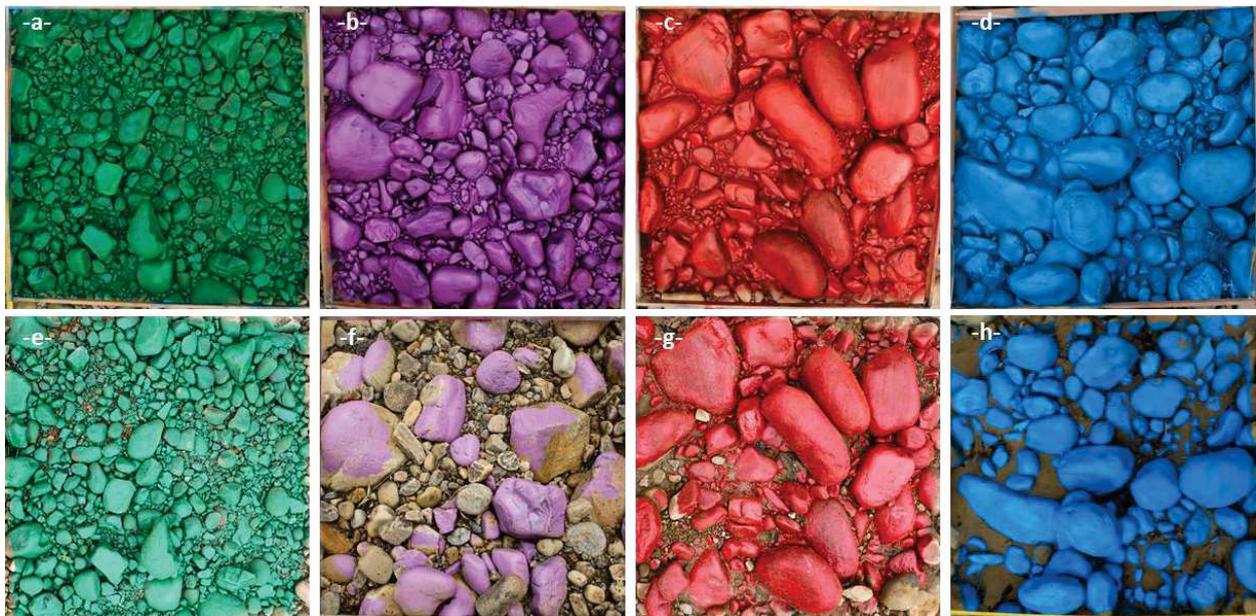
A flood event (or maybe several) occurred between the two field visits (estimated from flood marks as lower than bankfull stage) and some changes were observed on some of the painted patches (Figure 23). These changes were of different nature and reveal the different dynamics at play in different parts of the river. Patches on two bars (bars 3 and 5) showed no clear signs of change (=stability), or at least no change that could be attributed to flow (i.e. there was evidence of just a very small number of small clasts being displaced, but this was so limited that it could have been the result of the action of invertebrates or birds). Several particles of the patch painted on bar 7 were displaced and some were recovered at distances between 0.1 and 25 m downstream. It is important to highlight that some may have moved further but were not found (e.g. displaced out of the bar and/or in the wetted channel). In addition, unpainted sediments were found on top of the patch, showing that particle movement was not limited to the patch itself but likely occurred over much of the bar.

Finally, no particle movement was observed on the bar 9, but the patch was densely covered with sand. Here although the flood event was of the same magnitude as the other locations, sediment dynamics were more depositional than erosional.

Figure 23. Illustration of the different processes observed from painted patches, located on different gravel bars of the River Trusan; bar 3 (-a- & -e-), bar 5 (-b- & -f-), bar 7 (-c- & -g-) and bar 9 (-d- & -h-).

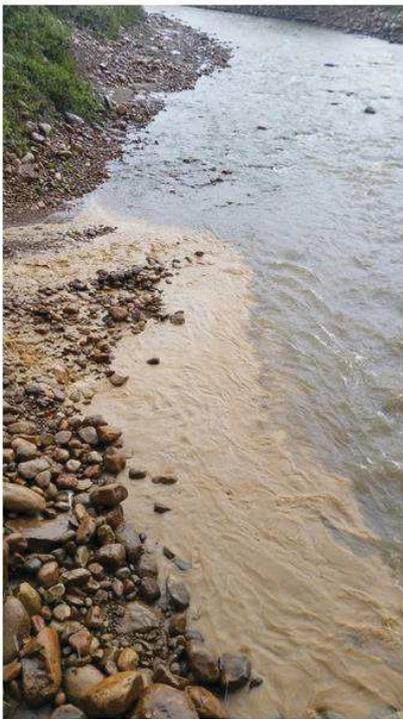
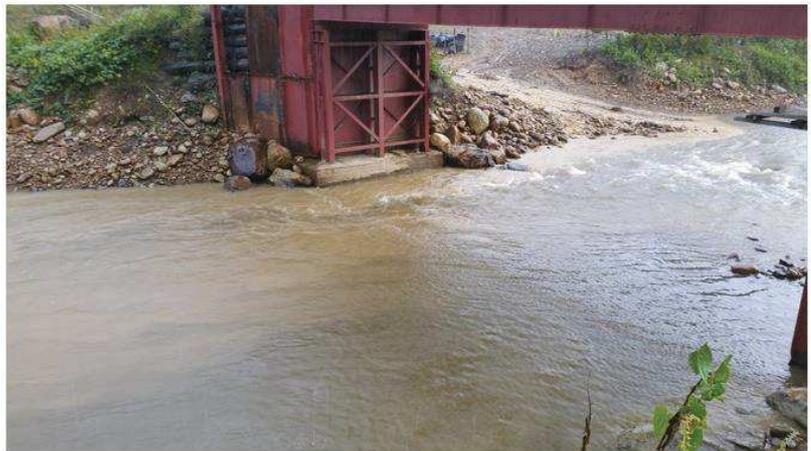
*Plate 2. Bridge at Punan Trusan. These images show water entering the river from an access track (left), and how the plume of fine sediment is conveyed downstream, resulting in a visible increase in turbidity across the channel. March 2018.*

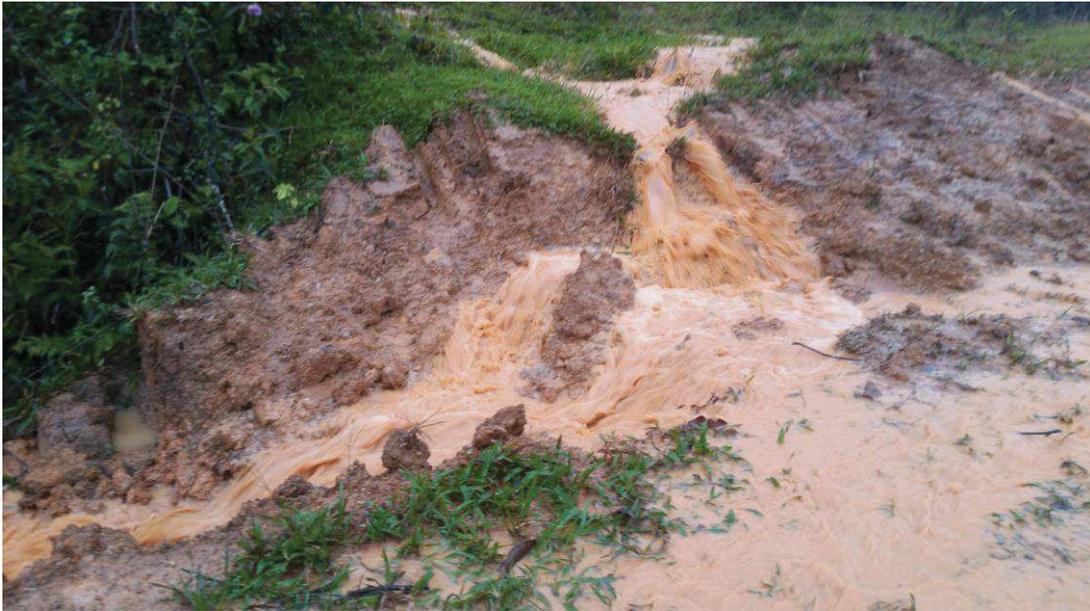
*Plate 3. Track on hillslope approximately 1 km above Punan Trusan. This image was taken during a late afternoon thunderstorm. March 2018.*

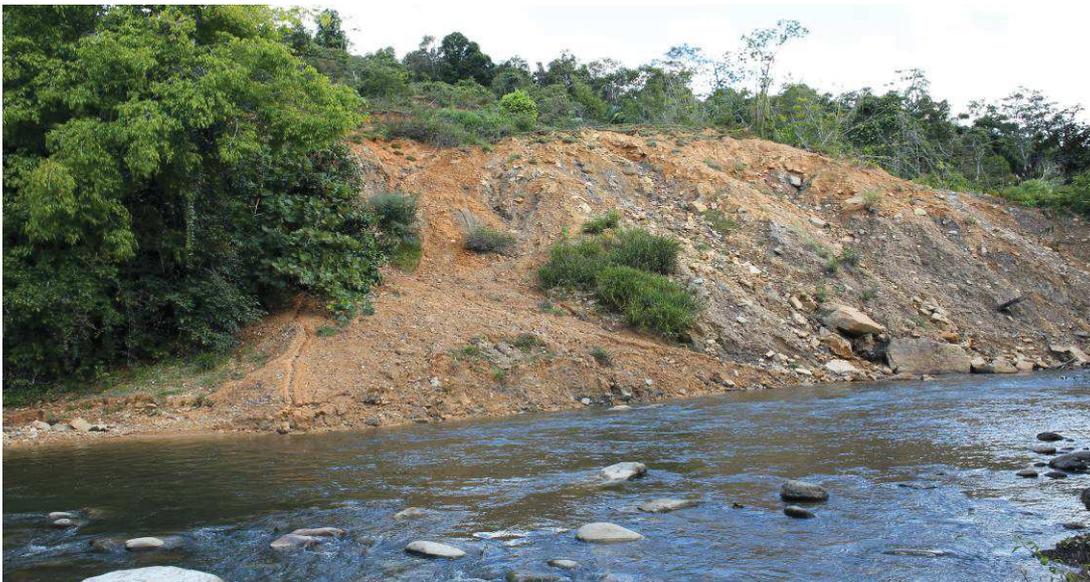
*Plate 4. An example of a major landslide associated with localised forest clearance.*

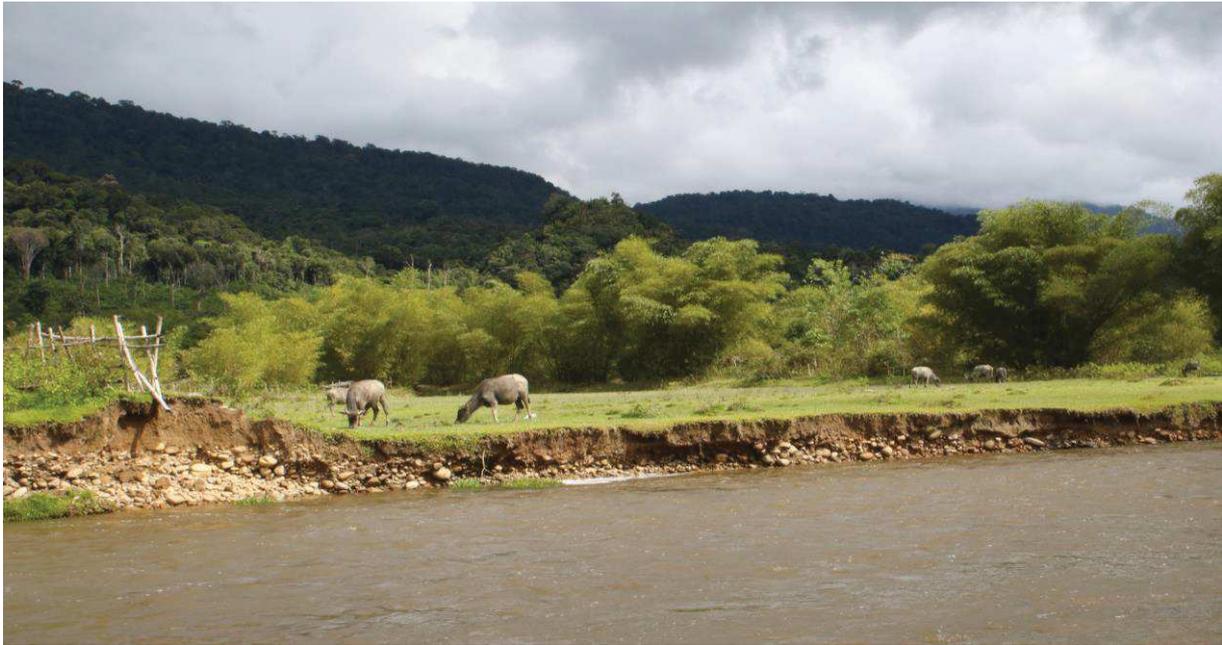
*Plate 5. Example of a cleared riparian area, with pasture land extending all the way to the riverbank. Not only are the banks unprotected (i.e. no binding tree roots), but they have the additional pressure of being trampled by buffalo. The bank is undermined over a distance of approximately 100 m, with retreat in this area estimated from aerial images to have been in the order of 18 m in the last three years (March 2018).*

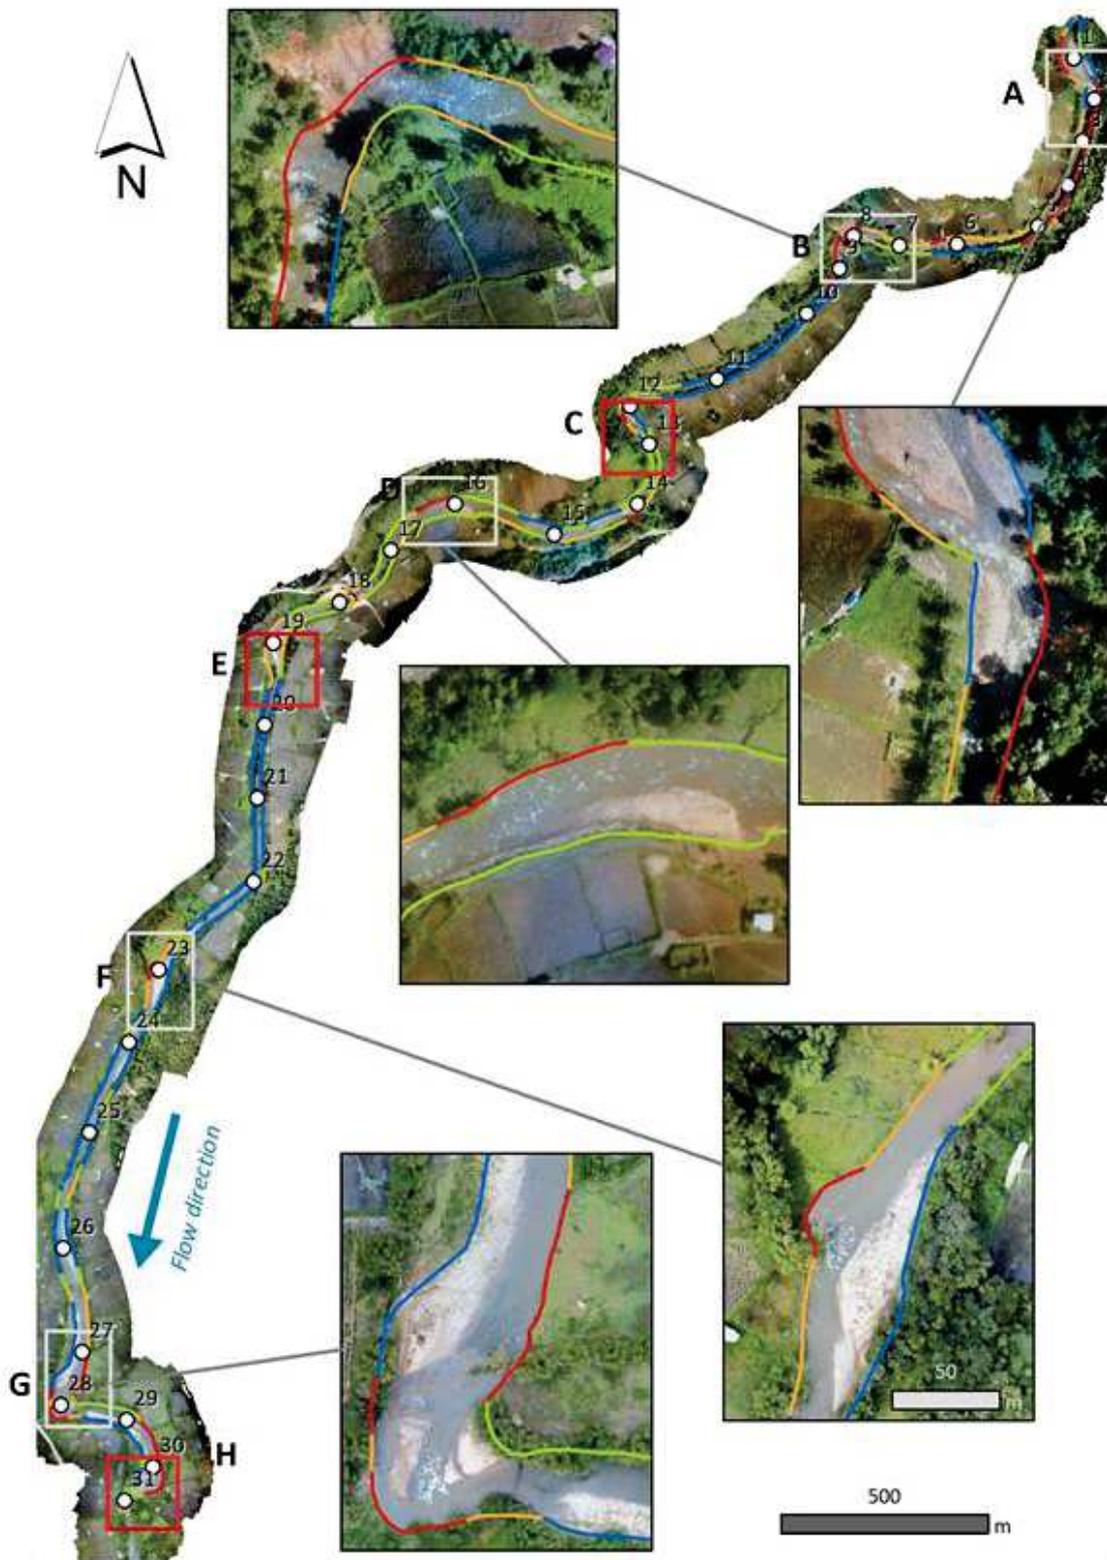
Figure 29. Map of erosion within the study section. Areas where localised measured may be considered are labelled A-F.

There is a small number of places where local intervention may be needed to avoid further deterioration of channel conditions. ‘Soft’ or ‘bio-engineering’ approaches should be adopted – these are less expensive than traditional or hard engineering solutions and offer greater prospects for long term success. To aid discussion of these, Figure 17 is repeated below. The key point to stress is that these interventions should be implemented alongside the catchment and corridor scale management outlined above.

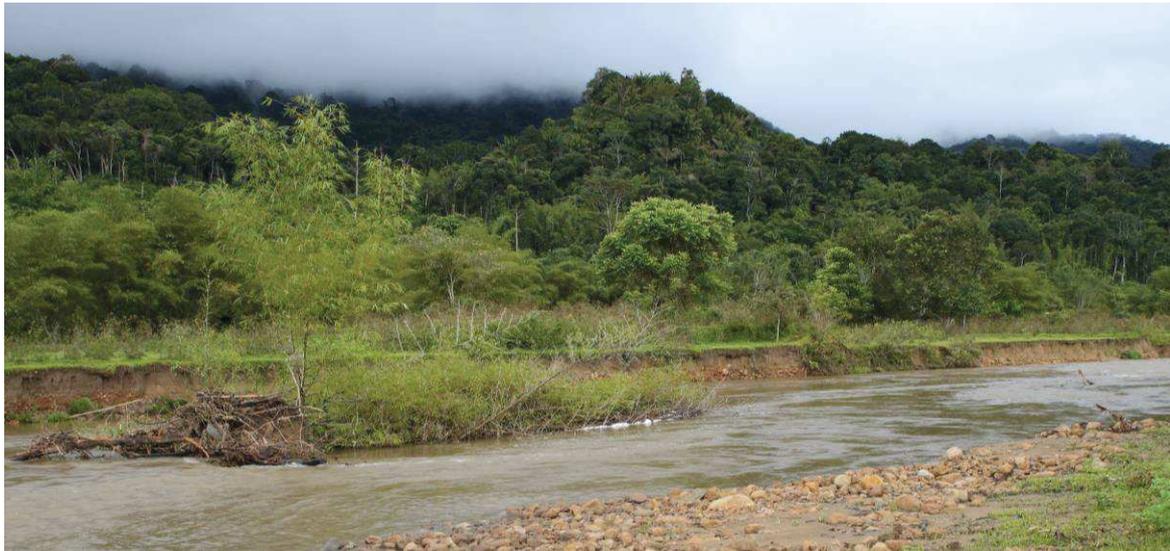
Plate 6. Erosion in the most downstream part of the study section (March 2018).

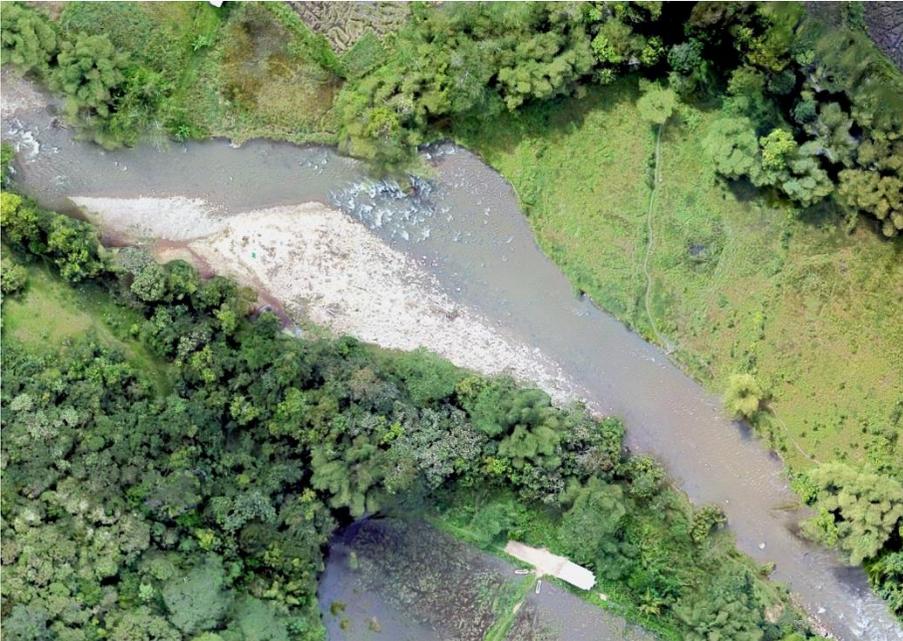
Appendix Km3.7 (continued).

8. In Section F, the absence of riparian vegetation (Figure 17 inset and appendix Km3.7) is responsible for the erosion observed on the right bank. Up to 18 m of bank (i.e. estimated 980 m<sup>2</sup> of land) has disappeared in this bend since 2015 (Figure 14c). At the moment this does not directly threaten valuable land, but if erosion continues it is likely that some rice paddies on the right side of the channel will be lost to the river.
