**HAL**  
open science

## Analysis of Failure Mechanisms Occuring at Breakdown Voltage in power p-GaN HEMT

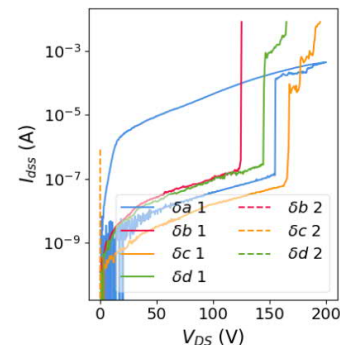
Fig. 1. Electrical signatures of the  $V_{BR}$  for devices  $\delta a, b, c$  and d. The drain current leakage increases abruptly at the  $V_{BR}$  reached at 154.6 V, 123.8 V, 144.5 V and 165.9 V for the respective device. The dashed lines show the signature after  $V_{BR} 1$ . The blue curve of device a shows with the hysteresis a change of leakage current on the forward sweep (increase by two orders of magnitude). The increase in drain leakage current is expected to be a drain source leakage current.

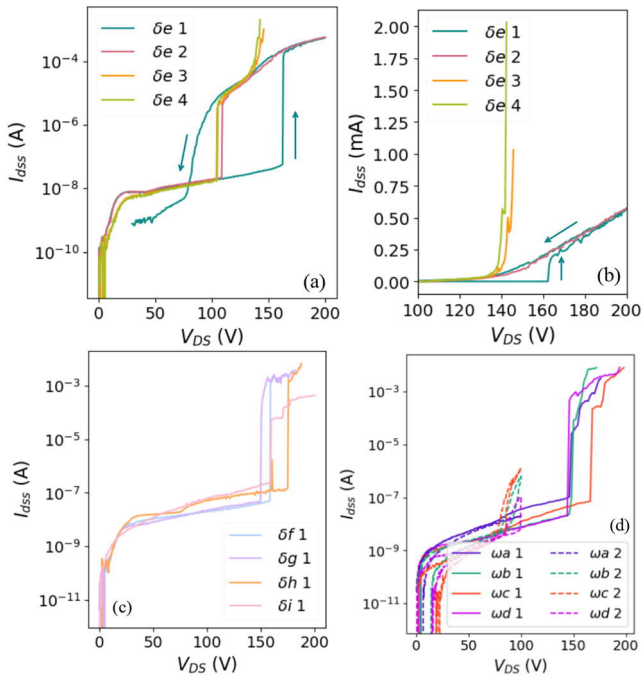
Fig. 2. Electrical signature of the repeated  $V_{BR}$  (1,2,3 and 4) for devices  $\delta e$ , other  $V_{BR}$  measurements were performed after the first one to study the propagation and evolution of the  $V_{BR}$  defect. No degradation was noticed after the first attempt like the devices on Fig. 1 (a) log display, (b) linear display, (c) Electrical signature of the first  $V_{BR}$  of the devices  $\delta f$  to  $\delta i$ , (d) Electrical signatures of the  $\omega$  devices.

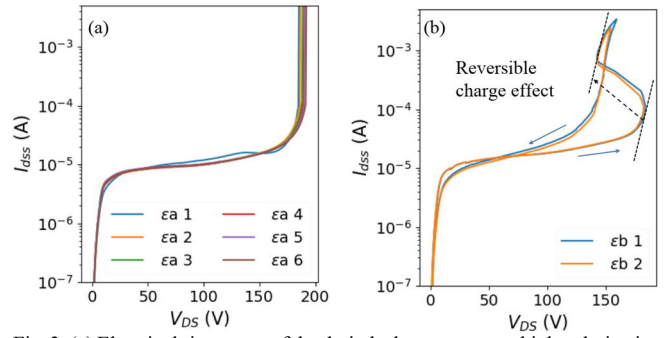
Fig. 3. (a) Electrical signatures of the drain leakage current at high polarization when looking for the  $V_{BR}$  of  $\epsilon$  devices. No change can be observed after the repetition of the high polarization. The power is limited by the tracer SMU to reach a flagrant degradation. (b) Example of charge leak out at high polarization that generate a shift of the leakage increase knee. The phenomenon does not seem to be related to a degradation as it is reversible.

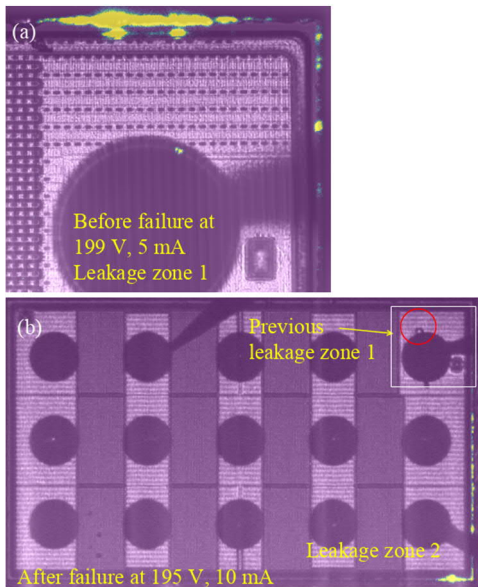
Fig. 4. PEM in frontside during the  $V_{BR}$  measurement of  $\epsilon$  devices. A first emission spot is visible in zone 1 at the top right corner of the device and a second one appeared at the bottom right corner of the device with the increase of the leakage current after the first one disappeared.

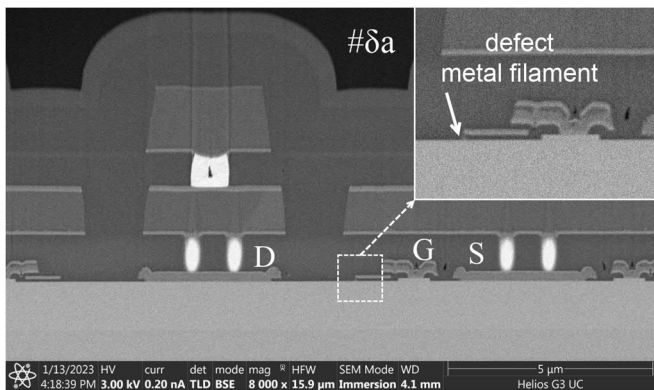
Fig. 5. FIB cross-section in the defect region of device  $\delta a$  (breakdown energy limited with the serial resistor). The drain source electrical short seems to originate from the melting of the metal field plate that reached the drain electrode through the 2DEG.

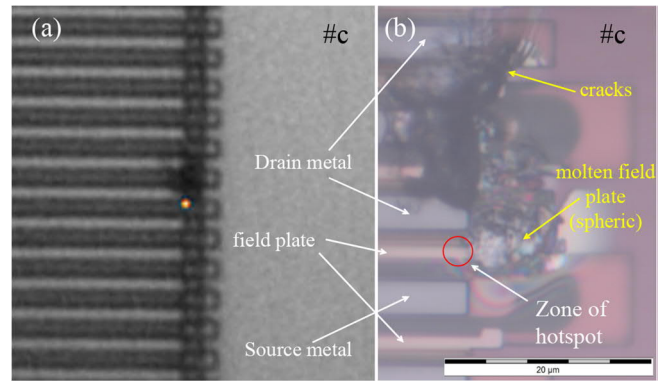
Fig. 6. (a) IR LIT Localization of defect of device  $\delta d$  (no serial resistance during  $V_{BR}$ ). A hotspot is visible on the field plate metal area near the drain. A black spot starts from this point and expands above it, which shows the propagation of the defect. (b) Zoom of the defect zone. The metal structure is visible from the backside through the GaN layers. The short led to the melting of the field plate metal.

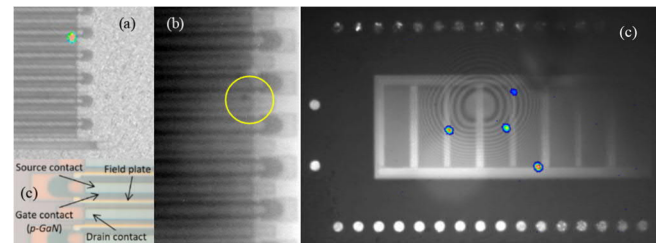
Fig. 7. (a) Defect localization for device  $\delta e$ . A spot is visible between the field plate metal and the drain metallization. (b) IR 71x zoom camera of the defect zone. A black spot is visible on the drain metallization (above the drain contact, probably in the GaN layer as it is a backside observation). (c) Defect localization with 10x magnification of device  $\delta e$ , four emission spots are visible on the edges of the active zones.

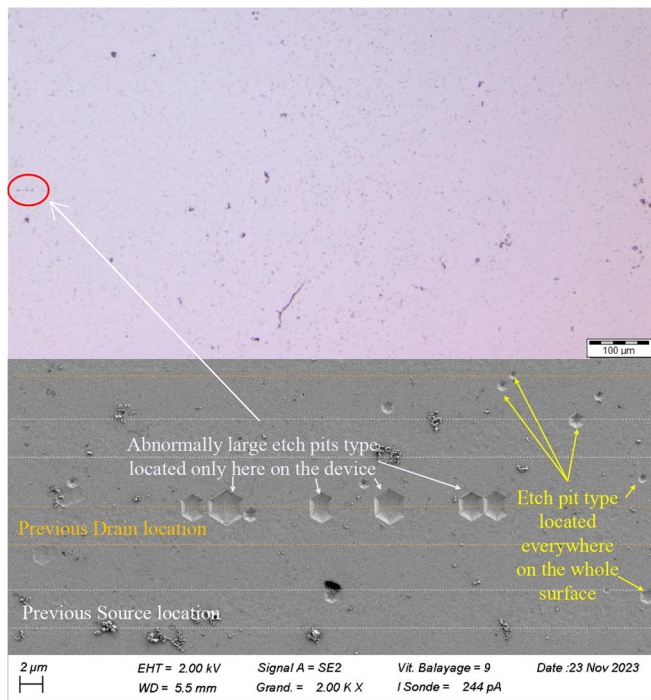
Fig. 8. (a) Optical view of the surface of the transistor after chemical etching with ortho phosphoric acid ( $H_3PO_4$ ), the small black dots on the whole surface are etch pits of revealed dislocations. On the left of the picture the bigger etch pits aligned of (b) are visible. (b) SEM observation of the GaN layer in frontside circle in red in Fig. 7a. Etch pits of some of the dislocations are visible on all the surface (yellow arrows), however on one border of the active zone, the pits are larger and aligned on the edge of the previous drain metal location (white arrows).

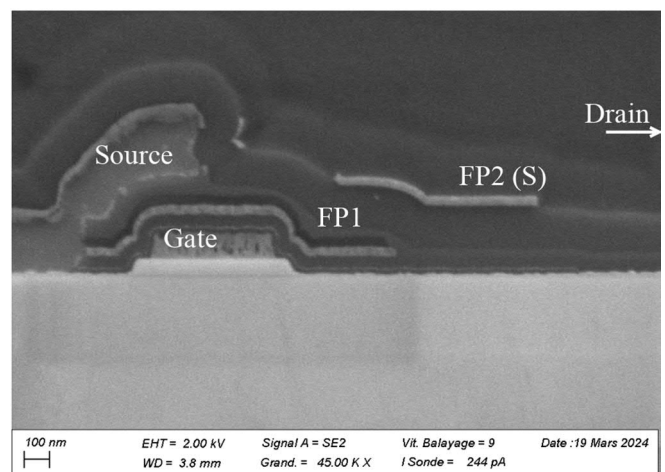
Fig. 9. SEM image of the cross section of the gate region of  $\epsilon$  devices. The second field FP2 improves the electrical isolation drain source between the field plate FP1 and the channel region.

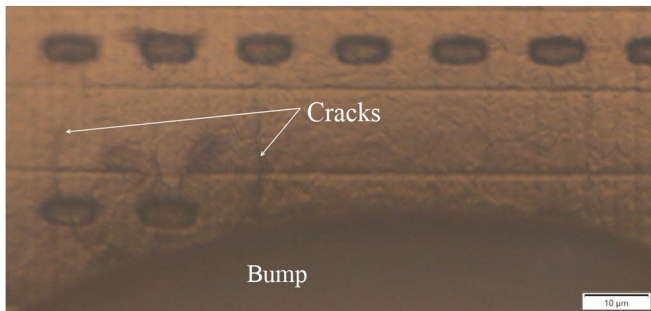
Fig. 10. Optical view of the defect zone (zone 1 in Fig. 4a). Some cracks on the metal are visible.

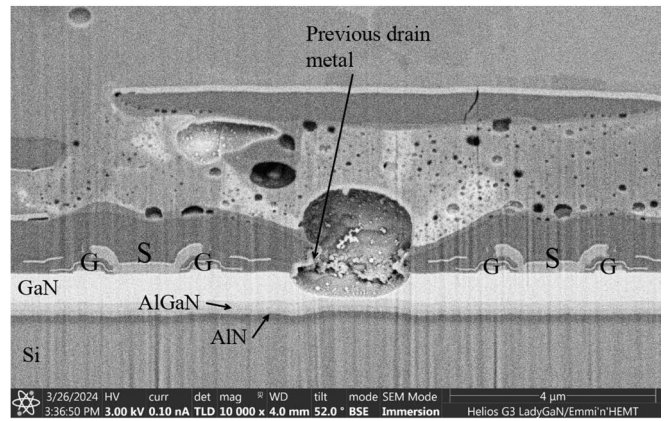
Fig. 11. SEM image of the cross-section of the defect of the  $\epsilon$  damaged device a void is expected to be the consequence of the melting of a metal filament under the drain metal where the electrical leakage path was. The image shows that the leakage observed at high  $V_{DS}$  polarization is vertical and in the GaN layer, the defect stops at the AlGaIn layer connected to the source.

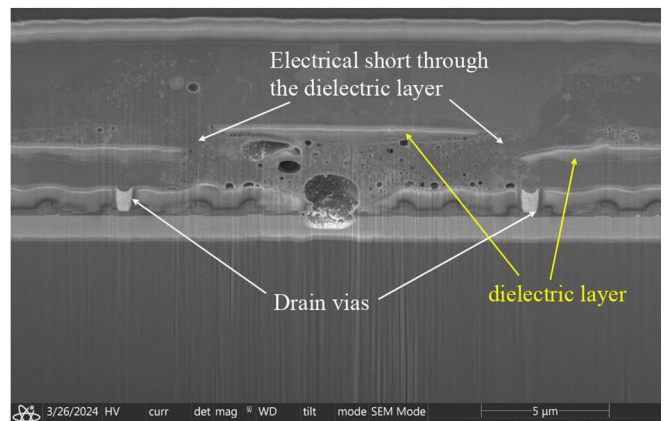
Fig. 11. SEM image of the cross-section of the defect of the  $\epsilon$  damaged device. The propagation of the melting of the drain metal to the drain via and then to the upper levels of metal shows the electrical short that traduces the complete failure of the device.
