## Photovoltaic failure diagnosis using imaging techniques and electrical characterization

# Photovoltaic failure diagnosis using imaging techniques and electrical characterization

**Abstract.** Inspections of 48 photovoltaic (PV) modules within a 302.4 kWp solar array were undertaken to expose the presence of defects after 12 years of operation under the harsh environmental conditions of Djibouti. To this end, a multiple-technique testing protocol was conducted including visual inspection (VI), infrared thermography (IR), current-voltage curve characterization (I-V), ultraviolet fluorescence (UVFL) and electroluminescence imaging (EL). The main visible degradation features observed were discoloration, bubbling and snail trails with occurrences of 100%, 93.7% and 2.1% respectively. According to the IR imaging results, hotspots were observed on cells affected by snail trails. IR was combined with convolutional neural network (CNN) techniques to automatically detect the different classes of failures that PV modules may experience. EL imaging reveals that the cracks of the cells underlie the observed snail trails during visual inspection and UVFL imaging. In addition, a decrease in

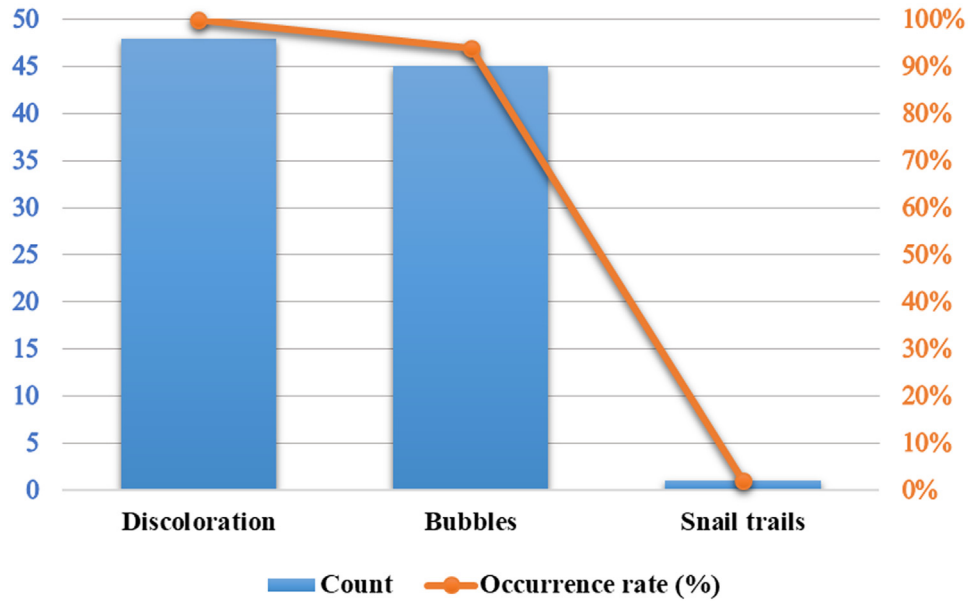
During the visual inspection, numerous defects were discovered, including encapsulant discoloration, snail trails and backsheet bubbling. A detailed description of the visual inspection results is shown in Table 3. A summary of the statistical analysis and evaluation of the degradation of the PV system component is displayed in Figure 9. Encapsulant discoloration was observed to be the most

common degradation mode in all PV modules. It was followed by backsheet bubbling and snail trails, which occurred in 45 over 48 modules (93.7%) and 2.1% of the cases respectively.

Fig. 9. Frequency count and occurrence of observed degradation during visual inspection.

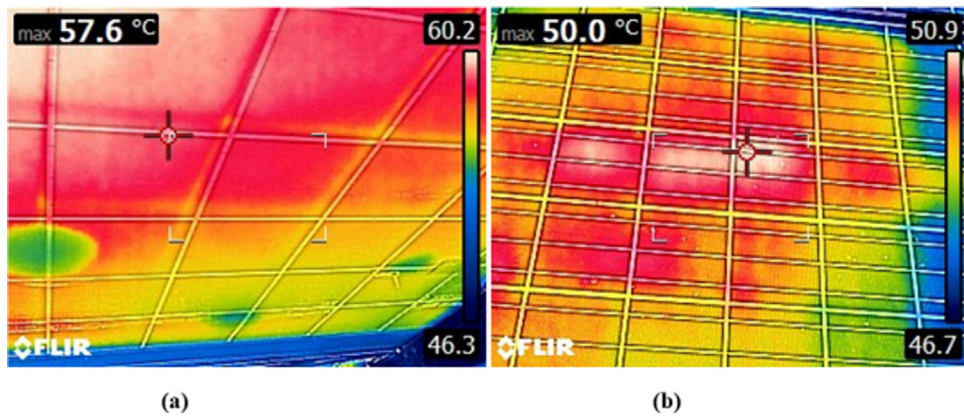
The observed defects on visual inspection were thoroughly analyzed through infrared thermography with the PV installation in operation. Figure 10 shows the infrared images of the front and rear sides of a module presenting bubbles. By analyzing these IR images (Fig. 10a), the exact location and the accurate size of the bubbles can be discerned. They are discernible and indicated by a greenish coloration. Based on the temperature gradient displayed in the image, the areas affected by this degradation had a lower apparent temperature than the rest of the backsheet, of around 50°C. On the front side, the infrared image indicated the presence of hotspots at an apparent temperature of 50.9°C (Fig. 10b) on certain cells according to the hot spot detection algorithm. These cells were precisely located where the bubbles were situated.

Fig. 10. Infrared images of bubbles on a PV module viewed on the backside (a) and on the front side (b).

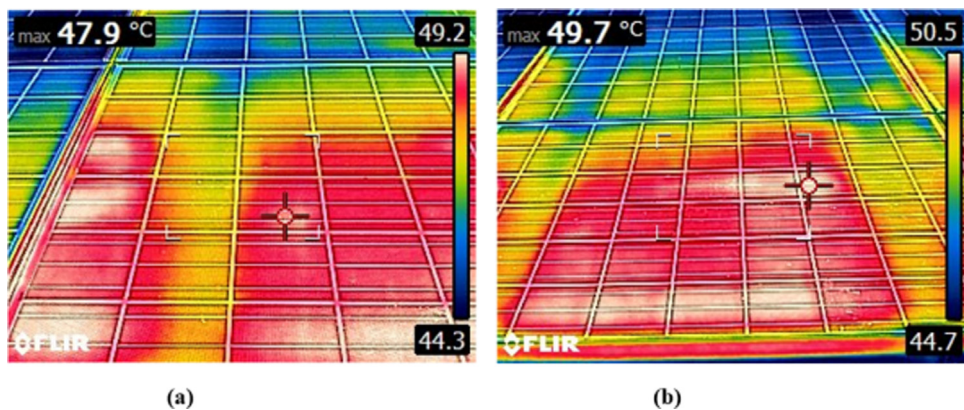
Figure 11 shows the IR images of a module presenting several snail trails. Multiple cells were found to exhibit relatively high temperatures with differences of 5 to 6°C. Indeed, hot spots were expected to be associated with snail trails since they are known to have a detrimental impact on the performance of PV modules and may serve as an indicator of moisture ingress, often attributed to mechanical stress resulting from the loss of module hermeticity and cell cracking.

Fig. 11. Infrared images of snail trails on a PV module viewed on the edges (a) and on the center (b).

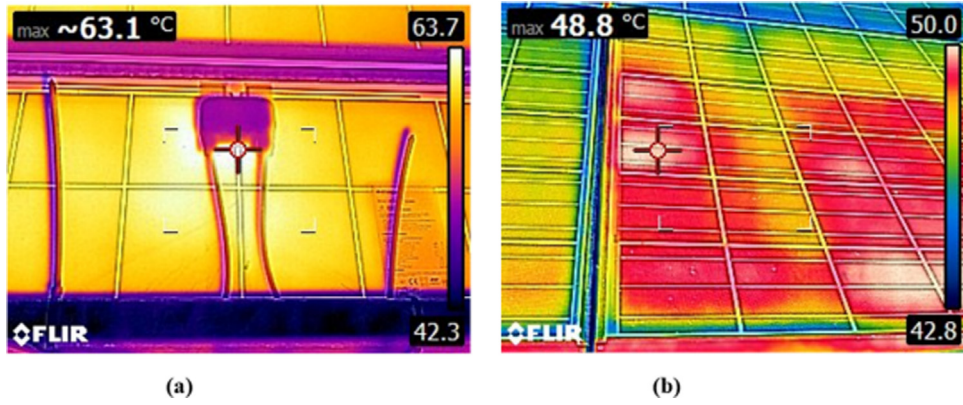
One of the key findings from the IR imaging analysis was that all solar cells located directly on top of the junction boxes were approximately hotter than the other cells with a temperature difference from 8°C to 13°C (Fig. 12). On the rear side of the PV module, it could be noticed that the temperature of the junction box was extremely elevated as high as 63.7°C. This indicated that more cell thermal stress may have occurred at these locations and as a result led to hot spots [48]. A higher temperature was observed when the bypass diode inside the junction box was activated.

Fig. 12. Infrared images of the junction box of a PV module on the backside (a) and on the front side (b).

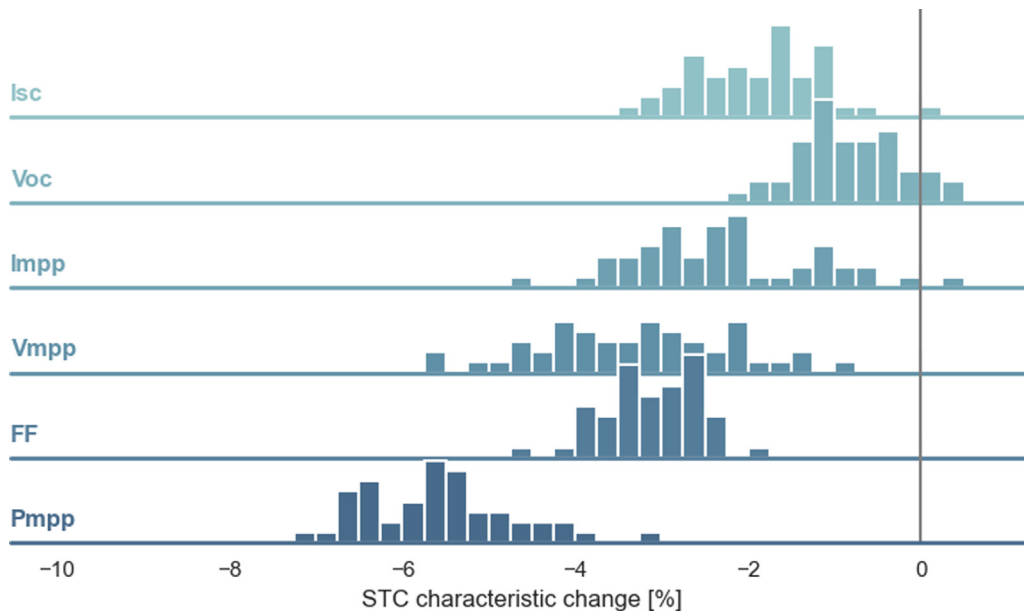
From [Figure 14](#), it can be observed that the characteristic points at the axis-intercepts with  $I_{sc}$  and  $V_{oc}$  were moderately impacted with a median decreasing by not more than 2%. The decrease at the operating points  $I_{mpp}$  and  $V_{mpp}$  had a wider distribution, but also exhibited a higher degradation with medians over 2%. The Fill Factor (FF) decreased within a range of 4.6% to 1.6% testifying for degradation on the resistance in series and in parallel. Overall, all the modules showed a decrease in STC power after 12 years of operation with a median reaching 5.5% corresponding to an average degradation rate of 0.46%/year which was well in line with silicon technology rates found in the literature [8,49].

Fig. 14. I-V characteristic degradation after 12 yr of operation on a population of 48 modules.

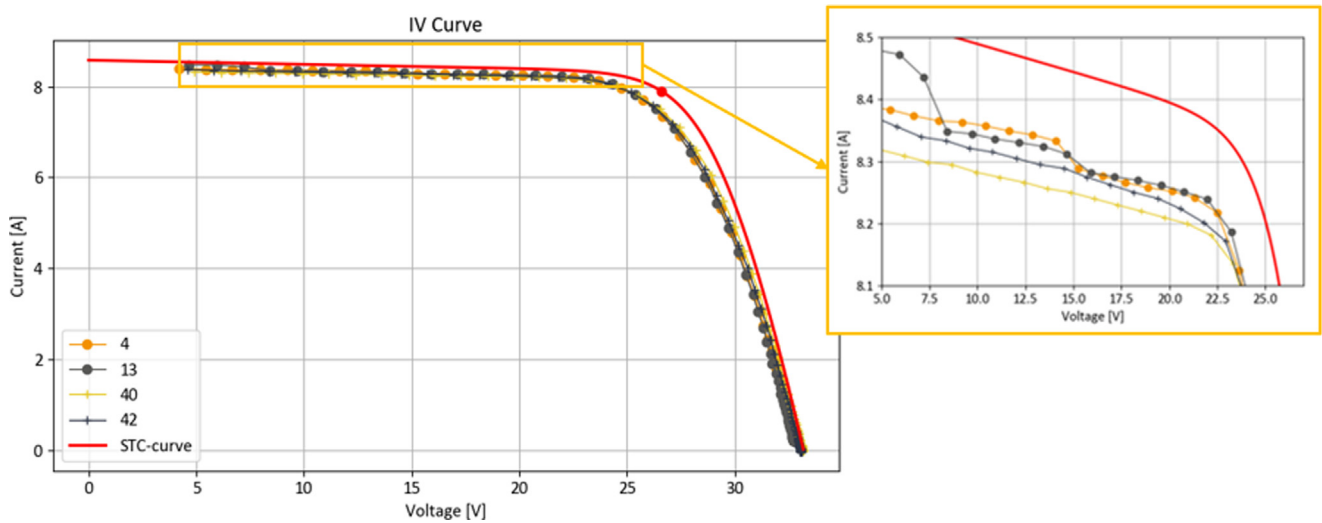
Upon closer inspection, some I-V curves were found to contain several degradation features. This is illustrated in [Figure 15](#), which shows a module exhibiting increased slopes at the  $V_{oc}$  intersection from all measured I-V curves. The more pronounced slopes are a feature of the

degradation of the resistance in series  $R_s$ , which can typically increase when the electrical circuit is deteriorated caused by, for instance, a higher corrosion level due to aging mechanisms. It must be noted that the measured I-V curves do not attain the  $V_{oc}$  due to the STC translation which shifts the curve to account for the temperature difference between the measurement and the STC conditions.

Then, when zooming on the section between 5 V and 25 V in [Figure 15](#), the slopes from modules 40 and 42 are sensibly smooth and almost parallel to the STC curve, but not for modules 4 and 13. For the latter two modules, a cascade of steps decreasing the current at around 7.5 V–8 V intervals indicates some mismatches in the current generation between the three cell strings, which are separated with bypass diodes in the module. This mismatch between the three cell strings is more clearly identified in [Figure 16](#) on module 13 where each cell string has a distinctive maximum current level. These mismatches are typical when the module

**Fig. 15.** I-V curves of the PV modules 4, 13, 40, 42 with the initial STC curve (red).

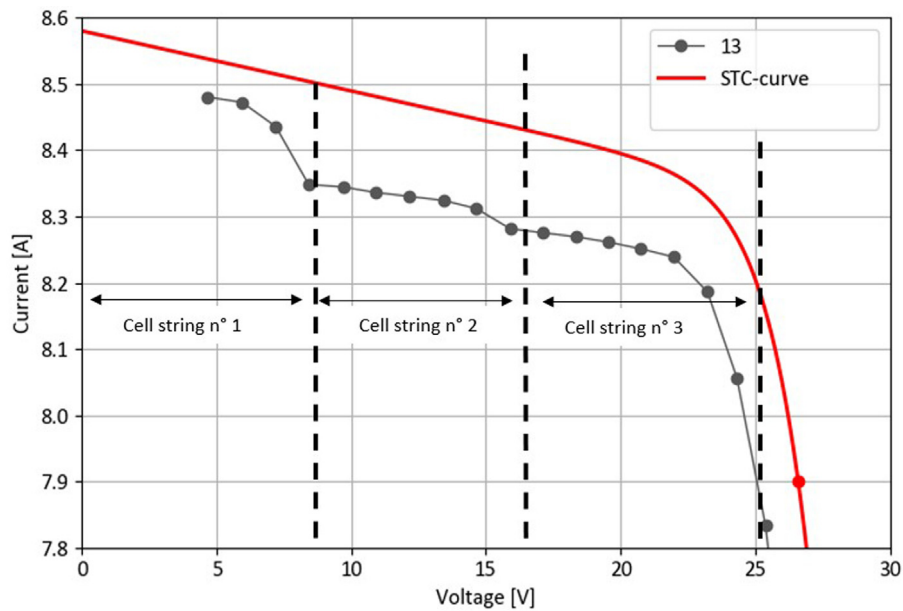
**Fig. 16.** I-V curve of the PV module 13 with the initial STC curve (red).

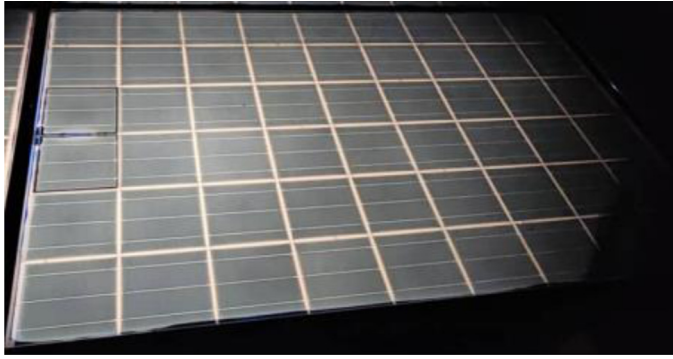
Fig. 17. UVFL image of a PV module.

In Figure 17, dark streaks are clearly visible in UVFL images of PV modules, located in the junction boxes. These dark streaks may potentially be attributed to the accumulation of contaminants such as dirt or dust in the vicinity of the cells adjacent to the junction boxes. Moreover, it was observed through infrared imaging that the areas where the cells or junction boxes were situated exhibited high temperatures in comparison to the remaining cells of the module, occasionally manifesting as 'hot spots'. Despite the absence of visible evidence during visual inspections, it is evident that the utilization of UVFL corroborates the outcomes obtained through the infrared imaging technique.

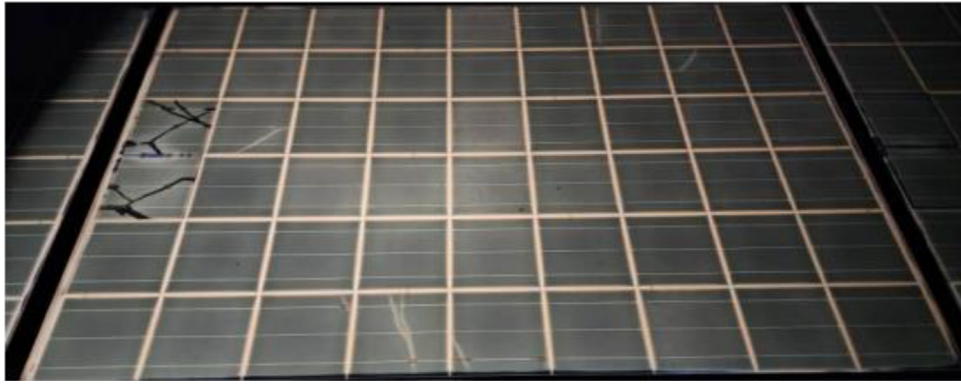
**Fig. 18.** UVFL image of a PV module affected by snail trails.

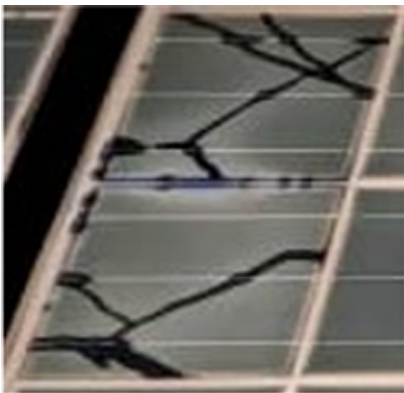
**(a) Snails trails**

**Fig. 19.** UVFL image of a PV module: (a) affected by snail trails and (b) affected by microcracks.

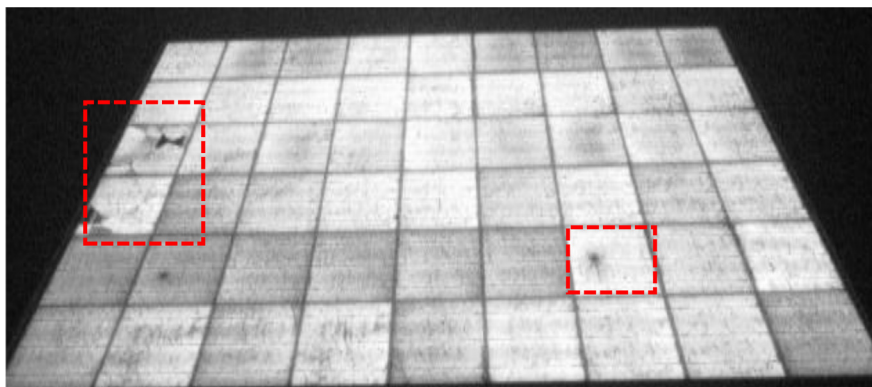
EL imaging technique enables a comprehensive understanding of PV module degradation modes. Therefore, EL analysis was conducted on field installed PV modules. To achieve this, the panel containing the snail trails for visual inspection was selected. A DC power supply was employed to pass a current equal to the rated short-circuit current of the module so as to achieve the forward biasing of the module. EL images were captured with an exposure duration of 10 seconds. Notably, since the modules within the site are affixed to the support structure, EL images obtained during the survey exhibit modules with a parallel orientation mounted on the structure. As depicted in Figure 20, the extent of cracks within the module becomes readily discernible in these images.

**Fig. 20.** EL images for 54 cells of a polycrystalline module.

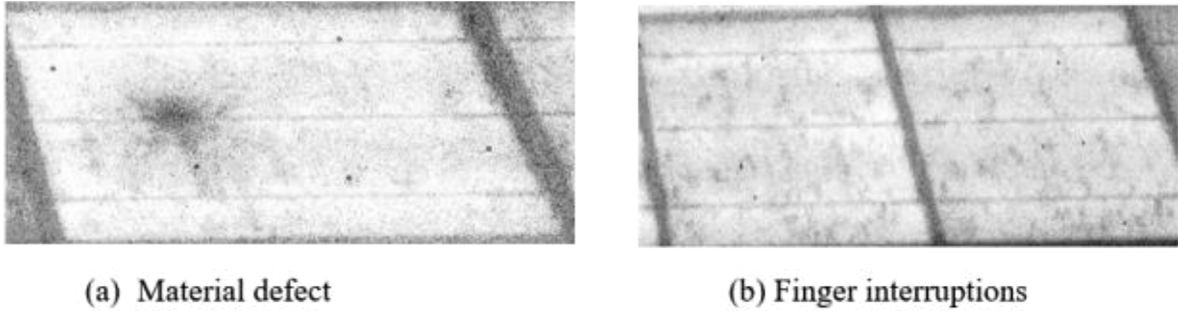
Figures 21a and 21b show material flaws that resulted from the production process, most notably finger interruptions. Unless they are caused by significant mechanical strain at the solder joints, these specific abnormalities normally do not shorten the operational lifespan of the involved solar panel. EL images reveal the presence of cracks in several modules. These cracks have been categorized into three groups, based on the extent of the affected area, as demonstrated in the EL image captured at the short circuit current, as depicted in Figure 22: (a) Mode A – hairline cracks, without any dark area (b) Mode B – cracks associated with grey areas in the cell (c) Mode C – cracks associated with dark areas in the cell. Mode A cracks are typically regarded as harmless and do not impact the power generation of the modules. On the other hand, the dark regions associated with Mode B and Mode C cracks can result in power loss. This is because dark areas in electroluminescence images signify a disruption in the electrical connection to the affected region, thereby influencing the efficiency of the cell and the overall power output of the photovoltaic panel.

Fig. 21. Defects on solar cells.

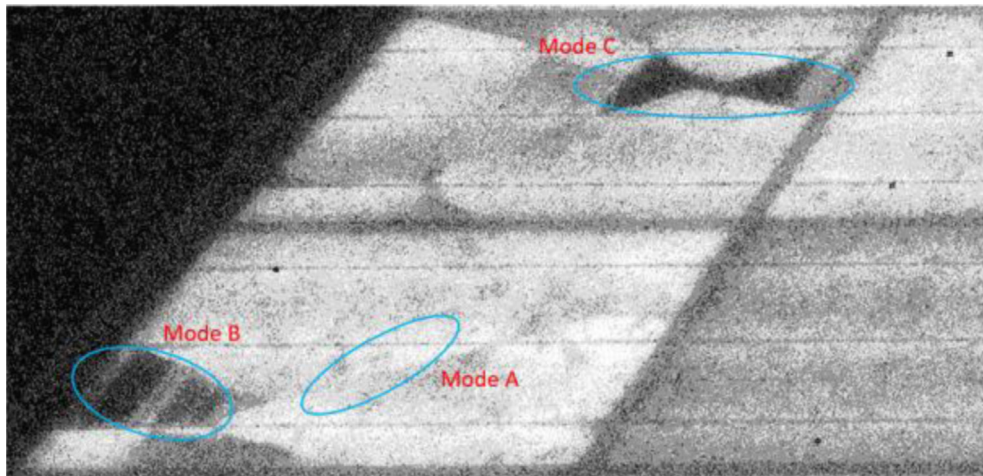
Fig. 22. Different types of cracks as visible in EL images.
