## Photovoltaic failure diagnosis using imaging techniques and electrical characterization

# Photovoltaic failure diagnosis using imaging techniques and electrical characterization

**Abstract.** Inspections of 48 photovoltaic (PV) modules within a 302.4 kWp solar array were undertaken to expose the presence of defects after 12 years of operation under the harsh environmental conditions of Djibouti. To this end, a multiple-technique testing protocol was conducted including visual inspection (VI), infrared thermography (IR), current-voltage curve characterization (I-V), ultraviolet fluorescence (UVFL) and electroluminescence imaging (EL). The main visible degradation features observed were discoloration, bubbling and snail trails with occurrences of 100%, 93.7% and 2.1% respectively. According to the IR imaging results, hotspots were observed on cells affected by snail trails. IR was combined with convolutional neural network (CNN) techniques to automatically detect the different classes of failures that PV modules may experience. EL imaging reveals that the cracks of the cells underlie the observed snail trails during visual inspection and UVFL imaging. In addition, a decrease in

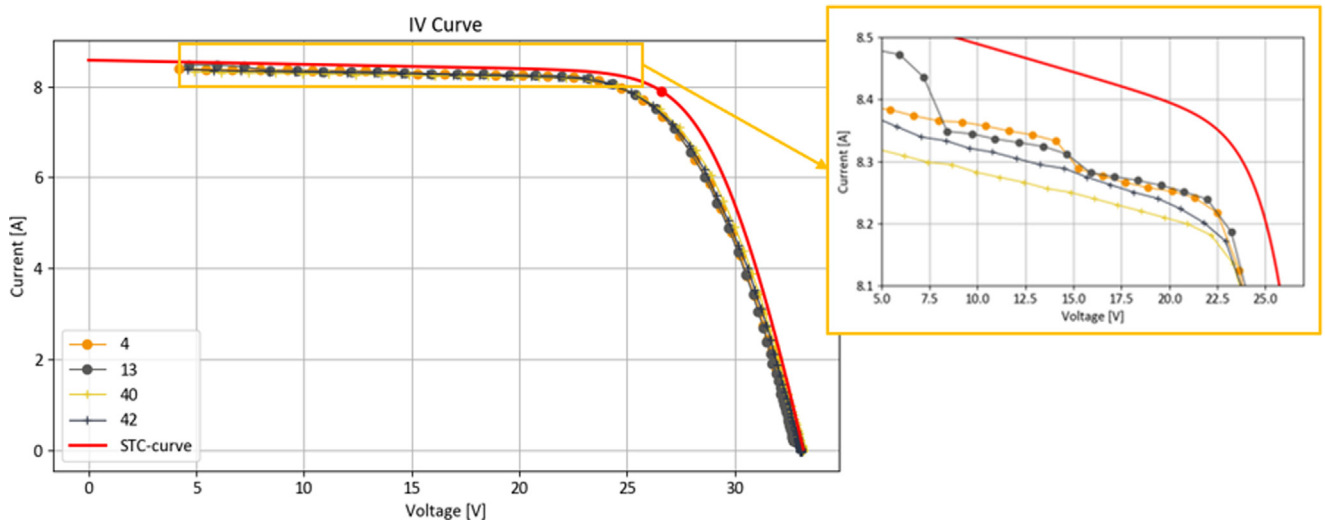
Upon closer inspection, some I-V curves were found to contain several degradation features. This is illustrated in [Figure 15](#), which shows a module exhibiting increased slopes at the  $V_{oc}$  intersection from all measured I-V curves. The more pronounced slopes are a feature of the

degradation of the resistance in series  $R_s$ , which can typically increase when the electrical circuit is deteriorated caused by, for instance, a higher corrosion level due to aging mechanisms. It must be noted that the measured I-V curves do not attain the  $V_{oc}$  due to the STC translation which shifts the curve to account for the temperature difference between the measurement and the STC conditions.

Then, when zooming on the section between 5 V and 25 V in [Figure 15](#), the slopes from modules 40 and 42 are sensibly smooth and almost parallel to the STC curve, but not for modules 4 and 13. For the latter two modules, a cascade of steps decreasing the current at around 7.5 V–8 V intervals indicates some mismatches in the current generation between the three cell strings, which are separated with bypass diodes in the module. This mismatch between the three cell strings is more clearly identified in [Figure 16](#) on module 13 where each cell string has a distinctive maximum current level. These mismatches are typical when the module

**Fig. 15.** I-V curves of the PV modules 4, 13, 40, 42 with the initial STC curve (red).

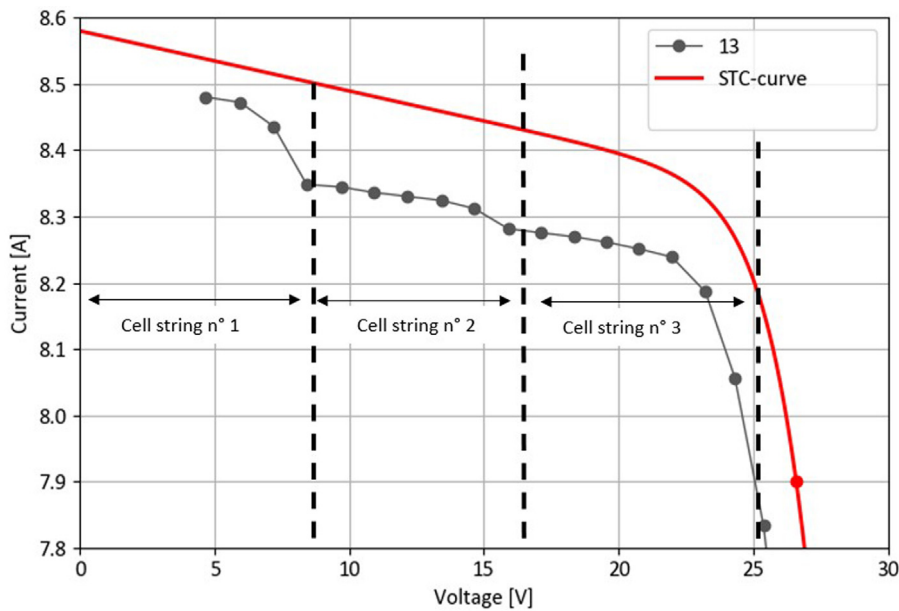
**Fig. 16.** I-V curve of the PV module 13 with the initial STC curve (red).

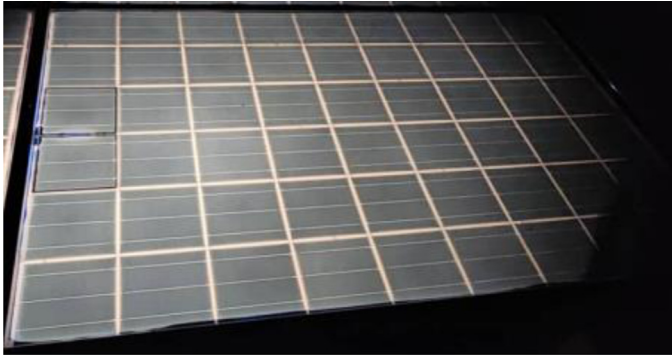
Fig. 17. UVFL image of a PV module.

In Figure 17, dark streaks are clearly visible in UVFL images of PV modules, located in the junction boxes. These dark streaks may potentially be attributed to the accumulation of contaminants such as dirt or dust in the vicinity of the cells adjacent to the junction boxes. Moreover, it was observed through infrared imaging that the areas where the cells or junction boxes were situated exhibited high temperatures in comparison to the remaining cells of the module, occasionally manifesting as 'hot spots'. Despite the absence of visible evidence during visual inspections, it is evident that the utilization of UVFL corroborates the outcomes obtained through the infrared imaging technique.

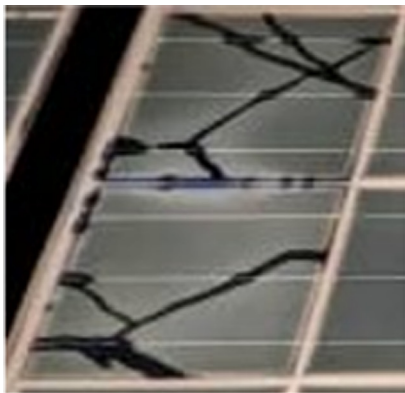
**(a) Snails trails**

**Fig. 19.** UVFL image of a PV module: (a) affected by snail trails and (b) affected by microcracks.

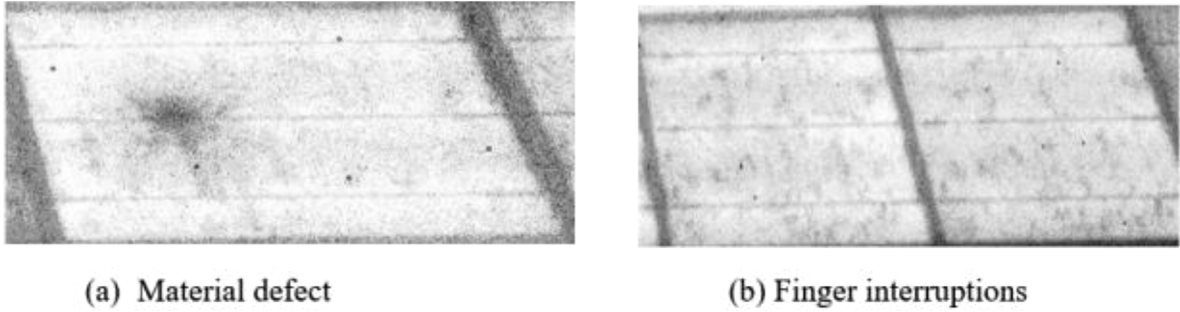
Figures 21a and 21b show material flaws that resulted from the production process, most notably finger interruptions. Unless they are caused by significant mechanical strain at the solder joints, these specific abnormalities normally do not shorten the operational lifespan of the involved solar panel. EL images reveal the presence of cracks in several modules. These cracks have been categorized into three groups, based on the extent of the affected area, as demonstrated in the EL image captured at the short circuit current, as depicted in Figure 22: (a) Mode A – hairline cracks, without any dark area (b) Mode B – cracks associated with grey areas in the cell (c) Mode C – cracks associated with dark areas in the cell. Mode A cracks are typically regarded as harmless and do not impact the power generation of the modules. On the other hand, the dark regions associated with Mode B and Mode C cracks can result in power loss. This is because dark areas in electroluminescence images signify a disruption in the electrical connection to the affected region, thereby influencing the efficiency of the cell and the overall power output of the photovoltaic panel.

Fig. 21. Defects on solar cells.

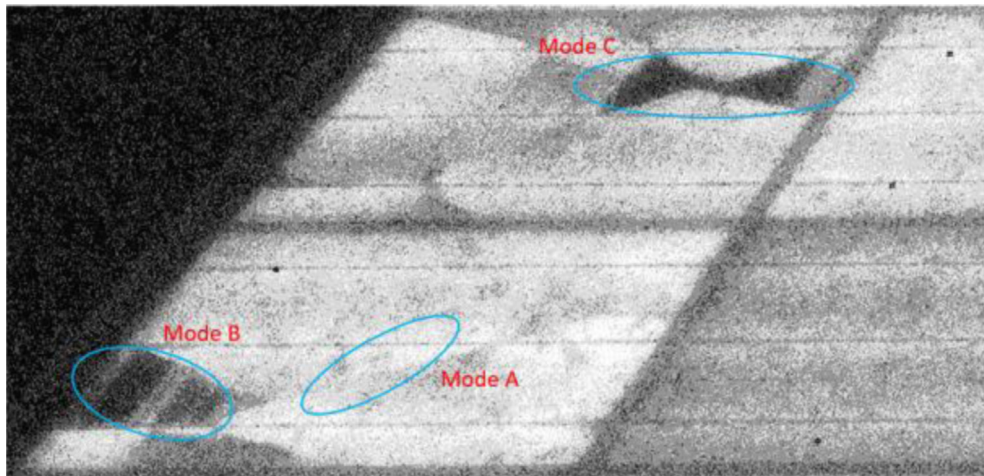
Fig. 22. Different types of cracks as visible in EL images.
