Photovoltaic failure diagnosis using imaging techniques and electrical characterization

Abstract. Inspections of 48 photovoltaic (PV) modules within a 302.4 kWp solar array were undertaken to expose the presence of defects after 12 years of operation under the harsh environmental conditions of Djibouti. To this end, a multiple-technique testing protocol was conducted including visual inspection (VI), infrared thermography (IR), current-voltage curve characterization (I-V), ultraviolet fluorescence (UVFL) and electroluminescence imaging (EL). The main visible degradation features observed were discoloration, bubbling and snail trails with occurrences of 100%, 93.7% and 2.1% respectively. According to the IR imaging results, hotspots were observed on cells affected by snail trails. IR was combined with convolutional neural network (CNN) techniques to automatically detect the different classes of failures that PV modules may experience. EL imaging reveals that the cracks of the cells underlie the observed snail trails during visual inspection and UVFL imaging. In addition, a decrease in STC power was observed after 12 yr of operation with a median reaching 5.5% corresponding to an av

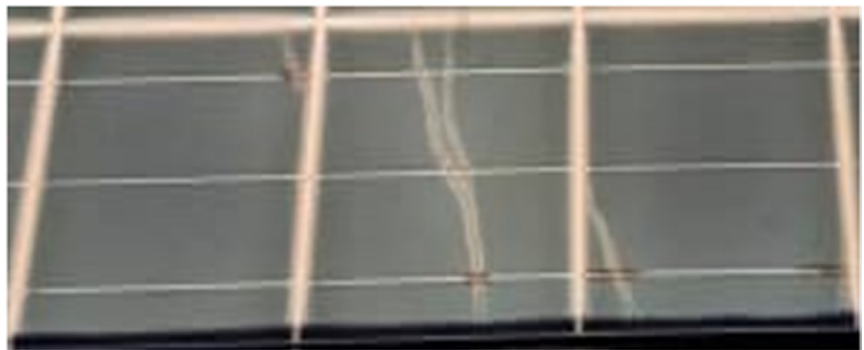
Fig. 19. UVFL image of a PV module: (a) affected by snail trails and (b) affected by microcracks.
