Localization and Physical Analysis of Defects in Degraded Power HEMT p-GaN Transistors Stressed with DC Voltage Surge and Voltage with Switching Stress

Abstract This paper presents a methodology for the physical analysis of defects on p-GaN power HEMTs that have been electrically stressed under DC surge or voltage switching stresses. The methodology includes a backside approach for sample preparation and defect localization. It is crucial to adapt the preparation process according to the position of the defect in the device structure (including metallurgy, dielectric layers, epitaxy, etc.), which depends on the type of stress applied. In our study of the reliability of the transistor under increased electrical stress in lifetime operation mode, failure analysis is used to identify the weakest areas in the design with respect to the type of stress applied. This paper presents a failure analysis consisting of techniques such as electrical characterization, photon emission microscopy and lock-in thermography for defect localization, focused ion beam slice and view, transmission electron microscopy analysis, and

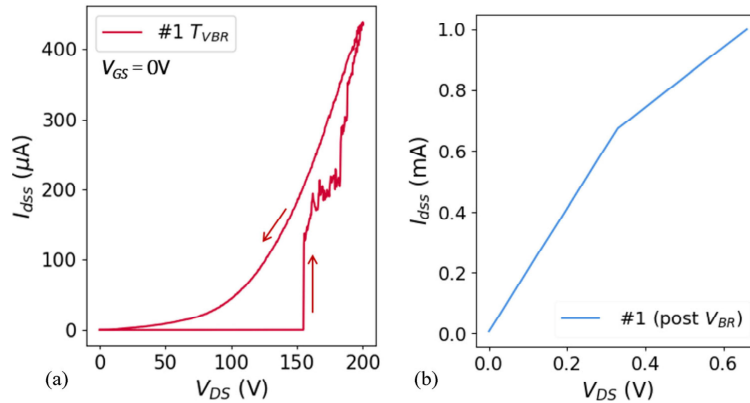
Figure 2 shows characterization curves of #2 stressed in AC mode illustrating the relationship between leakage current I_{dss} and V_{DS} , shown in blue at t_0 and in orange after stress at $t_{0+35\text{ h}}$. A sudden increase in leakage current is seen at $t_{0+35\text{ h}}$, but only above 90 V in Fig. 1a. Despite this current leakage, the transistor remains operational after aging. This current leakage is purely intermediate, as the

gate leakage current is not affected during this measurement, as can be seen in Fig. 2b. Failure analysis was performed to identify the location and nature of the defect, in both static and dynamic voltage stress.

Fig. 1 (a) Electrical characterization of the breakdown voltage of transistor #1, a steep increase of the current I_D between drain and source occurs at 155 V. (b) Electrical characterization of the leakage current after the breakdown voltage experiment

Fig. 2 Electrical characterization of the aged transistor #2 of the leakage current I_{dss} under V_{DS} at t_0 in blue and after 35 hours of electrical stress at t_{0+35h} in orange. A high leakage current appears

only after 90 V. Forward and backward sweeps are performed to account for possible hysteresis (arrows near the curves). #3 has a similar I_{dss} curve to #2

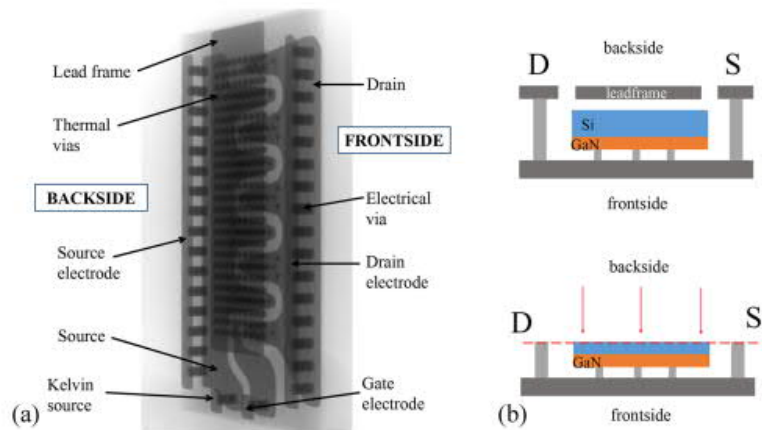
Fig. 3 (a) RX view of the PQFN package of the device (b) scheme of the parallel lapping modification from the backside before the localization of defects, the electrical polarization is still possible on both the backside and the frontside thanks to the traversing vias

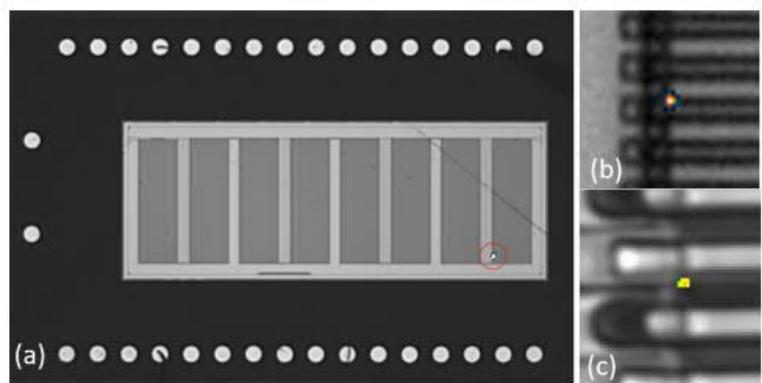
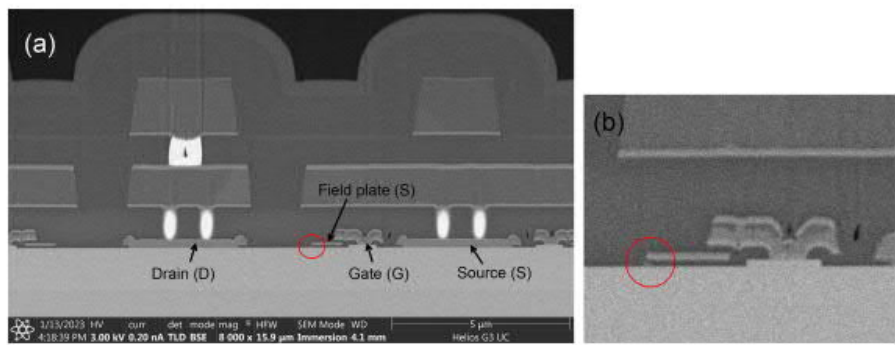
The cross section for the FIB slice and view is 2 μm away from the hot spot (see Fig. 5a) and a small pitch of 50 nm is required to determine the defect size. A filamentary breakdown defect can be seen in only one image of the slice and view (see enlarged Fig. 5b). This defect is located in the Si_xO_y and AlGaIn layers where the electric field is highest between the 2D electron gas (2DEG) connected to the drain electrode and the corner of the drain-side field plate (FP) connected to the source, as expected. This defect appears to be a metal filament formed by the localized fusion of the FP metal with Si_xO_y and AlGaIn to connect to the 2DEG. The dimensions of this defect are extremely small (a few tens of nanometers), and the resolution of the FIB slice and view sections is insufficient. Therefore, accurate analysis of this defect type requires TEM observation.

Fig. 4 (a) LIT amplitude signal of the prepared transistor #1 at $5 \times$ magnification (lock-in frequency 25 Hz), polarized at 2 V with probes landed on the electrical vias. (b) LIT at $10 \times$ magnification focused on the hot spot (c) InGaAs camera PEM image at $71 \times$ magnification focused on the emission spot (good correlation with LIT hot spot position)

Fig. 5 (a) FIB slice and view cross section in the defect zone of transistor #1. The zoom in (b) shows at the corner of the source field plate the leakage path formed at the breakdown voltage in Fig. 1a. This is the zone where the electric field is locally most significant

above the metal lines (Drain, Source, Field Plate), where the defect was found by LIT and PEM.

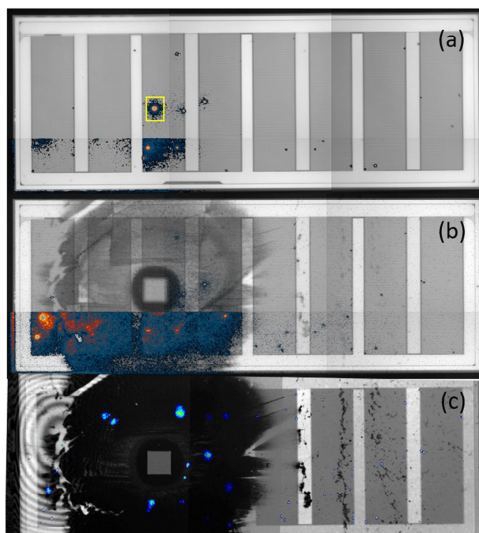
The transistor #2 shows more hotspots during LIT backside analysis (Fig. 6a) after backside parallel lapping (silicon substrate thinned to 100 μm). These hotspots appear when the transistor is stressed and the electric field is above 90 V. They match the high leakage shown in Fig. 2a. PEM analysis still correlates with the observed spots, despite minor variations. The same trenching method used on transistor #1 did not find any more spots at that position with either LIT or PEM.

Fig. 6 (a) Superimposed LIT of #2 with polarization between 75 and 95 V, more than 20 hot spots are visible, a brighter hot spot is visible in the yellow square (b) LIT after FIB silicon trenching locally over the brightest hot spot location which has disappeared (c) InGaAs camera PEM image after FIB silicon trenching, the emission spot has also disappeared (Color figure online)

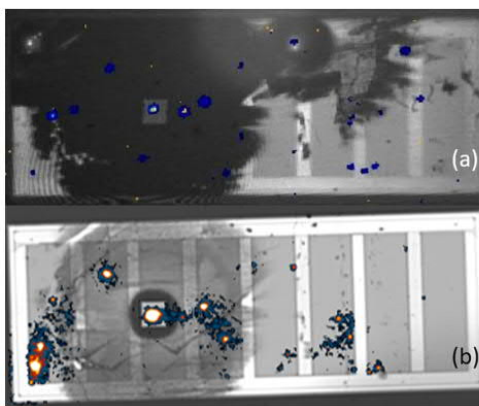
disappeared after Si trenching is now visible again with LIT and PEM after Raman spectroscopy (Fig. 9a and b).

Fig. 9 (a) PEM after Raman analysis, the brightest emission spot that disappeared after trenching now has signal. (b) LIT amplitude after Raman analysis, as with PEM, the hot spot reappeared after Raman analysis

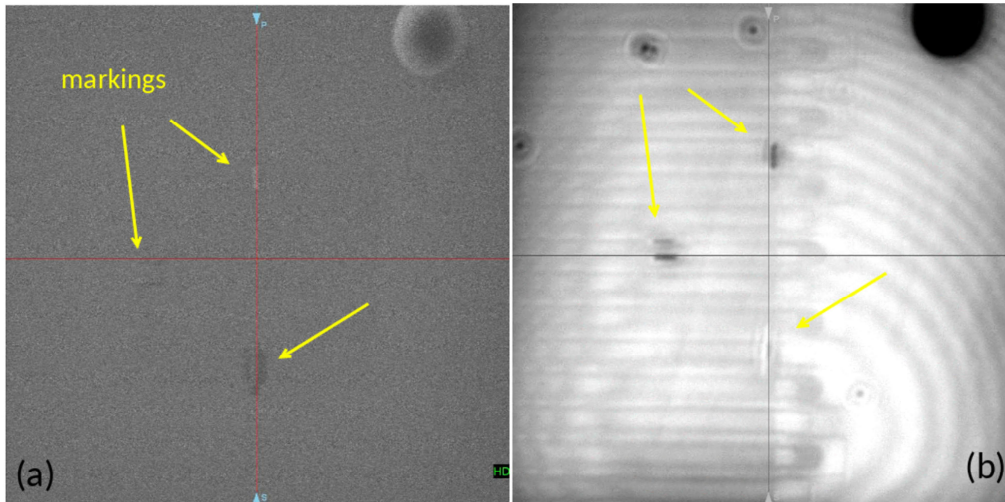
In order to see all layers during the TEM wafer inspection, the silicon layer was partially removed during the FIB trench (see Fig. 10). A significant thickness was retained because the defect was believed to be under the active region in the GaN/epitaxial layers.

Fig. 10 (a) SEM image of the trench with 10 μm of remaining silicon and marking. (b) In-situ IR camera image through the remaining silicon and view of the etched lines marking the hot spot position for TEM lamella extraction

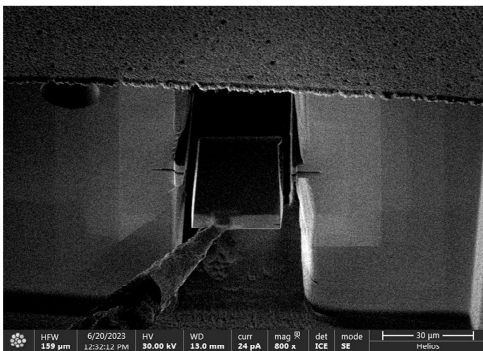
Figure 11 shows the TEM lamella of device #2 on a drain defect. The defect area is coated with platinum for protection. FIB boxes are carved on both sides of the mark. The unthinned lamella is then removed with a micromanipulator and positioned on a TEM grid. The final FIB thinning is performed to obtain a sample thickness of 100 nm.

Fig. 11 TEM lamella extraction in the area bounded by the optiFIB markers after milling and side cutting

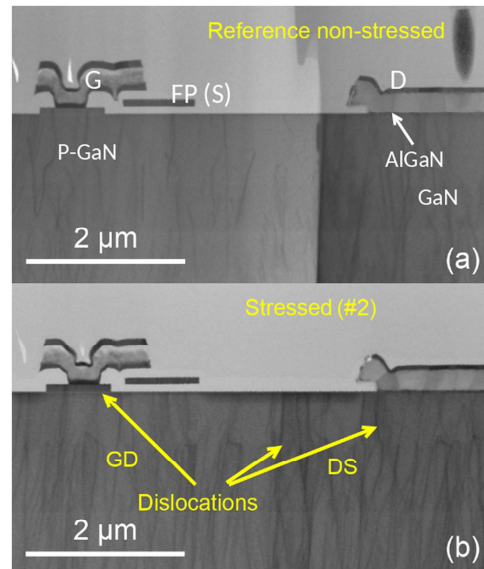
Figure 12 shows that the TEM images of the same zone for an unstressed reference part (Fig. 12a) and a stressed part (Fig. 12b) clearly show that the dislocation density has

increased for the stressed transistors, especially in the gate drain region and below the drain metal where the electric field is most significant and where the spots are visible in the localization of defects. The drain region is more stressed than the gate region, for example, because the 2DEG is more depleted in the off-state for a higher V_{DS} voltage. We believe that the vertical leakage current path may be caused by changes in the quality of the GaN layer

in the buffer near the drain due to the electric field stress. Dislocations may grow or appear due to the piezoelectric effect, which creates a mechanical constraint between the layers (relative to the electric field).

In Fig. 12b, the leakage current could pass through a 2DEG at one of the AlGaIn/GaN interfaces or reach a conductive GaN layer. We think that when the silicon is removed by FIB trenching, it could change the electrostatic polarization around the leakage path. This could cause the spot in localization of defects to disappear with the same polarization parameters (in Figs. 6b and c), while the defect is still in the device.

Fig. 12 (a) TEM lamella observation of our reference device that was not stressed (b) TEM of the drain region of device two #2 (stressed in AC at 120 V). The density of dislocation seems to be more significant for stressed devices compared to the pristine one

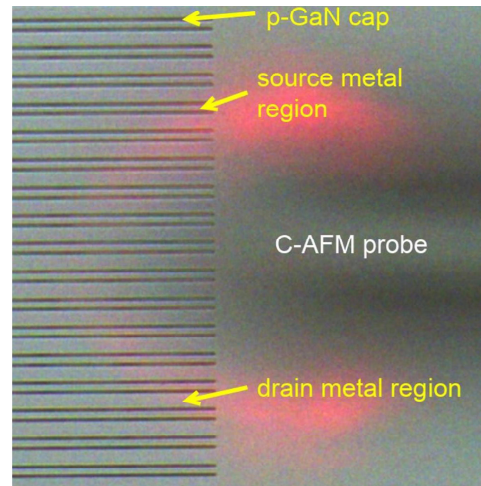
Fig. 13 Optical observation of the frontside surface after HF acid, the double line patterns observed are p-GaN caps, the rest of the observed surface is AlGaIn, except in the previous source and drain metals the two p-GaN caps and location (see Figs. 7c and 17), where the surface is the GaN layer

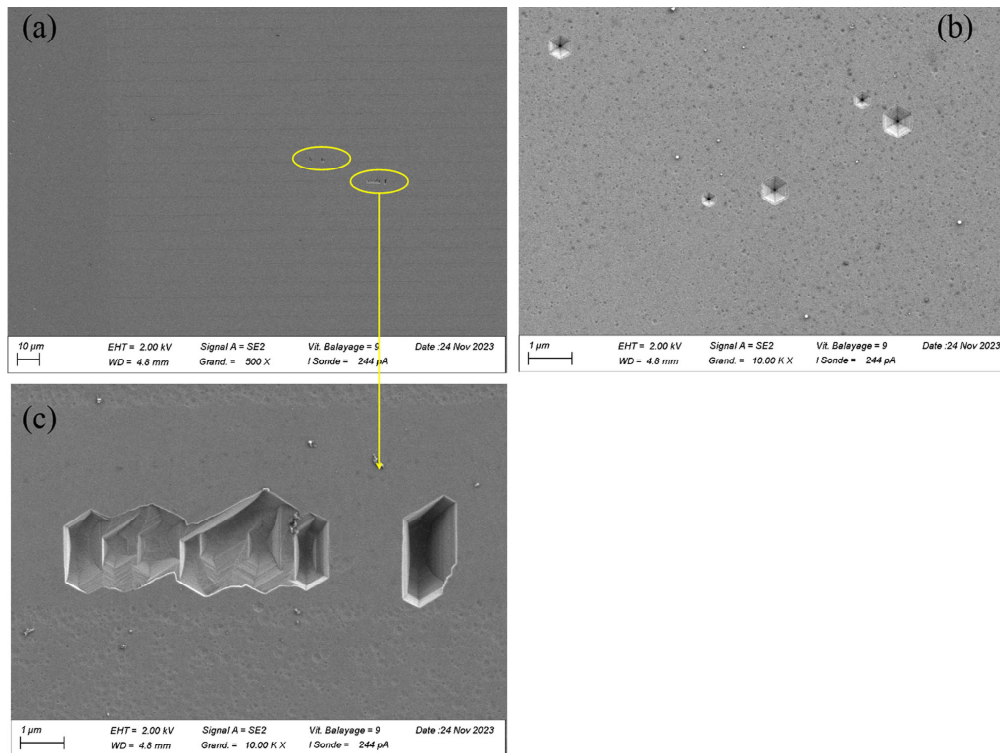
The previous reference device and device #3 were chemically exposed with H_3PO_4 at 130 °C for 30 minutes. Some etch pits of revealed dislocations are visible on both devices (stressed and unstressed) which are less than 1 μm in diameter (Fig. 16b). On the stressed device, some zones are different from the unstressed device and lines of larger etch pits can be observed as shown in Fig. 16a and c. This pattern is expected to be related to the vertical leakage through the GaN buffer and the increased density of dislocations. The larger pits could be caused by the favored etching of the GaN in these areas due to the locally higher aluminum concentration brought about by the formation of dislocations, which reduces the electrical insulation and generates the vertical current leakage path for V_{DS} greater than 90 V [11–13].

Fig. 16 Etch pits obtained by chemical exposure with H_3PO_4 from tool #3. (a) Different etch pits pattern observed on the surface. Both the reference and the #3 have the small hexagonal etch pit visible in (b), but only the #3 has the line of (c)
