Localization and Physical Analysis of Defects in Degraded Power HEMT p-GaN Transistors Stressed with DC Voltage Surge and Voltage with Switching Stress

Abstract This paper presents a methodology for the physical analysis of defects on p-GaN power HEMTs that have been electrically stressed under DC surge or voltage switching stresses. The methodology includes a backside approach for sample preparation and defect localization. It is crucial to adapt the preparation process according to the position of the defect in the device structure (including metallurgy, dielectric layers, epitaxy, etc.), which depends on the type of stress applied. In our study of the reliability of the transistor under increased electrical stress in lifetime operation mode, failure analysis is used to identify the weakest areas in the design with respect to the type of stress applied. This paper presents a failure analysis consisting of techniques such as electrical characterization, photon emission microscopy and lock-in thermography for defect localization, focused ion beam slice and view, transmission electron microscopy analysis, and

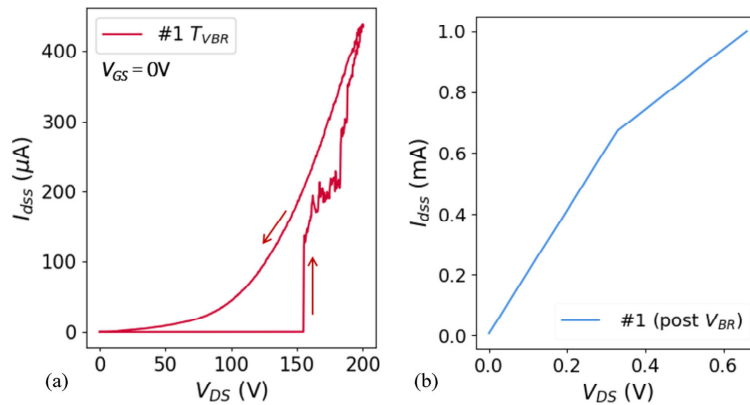
Fig. 1 (a) Electrical characterization of the breakdown voltage of transistor #1, a steep increase of the current I_D between drain and source occurs at 155 V. (b) Electrical characterization of the leakage current after the breakdown voltage experiment

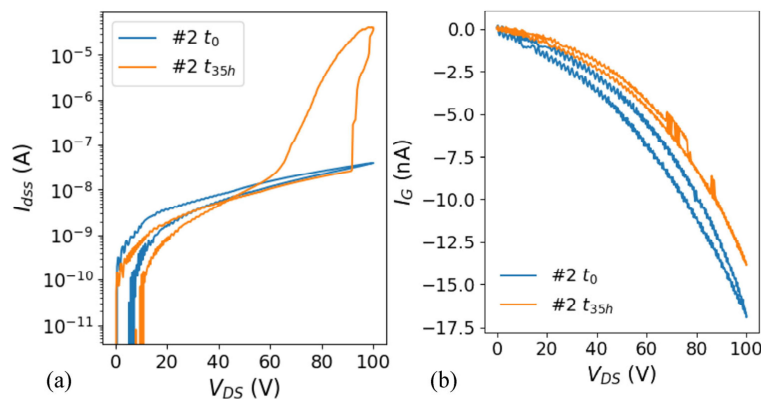
Figure 2 shows characterization curves of #2 stressed in AC mode illustrating the relationship between leakage current I_{dss} and V_{DS} , shown in blue at t_0 and in orange after stress at $t_{0+35\text{ h}}$. A sudden increase in leakage current is seen at $t_{0+35\text{ h}}$, but only above 90 V in Fig. 1a. Despite this current leakage, the transistor remains operational after aging. This current leakage is purely intermediate, as the

gate leakage current is not affected during this measurement, as can be seen in Fig. 2b. Failure analysis was performed to identify the location and nature of the defect, in both static and dynamic voltage stress.

Fig. 2 Electrical characterization of the aged transistor #2 of the leakage current I_{dss} under V_{DS} at t_0 in blue and after 35 hours of electrical stress at t_{0+35h} in orange. A high leakage current appears

only after 90 V. Forward and backward sweeps are performed to account for possible hysteresis (arrows near the curves). #3 has a similar I_{dss} curve to #2

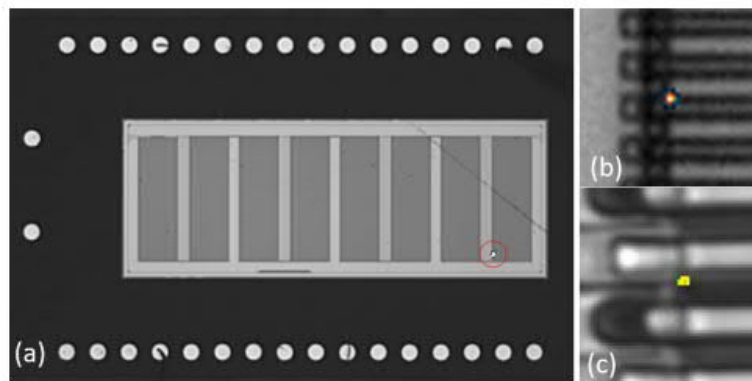
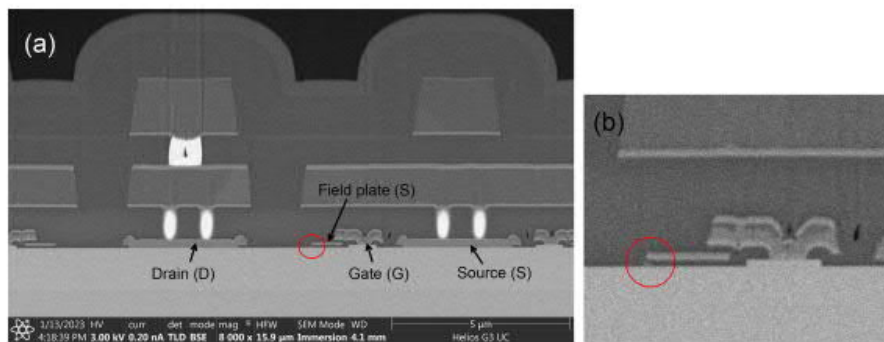
Fig. 4 (a) LIT amplitude signal of the prepared transistor #1 at $5 \times$ magnification (lock-in frequency 25 Hz), polarized at 2 V with probes landed on the electrical vias. (b) LIT at $10 \times$ magnification focused on the hot spot (c) InGaAs camera PEM image at $71 \times$ magnification focused on the emission spot (good correlation with LIT hot spot position)

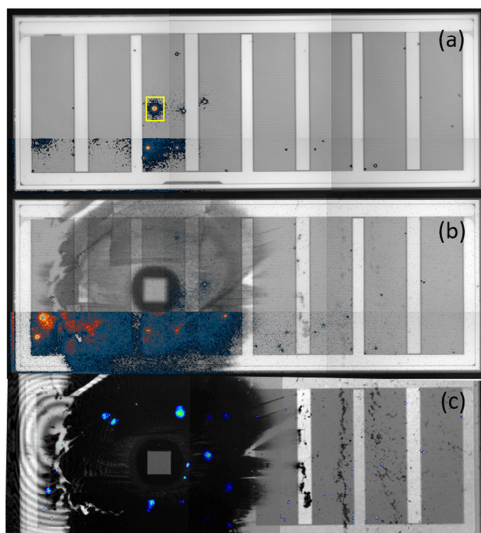
The transistor #2 shows more hotspots during LIT backside analysis (Fig. 6a) after backside parallel lapping (silicon substrate thinned to 100 μm). These hotspots appear when the transistor is stressed and the electric field is above 90 V. They match the high leakage shown in Fig. 2a. PEM analysis still correlates with the observed spots, despite minor variations. The same trenching method used on transistor #1 did not find any more spots at that position with either LIT or PEM.

Fig. 6 (a) Superimposed LIT of #2 with polarization between 75 and 95 V, more than 20 hot spots are visible, a brighter hot spot is visible in the yellow square (b) LIT after FIB silicon trenching locally over the brightest hot spot location which has disappeared (c) InGaAs camera PEM image after FIB silicon trenching, the emission spot has also disappeared (Color figure online)

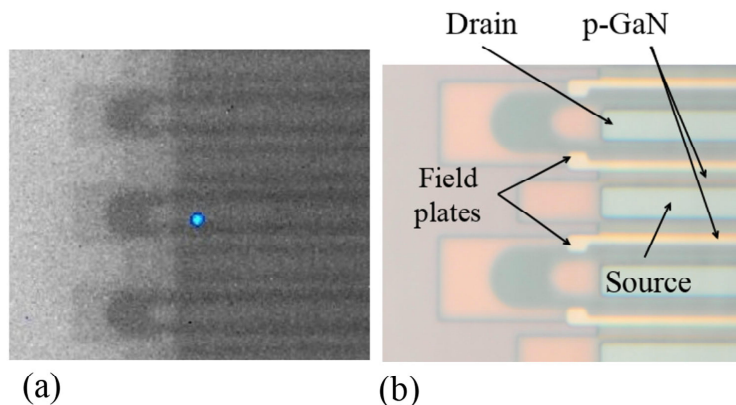
Hotspots and emission spots on transistor #2 are mostly near the drain edge electrode, as shown in Fig. 7b. Some spots are visible near the gate region. The spots in

Fig. 7 (a) InGaAs camera PEM image of the emission spots. The defects are near the drain metal, which is expected to be a DS leakage through the GaN layer (transistor #2). (b) Optical zoom of the metal structure seen from the backside

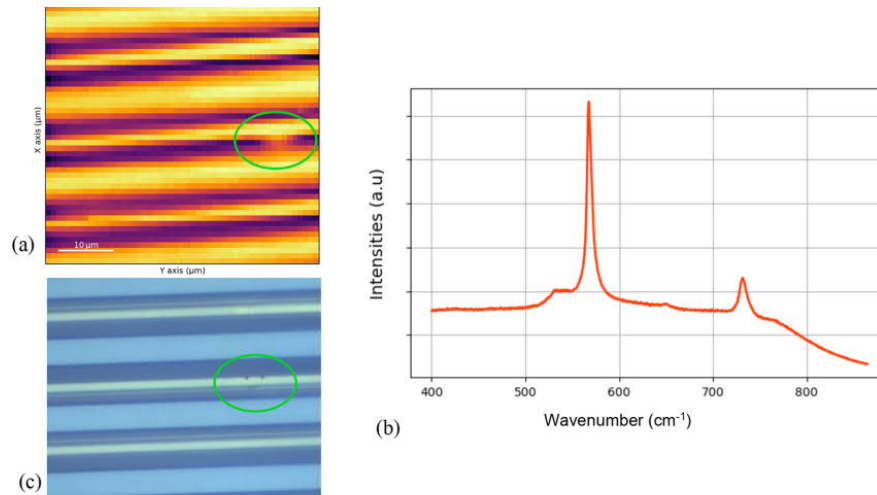
Figure 8c shows a $100\times$ view of the GaN layer. It reveals dark spots that were not seen before after FIB trenching. Raman spectroscopy helped find the defect after trenching the silicon substrate. But it seems that this and the laser power made the defect worse. The hotspot that

Fig. 8 Raman spectroscopy using a 532 nm laser beam with a diameter of 300 nm. (a) Mapping of the main Raman peak (1 μm scan step). (b) Long exposure Raman spectrum associated with (a, b)

acquired for one pixel. (c) Optical view of the defect at 100 \times at the coordinates given in (a)

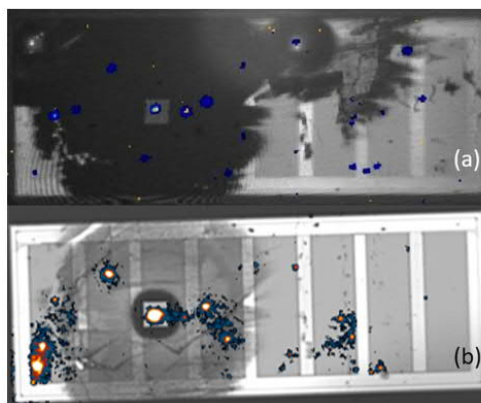
disappeared after Si trenching is now visible again with LIT and PEM after Raman spectroscopy (Fig. 9a and b).

Fig. 9 (a) PEM after Raman analysis, the brightest emission spot that disappeared after trenching now has signal. (b) LIT amplitude after Raman analysis, as with PEM, the hot spot reappeared after Raman analysis

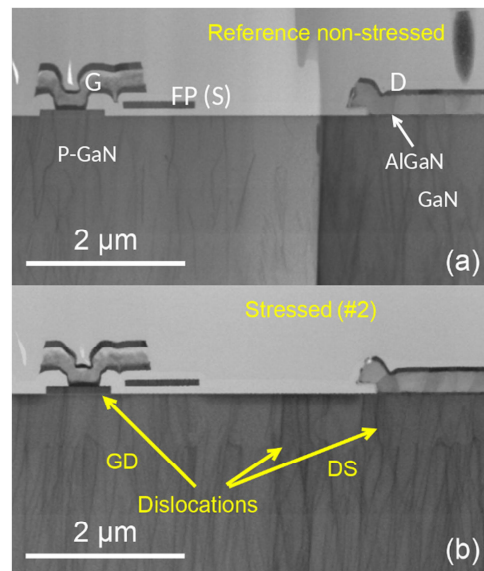
Figure 12 shows that the TEM images of the same zone for an unstressed reference part (Fig. 12a) and a stressed part (Fig. 12b) clearly show that the dislocation density has

increased for the stressed transistors, especially in the gate drain region and below the drain metal where the electric field is most significant and where the spots are visible in the localization of defects. The drain region is more stressed than the gate region, for example, because the 2DEG is more depleted in the off-state for a higher V_{DS} voltage. We believe that the vertical leakage current path may be caused by changes in the quality of the GaN layer

in the buffer near the drain due to the electric field stress. Dislocations may grow or appear due to the piezoelectric effect, which creates a mechanical constraint between the layers (relative to the electric field).

In Fig. 12b, the leakage current could pass through a 2DEG at one of the AlGaIn/GaN interfaces or reach a conductive GaN layer. We think that when the silicon is removed by FIB trenching, it could change the electrostatic polarization around the leakage path. This could cause the spot in localization of defects to disappear with the same polarization parameters (in Figs. 6b and c), while the defect is still in the device.

Fig. 12 (a) TEM lamella observation of our reference device that was not stressed (b) TEM of the drain region of device two #2 (stressed in AC at 120 V). The density of dislocation seems to be more significant for stressed devices compared to the pristine one

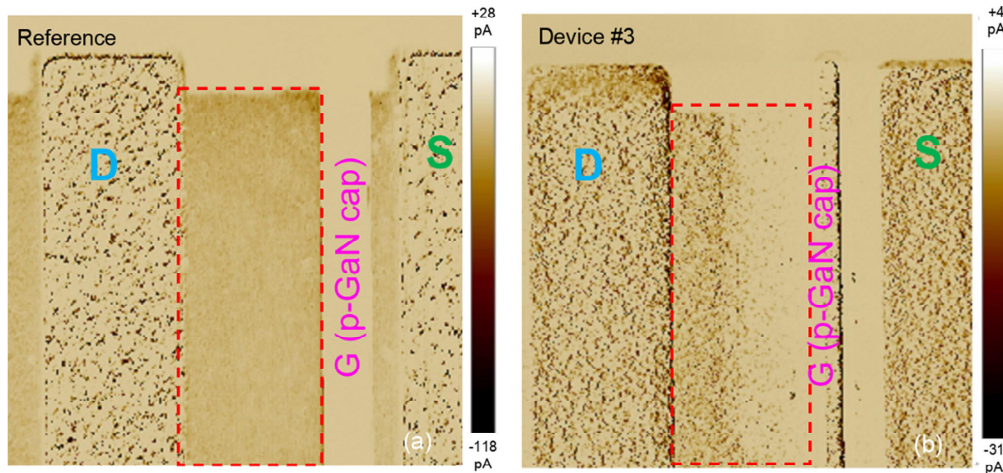
Fig. 15 Current leakage mapping obtained with conductive AFM, the black dots are the current leakage paths. The areas where the metal contacts were previously are always more conductive due to their proximity to the 2DEG, which facilitates surface leakage currents

However, although the comparison is difficult, a comprehensive analysis of the current leakage mappings reveals some differences that can be attributed to stress. First, it was observed that the leakage current in the region of interest and in the region between the p-GaN and the source metal (GS region) differs for the same device. For unstressed devices, the leakage current in both regions is remarkably similar. However, for device #3, the region bounded by the red lines in Fig. 15b appears to be more conductive than the GS region (which is not particularly stressed because the 2DEG is always in this region, reducing local hot electron effects and electric field value). In addition, the leakage current for the stressed device (#3) is less uniformly distributed over the region of interest compared to the reference device. In fact, the leakage is higher at several precise locations that form black dots in the C-AFM scan shown in Fig. 15b. Some of these dots may represent the leakage current flowing through the threading dislocations observed in the TEM lamellae.

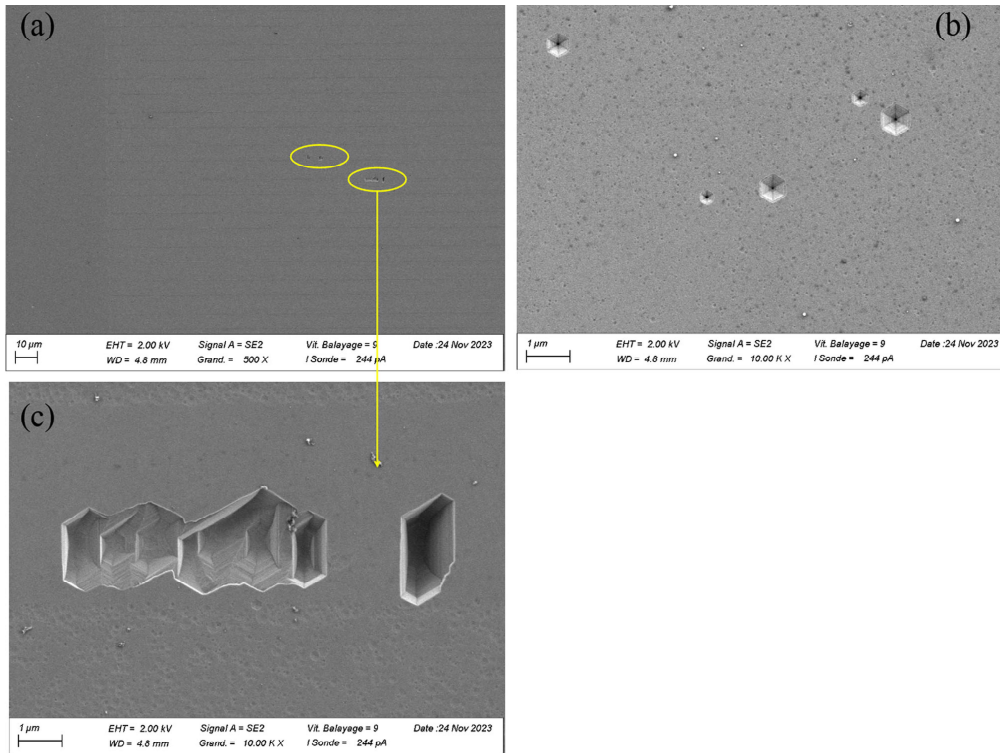
The previous reference device and device #3 were chemically exposed with H_3PO_4 at $130\text{ }^\circ\text{C}$ for 30 minutes. Some etch pits of revealed dislocations are visible on both devices (stressed and unstressed) which are less than $1\text{ }\mu\text{m}$ in diameter (Fig. 16b). On the stressed device, some zones are different from the unstressed device and lines of larger etch pits can be observed as shown in Fig. 16a and c. This pattern is expected to be related to the vertical leakage through the GaN buffer and the increased density of dislocations. The larger pits could be caused by the favored etching of the GaN in these areas due to the locally higher aluminum concentration brought about by the formation of dislocations, which reduces the electrical insulation and generates the vertical current leakage path for V_{DS} greater than 90 V [11–13].

Fig. 16 Etch pits obtained by chemical exposure with H_3PO_4 from tool #3. (a) Different etch pits pattern observed on the surface. Both the reference and the #3 have the small hexagonal etch pit visible in (b), but only the #3 has the line of (c)
