Criticality Accidents Occurred in Research Reactor Facilities in France

Fabien Duret¹, Aurélie Bardelay¹ and Tristan Adatte¹

¹Autorité de Sûreté Nucléaire et de Radioprotection (ASNR)
BP 17, 92262 Fontenay-aux-Roses Cedex, France

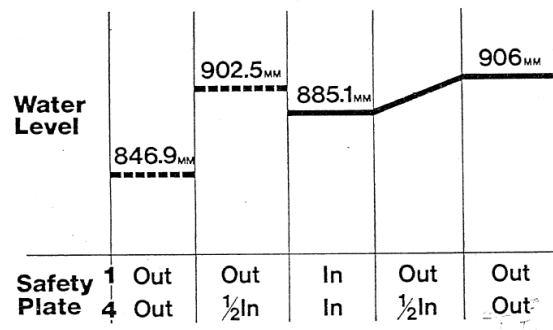
Figure 2. Evolution of water level during the experiment [2]

On March 15, 1960, only one operator was operating the reactor. Before starting the water filling, the safety plate #1 was removed but, for some unknown reason, the safety plate #4 was not completely removed. However, the operator started to fill the tank. At a water height of 806.5 mm, the operator noted that the counting rates was abnormally low compared to previous experiments. He then realized that a safety plate was still in the core and decided to raise safety plate #4 to mid-core position. The neutron counting rates became higher than before but still lower than expected, which should have warned him. However, he continued to fill the tank. At a water height of 845.3 mm, based on measured counting rates, he determined from extrapolation the critical water height at 902.5 mm. This value was totally inconsistent with the well-known critical water height of 846.9 mm. Despite this difference, the operator continued water filling.

At a water height of 885.1 mm, the cadmium plates automatically dropped to shut down the reactor. Following this shutdown, the operator forgot to change the sensitivity of measurement devices, which stayed on the lower sensitivity. This omission explains why the operator did not notice the slow divergence of the reactor. The operator removed safety plate #1 and raised safety plate #4 to mid-core position. He then resumed water filling. When the water height reached 906 mm, the neutronic chains detected divergence. The operator thought of an instrument error and set it to zero. This action cancelled the safety scram by fast water dump by the neutronic period threshold. He then removed completely safety plate #4.

Although the reactor was supercritical, the safety plates failed to scram, probably because the triggering threshold had been passed too rapidly. The operator, finally looking to the reactor status, shut down the reactor manually by dropping the cadmium plates. He then started the water dump of the tank. 20 minutes after the dump, the group leader decided to fill the tank to a water height of 650 mm to avoid a heat of the fuel.

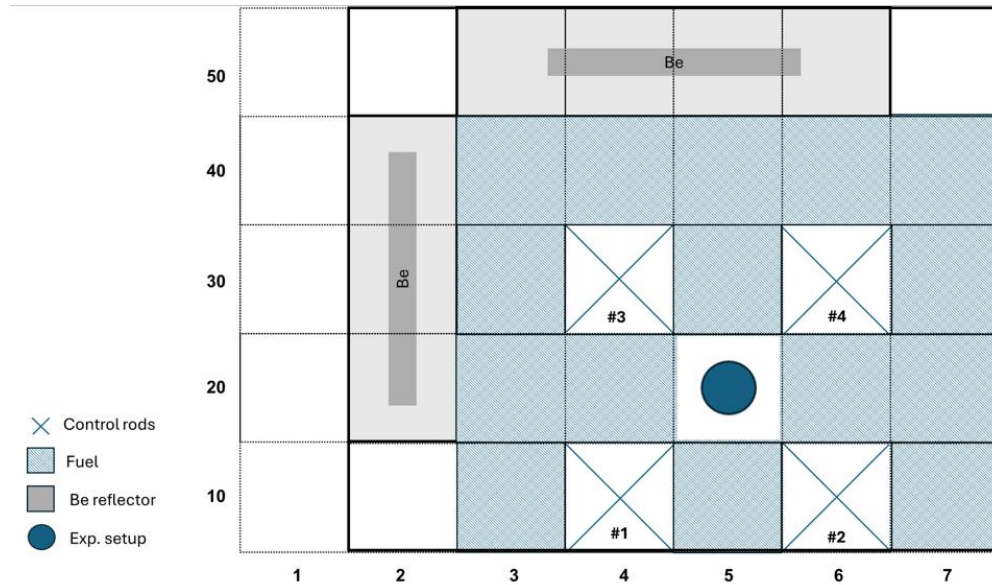
Figure 3. The core configuration before the accident [2]

After having supposedly inserted the control rods #1 and #4, an operator located in the control room gave the order to unload the experimental device to another operator located in the reactor hall. The operator, positioned on the bridge directly above the core, checked that the experimental device was not stuck before attaching it to a crane to unload it. To do this verification, he lifted the device manually by at most about 10 centimeters. An intense flashlight from the core was suddenly observed, as well as significant water movements without projection and the sound of an explosion was heard. Quickly understanding that an accidental power excursion was occurring, the operator dropped the experimental device, reinserting it into the core. The reinsertion of the device stopped the power excursion. The control rods #2 and #3 (in positions

16 and 34, see Figure 3 below), which had been deliberately left in high position during the operation, fell because the core instrumentation had exceeded the safety thresholds. The operator in the control room thought that the fall of the rods was due to a recurrent power failure. So, he reset the safety chain, thereby erasing all the warning displays. He was then informed about the accidental excursion by a call from the radiation protection service, whose measurement chain indicated that the safety threshold had been exceeded.

The power excursion was produced by the partial removal of the highly neutron-absorbing central device. However, several times in past operations, this device had been safely removed from an identical core configuration with both control rods #1 and #4 set in low position. The accident can therefore only be explained by a position error of one or both control rods. This was confirmed after the accident by activity measurements, which showed that the control rods #1 and #4 had been only partially inserted, as both their uranium and cobalt parts had been activated. Figure 4 shows the collimation system used to measure relative gamma activity along a rod and the comparison of the axial activation profile of rod #4 with the profile of a not inserted rod (rod #3). The offset between the activity maxima indicates the offset between the position of rod #4 at the time of the accident and its high position. The activation of the cobalt zone of rod #4 is also shown.

- the modification of the control room lighting,
- the painting in bright colors of some parts of control rods for better visual identification of their position from the bridge,
- technical improvements of both clamping devices of the rod insertion mechanisms and devices signaling the rod positions (microswitches on the mechanisms, etc.),
- organizational improvements (notably, before any operation on the core, a communication between operators in the reactor room and in the control room, to confirm the position of the control rods as expected).

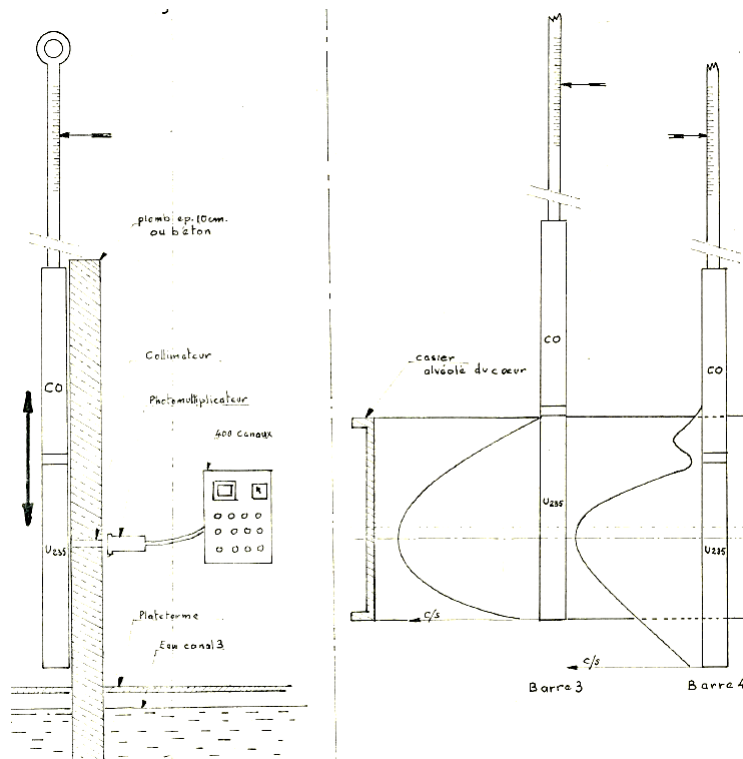
Figure 4. Left: collimation system. Right: activation of both the cobalt and uranium zones of rod #4 (partially inserted), compared with the axial profile of rod #3 (not inserted)

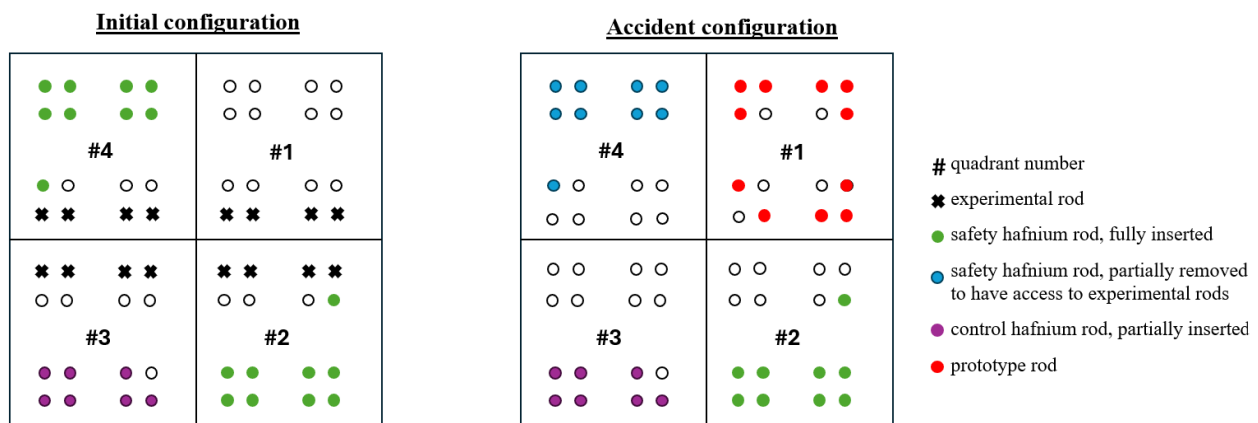
The day of the accident, after performing the water drain at a level of 70 mm below the upper end of the fuel elements, engineers performed the operations planned for quadrants #1 to #4. The critical excursion occurred during the removal of the last experimental rod from quadrant #4, while the safety absorbers were raised. This rods configuration is shown in Figure 5 below, right image.

Figure 5. Representation of experimental, safety Hf and prototypes rods before and during the accident (no representation of the fuel)

The accident occurred because of a very insufficient draining (at a level of only 70 mm below the upper end of the fuel elements) prior to the removal of the experimental rods, which was considered to be an insignificant modification. This assumption was not correct because of the small size of the core, the experimental rods provided significant anti-reactivity which was underestimated.

- insufficient preparation of the intervention, probably associated with fatigue at the end of an intensive program. These conditions led to an erroneous statement on the low impact of experimental rods on core reactivity. It was then concluded that emptying core tank followed by a new subcritical approach (as imposed by the instructions for each new loading) were not necessary. To address this point, the operator decided to modify the safety report and instructions to reinforce vigilance when modifying the absorbers, equally as when modifying the fuel elements,

- the absence of measures and means of rapid action that would have made it possible to reduce the irradiation of personnel (in particular, the assistant engineer had to move to the control room to activate the rapid draining). To address this point, the operator decided to install an automatic rapid draining system controlled by the neutron flux in the vicinity of the reactor.
