# Simultaneous monitoring of a collapsing landslide with video cameras

K. Fujisawa, J. Ohara

Public Works Research Institute, Japan

Received: 19 June 2007 - Revised: 7 August 2007 - Accepted: 8 August 2007 - Published: 2 January 2008

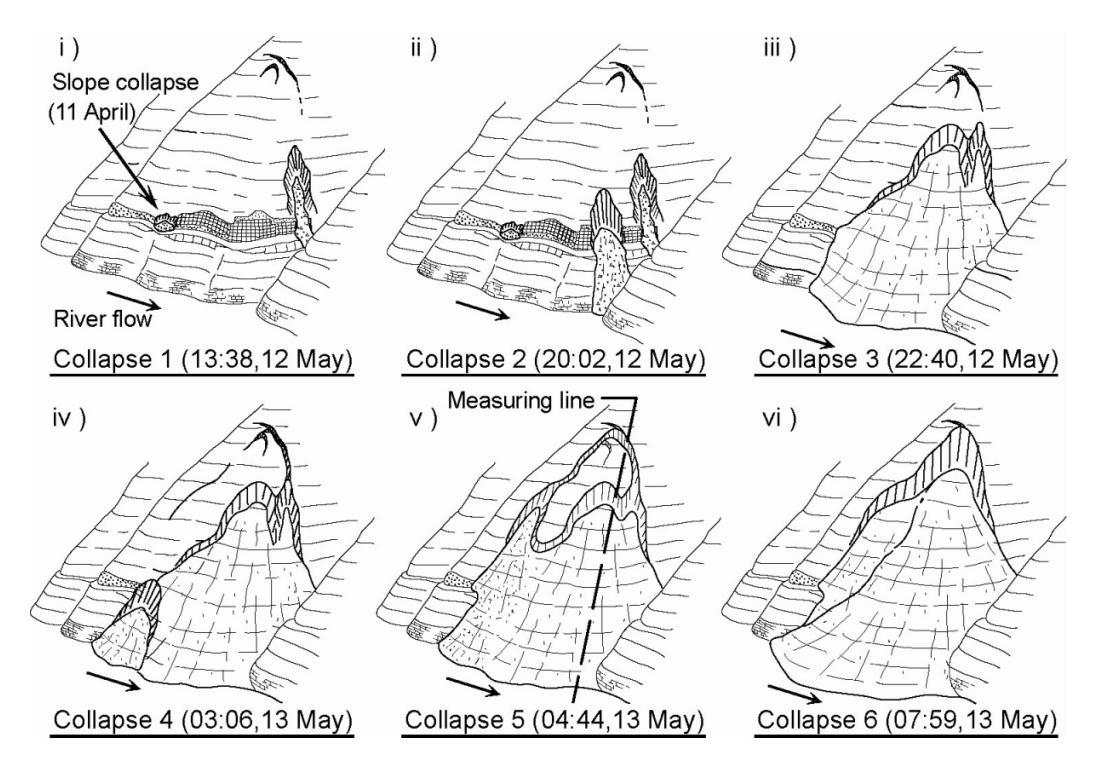
Fig. 2. History of collapses.

The analysis of images before and after the landslide showed that the slope collapse involved debris in excess of  $1000 \text{ m}^3$ , and that six separate landslide events occurred. Figure 2 shows sketches of each landslide event, numbered 1 through 6. Based on analysis of the images, the sequence of events leading to the landslide is thought to be as follows:

- 1. Slope collapse is confirmed on the slope next to the road on the mountain on 11 April. A major crack is identified at the top of the slope on 21 April. A slope collapse of approx.  $2000 \text{ m}^3$  (Fig. 2i) occurs near the downstream extension of the crack at 13:38 on 12 May.

- Several minor falling rock events occur in the region of Collapse 1 followed by a further slope collapse on 11 April. A second slope collapse of around 1000 m<sup>3</sup> (Fig. 2ii) occurs at 20:02 on 12 May a short distance upstream of Collapse 1.

- 3. A steady succession of falling rock and slope collapse events begins at 22:23 on 12 May, in the vicinity of Collapses 1 and 2, leading to a major slope collapse of approximately 10 000 m<sup>3</sup> at 22:40 (Fig. 2iii).

- 4. After a brief hiatus following Collapse 3, the next major slope collapse (Fig. 2iv, estimated at 1000 m<sup>3</sup>) occurs at 03:06 on 13 May near the foot of the slope on the upstream side. Due to the camera angle and poor visibility at night, the images provide only limited detail, although evidence of localized tree shaking suggests that the crack at the head of the landslide was beginning to extend upstream of the slope.

- 5. A further slope collapse (Fig. 2v, 1000 m<sup>3</sup>) occurs at 04:44 on 13 May on the slope further up the slope from Collapse 4.
- 6. Falling rock and slope collapse events begin at approximately 07:40 on 13 May on the middle and lower part of the slope and become more frequent, culminating in a major slope collapse (Fig. 2vi, 40 000 m<sup>3</sup>) at 07:59. This is followed by more falling rocks and minor collapses, but without any further significant topographical

Thus, the sequence of events leading up to the landslide began with collapses at the periphery of the landslide area (from the head to the sides and toe), where the effect of stress caused by movement is most apparent, followed by an increasing incidence of falling rocks and minor collapses in the area.

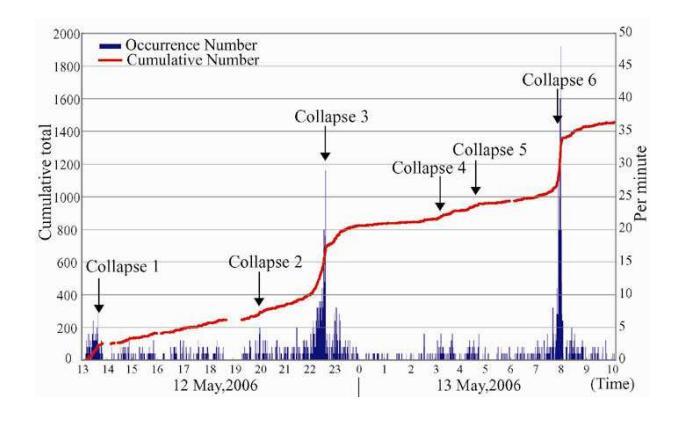
Fig. 3. Other events - falling rocks, slope collapses and fallen trees.

Figure 3 shows the count of falling rock events, slope collapses and fallen trees. Prior to the six major collapses, the frequency of these events steadily increased. The rate of increase was particularly pronounced prior to the two largest collapses (numbers 3 and 6).

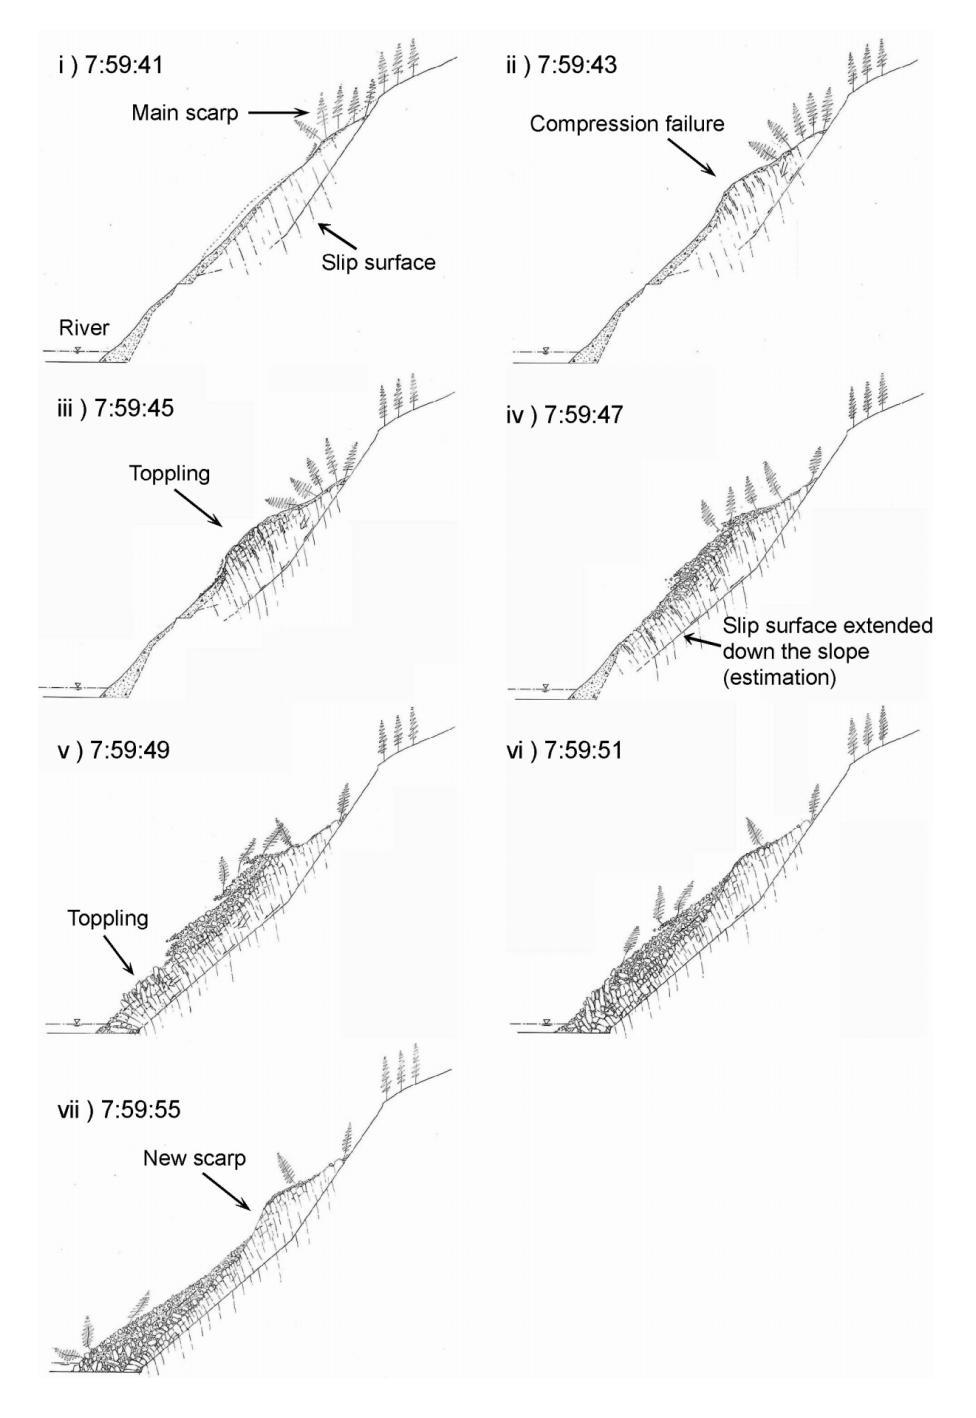
Fig. 4. History of collapses during sliding of Collapse 6 (occurring at 7:59 a.m. on 13 May).

Figure 4 shows the results of sketches made for about 20 s during the movement of Collapse 6 shown in Fig. 2 (occurring at 7:59 a.m. on 13 May), the largest slide that occurred while the landslide moved.

As shown in Fig. 4, the section diagrams were estimated based on several images taken from some different angles representing the 20 s from 07:59:35 to 07:59:55 on 13 May. These section diagrams were prepared along the measuring line shown in Fig. 2v. These were used to study the state of change of the moving soil mass accompanying the movement of the landslide.

The results showed that cracks formed in the landslide body located below the main scarp at the time of Collapse 5, and the collapse expanded from that location. When the landslide started to move, many collapses began to occur along the edges of the landslide (head – side/toe) (Fig. 4i). The movement of the landslide is thus assumed to be accompanied by a toppling movement (Fig. 4ii–iii). Afterwards, the head to the middle of the landslide body was crushed, resulting in the formation of debris deposit. (Fig. 4iv) As this debris deposit covered the entire lower part of the slope, the toppling was confirmed at the top of the landslide (Fig. 4v– vi). It is presumed that the toppling occurred at the toe of the

landslide because the stress produced by the movement of the landslide reached the lower part of the slope. The landslide body remained near the top of the slope; however, because the collapse flowed downward with the toppling, a new scarp was formed near the center of the slope (Fig. 4vii).

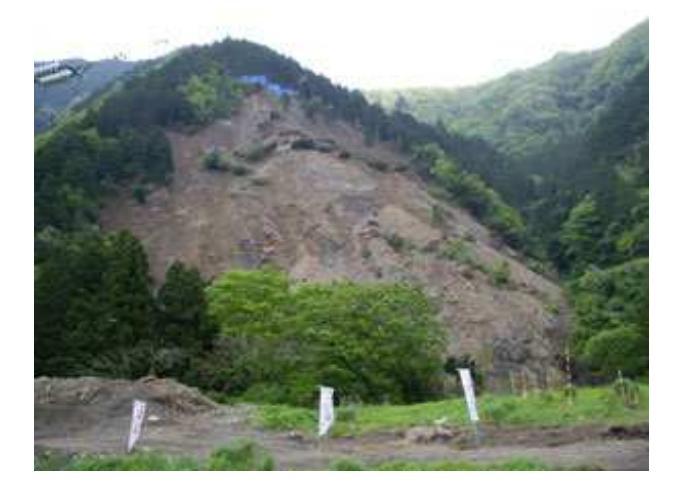
Fig. 5. General view of the landslide site (14 May 2006).

approximately 150 m in width by 135 m in height, with a volume of approximately  $250\,000 \text{ m}^3$  (Fig. 5).

The landslide occurred on a steep slope with an average inclination of 35° located between elevations of 145 m and 270 m facing the Ibi River. The ground, composed chiefly of clay slate in a Mino zone from Mesozoic and Paleozoic strata of the Permian period, is in a reverse-dip slope. The head and toe of the landslide showed evidence of severe weathering. A crush zone with reverse-dip slope was identified in the loose region around the toe.

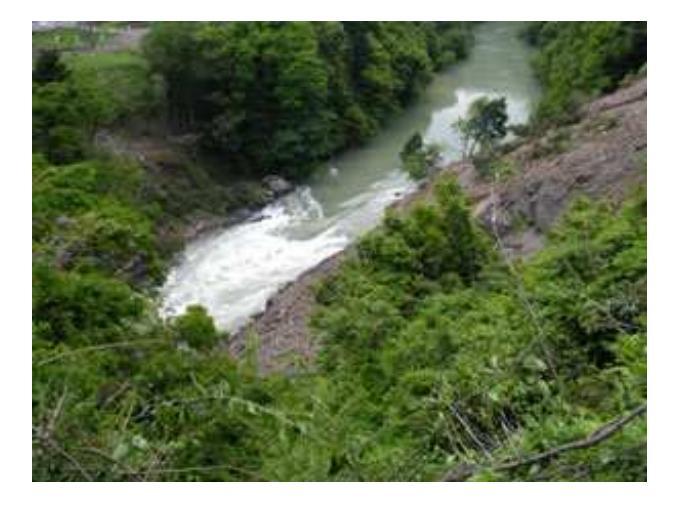
Fig. 6. Debris deposits in the river course (14 May 2006).

Image analysis, together with field measurements using a ground-based laser scanner after the collapse, indicated that the landslide produced a total of  $50\,000\,\text{m}^3$  of debris. It flowed into the river during the landslide. As Fig. 6 shows, this blocked some two-thirds of the width of the river, and also caused damage to several local roads, but most of the landslide body remained on the affected slope.
