Seismically reactivated Hattian slide in Kashmir, Northern Pakistan

Jean F. Schneider

Received: 20 March 2008 / Accepted: 3 April 2008 / Published online: 14 May 2008
© Springer Science + Business Media B.V. 2008

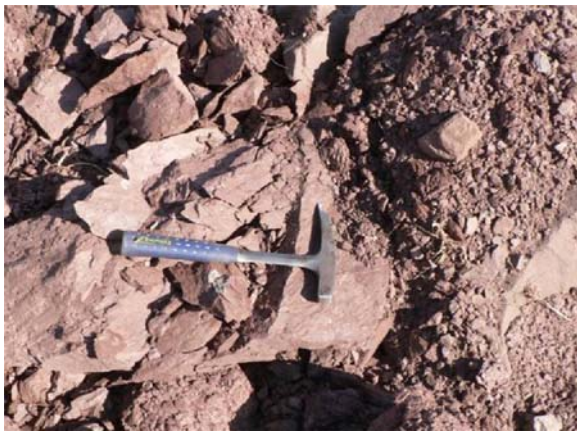
Fig. 5 Shale of the Murree Formation on dam proximal to the landslide (hammer for scale). The clayey to silty material is crumbling apart, wetted by the morning dew. The resulting soil is quite impermeable and can thus act as an aquiclude. Monsoon rainfall will enhance this effect, adding to the consolidation of the slide debris

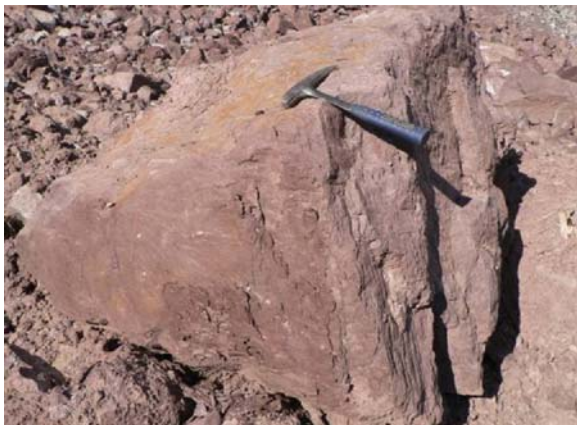
Fig. 6 Sandstone block of Murree Formation in the distal highest part of slide mass (elevation 1446 m, hammer for scale). The size and number of large blocks increases with increasing distance from slide (segregation). While excavating the artificial spillway in the proximal area, only a few large blocks have been found

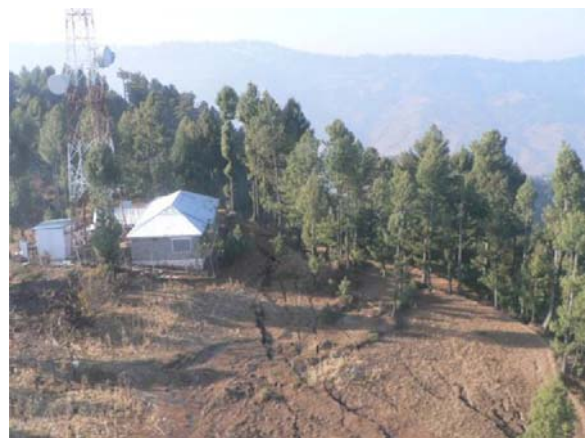
Fig. 7 Lateral spreading at Dana hilltop in the vicinity of the SCO-Tower. Most cracks are oriented N – S. Such cracks can be seen all along the Dana hillcrest from the Tanda fault in the south to Dana hilltop (Heli view to south)

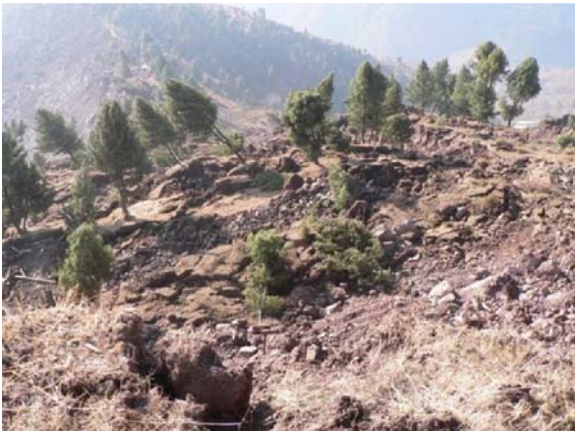
Fig. 8 Massive disruption of the Murree formation at the hillcrest between the communication tower and the top of actual landslide (view to south). This scene looks quite different from a normal landslide escarpment. Large amounts of shattered rock remain on the slope in unstable condition, which could potentially create further mass movements

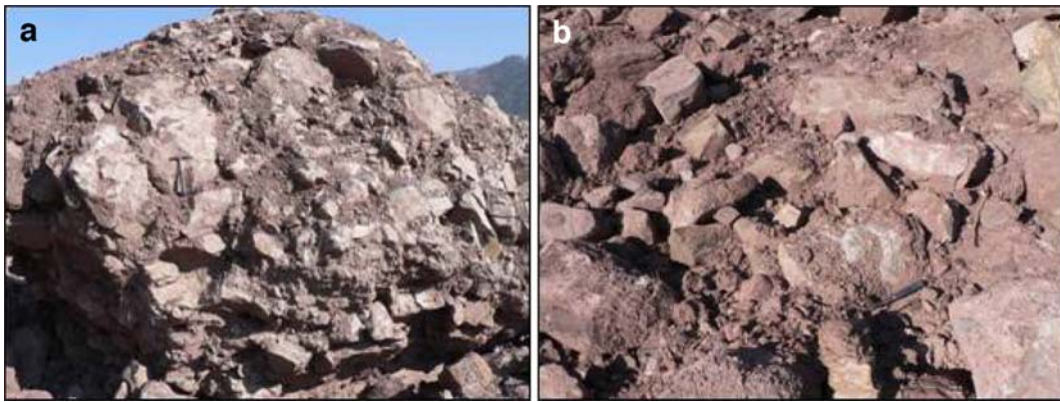
Fig. 13 a, b: Cemented breccia of slide debris from former landslide found in central distal area of landslide dam on the left photo. The cement consists of carbonates (tested with hydrochloric acid, see hammer for scale). The right photo

shows in comparison a similar breccia with sandstone components, clay and silt as matrix, but not cemented, lying in the central part of the actual landslide dam (see hammer for scale)
