Compressive Failure of UD-CFRP Containing Void Defects: In situ SEM Microanalysis

Julia Hapke^{*,a}, F. Gehrig^b, N. Huber^a, K. Schulte^b, and E.T. Lilleodden^a

Abstract

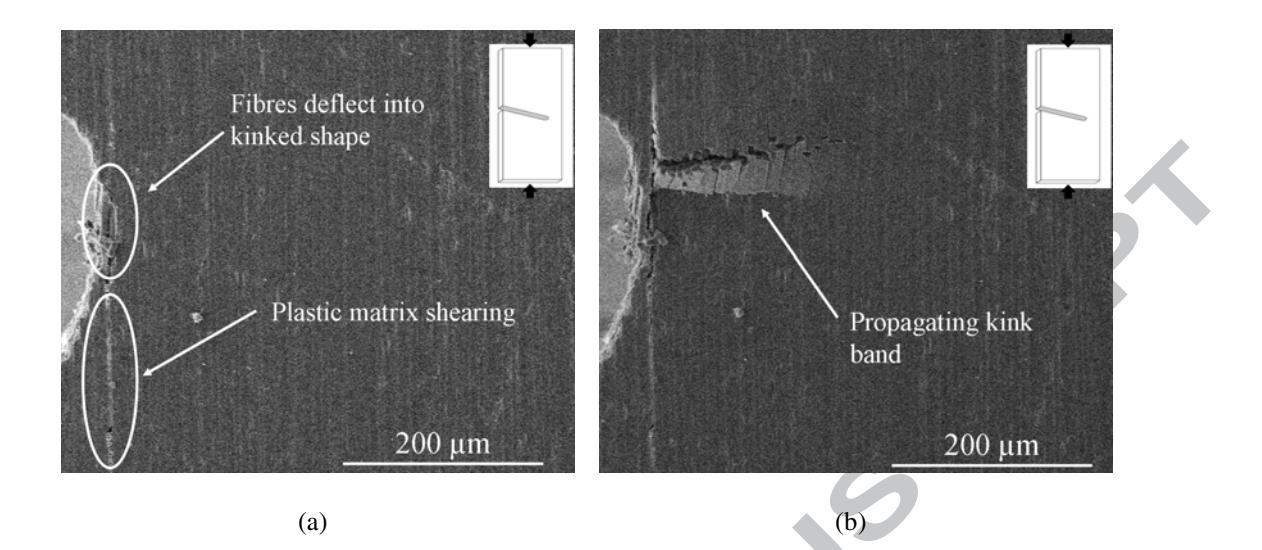
The first feature visible upon loading is large plastic shearing in the matrix, as evidenced by the formation of shear cups (Fig. 3(a)). Another *in situ* SEM study by Sivashanker et al. [18] on centre-notched specimens revealed fibre kinking as well as longitudinal splitting induced by interfacial debonding. However, such interfacial debonding was not observed in our experiments. Furthermore, the clearly visible matrix degradation shown in Fig. 3(a) supports the assumption of a largely stable fibre-matrix bonding at this

Figure 3: Two subsequent frames from the movie captured during initial loading. Frame (a) is the last frame before kink band propagation starts. Already visible is large plastic matrix shearing and fibre deflection into a kinked shape. Taken 0.2 sec later, frame (b) shows a kink band already having propagated over more than a 100 μ m, illustrating the sudden and catastrophic nature of failure.

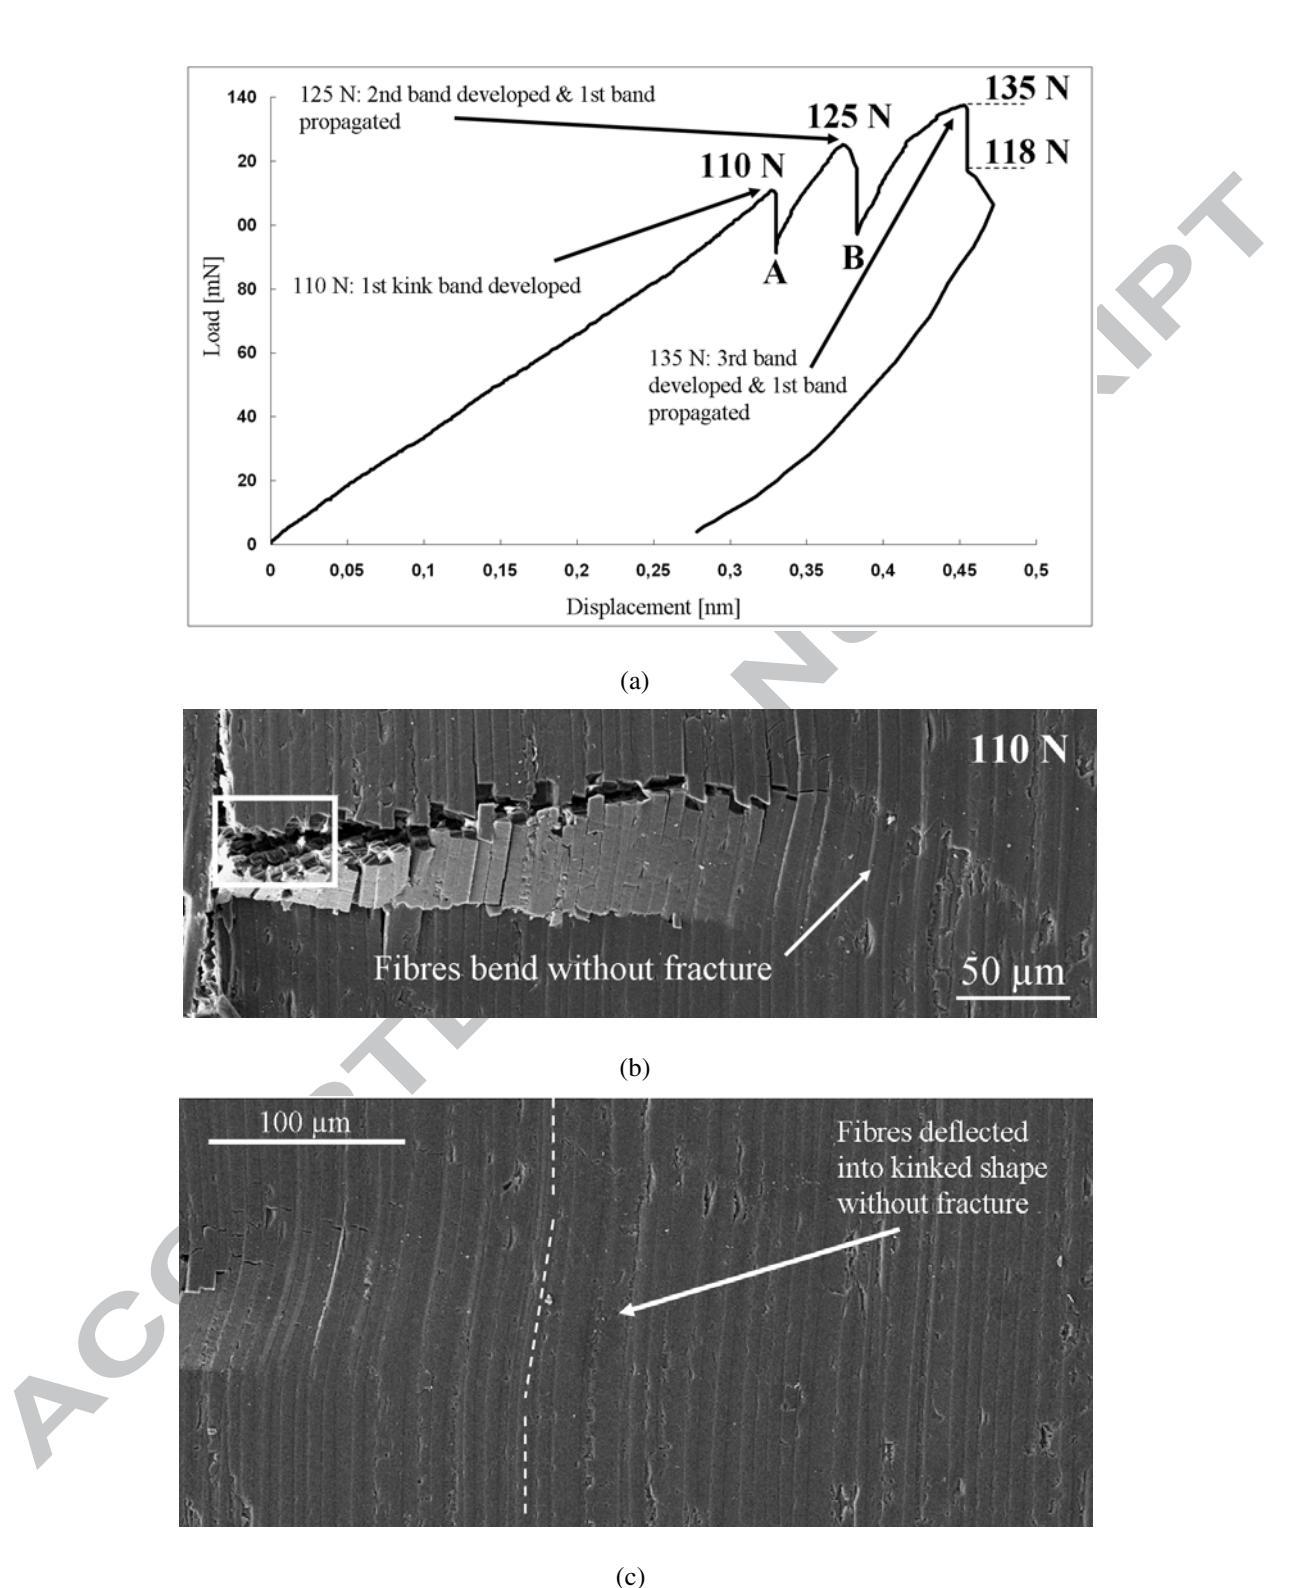
As evidenced in Fig. 4(a), every hold segment is accompanied by significant load relaxation. While held at constant displacement before final unloading, further fibre fracture occurred at the band tip, as shown in Fig. 6(a) and 6(b) taken at an interval of 15 minutes during the constant displacement period. During reloading, an additional kink band is initiated at the same site, propagates along the same path and shares one boundary with the original band. The formation of such additional kink bands can be observed on all tested specimens during loading after a holding period. However, only the initial band is ever observed to propagate across the whole width of the sample; subsequent kink bands arrest as soon as the shared boundary with the initial bands terminates.

Figure 4: (a) A generic load-displacement curve including several hold periods for imaging followed by further loading; at the point labelled with 110 N the kink band has been arrested directly after it has started to propagate. The associated images are presented in (b), revealing fibres already bent but not yet fractured ahead of the band tip. Also a large out-of-plane deformation is visible, especially close to the notch ground. In (c), fibre deflection into a kinked shape of yet unfractured fibres is visible in front of the fracture zone.

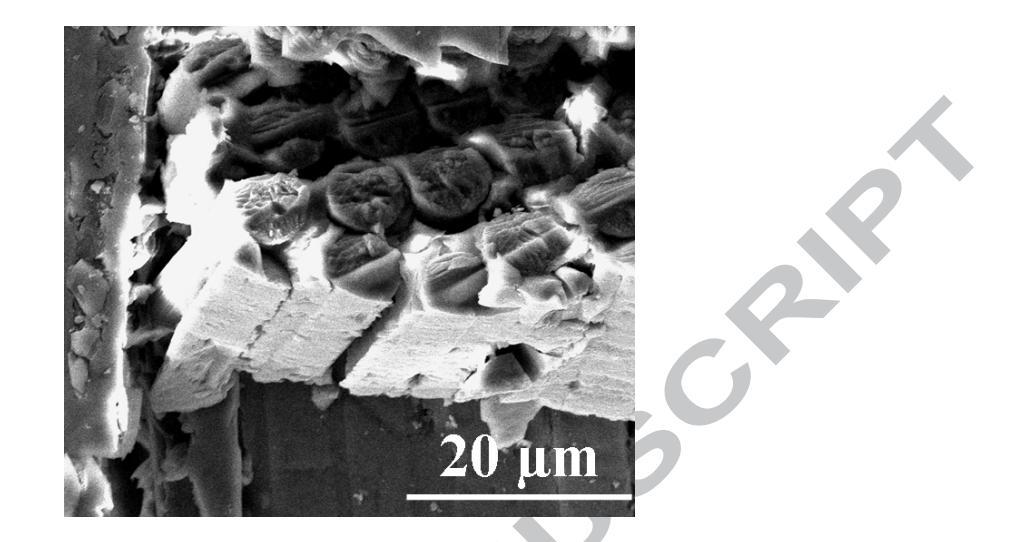
Closer examination of the fibres' fracture surfaces in Fig. 5 reveals smooth lines along the fibre transverse axis on fibres in several plies, suggesting that fracture is mainly driven by the deformation in the thickness direction. As the fibres on the surface plies have been partly removed by sample polishing, this out-of-plane deformation is not necessarily a result of specimen misalignment, but rather a consequence of the surface fibres' reduced load-bearing capacity due to their smaller cross section and damaged internal structure. The issue of possible influences from surface effects will be addressed in greater detail in the section on the analysis of the defect morphology in the plies below the surface. Due to the large out-of-plane deformation, the final fibre inclination and the kink band angle cannot be determined from the SEM images directly. However, bandwidth measurements have been made, showing values in the range of 50 to 60 μ m for all bands.

Figure 5: A higher resolution image of the area highlighted in Fig. 4(b), showing lines along the fibre transverse axis on the fibre fracture surfaces, suggesting fracture to be mainly driven by out-of -plane forces.

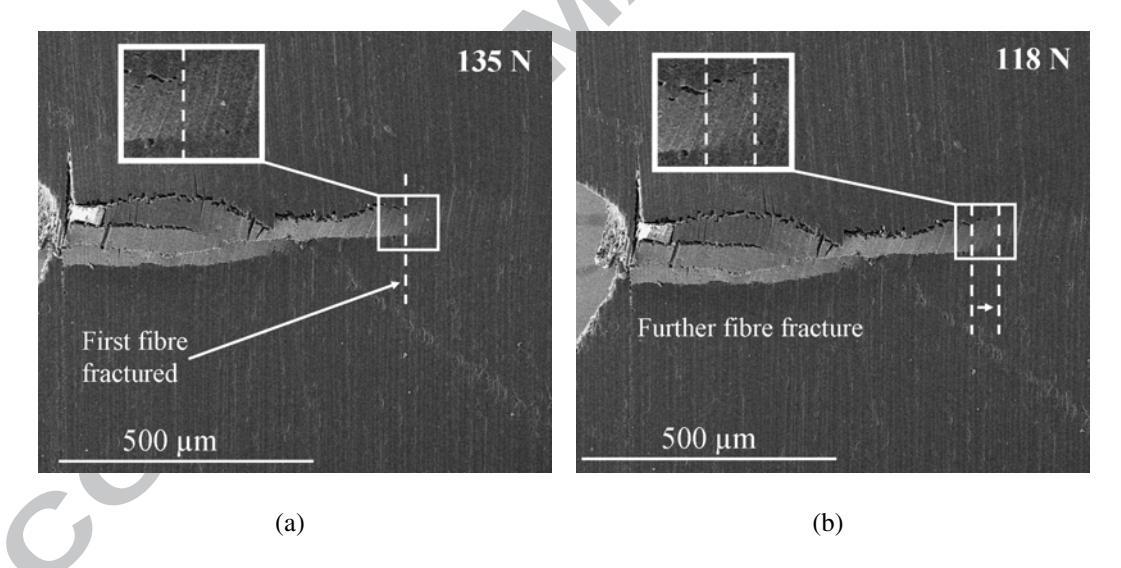
Figure 6: Images taken at the beginning (a) and 15 min. later at the end (b) of a hold period, marked with 135 N and 118 N in Fig. 4(a). Highlighted areas show further fibre fracture at the band tip, illustrating the large impact of time-dependent processes on damage morphology.

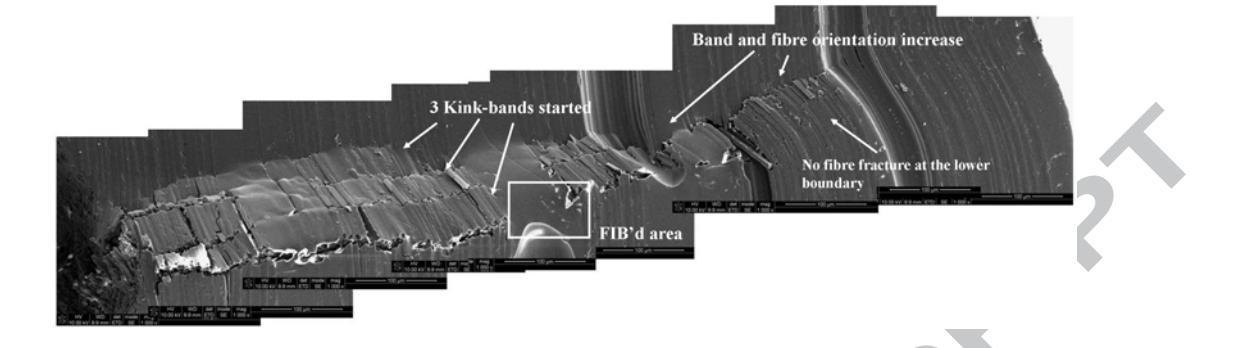
Figure 7: Final kink band morphology in a void-containing specimen. Loading has been interrupted three times, after each hold period a new kink band has started from the stress riser; only one band has propagated over the entire specimen width. Band and fibre inclination increase cumulatively with each void passed; in the final band segment fibre fracture is reduced to only one boundary. In the area highlighted, surface plies have subsequently been removed by the FIB technique to analyse damage morphology in the plies below.

In the case where a defect is located with its centre in front of the defect (Fig. 7), no failure propagation through the void can be observed. Fibres bend and deflect into the void, but the absence of the load-transferring resin seems to effectively hinder band propagation. Resin-rich areas, usually found to circumvent voids in composite materials, were not observed to have any influence on band evolution.

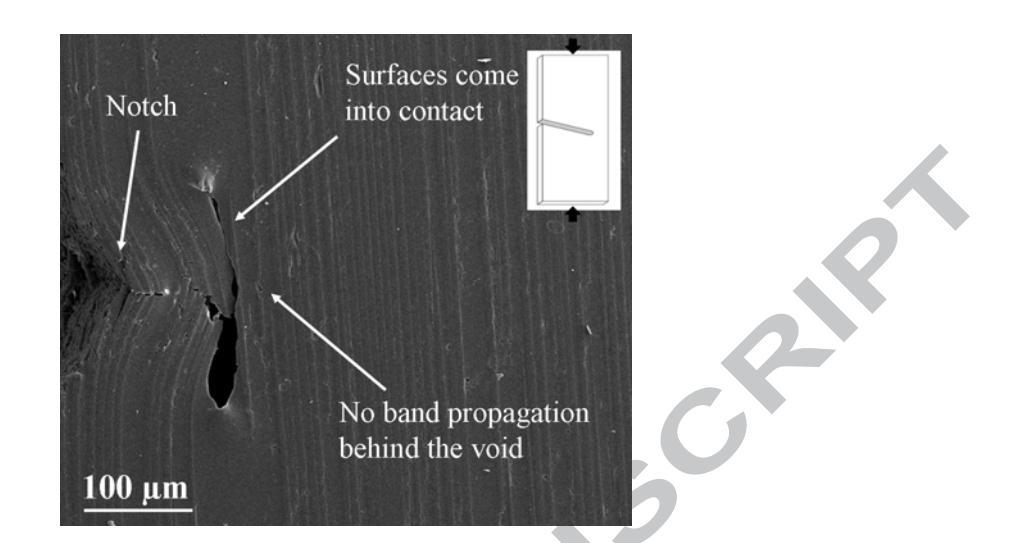
Figure 8: Final kink band morphology in a void-containing specimen; in contrast to the specimen presented in Fig. 7 here the kink band had to propagate directly into the void's centre. Fibres and matrix undergo large deformations bringing the void's inner surfaces into contact, no band propagation behind the void can be observed.

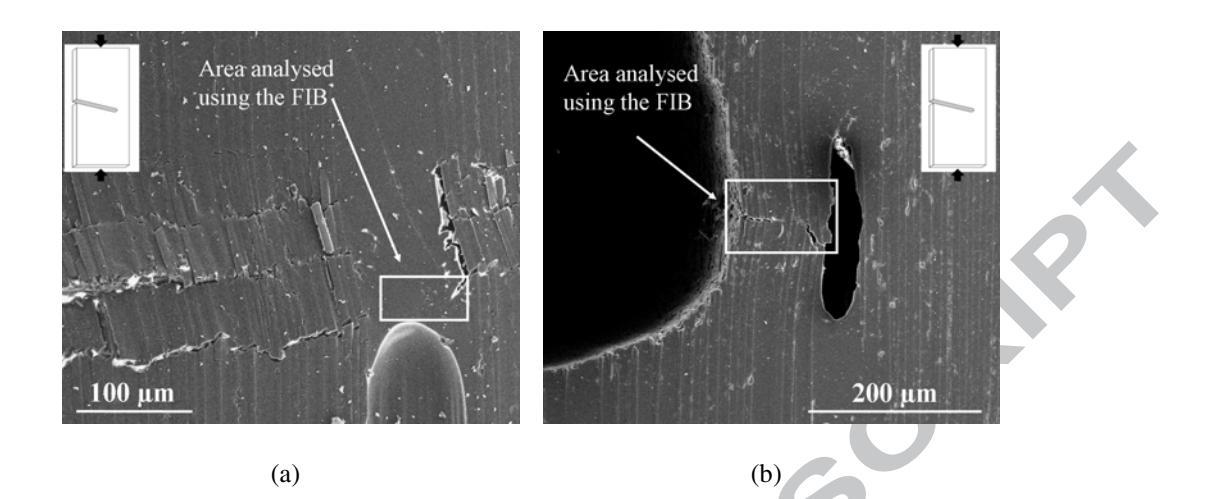
Two specimens were analysed weeks after testing to examine the effects of timedependent relaxation. One sample was re-examined two weeks after testing (Fig. 9(a)) and a second one four weeks after testing (Fig. 9(b)). In both cases significant changes in the failure pattern are evident. Fibres and voids have almost completely returned to their original configuration and the fibres' kinked shape has vanished. A *post mortem* investiga-

Figure 9: : In (a), the specimen presented in Fig. 7 is shown two weeks after testing, significant relaxation of the former pronounced kinked fibres is visible. A micrograph of the specimen presented in Fig. 8 four weeks after testing is given in (b); fibres have almost returned into their initial shape. In the areas highlighted in (a) and (b), material has been removed from the surface using the focused ion beam technique.

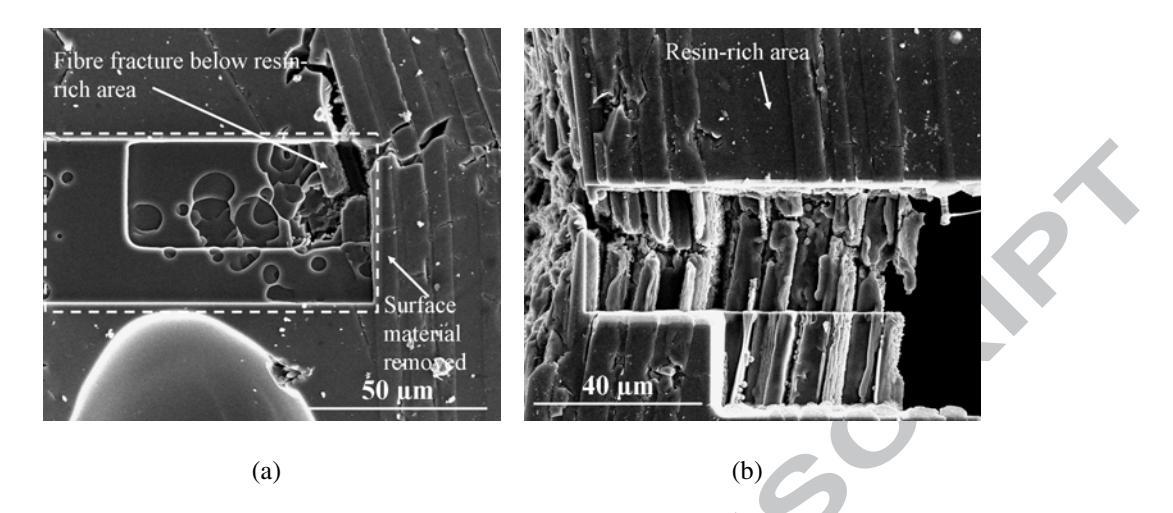
Figure 10: Fractured fibres below the resin-rich area denoted in Fig. 9(a) can be observed in (a), damage in the sub-surface plies resembling the pattern visible in Fig. 9(b) is presented in (b).
