HAL
open science

Aluminum metallization and wire bonding aging in power MOSFET modules

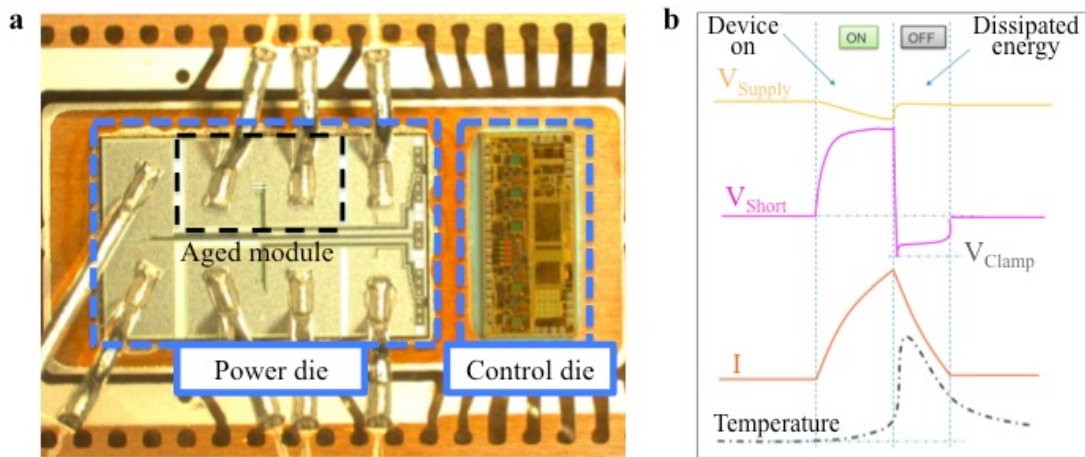
Fig. 1. (a) 12 V NXP's SmartMOS[®] including the power and the control die. (b) Typical signals during a short cycle event in the power MOSFET by activation of overload protection.

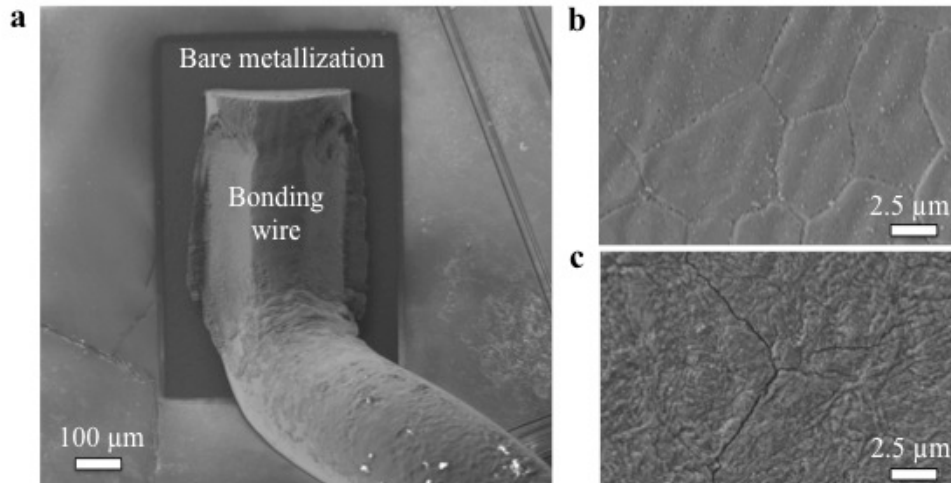
Fig. 2. (a) SEM image of an Al bond wire welded on the Al source metallization. Away from the bonding area the metallization is coated by a SiO_2 passivation layer. At higher magnification, bare metallization (close to the bond wire) of an (b) as-is module and (c) an aged one.

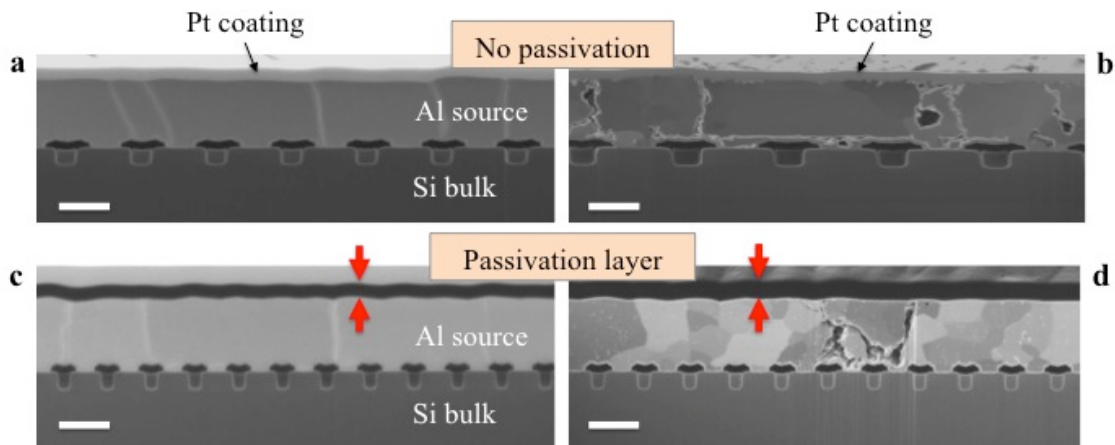
Fig. 3. FIB imaging of the bare metallization of an (a) as-is and (b) aged (70 °C) power module and of a SiO₂ coated metallization in an (c) as-is and (d) aged (70 °C) power module. The red arrows highlight the SiO₂ passivation layer. Scale bar 2.5 μm.

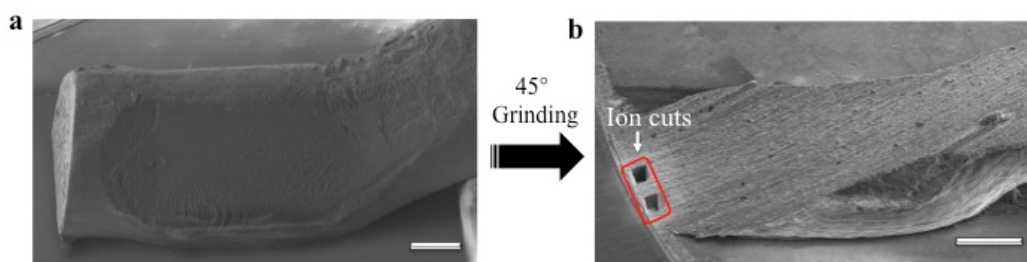
Fig. 4. (a) Bonding wire welded on the source metal of a power module. (b) The wire is cut and polished at 45° before being cut by FIB for interface observation. Scale bar 100 μm.
