Crack arrest capabilities of AA2024 and AA7175 aluminum alloys under impact loading

Gunasilan Manar, Patrice Longère

Gunasilan Manar, Patrice Longère. Crack arrest capabilities of AA2024 and AA7175 aluminum alloys under impact loading. *Engineering Failure Analysis*, 2019, 10.1016/j.engfailanal.2019.06.075 . hal-02164321

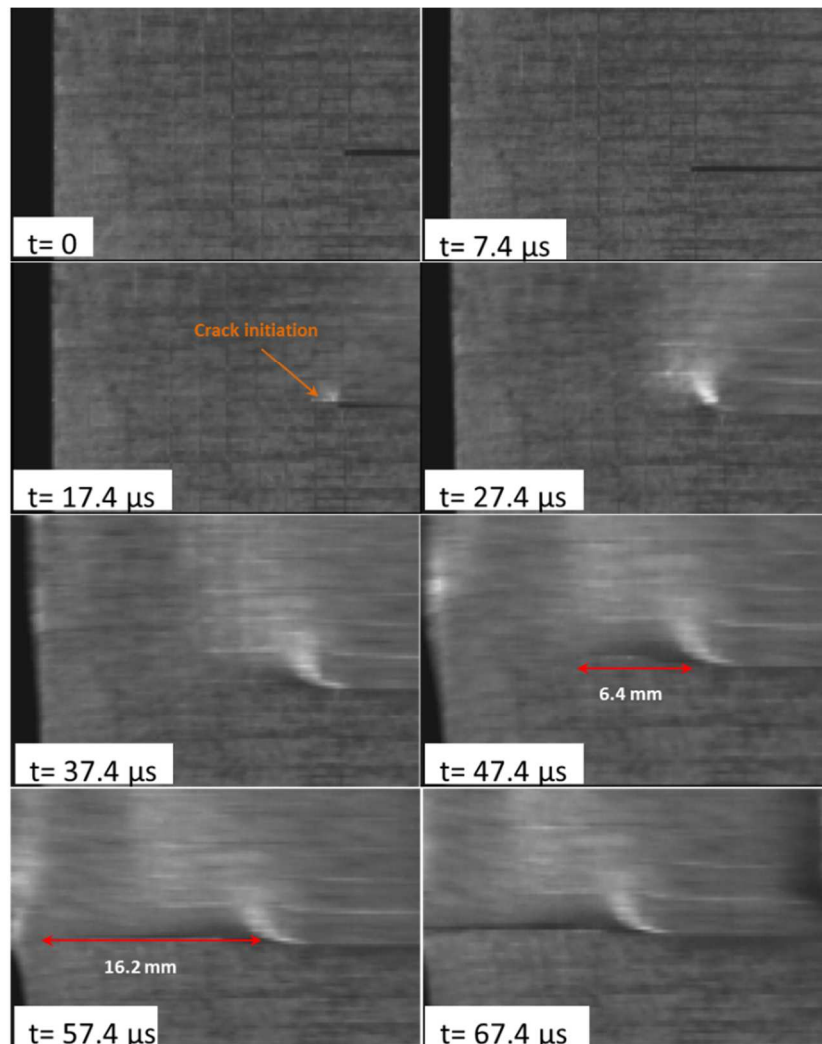
Fig.15 depicts the chronology for AA2024 plate at impact speed of 222 m.s^{-1} with one frame every $10 \mu\text{s}$. The following steps can be observed:

- between $t=0$ and $t=17.4\mu\text{s}$: a compression wave propagates throughout the part of the plate impacted by the projectile leading to the formation of a shear wave at the notch tips; the crack initiates.
- between $t=17.4 \mu\text{s}$ and $t=37.4\mu\text{s}$: due to Poisson-like effect the compression of the part of the plate impacted by the projectile leads progressively to the closure of the gap between notch lips. For the lower notch the upper lip thus hits the lower lip yielding the propagation of a compression wave of the part of the plate above the lower notch; the compression wave propagates towards the lower free edge of the plate.
- between $t=37.4 \mu\text{s}$ to $t=47.4 \mu\text{s}$ the crack propagates and measures 6.4 mm
- the crack reaches the length of 16.2 at $t=57.4 \mu\text{s}$

Fig.15 : Lower part of the AA 2024 plate during impact at 222 m.s^{-1}

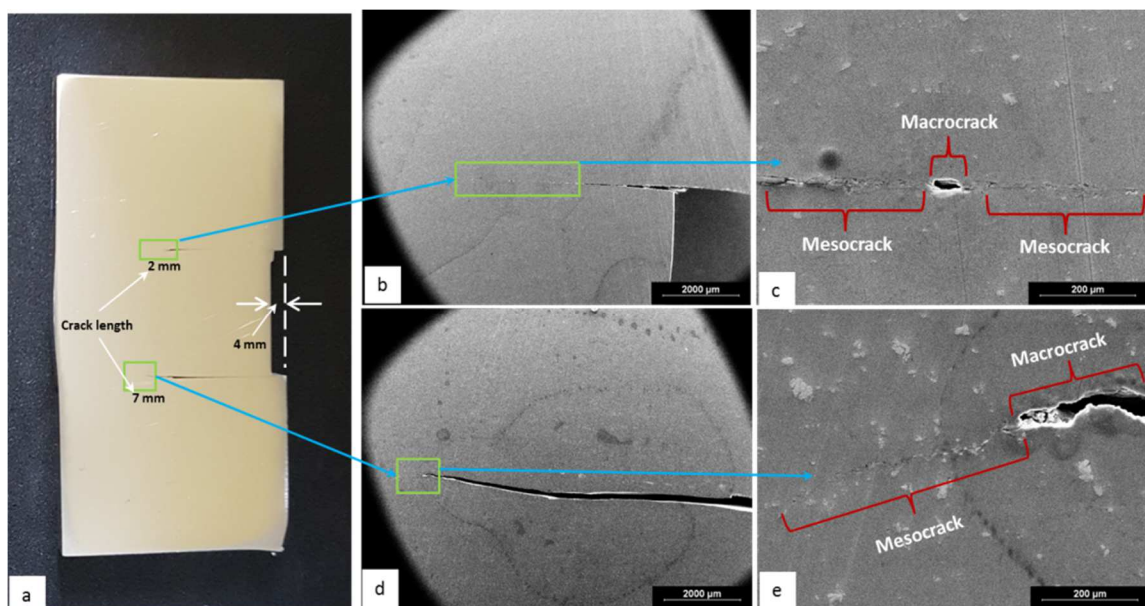
Fig.20 : Post-mortem AA 2024 specimen after impact at $111\ \text{m.s}^{-1}$

For impact speed of $111\ \text{m.s}^{-1}$, lower notch crack is longer than upper notch, see Fig.20 (a-c). Lower notch crack length is 7 mm and upper notch crack length is 2 mm, see Fig.20 (a). The depth of the impacted indentation is about 4 mm, see Fig.20 (a). The cracks are composed of a succession of macro-cracks (in minority) and meso-cracks (in majority), see Fig.20 (c-d).

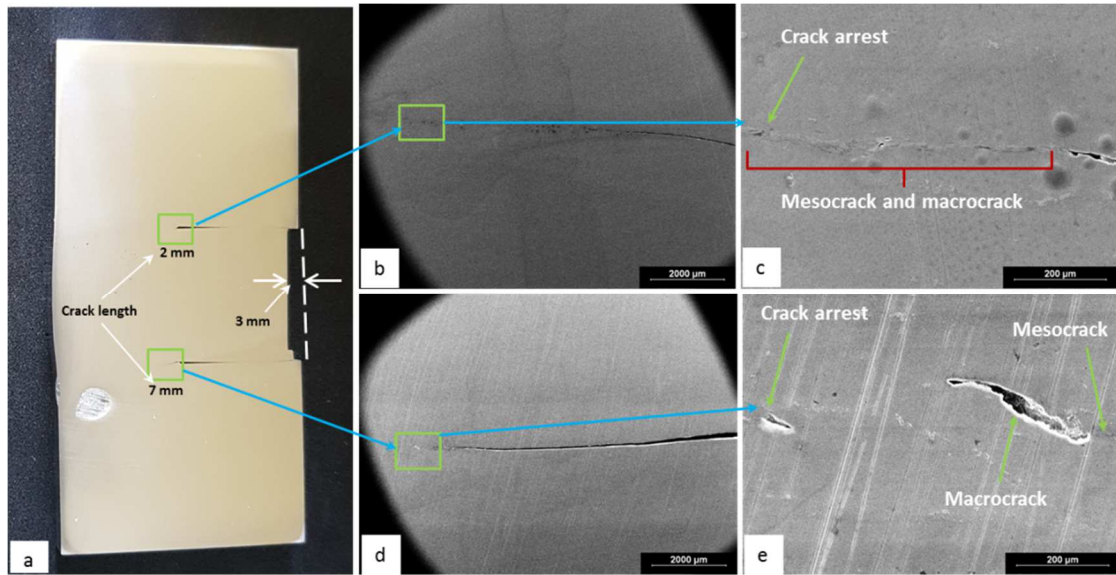
Fig.23(a) shows the specimen AA 7175 after impact at speed of 120 m.s^{-1} with crack length for both upper and lower notches of 2 mm and 7 mm respectively. The indentation depth is 3 mm, see Fig.23 (a). Crack propagation is depicted in Fig.23 (b) and (d) for upper and lower notch respectively. There are meso-cracks and macro-cracks appearing in both crack tips, see Fig.23(c) and (e).

Fig.23 : Post-mortem AA 7175 specimen after impact at 120 m.s^{-1}

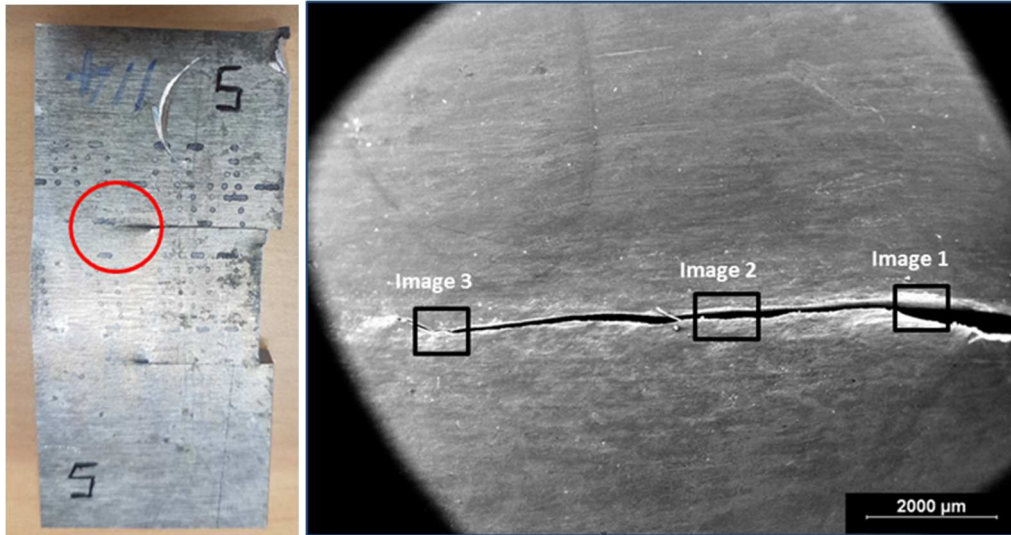
Fig.24(a) shows the crack propagation for AA2024 KW specimen impacted at speed of 114 m.s^{-1} . The upper part of the crack was chosen for analyze because of its longer crack length. Total length of crack is about 7 mm.

Fig.24 : (a) Post impacted AA 2024 double notch plate at 114m.s^{-1} (b) Macroscopic view of crack after surface polishing

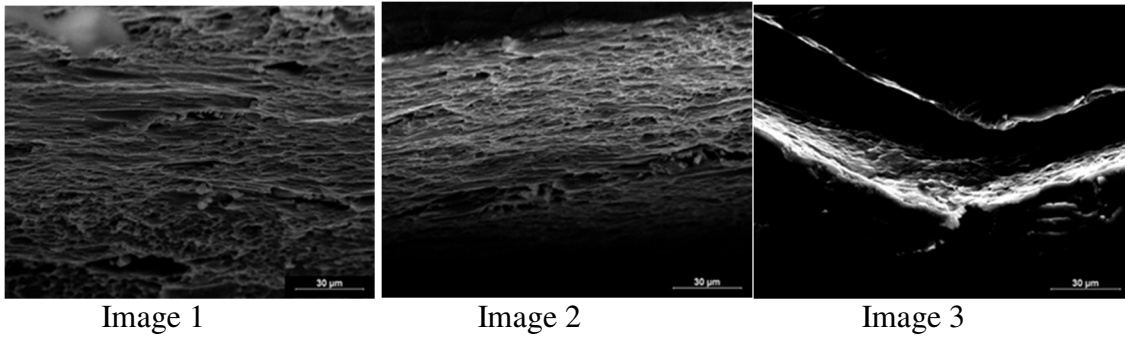
The crack was analyzed at 3 zones as shown in Fig.24(b). Fig.25 shows the detail of microstructure of the three zones. Image 1, Fig.25 shows that the initiation of crack from the notch tip is characterized by flat shear and elongated dimples. The beginning of crack propagation proceeds by predominant shear Mode II due to the surface is characterized by flat shear and elongated dimple, see image 2, Fig.25. Image 3, Fig.25 shows crack bifurcation characterized by changes in the loading mode. It is worth noting that the crack bifurcates upwards, i.e. according to clockwise rotation. The microstructure inside the bifurcation zone depicts the combination of flat shear and dimple cluster, as a consequence of the combination of tension loading in opening Mode I and shear loading induced Mode II.

Fig.25 : Microstructure of crack for AA 2024 after impact speed of 114 m.s^{-1}

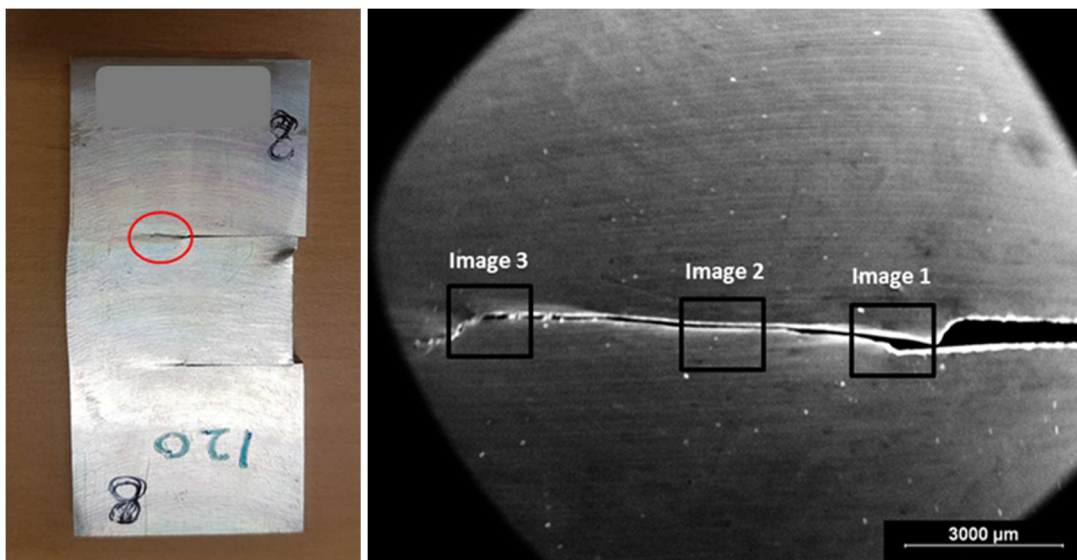
Fig.26(a) shows the crack arrest inside the AA7175 specimen for the impact speed of 120 m.s^{-1} . Fig.26 (b) shows the macroscopic view of the crack. The total length of the crack is close to 8 mm.

Fig.26 : (a) Post impacted AA 7175 double notch plate at 120 m.s^{-1} (b) Macroscopic view of crack after surface polishing

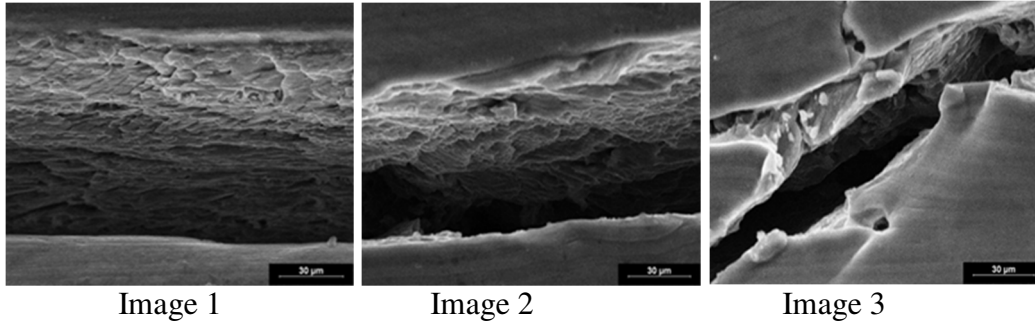
notch tip is characterized by flat shear surface dominated by shearing induced Mode II failure, see image 1, Fig.27. Image 2, Fig.27 reveals that the crack propagation seems to proceed with predominant shearing induced Mode II due to existence of flat shear surface. Image 3, Fig.27 shows the change in loading direction at crack bifurcation zone, where the microstructure is flat shear surface and mode II failure still seems predominant. It is worth noting that the crack bifurcates downwards, i.e. according to anti-clockwise rotation.

Fig.27 : Microstructure of crack for AA 2024 after impact speed of 114 m.s^{-1}

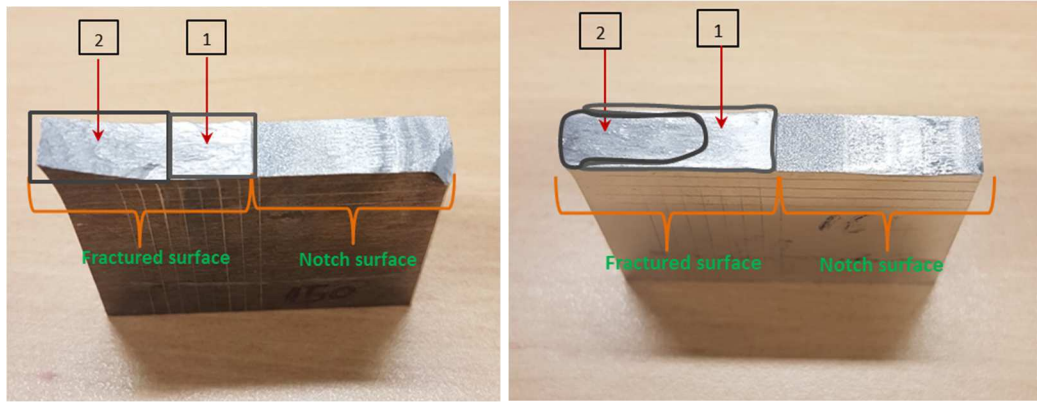
Fig.28 : Fractography of ruptured surface (a) AA2024 at impact speed of 150 m.s⁻¹ (b) AA7175 at impact speed of 164 m.s⁻¹

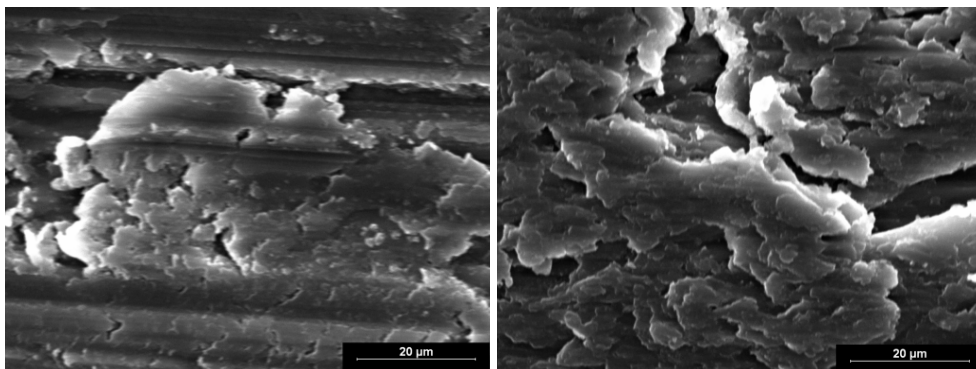
Fig.30 shows the microstructure of AA7175 after impact at speed of 164 m.s^{-1} . Microstructural view of AA7175 shows both region are flat shear surface, thus the failure is mainly due to shear (Mode II).

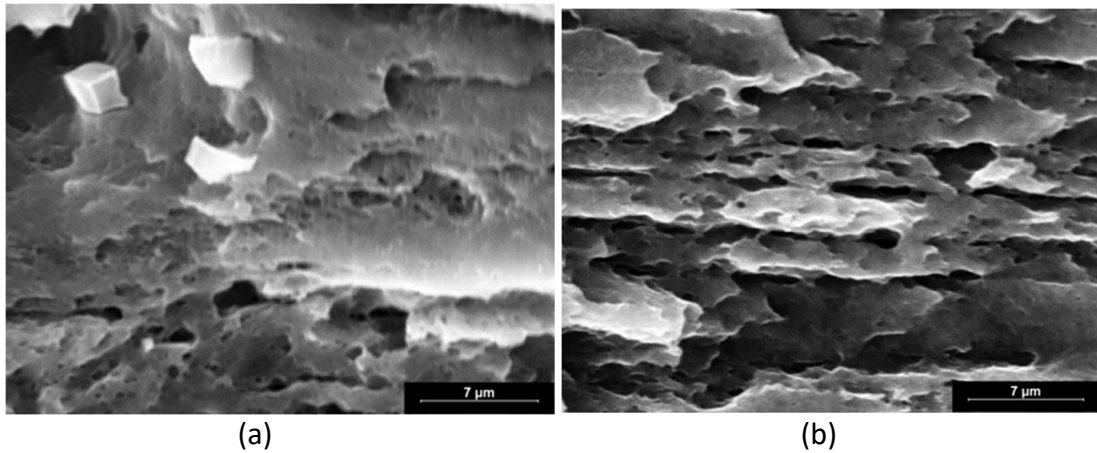
For AA2024, there are evidences of zones of failures under Mode II and Mode I.
For AA7175, there are evidences of zones of failures under Mode II only.

Fig.33 : Microstructure view of AA7175 at ruptured surface (a) Flat shear (b) Flat shear

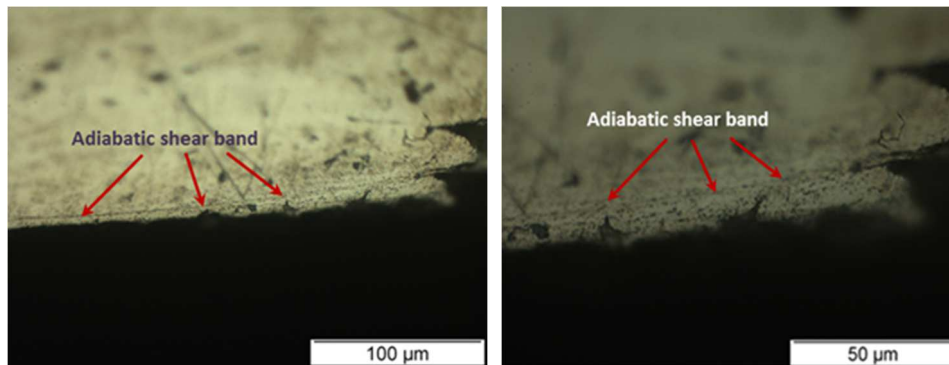
For AA2024 crack lip analysis does not show any evidence of shear band see Fig.35, and on the other hand for AA7175 the adiabatic shear band with average width of $6\mu\text{m}$ is visible on the crack lips as shown in Fig.36.

Fig.36 : Optical microscopic view of crack lip region for AA7175

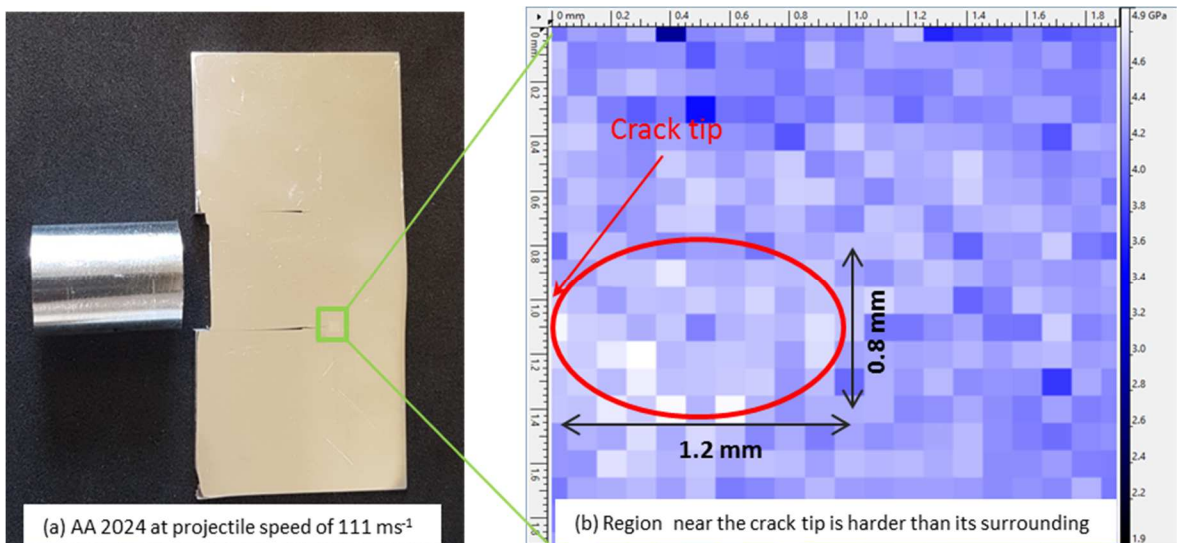
Fig.37 : Nanohardness of crack tip for AA 2024 at impacted speed of 111 m.s^{-1} . Light blue for higher hardness value and dark blue for lower hardness value.

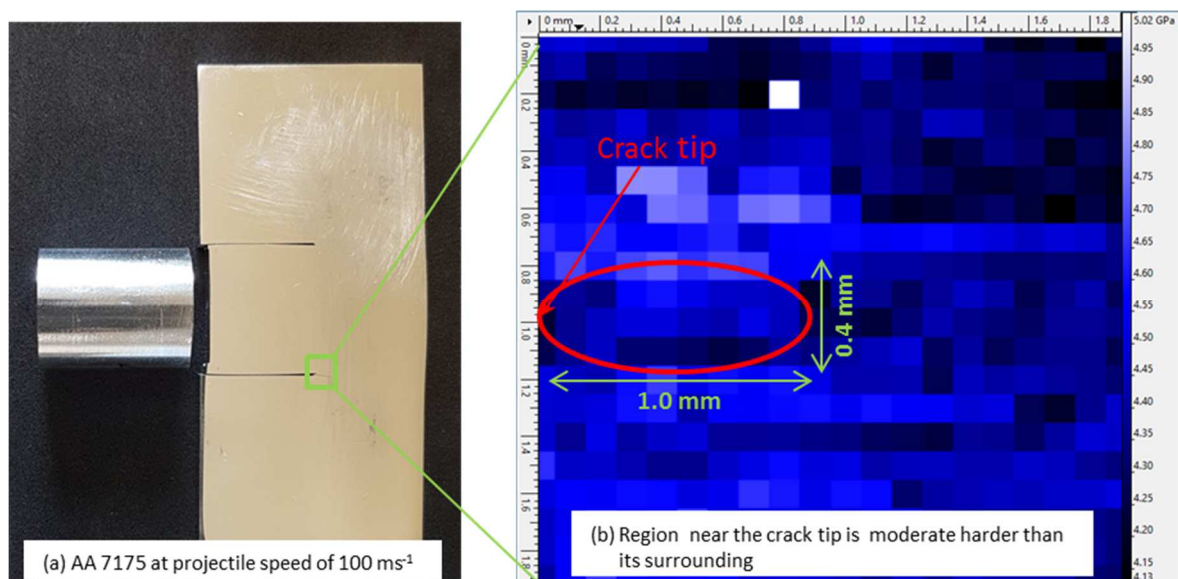
Fig.39 : Nanohardness of crack tip for AA 7175 at impacted speed of 100 m.s^{-1} . Light blue for higher hardness value and dark blue for lower hardness value.
