**HAL**  
open science

# Detection and evaluation of barely visible impact damage in woven glass fabric reinforced polyamide 6.6/6 composite using ultrasonic imaging, X-ray tomography and optical profilometry

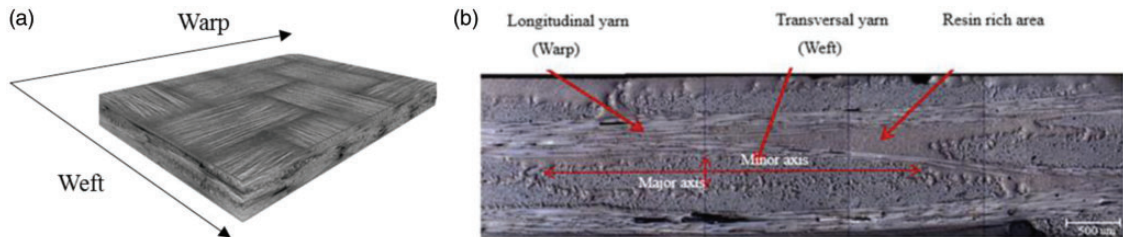
**Figure 1.** Mesostructure (a) and microstructure microscopic observation (b) of the woven glass fabric-PA66-6 composite showing warp and weft orientation (Pomarède et al., 2018).

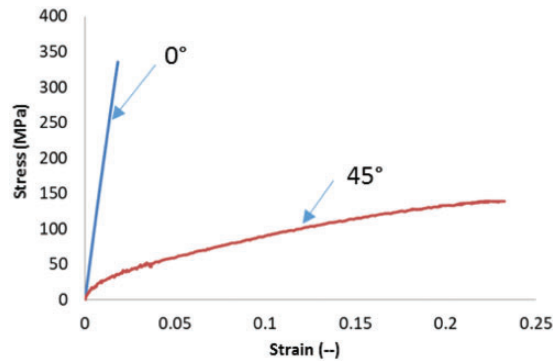
**Figure 2.** Typical stress-strain responses of the woven glass fabric-PA66-6 composite under tensile loading in 0° and 45° directions (Pomarède, 2018).

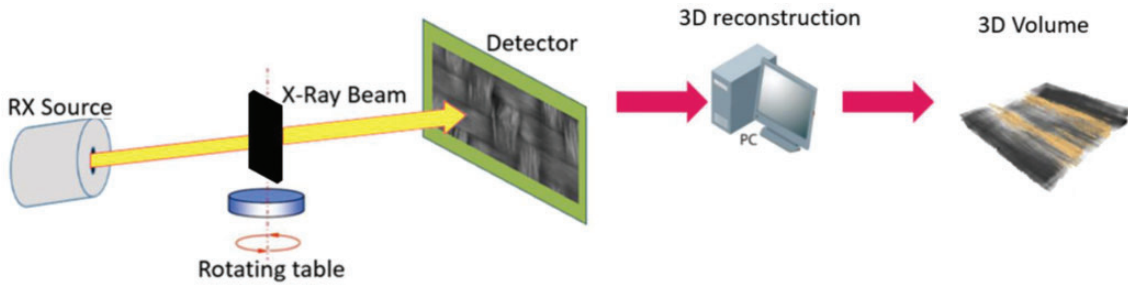
**Figure 4.** Principle of X-Ray tomography technique: the investigated object is first positioned on a rotating table; the X-Rays penetrate it and are then projected on a flat detector.

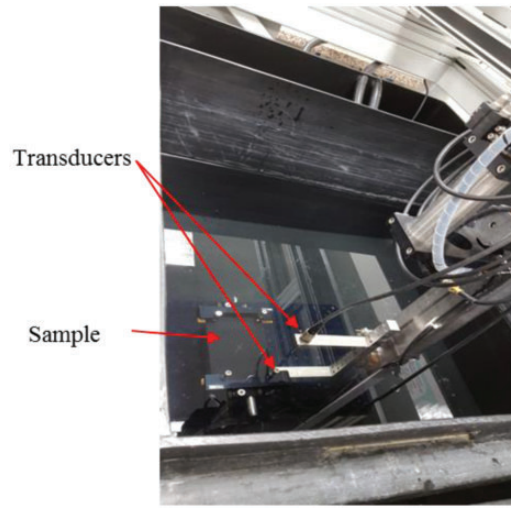
**Figure 5.** Transmission C-scan setup showing a clamped sample immersed in a tank filled with water and two 10 MHz transducers that scan the sample following a serpentine path.

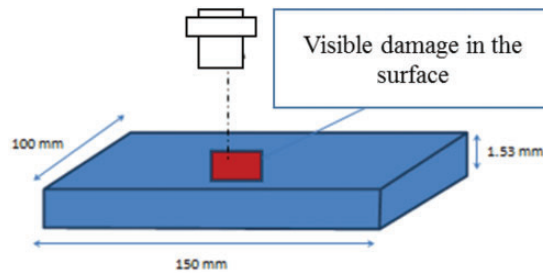
**Figure 6.** Pulse/echo C-scan configuration using one single 10 MHz transducer that plays the role of both the emitter and the receiver.

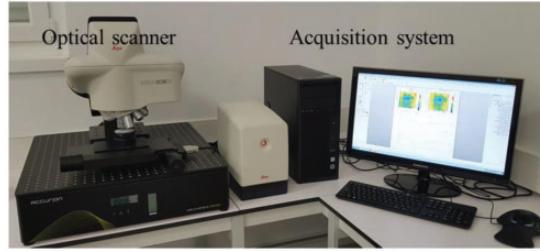
**Figure 7.** Leica DCM3D device showing the optical scanner and the acquisition system.

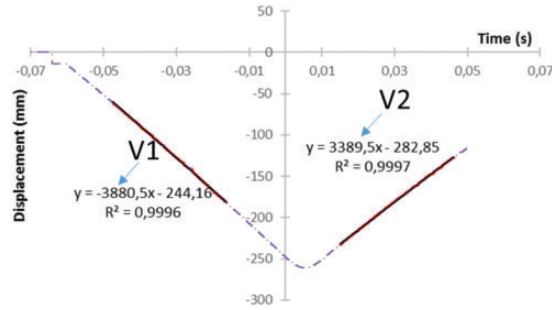
**Figure 10.** Impactor's displacement- time curve for the sample loaded at 7.30 J detailing the followed method to compute the absorbed energy.

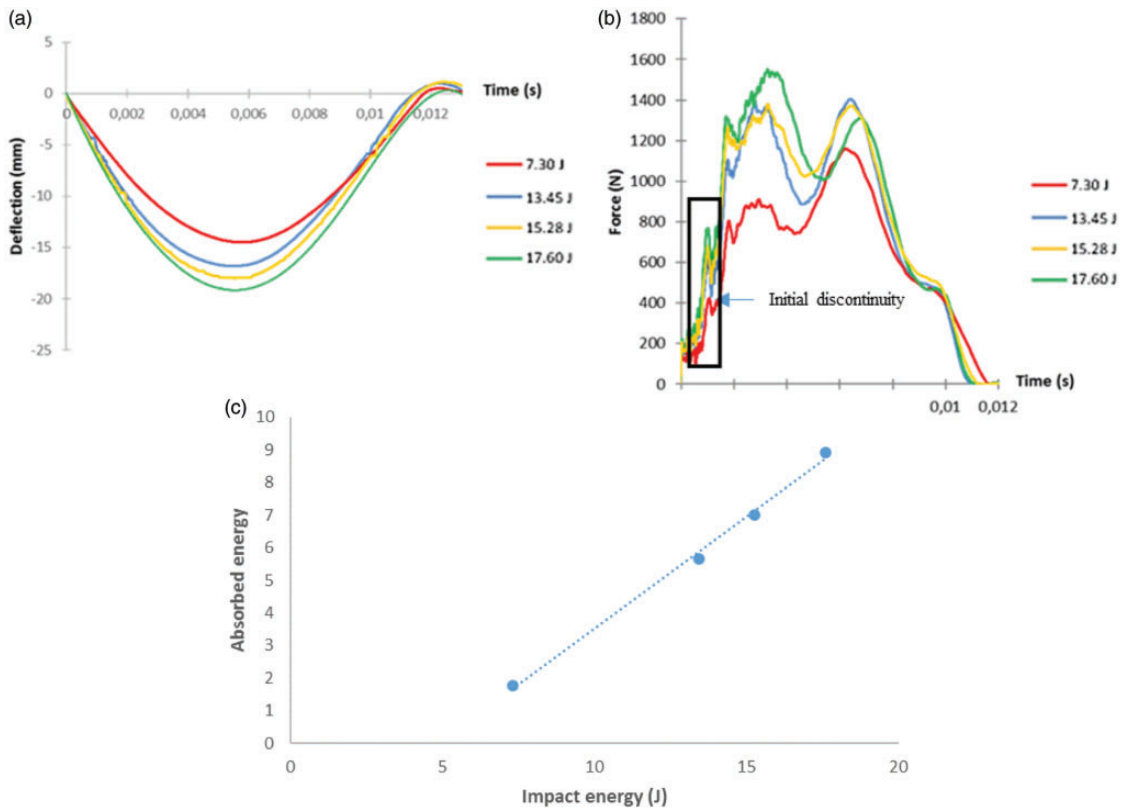
**Figure 11.** (a) Displacement -time curves and (b) force-time curves for the four considered drop weight energies, (c) the absorbed energy-impact energy.

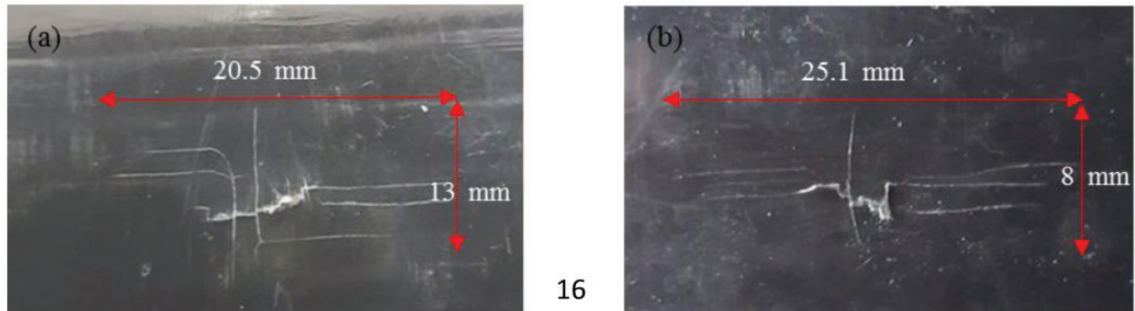
**Figure 13.** Dimensions of the damage occurring on the impacted samples loaded at energy of (a) 15.28 J and (b) 17.60 J observed by naked eye.

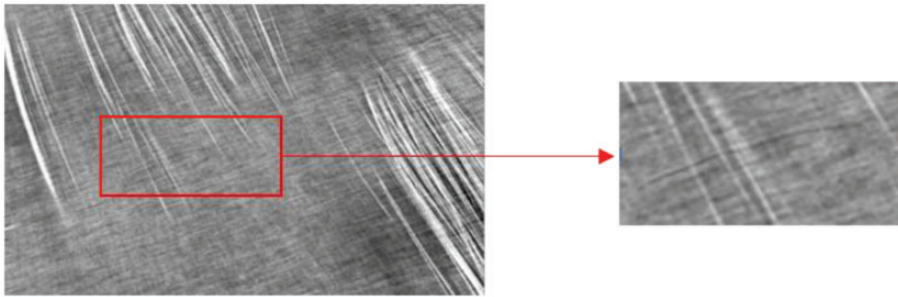
**Figure 14.** X-ray tomography observations performed on the samples impacted at an energy level of 13.45 J showing the matrix micro-crack.

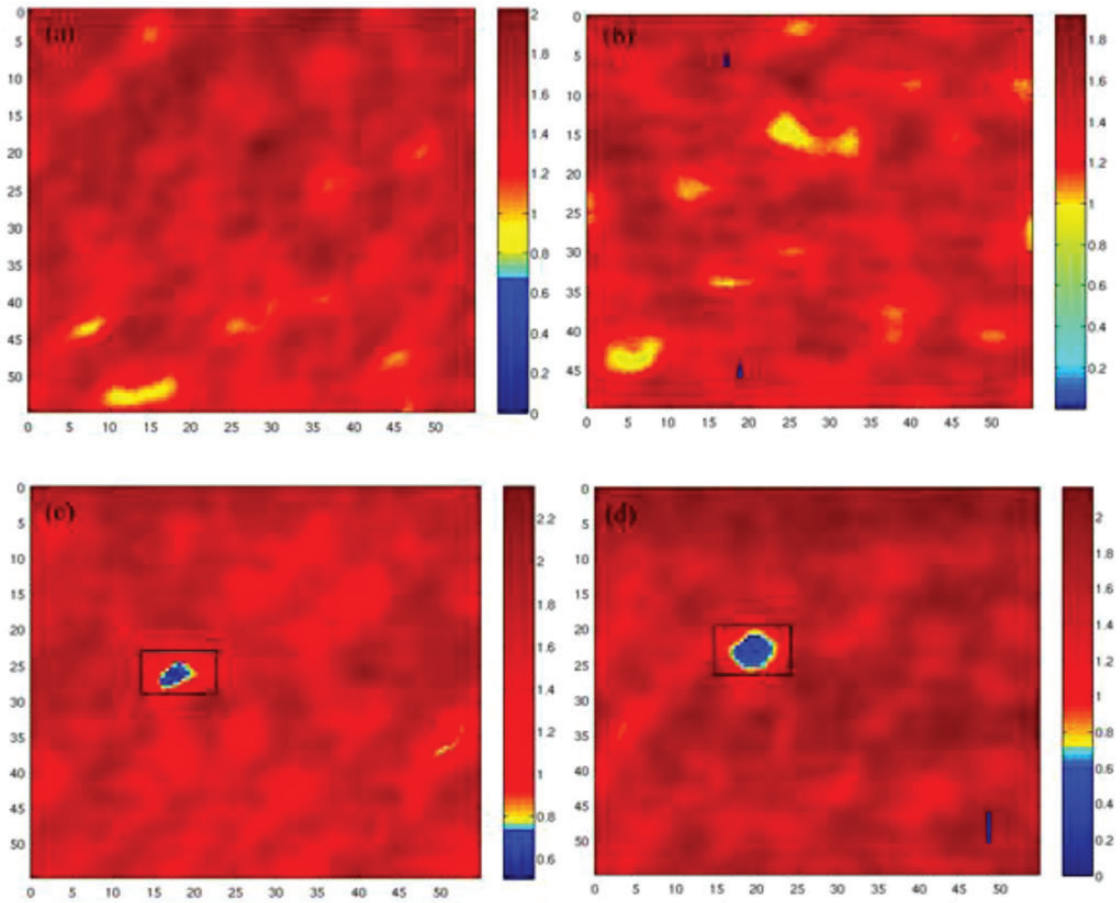
**Figure 18.** Pulse/echo C-scan results for the four impacted samples: (a) 7.30 J, (b) 13.45 J, (c) 15.28 J and (d) 17.60 J using a 10 MHz transducer.

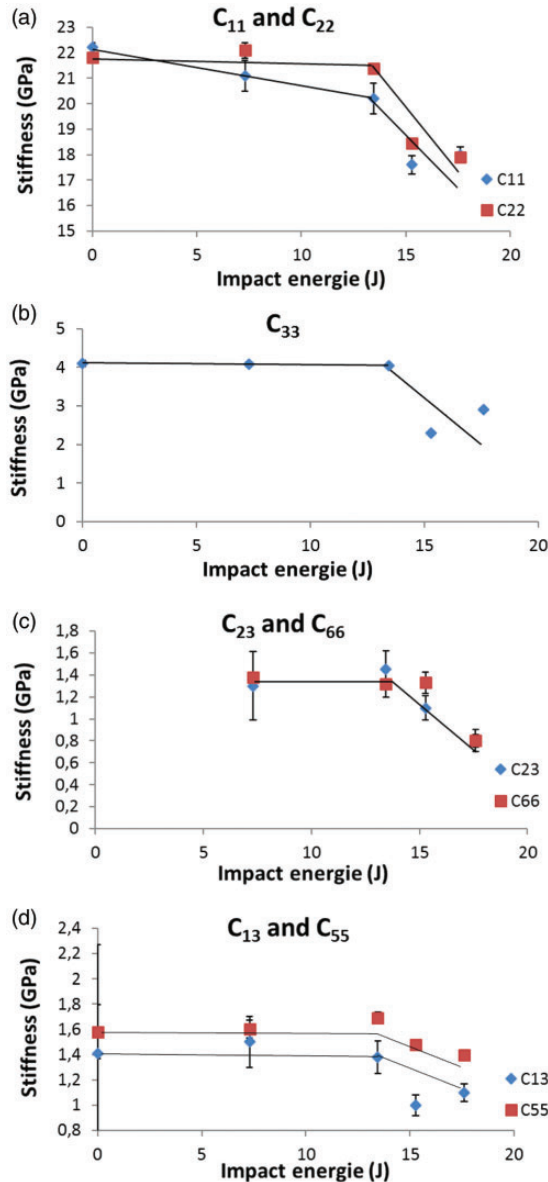
**Figure 23.** Experimental stiffness components for the samples impacted at energies of 7.30J, 13.45J, 15.28J and 17.60J showing: (a)  $C_{11}$  and  $C_{22}$ , (b)  $C_{33}$ , (c)  $C_{23}$  and  $C_{66}$  and (d)  $C_{13}$  and  $C_{55}$ .
