HAL
open science

Backside Fault Localization and Defect Physical Analysis of Degraded Power HEMT p-GaN Transistors Stressed in DC and AC Switching Modes

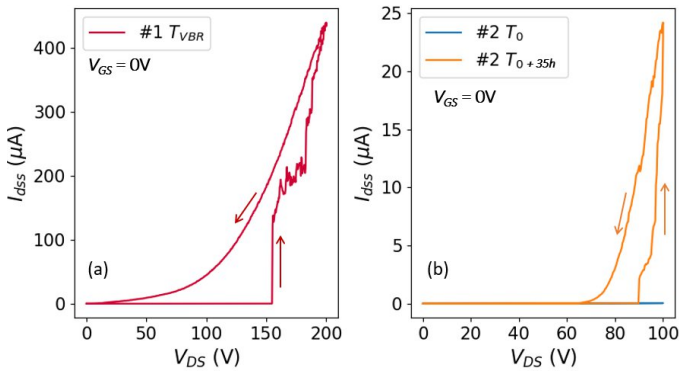
Figure 1: (a) Electrical signature of breakdown voltage of transistor #1, the curves are similar for transistor #3, a steep increase of current I_D between drain and source occurs at 155V. (b) Electrical characterization of the aged transistor #2 of the leakage current I_{dss} under V_{DS} at T_0 in blue and after 35 hours of electrical stress at T_{0+35h} in orange. A high leakage current appears only after 90V. Forward and backward sweeps are performed to take into account a possible hysteresis (arrows close to curves). #3 has similar I_{dss} curve than #2.

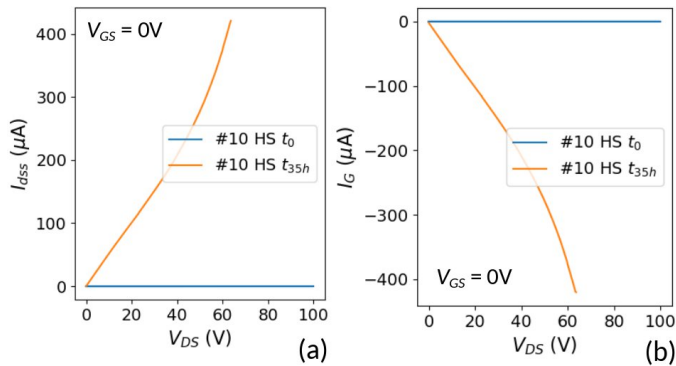
Figure 2: Drain leakage current $I_{dss} = f(V_{DS})$ at $V_{GS} = 0V$ of transistor #10 before stress (at t_0) and after stress at t_{35h} (stress under switched voltage of 67V). (a) Drain current (b) gate current during this characterization measurement. The degradation observed is a leakage current between the drain and the gate of the transistor.

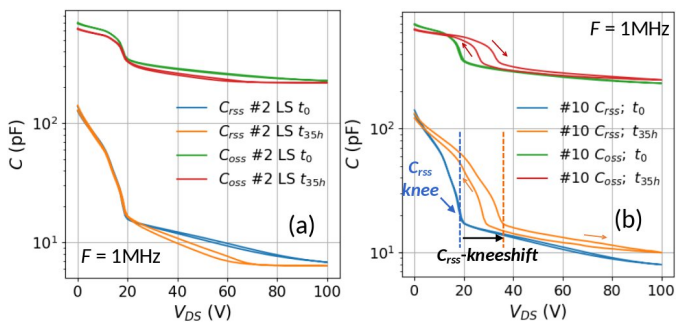
Figure 3: C_{oss} and $C_{rss} = f(V_{DS})$ capacitance measurement with Keysight B1505A before and after stress for (a) transistor #2 (for #3 the curves are similar) (120V) and (b) transistor #10 (67V). The main change for #2 and #3 is observable in the higher voltage values where the capacitance value becomes constant. For transistor #10 the capacitance knee is shifted to higher V_{DS} values and the hysteresis increases.

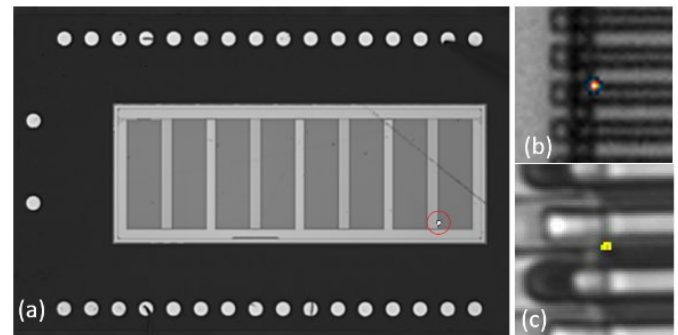
Figure 4: (a) LIT Amplitude signal of the prepared transistor #1 with a 5x magnification (lock-in frequency 25Hz), polarized at 2V with probes landed on the electrical vias. (b) LIT at 10x magnification focused on the hot spot (c) InGaAs camera PEM image with a 71x magnification focused on the emission spot (good correlation with LIT hot spot position)

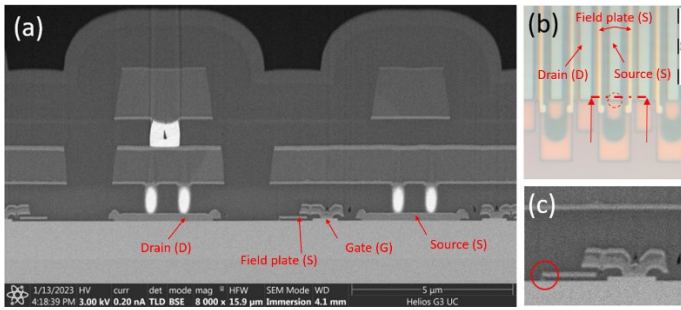
Figure 5: (a) FIB slice&view cross section in the defect zone of #1 transistor, the section axis observed is indicated by the red arrows in (b) the zoom in (c) shows at the corner of the source field plate the leakage path formed at the breakdown voltage in figure 1(a). This zone is where the electrical field is locally the most significant.

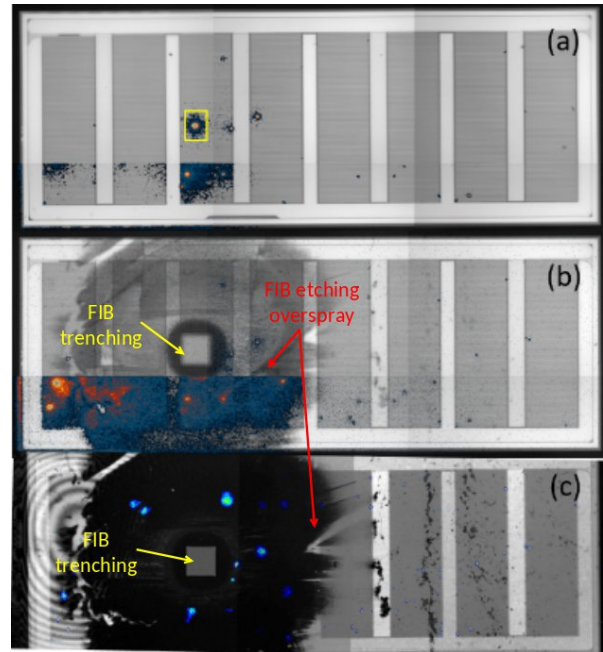
Figure 6: (a) superimposed LIT of #2 with polarization between 75V and 95V, more than 20 hot spots are visible, a brighter hot spot is visible in the yellow square (b) LIT after FIB silicon trenching locally above the brightest hot spot that has disappeared (c) InGaAs camera PEM image after FIB silicon trenching, emission spot has also disappeared.

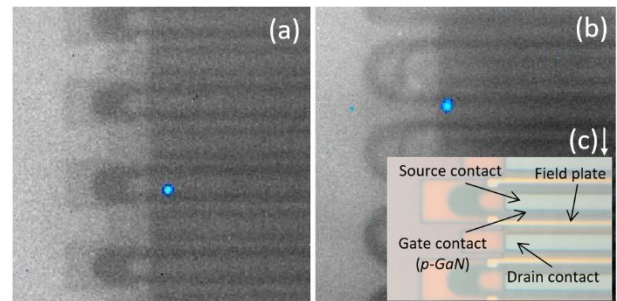
Figure 7: InGaAs camera PEM image of the emission spots. (a) Defect near the gate that might be a GD leakage current through the AlGaN barrier (#10 transistor) (b) defect near the drain metal that is expected to be a DS leakage current through the GaN layer (#2 transistor). (c) optical zoom of the metal structure seen from the backside.

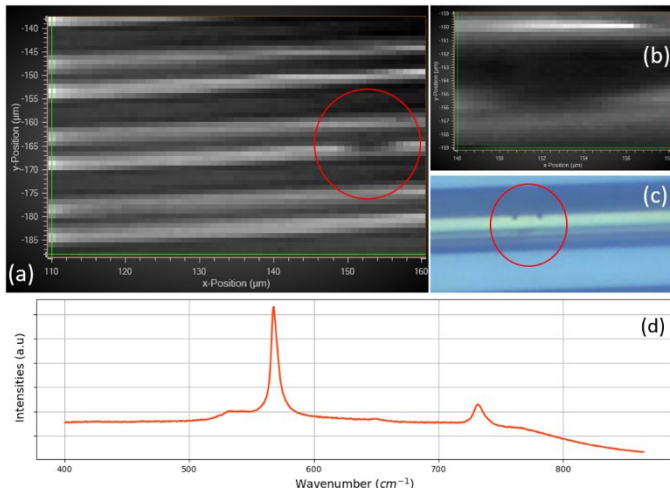
Figure 8: Raman spectroscopy using 532-nm laser beam diameter 300nm. (a) Mapping of the principal Raman peak (1 μ m scanning step). (b) Higher resolution mapping (300nm scanning step) focused on the defect zone. Optical view of the defect at 100x at the coordinates given by (b). (d) Long exposure Raman spectrum associated with (a,b) acquired for one pixel.

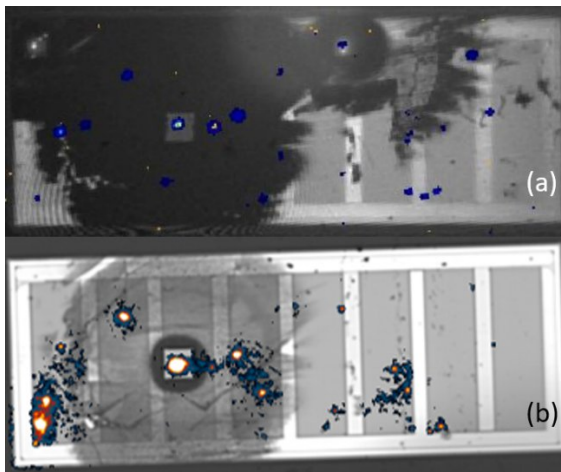
Figure 9: (a) PEM after Raman analysis, the brightest emission spot that disappeared after trenching has now signal. (b) LIT amplitude after Raman analysis, like with PEM, the hot spot reappeared after the Raman analysis.

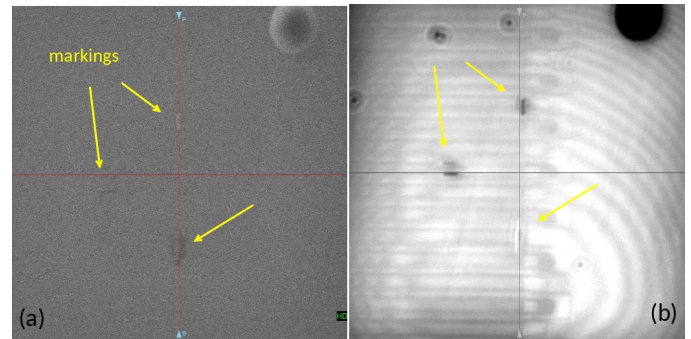
Figure 10: (a) ionic image of the trenching with 10 μ m of remaining silicon and marking. (b) In-situ IR camera image through the remaining silicon and view of the etched lines marking the hot spot position for TEM lamella extraction.

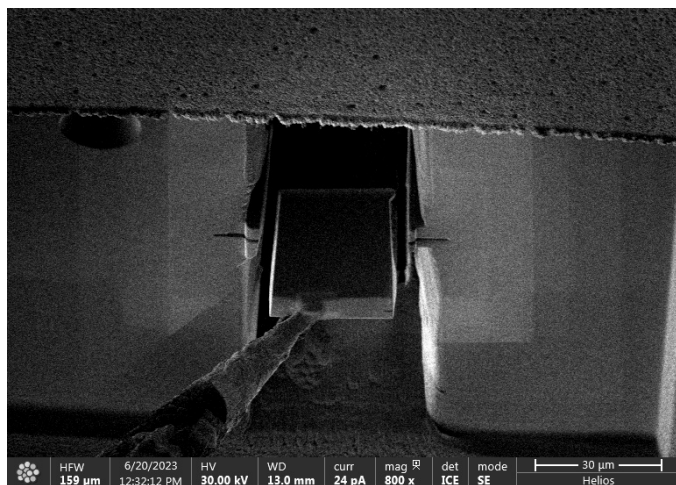
Figure 11: (a) TEM lamella extraction in the area delimited by the optiFIB markings after milling and side cuts.

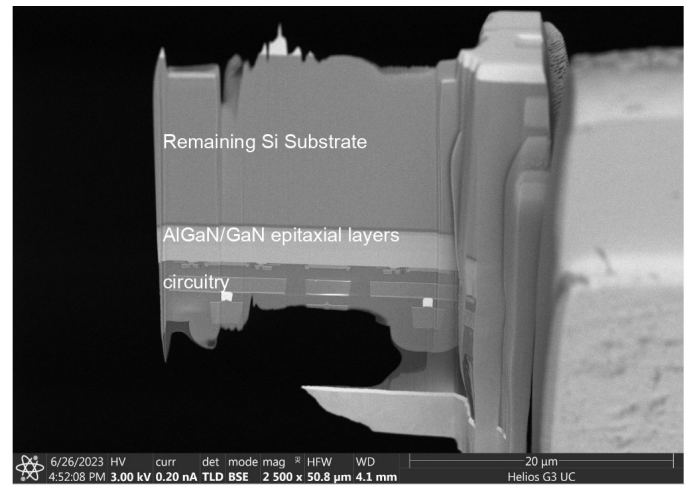
Figure 12: (a) TEM lamella thinned to 100 nm in the defect region before observation.

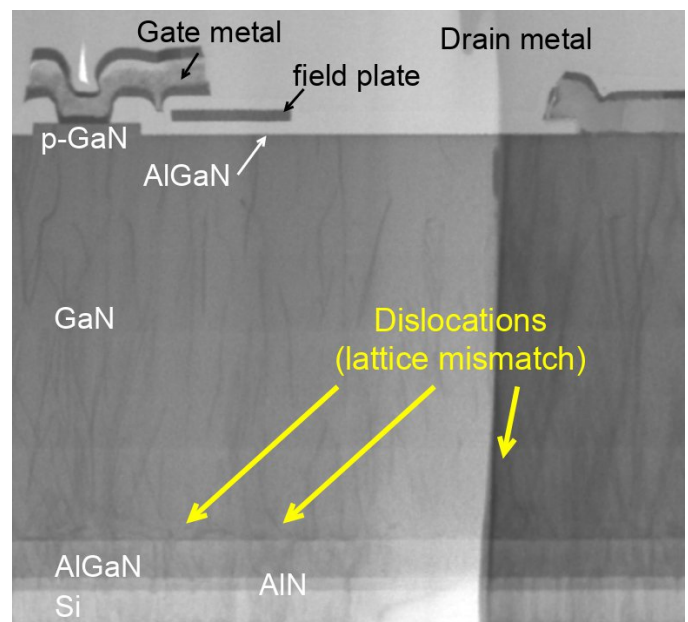
Figure 13: TEM lamella observation of the reference device in the gate-drain region. Dislocation starting from the lower part of the device can be observed. These dislocations can be generated by the lattice mismatch between Si and GaN.

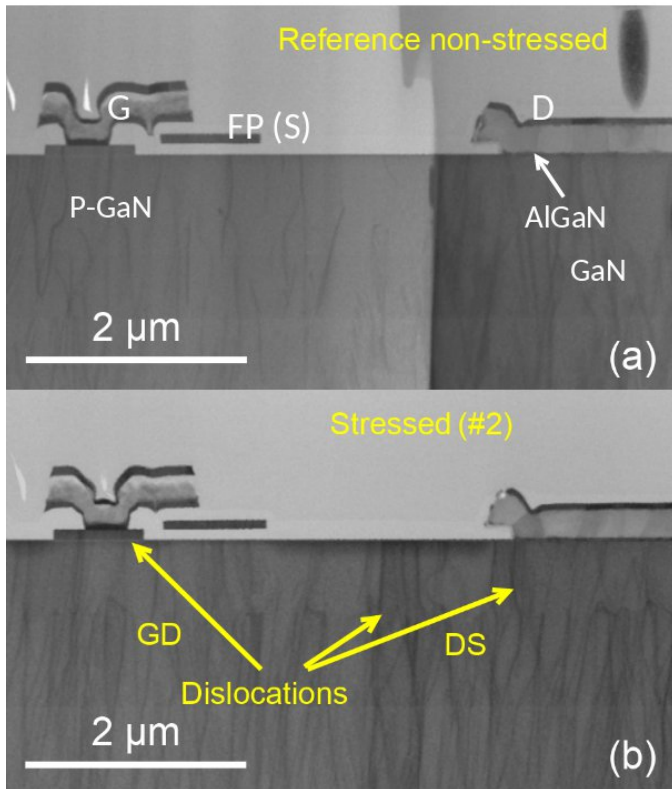
Figure 14: (a) TEM lamella observation of our reference device that was not stressed (b) TEM observation of the GD region of device two #2 (stressed in AC at 120V in cross-conduction switching mode).

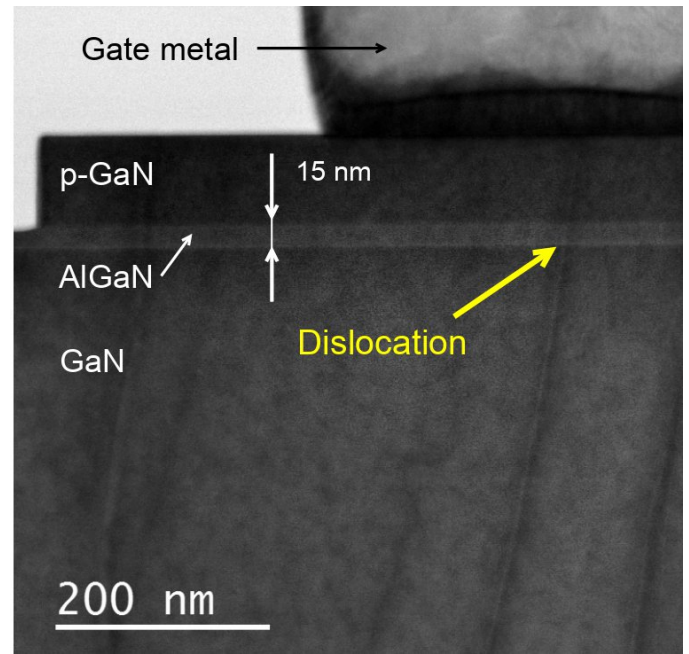
Figure 15: (a) TEM lamella observation in the region illustrated in figure 7a that corresponds with a gate drain leakage such as transistor #10. The leakage is through the AlGaN barrier through one of the dislocations observed such as the one showed by the yellow arrow in the figure.

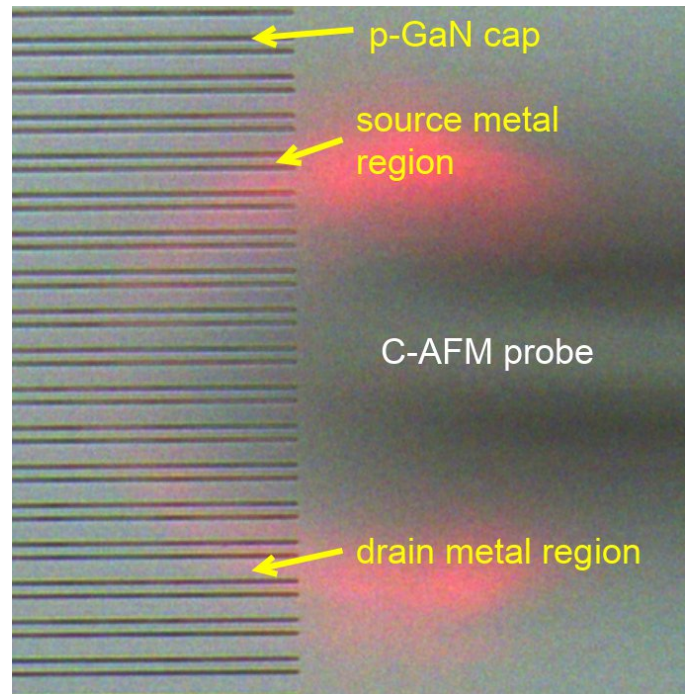
Figure 16: Optical observation of the frontside surface after deep HF, the double lines patterns observed are p-GaN caps, the rest of the observed surface is AlGaN except in the previous source and drain metals the two p-GaN caps and location (see figure 7c and 17) where the surface is the GaN layer.

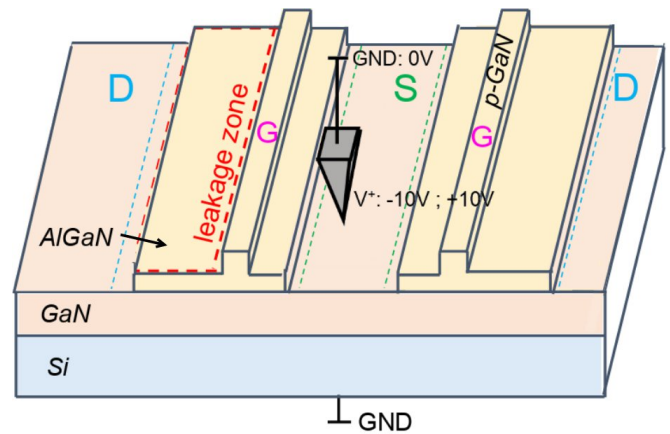
Figure 17: Setup of conductive AFM experiment performed. The probe is electrically polarized between $-10V$ and $+10V$. The blue squares are the previous drain metal region and the green ones are the previous source metal regions.

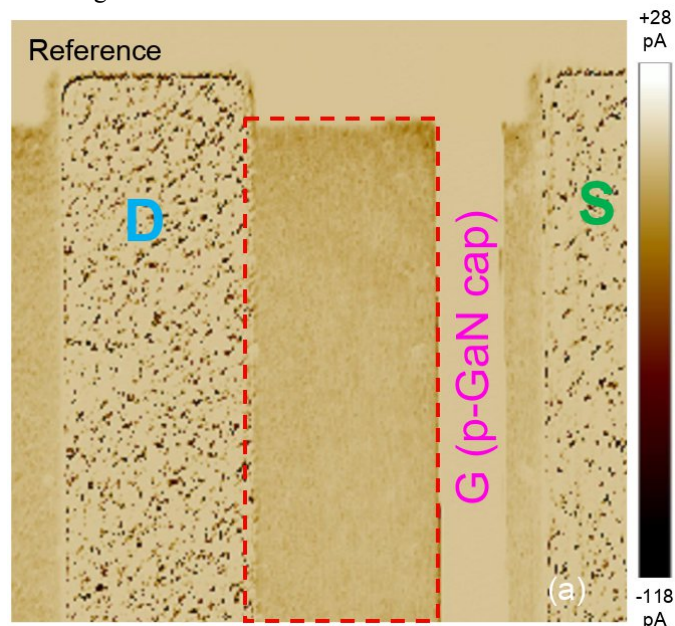
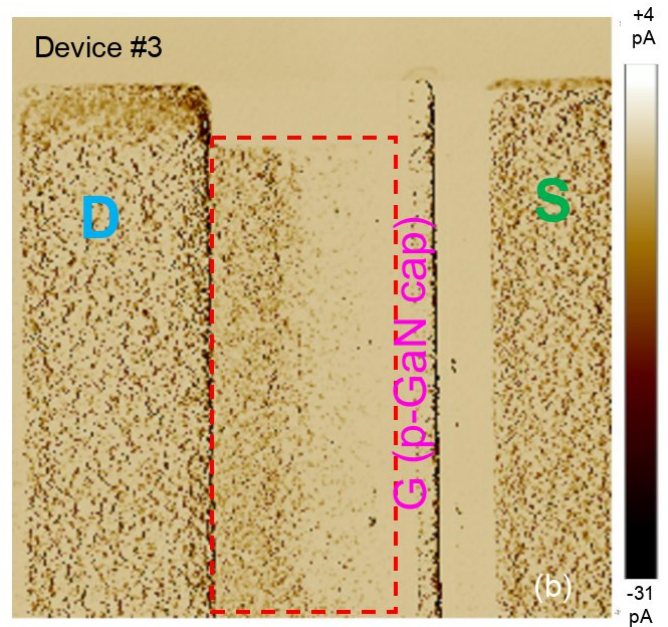
Figure 18: Current leakage mapping obtained with conductive AFM, the black dots are the current leakage paths. The zones where the metal contacts were previously are always more conductive due to their proximity with the 2DEG that facilitates surface leakage currents.
