HAL
open science

Localization and Physical Analysis of Defects in Degraded Power HEMT p-GaN Transistors Stressed with DC Voltage Surge and Voltage with Switching Stress

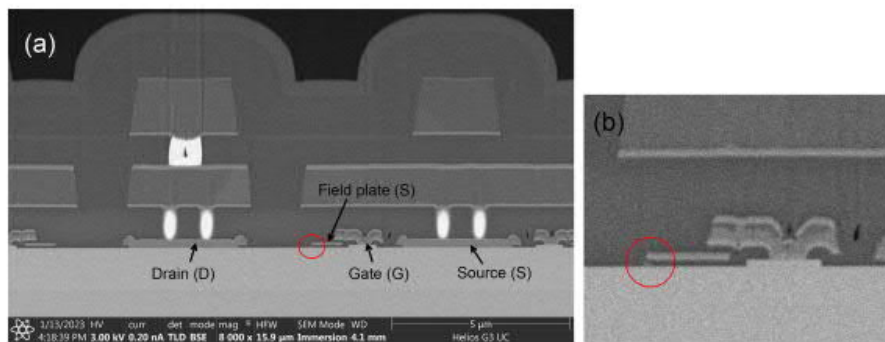
Fig. 5 (a) FIB slice and view cross section in the defect zone of transistor #1. The zoom in (b) shows at the corner of the source field plate the leakage path formed at the breakdown voltage in Fig. 1a. This is the zone where the electric field is locally most significant

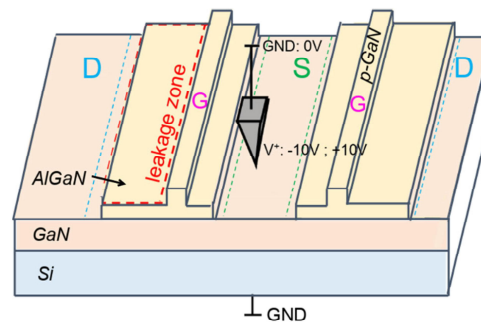
Fig. 14 Setup of a conductive AFM experiment. The probe is electrically polarized between -10 and $+10$ V. The blue squares are the previous drain metal regions and the green squares are the previous source metal regions (Color figure online)

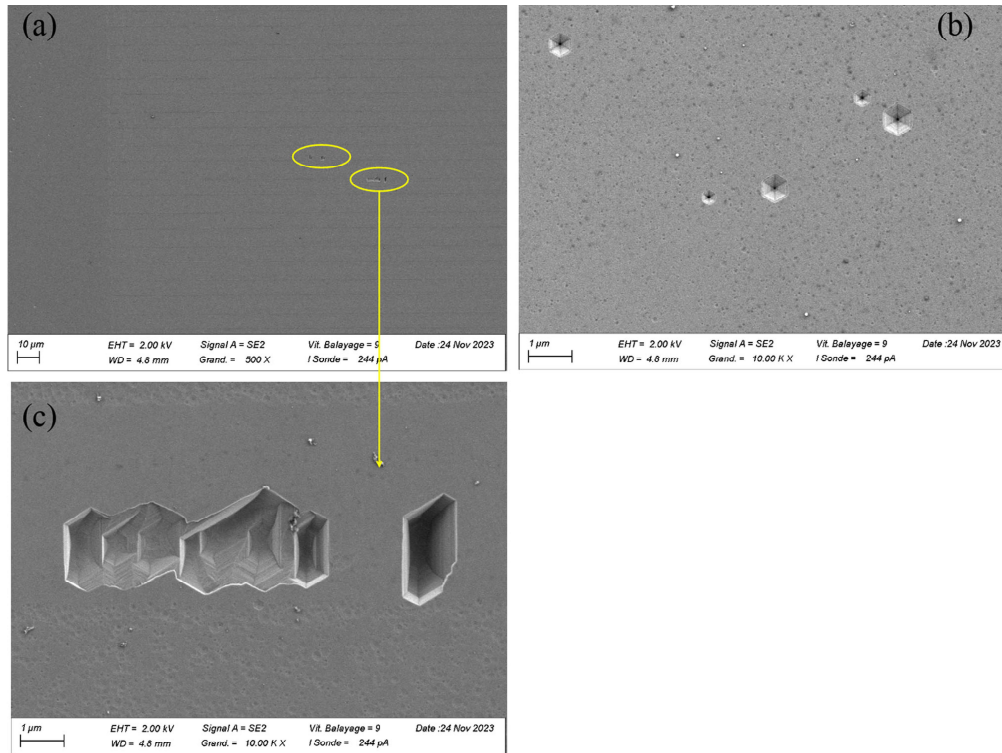
Fig. 16 Etch pits obtained by chemical exposure with H_3PO_4 from tool #3. (a) Different etch pits pattern observed on the surface. Both the reference and the #3 have the small hexagonal etch pit visible in (b), but only the #3 has the line of (c)
