## Effect of varying conditions of exposure to an aggressive medium on the corrosion behavior of the 2050 Al–Cu–Li alloy

Mathilde Guérin, Eric Andrieu, Grégory Odemer, Joël Alexis, Christine Blanc. Effect of varying conditions of exposure to an aggressive medium on the corrosion behavior of the 2050 Al–Cu–Li alloy. *Corrosion Science*, 2014, vol. 85, pp. 455-470. 10.1016/j.corsci.2014.04.042 . hal-01024706

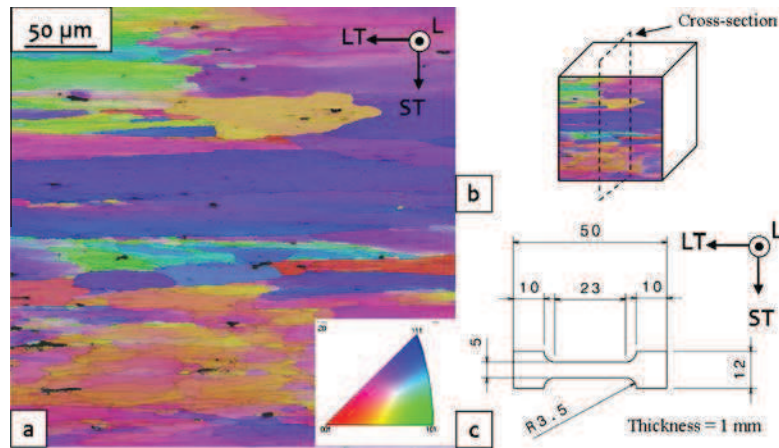
**Fig. 1.** (a) EBSD/IPF-z0 map of the LT-ST plane of the 2050 NHT alloy; (b) schema of a cubic sample used for corrosion tests; (c) schema of a tensile specimen (size in mm).

EBSD scans were performed using a JEOL 7000F field emission gun SEM at an accelerating voltage of 15 kV with a Nordlys II F+ camera. EBSD measurements were helpful in both analyzing the microstructure of the alloy (Fig. 1a) and characterizing the corrosion morphology. Thus, EBSD maps were performed on 2  $\text{mm}^2$  areas with a step size of 1  $\mu\text{m}$  before and after corrosion tests. Maps that are more precise were also performed around corrosion

Mechanical tests were performed to evaluate the residual mechanical properties of the corroded samples. Tensile tests were performed on tensile specimens (Fig. 1c) at a strain rate of  $10^{-3} \text{ s}^{-1}$  using an Instron testing machine equipped with a 10 kN load cell. Mechanical tests were performed on unexposed samples and on pre-corroded samples prepared according to the corrosion testing conditions previously described. The LT-ST planes of the tensile specimens were exposed to the medium, with the other planes protected by a varnish, and the samples were strained along the LT direction. To amplify the corrosion effects on the mechanical behavior, pre-corrosion tests corresponded to CR 168 h and CF 168 h (7 cycles). Therefore, CI 168 h tests were compared with the cyclic tests CR 168 h and CF 168 h in terms of the residual mechanical properties of the tensile specimens (Table 1). Hydrogen content measurements were performed using a Horiba EMGA-621W and a Brüker Galileo HMat Instrumental Gas Analyzers (IGA) in which the sample was heated until 1200  $^{\circ}\text{C}$ . Before performing measurements, the corrosion products were removed from the surface by mechanical polishing, and the samples were cut into small pieces of approximately 0.1 g. Both tensile tests and hydrogen content measurements were repeated three times for each condition.

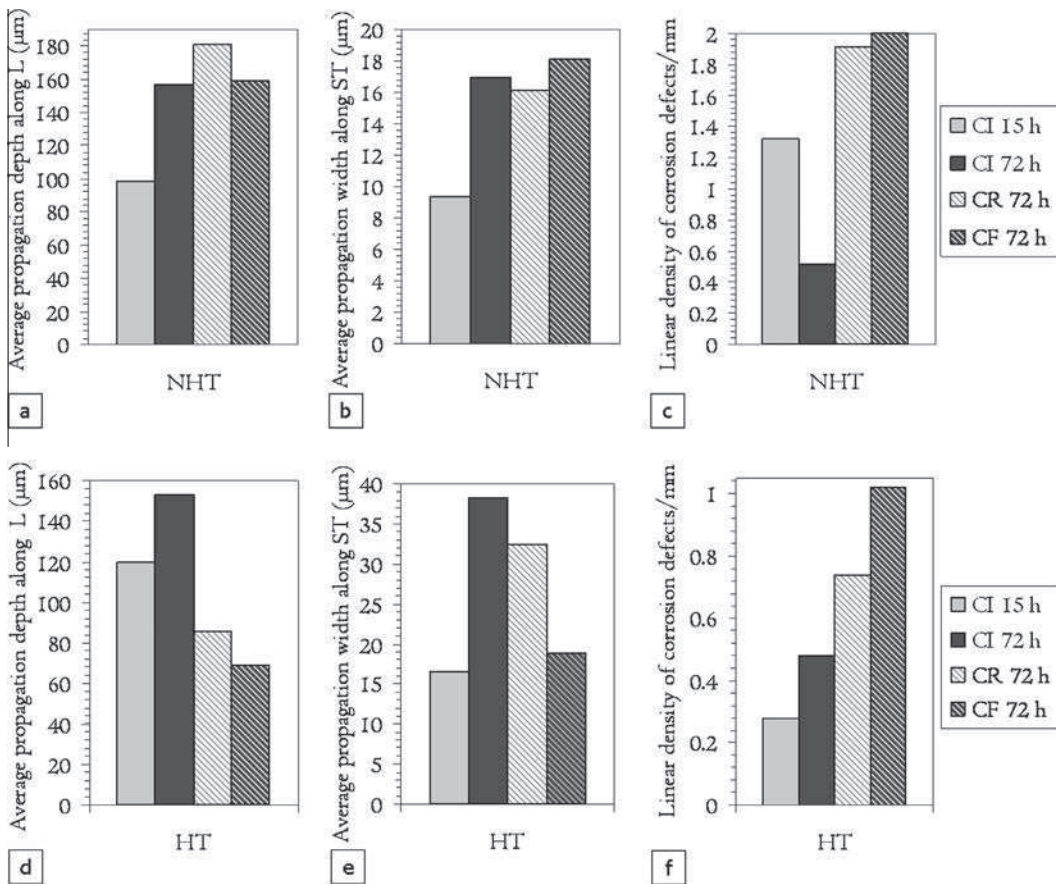
**Fig. 3.** Average propagation depth of corrosion defects for NHT samples in (a) L and (b) ST directions and for HT samples in (d) L and (e) ST directions. Linear density of corrosion defects in the ST direction for (c) NHT and (f) HT samples. The data are given for both continuous immersion tests and cyclic corrosion tests.

To better describe the corrosion damage, a statistical analysis was performed. Fig. 3 shows the average propagation depth of the corrosion defects in the L direction and their average propagation width in the ST direction for both NHT and HT samples after different corrosion tests. It can be added that, when several corroded grain boundaries were connected, these boundaries were considered only one corrosion defect. Therefore, when the alloy is susceptible to intergranular corrosion, the last criterion, i.e., the propagation width in the ST direction, allows the evaluation of the branching of the corrosion defects, assuming that, for a corroded grain boundary considered individually, its average width in the ST direction was less than 1  $\mu\text{m}$  and approximately 2–3  $\mu\text{m}$  after CI 15 h and CI 72 h, respectively. The 3rd parameter is the number of corrosion defects observed per mm of cross sections analyzed and is called the “linear density of corrosion defects”. For NHT samples, after continuous immersion tests, the quantification of the corrosion susceptibility, according to the corrosion exposure time, shows an increase in the defects size when the corrosion exposure time increases. Considering the propagation along the L direction, after a CI 72 h corrosion test, corrosion defects are longer than for a CI 15 h corrosion test, with propagation depths equal to 100 and 160  $\mu\text{m}$ , respectively. Surprisingly, the linear density of corrosion defects was smaller after CI 72 h compared with CI 15 h tests. This result could be explained by the stronger density of pits in the CI 72 h samples compared with CI 15 h samples. For the CI 15 h samples, no pit was observed in the L–ST plane for a cumulative length observed in the ST direction of 80 mm. On the contrary, for the CI 72 h samples, 19 pits were observed in the L–ST plane for a cumulative length observed in the ST direction of 40 mm. Their mean depth in the L direction was 17  $\mu\text{m}$  with values between 11 and 25  $\mu\text{m}$ . Many intergranular corrosion defects were assumed to initiate after CI 72 h tests; however, these defects did not propagate enough to be detected due to pit propagation in their surroundings. This hypothesis suggested that the interactions between the two types of corrosion, i.e., pitting and intergranular corrosion, significantly affected intergranular corrosion propagation.

literature [25]. Indeed, as previously explained, microgalvanic coupling phenomena between  $T_1$  phases and the matrix must be considered. When the NHT samples were aged to obtain HT samples,  $T_1$  precipitates formed in the grain boundaries; however, numerous  $T_1$  precipitates also formed inside the grains. Therefore, both the corrosion potentials of the grain boundaries and the grains became more negative with a decrease in the difference between the two corrosion potential values. The galvanic coupling effect between the grains and the grain boundaries was reduced so that intergranular corrosion did not occur. Moreover, with a more negative potential due to the presence of  $T_1$  precipitates and to a lower copper content, the grains in the HT samples were more reactive, which led to intragranular corrosion. Concerning the influence of the immersion time in the chloride solution, corrosion defects were both longer (L direction) and wider (ST direction), and their linear density increased (Figs. 3d–f), when the immersion time increased.

correlated with a lower propagation depth in the L direction for the corrosion defects after CR tests compared with CI 15 h and CI 72 h (Fig. 3d). However, similar to that for NHT samples, the linear density of the corrosion defects increased for CR tests (Fig. 3f). This evolution could be explained, similar to that for NHT samples, by the increase in the chloride concentration at the tip of the corrosion defects during the emersion period. Due to the increased aggressiveness of the electrolyte trapped inside the corrosion defects, new corrosion defects initiated, and the dissolution of

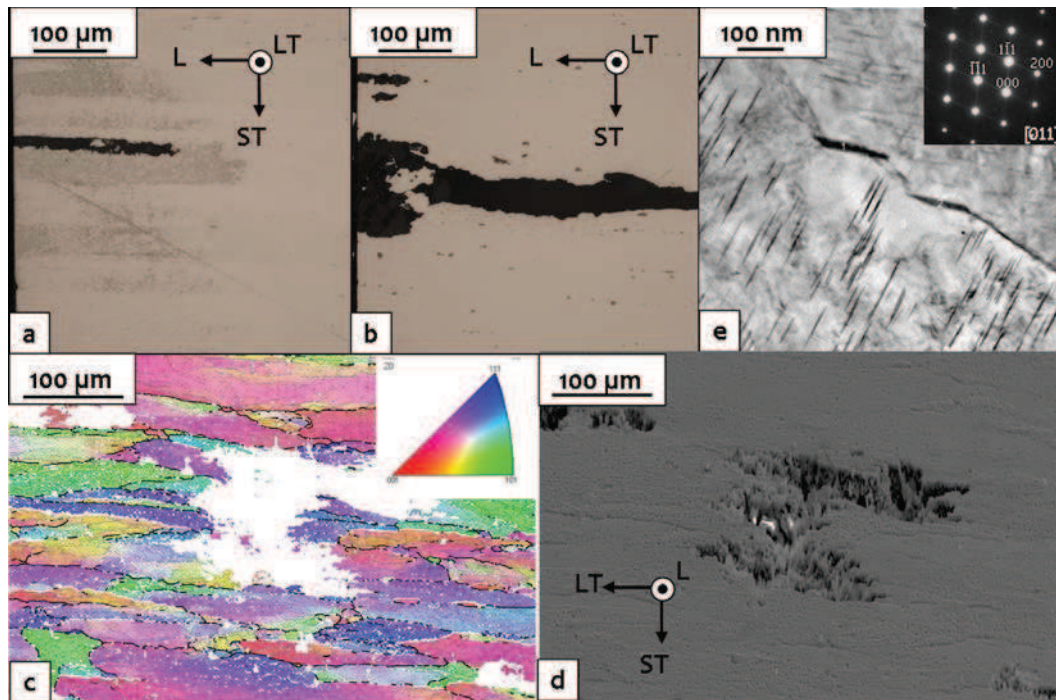
**Fig. 4.** HT sample. OM observations of intragranular corrosion defects after (a) CI 15 h and after (b) CI 72 h; (c) EBSD observations of a corrosion defect after a continuous immersion test; (d) SEM observations of the corrosion defect shown in (c); (e) TEM observation of hardening  $T_1$  precipitates along  $[011]$  zone axis; micrograph and selected area diffraction pattern with characteristic strikes of needles.

For the HT alloy, the material was susceptible to intragranular corrosion (Fig. 4a and b). The EBSD analysis (Fig. 4c), which was combined with SEM observations (Fig. 4d) of the same corrosion defect confirmed this corrosion morphology. TEM observations along [011] zone axis (Fig. 4e) showed the presence of  $T_1$  precipitates both in the grains and at the grain boundaries with characteristic strikes of needles observed on the selected area diffraction pattern. The susceptibility of the HT alloy to intragranular corrosion was due to the precipitation of  $T_1$  phases both in the grain and at the grain boundaries, which is in agreement with the

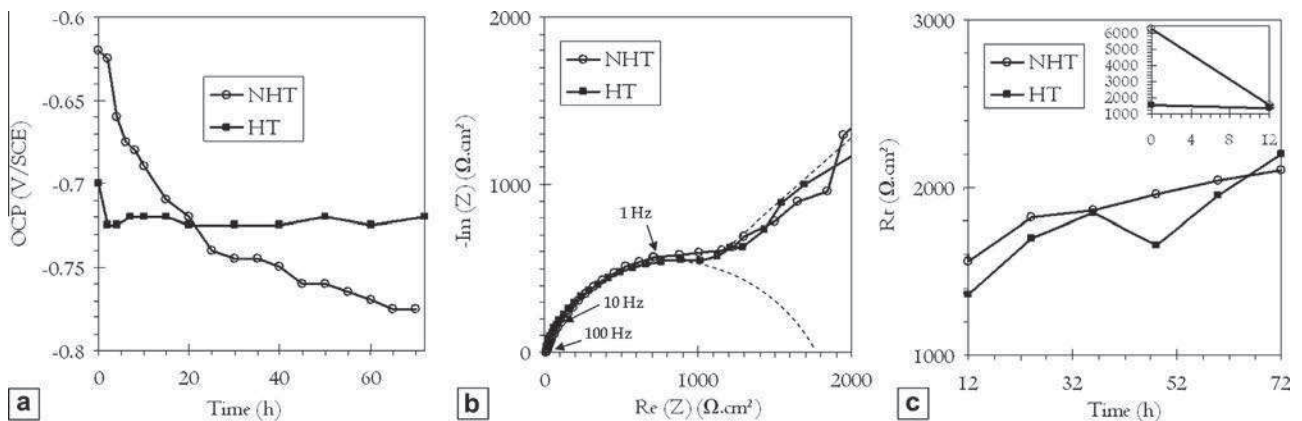
**Fig. 7.** Evolution of the electrochemical parameters during continuous immersion in 0.7 M NaCl. (a) Open circuit potential (OCP) as a function of immersion time for NHT and HT samples. (b) Impedance diagrams (Nyquist plots) for NHT and HT alloys after 24 h of continuous immersion in the electrolyte. (c)  $R_t$  versus immersion time for NHT and HT samples.

Additional electrochemical measurements were performed for both NHT and HT samples during continuous immersion in the chloride solution to better analyze their corrosion behavior. Fig. 7a shows a decrease in the OCP for NHT samples when the

immersion time increases from 0 to 72 h. Two steps can be defined in the OCP variation: during the first day of immersion, an important drop in the OCP is observed, whereas during the next two

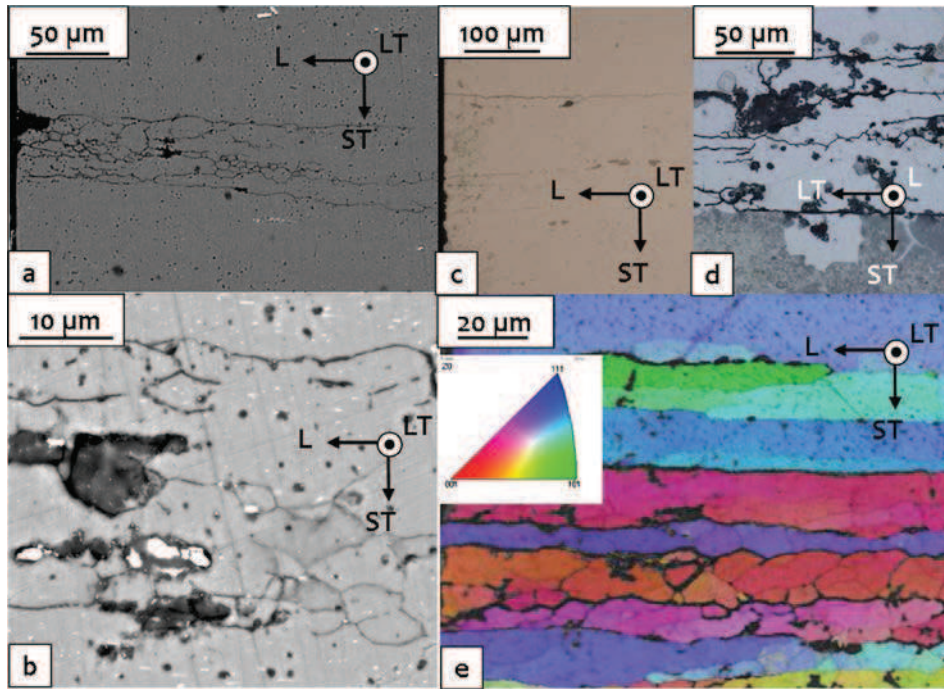
**Fig. 8.** (a) SEM observations of intergranular corrosion defects for NHT samples after a CR test; (b) close-up of (a). OM observations of intergranular corrosion defects for NHT samples after CI 72 h in NaCl 5 M (c) in cross-section; (d) of the surface. (e) EBSD observations of intergranular corrosion defects of NHT samples after a CR test.

Global observations of NHT corroded samples after CR tests show corrosion susceptibility similar to NHT samples after continuous immersion, with the presence of intergranular corrosion defects (Fig. 8). However, the observations highlighted significant differences in the morphology of the corrosion defects. After a CR test (Fig. 8a and b), intergranular corrosion defects are thinner and more branched than after continuous immersion (Fig. 2). The branching of the corrosion defects is clearly visible in Fig. 3b, with the high value of the average propagation depth along ST for CR samples. The fact that intergranular corrosion defects were thinner might be explained by the low duration of immersion for a CR test, which is only equal to 15 h for a total test duration of 72 h. However, a comparison of the corrosion defect morphology with that of CI 15 h samples (Fig. 2a) shows that this explanation is not convincing or sufficient; after a cyclic corrosion test, the corrosion defects are thinner than after continuous immersion for an equivalent duration of immersion in the electrolyte. To help to explain this result, continuous immersion tests with a higher chloride concentration, i.e., 5 M, were performed (Fig. 8c and d); the results show that the intergranular defect morphology moves toward that observed after cyclic corrosion tests, with clearly thinner defects than those defects observed after the same immersion time in a 0.7 M chloride solution. This result was consistent with results in the literature. For a 2024 alloy during continuous immersion tests, by testing chloride solutions with different chloride concentrations, Augustin et al. showed that the higher the chloride concentration of the electrolyte is, the thinner the intergranular corrosion defects [26]. Laignon et al. completed this study for the 2024 alloy and compared the corrosion defect morphology after continuous immersion and after cyclic corrosion tests. These authors showed the existence of a chloride concentration gradient inside the intergranular corrosion defects formed during continuous immersion and during cyclic corrosion tests. During a CR test, the chloride concentration could reach a value equal to 5 M at the

showed that the corrosion also propagated at subgrain boundaries after CR tests (Fig. 8e), whereas the corrosion of subgrain boundaries was not observed after continuous immersion. This result was also comparable to observations performed for the 2024 alloy after CR tests [24]. To confirm this observation, a more accurate EBSD analysis of the corrosion defects was performed. Fig. 9 illustrates the methodology used (the example concerns a CI sample). In the first step, several zones were accurately localized. For each zone, IPF-z0 were plotted to reveal the grain and subgrains (Fig. 9c), and the misorientations were calculated to differentiate grain boundaries and subgrain boundaries. Interfaces were considered grain boundaries for misorientations higher than  $10^\circ$  and subgrain boundaries for misorientations from  $2^\circ$  to  $10^\circ$ . Then, the sample was slightly polished, submitted to the corrosion test, rinsed and dried. All the previously localized zones were observed using a SEM in the backscattered electron mode (Fig. 9a) to easily determine the corrosion defects due to the presence of corrosion products. Then, SEM micrographs were analyzed using an image analysis software (Image J), and the corrosion defects were highlighted (Fig. 9b) to obtain a 'corrosion map'. This map was superimposed on the IPF-z0 (Fig. 9c and d) to determine the nature of the corroded 'object' (grain or interface) and of the corroded interface (grain boundaries or subgrain boundaries). This methodology was applied for NHT samples after CI and CR tests. The results showed that the corrosion defects were localized at the grain boundaries for NHT samples after CI tests, which is consistent with the observations shown in Fig. 2. These results also confirmed that cyclic corrosion tests led to a modification of the corrosion morphology compared with continuous immersion tests. After CR tests, for NHT samples, corrosion extended to the subgrain boundaries (Fig. 10a–c). The explanations previously provided, i.e., the high chloride concentration reached at the tip of the corrosion defects during CR tests and the corrosion rate controlled at a local scale ( $H^+$  reduction) could explain the dissolution of subgrain boundaries.

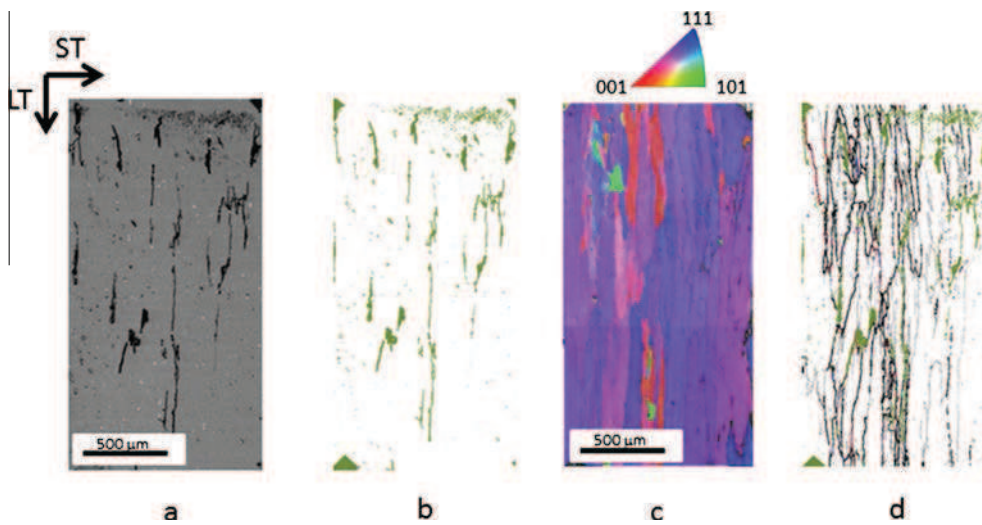
**Fig. 9.** Analysis of a NHT sample after a CI test in a well-identified zone. (a) SEM observation of the corrosion defect, backscattered electron image (b) 'corrosion map'; (c) IPF-z0; (d) identification of the interfaces (grain boundaries in black or in color and subgrain boundaries in grey). (For interpretation of the references to color in this figure legend, the reader is referred to the web version of this article.)

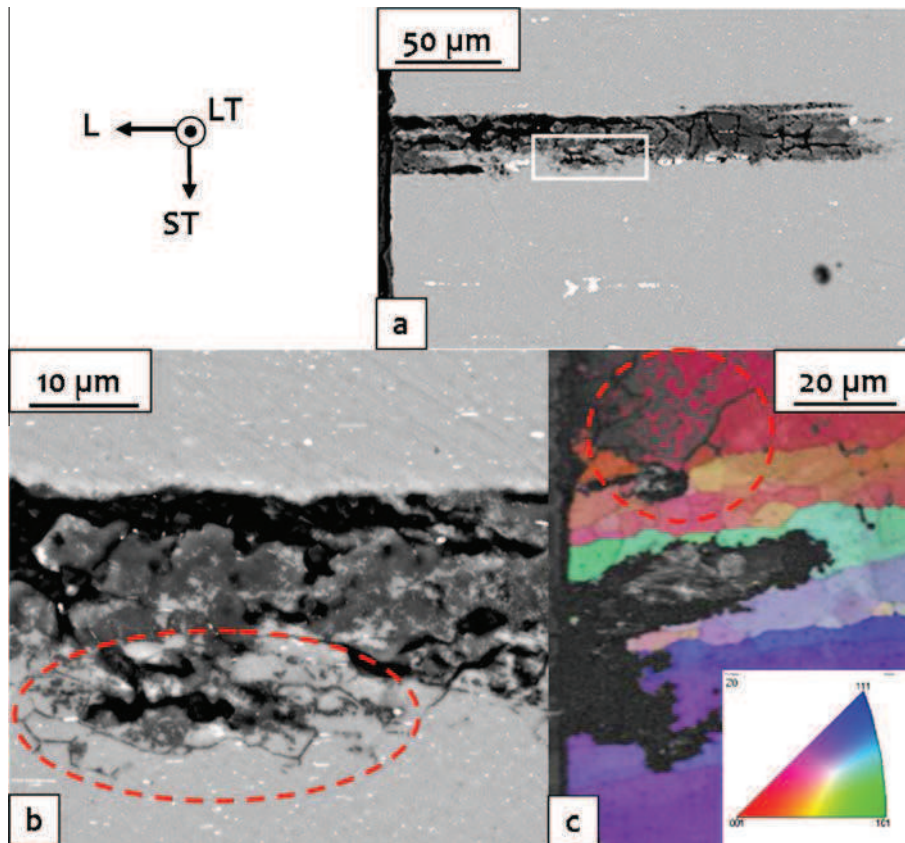
Fig. 11. HT sample after a CR test. (a) SEM observations of corrosion defects; (b) close-up on (a); (c) EBSD observations.

For the HT samples after CR tests, the corrosion morphology was intragranular (Fig. 11), which is similar to that for samples

exposed to continuous immersion tests. However, corrosion at grain and/or subgrain boundaries was also observed in cross-sections observed by SEM (Fig. 11b) but particularly for those cross-sections observed using EBSD (Fig. 11c). Further EBSD analysis, which was performed according to the methodology described in Fig. 9, confirmed that intragranular corrosion remained observed for HT samples after CR tests; however, a few grain boundaries and many subgrain boundaries were found to be corroded (Fig. 10d–f). This change in the corrosion morphology

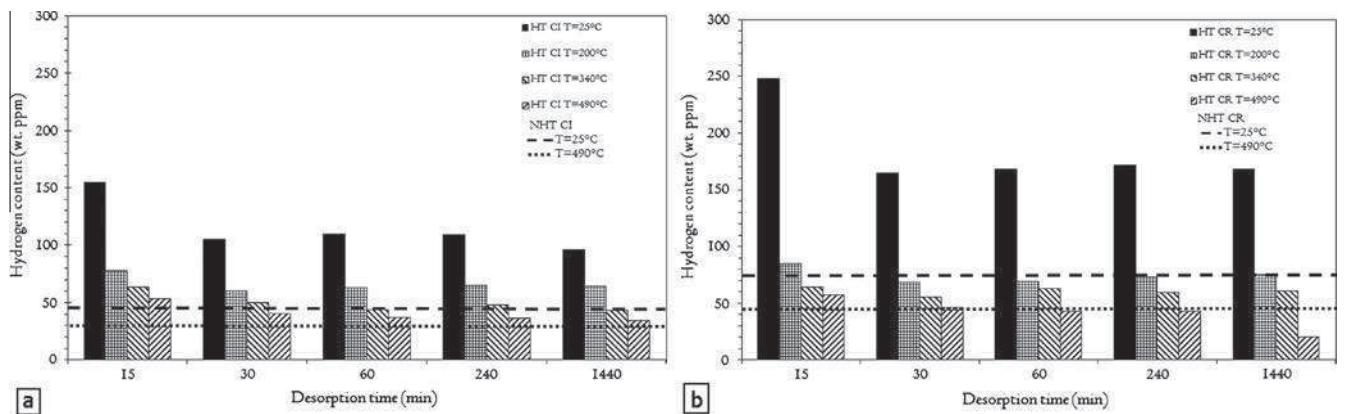
**Fig. 12.** Hydrogen content versus desorption time for desorption treatments at 25, 200, 340 and 490 °C. Results are given for corroded NHT and HT samples after (a) CI 72 h and (b) CR 72 h corrosion tests.

precipitates, desorption experiments were performed. NHT and HT samples were submitted to CI 72 h and CR 72 h tests. Immediately after the corrosion tests, the corrosion products were removed from the sample surface and the samples were submitted to desorption treatments. To take into account the discrepancy in the corrosion extent from one sample to another, only one sample was used for each corrosion test. The size of the samples was chosen so that they could be cut in several specimens. Each specimen was immediately submitted to a desorption treatment. The temperature for the desorption treatment was 25 °C, 200 °C, 340 °C and 490 °C, as suggested by Smith and Scully [17,18]. The duration for the desorption treatment varied between 15 min and 24 h. Immediately after the desorption treatment, the hydrogen content was measured. Results are reported in Fig. 12. For the NHT alloy, the results clearly showed that, for both CI 72 h and CR 72 h, the hydrogen content decreased when the desorption temperature increased from 25 °C to 490 °C. This showed that hydrogen desorption occurred and, therefore, that hydrogen was trapped inside the corroded material. Furthermore, independent of the desorption temperature, the hydrogen content was higher for the CR 72 h samples than for CI 72 h samples which was in good agreement with previous hydrogen content measurements (Fig. 5). However, except for the decrease of the hydrogen content when the desorption temperature increased from 25 to 490 °C, no significant tendency was observed when hydrogen content versus desorption time for a given desorption temperature or hydrogen content versus desorption temperature for a given desorption time were plotted. For NHT alloy, hydrogen trapping at  $T_1$  precipitates did not occur because of the absence of  $T_1$  in this metallurgical state. Hydrogen could then be trapped at dislocations or grain boundaries but with the methodology used, it was not possible to differentiate these trapping sites maybe due to the low hydrogen content compared to corrosion products that remained inside the corrosion defects. On the contrary, for HT samples, Fig. 12 clearly showed significant variation regarding the hydrogen content versus the temperature desorption and the hydrogen content versus desorption time. The tendency was the same for both CI 72 h and CR 72 h samples with, for all the desorption temperatures and all the desorption times, higher hydrogen contents for CR 72 h samples compared to CI 72 h samples in agreement with results shown in Fig. 6. Differences between the results shown in Figs. 6 and 12 were related to the discrepancy in corrosion extent from one sample to another. As explained before, the desorption treatments were performed for the same corroded sample (cut in small pieces) to allow comparison between the different desorption times and temperatures. Independent of the desorption time, the hydrogen content progressively decreased when the desorption temperature increased from 25 °C to 490 °C which allowed to reveal the different trapping sites identified by Smith and Scully [17,18]. Furthermore, for a long desorption time (24 h) at 490 °C, a significant decrease of the hydrogen content was observed, in particular for the CR 72 h samples. The hydrogen content reached a value around 20 ppm corresponding to the hydrogen content measured for a non-corroded sample. Such a desorption treatment led to the release of hydrogen from  $T_1$  precipitates showing that hydrogen trapping at  $T_1$  precipitates was a major phenomenon for HT samples.

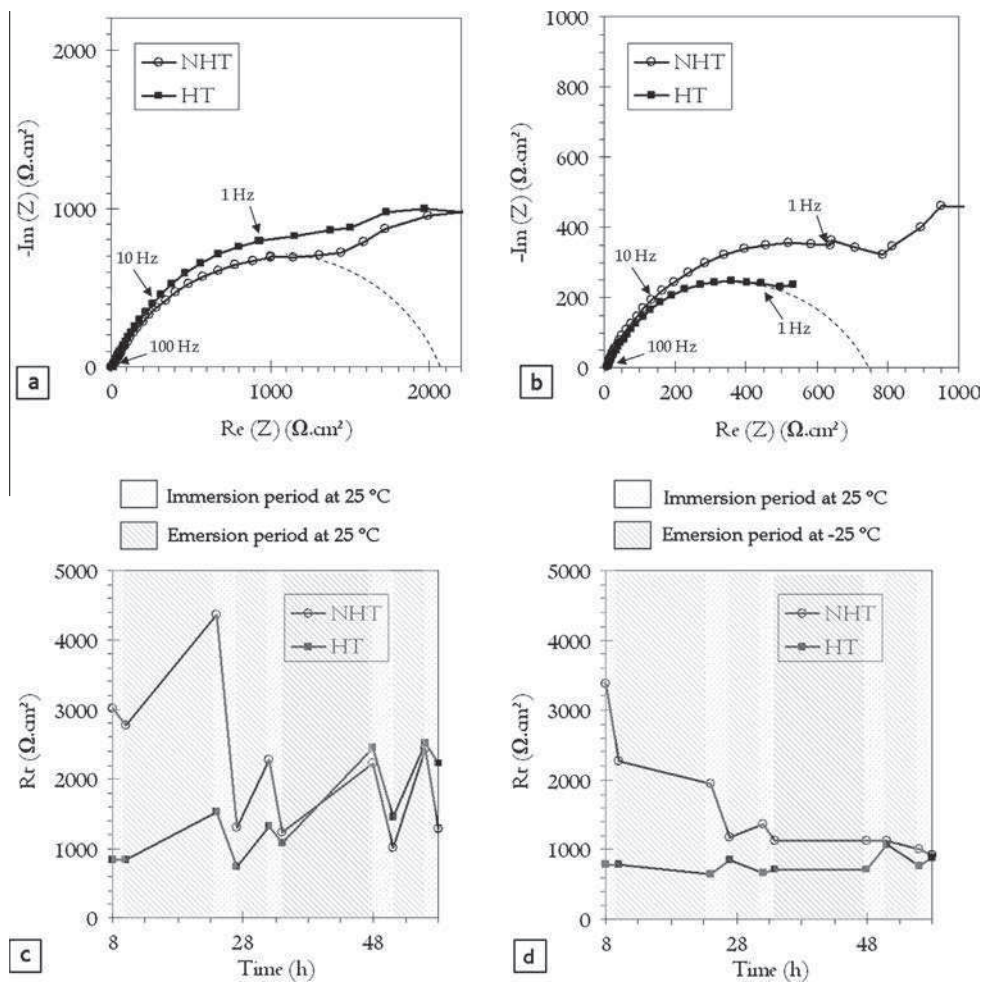
**Fig. 13.** Impedance diagrams (Nyquist plots) plotted at the beginning of the 5th immersion period of cyclic corrosion tests (48 h after the beginning of the cyclic corrosion test) for NHT and HT alloys (a) CR sample; (b) CF sample.  $R_r$  versus time for NHT and HT alloys for (c) CR samples and (d) CF samples.

the air exposure and to the accumulation of corrosion products inside the corrosion defects. In contrast, the continuous decrease of  $R_t$  for CF samples (Fig. 13d) suggested a defective oxide layer, as previously proposed, which could be related to the high linear density of corrosion defects (Fig. 3c and f), despite questions concerning the reliability of such data. Notably, the amplitude of the variations for the  $R_t$  values was higher for NHT samples compared with HT samples; in particular, for HT samples and CF tests,  $R_t$  only slightly varied during the entire duration of the test. The OCP measurements confirmed these results. Fig. 14 shows the evolution of the OCP during continuous immersion and during each immersion phase of CR and CF tests for both NHT (Fig. 14a) and HT alloys (Fig. 14b). For the NHT alloy, the OCP continuously decreased during continuous immersion, whereas for cyclic corrosion tests, the variation in the OCP was more complex (Fig. 14a). Considering the entire duration of the corrosion tests, the OCP globally decreased for both CR and CF tests, with a stronger decrease for CF tests. Examining the variations during each step of the corrosion tests, the OCP decreased during the immersion period; however, after each air exposure, the potential recovered to a value close to the potential value at the beginning of the corrosion test. The growth of an oxide layer on the alloy surface or the accumulation of corrosion products inside the corrosion defects during the emersion phase could be perceived as a healing of the corroded surface and could explain this result. However, the artificial healing of the oxide layer quickly disappeared during CF tests, as shown by the OCP decrease during the immersion period, which confirmed that the oxide layer was defective. In contrast, the OCP slightly dropped during the immersion period for CR tests, showing a more efficient healing phenomenon and a more protective oxide layer. Therefore, for NHT samples, the results showed that emersion periods at a negative temperature significantly influenced the properties of the oxide layer on the sample surface and inside the corrosion defects. Due to the stress developed by the electrolyte solidification trapped inside the intergranular corrosion defects during the emersion periods, the oxide layer was defective, which allowed hydrogen penetration. The increase in the surface, which allowed hydrogen penetration, compensated the reduced amount of hydrogen produced during CF tests compared with CR tests, which explained the slight differences in the hydrogen content between CF and CR samples. For HT samples, the OCP variations during the cyclic corrosion tests were extremely low, which could be related to the highly stable OCP measured during continuous immersion tests. This result was consistent with the impedance measurements and with the low amplitude of the variations in the  $R_t$  values. Such a behavior could be explained by the corrosion morphology. For HT samples, during the emersion period at

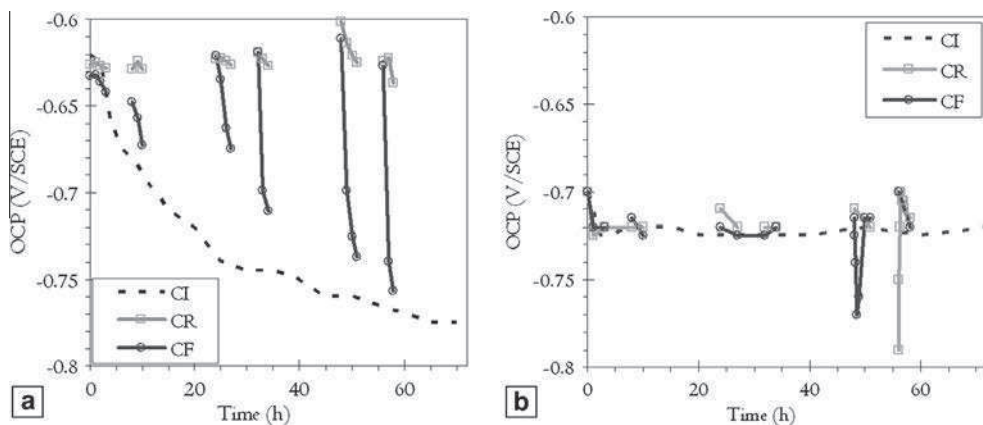
**Fig. 14.** Evolution of the open circuit potential (OCP) as a function of immersion time for CI, CR and CF tests (for cyclic corrosion tests, OCP is recorded during the immersion periods). (a) NHT sample; (b) HT sample.
