Nondestructive damage evaluation of reinforced concrete structure using infrared thermography

Minh-Phong Luong

Minh-Phong Luong. Nondestructive damage evaluation of reinforced concrete structure using infrared thermography. Nondestructive evaluation of aging materials and composites IV, pp.98-107, 2000, 10.1117/12.385481 . hal-00112273

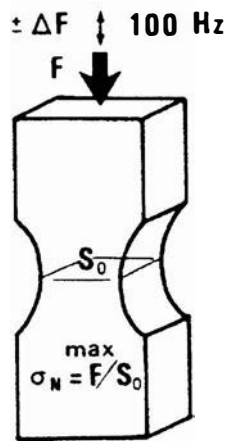
Figure 1. The concrete specimen is subjected to a given static compression superimposed by a vibratory compressive excitation (frequency = 100 Hz)

In laboratory, the high frequency servo-hydraulic test machine provides a means of vibration and dynamic testing of engineering materials. A vibratory loading at 100 Hz, applied on the specimen (Figure 1) that is subjected to a given static compression, exhibits in a nondestructive manner the irreversible plastic strain concentrations around gaps or cracks. The contribution of the plasticity term is revealed by the rapid evolution of heat dissipation once the stable reversible stress domain is exceeded, demonstrating the occurrence of an unstable crack propagation or coalescence of flaws existing in the concrete specimen. Experimental results have already shown that:

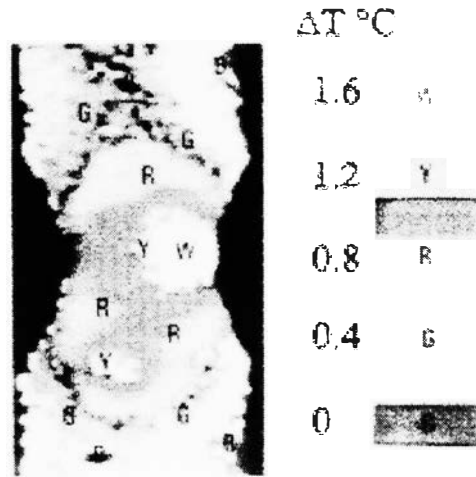
Figure 2. Infrared thermography of a concrete specimen under vibratory compressive excitation ($0.63 < \sigma/\sigma_N < 0.88$) Weakness zones are readily detected by heat patterns after 7,000 load cycles ($0.2\text{ }^\circ\text{C}$ for each color hue)

High strength concrete ($R_c = 43\text{ MPa}$) in use in oil offshore concrete structures (North Sea)

- a) Under a vibratory excitation between 25 and 50 percent of the nominal uniaxial compression $\sigma_N = F/S_0$, the heat dissipation, detected for 2000 load cycles, is small, even at the hottest location.
- b) When $0.50 \leq \sigma/\sigma_N \leq 0.75$, stress concentrations around cracks or defects are readily detected at the 1,000th load cycle.
- c) For $0.63 \leq \sigma/\sigma_N \leq 0.88$, cracking occurs increasingly in the reduced section part of the specimen.

Infrared thermography readily depicts intrinsic dissipation localization announcing quite different mechanisms of damage preceding concrete failure. The different phases of heat dissipation, operating during an unstable failure, are readily described by heat patterns. When defects or weakness zones are present on the specimen, infrared observations evidence the progressive mechanism of defect coalescence (Figure 2). The rate of heat generation at the hottest location is used to detect the threshold of the failure process if compared with the traditional stress-strain curve. These results have been readily extended to rock materials¹⁰.

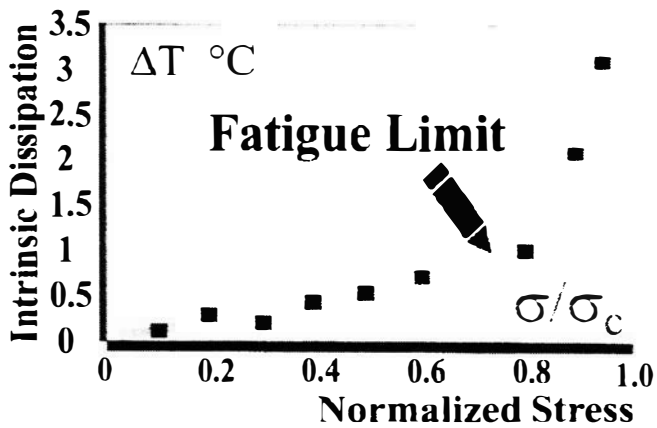
Figure 3. The fatigue limit of the concrete specimen under compressive loading is graphically determined by a drastic change of the dissipative regime.

Experimental results are summarized in Figure 3 that illustrates how the fatigue limit is determined using a graphical procedure. The threshold of critical thermal dissipation is roughly the same for different chosen number of load cycles. It roughly corresponds to the value deduced from standard procedures. These experiments have shown that the infrared thermographic technique can provide the fatigue limit of concrete within a few hours instead of several months when using for instance the traditional standard staircase method. These results are consistent with those obtained on concrete prisms

subjected to compressive fatigue testing²¹. This so determined stress limit could also be understood as a threshold of acceptable damage for plain concrete under compressive loading.

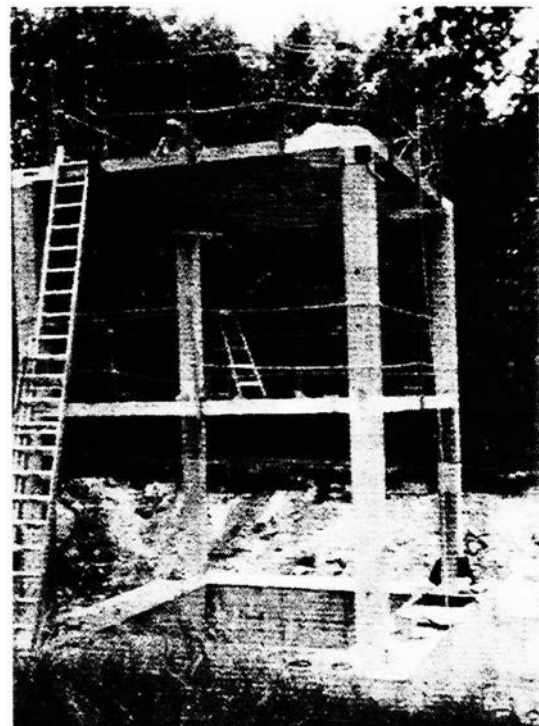
Figure 4. Experimental full scale concrete structure under a seismic type loading

The damaged areas are located and highlighted by heat patterns. These results support and validate the assumptions to be taken into consideration in numerical procedures for stability and integrity assessment of concrete structures. The phenomenological behavior in consideration is therefore the standard of reference, allowing the use of the methods and results of continuum mechanics for analyzing and modeling their engineering performance. Information about the location and significance of structural defects as a basis for maintenance decisions, including the extreme case of removal from service, can be obtained through inspection and nondestructive evaluation.

The proposed infrared thermographic procedure involves careful examination of areas where defects are most likely to occur. Analyzing the structure and the service histories of similar structures in similar environments can identify the critical areas. The application of infrared scanning to inspection of concrete structure relies on the fact that the energy is dissipated during the process of accumulative damage when internal cracks or flaws develop. Figure 4 presents an experimental reinforced concrete building frame, intended for earthquake resistance studies. The most severe likely earthquake can be survived if the members are sufficiently ductile to absorb and dissipate seismic energy by inelastic deformations with little decrease in strength.

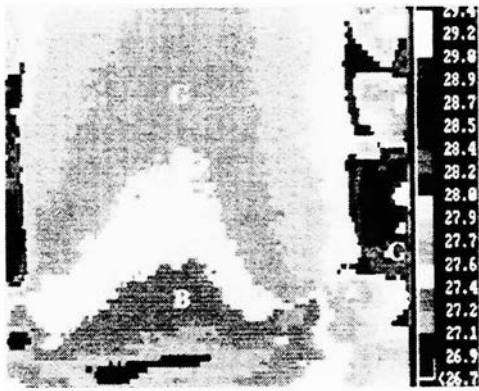
Figure 5. Thermal image of a column base of the reinforced concrete structure subjected to seismic type loading at reference time.

Under seismic-like loading, simulated by a rotating mass exciter placed on the top of the building, plastic hinges form progressively at the column bases where heat dissipation can be observed using infrared thermography as a function of the number of load cycles (Figures 5 and 6).

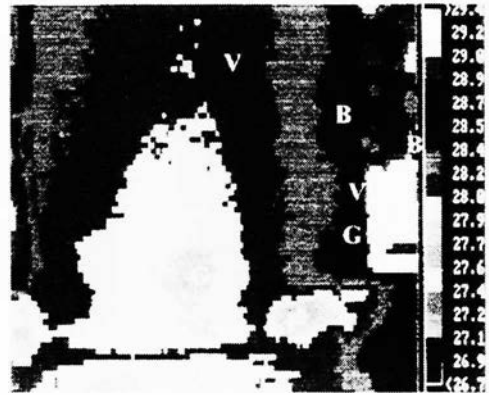
Figure 6. Thermal image of a column base of the reinforced concrete structure subjected to seismic type loading after N cycles of loading.

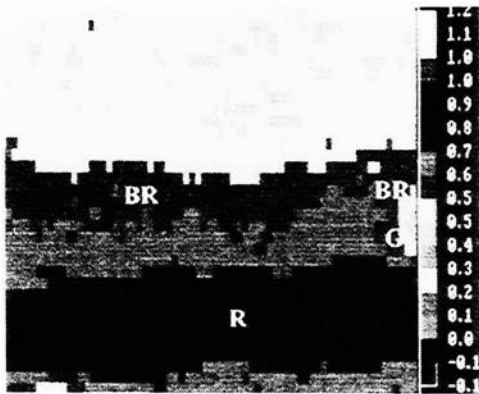
Figure 7. Intrinsic dissipation due to N load cycles (Figure 6 subtracted by Figure 5).

Computer aid thermography software allows the data reduction of the thermal images using the function subtraction of images and shows the progressive evolution of heat dissipation at a column base before crack line becomes visible. The resulting image is a subtracted image showing the temperature change between the reference time and after N load cycles (Figure 7). This image processing provided quantitative values of intrinsic dissipation corresponding to different numbers of load cycles. Obtained results after 270 load cycles (Figure 8) and after 360 load cycles (Figure 9) lead to a (log N - intrinsic dissipation) plot (Figure 10) that allows evaluation of fatigue lifetime of a column base of the experimental reinforced concrete structure subject to seismic-type loading.

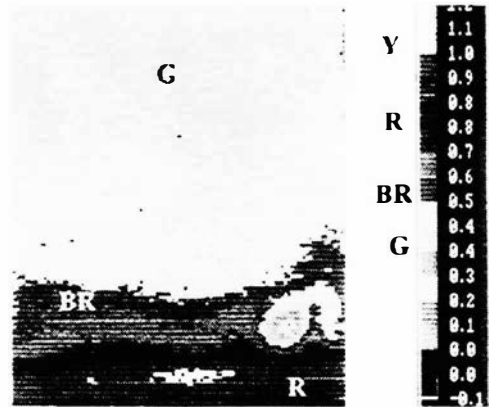
Figure 8. Intrinsic dissipation due to N = 270 load cycles.

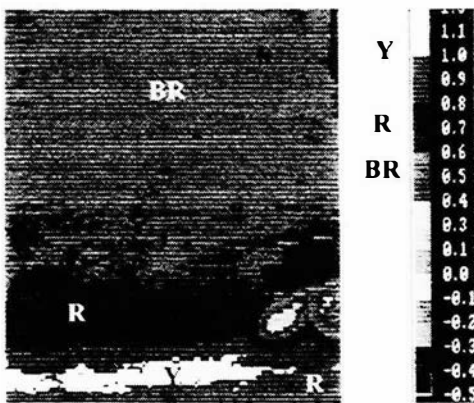
Figure 9. Intrinsic dissipation due to N = 360 load cycles.

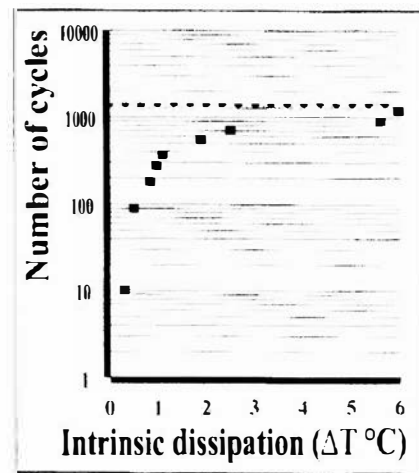
Figure 10. Fatigue lifetime evaluation of a column base of the reinforced concrete structure subjected to seismic type loading.

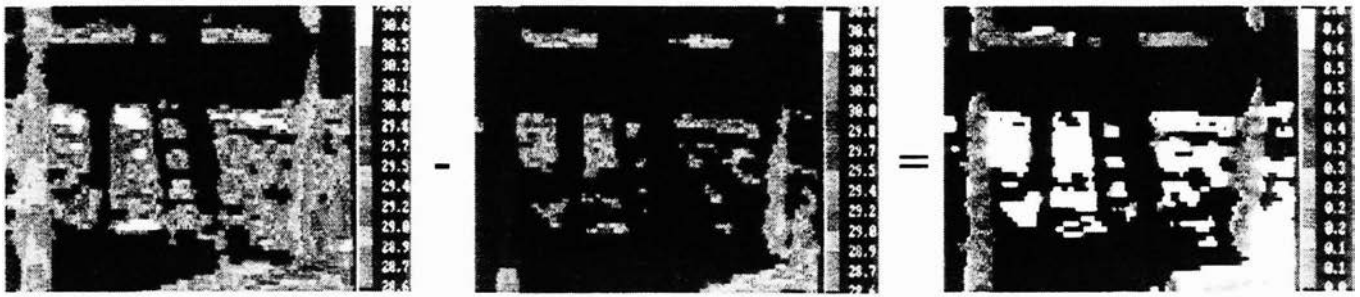
Thermal image after excitation

Thermal image before excitation

Localization of dissipation zones

Figure 11. Subtraction between thermal images after and before excitation evidences the localization of dissipation or damaged zones

The above data processing (heat image subtraction) applied for the overall structure provides useful information about localization of dissipation or damageable zones (Figure 11).

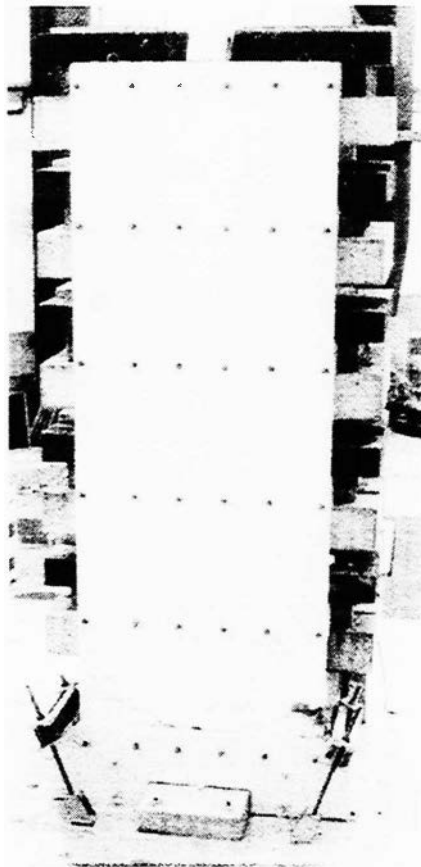
Figure 12. CAMUS III mock-up on the shaking table of CEA Saclay.

The CAMUS III specimen, composed of two lightly reinforced walls anchored to the shaking table, is designed as recommended Eurocode 8 allowing a plastic hinge at the base. Special attention has been paid on the influence of different reinforcement ratios and boundary conditions¹⁹. During the performed tests, CAMUS III mock-up suffered from high damage levels. Its behavior was mostly conditioned by its flexural bending. Examination after tests evidenced failure of steel reinforcements (Figure 12).

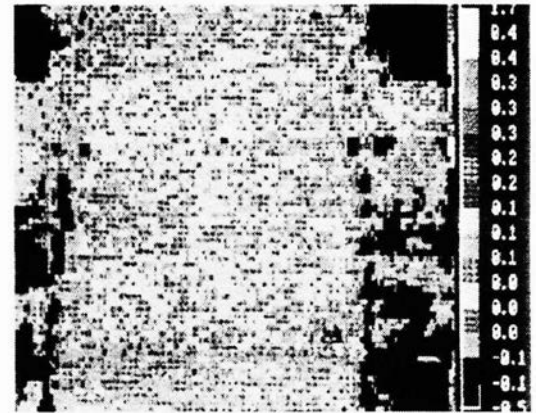
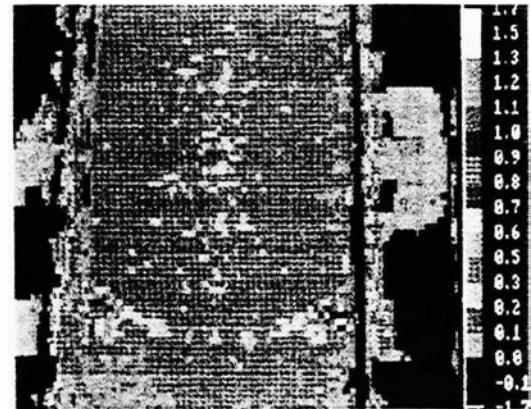
Heat image of CAMUS III
3 minutes after testing at peak
ground acceleration
PGA = 0.8g

Temperature changes are given in °C

Heat image of CAMUS III
3 minutes after testing at peak
ground acceleration
PGA = 0.85g

Figure 13 Infrared thermographic detection of dissipation caused by plasticity of steel reinforcements.

In this case, the dissipation mechanism caused by plasticity of steel reinforcements can be considered as an internal parameter so that the equation (1) has to be completed with two supplementary terms representing the cross coupling effects⁶, the former is caused by the dependence of the stress tensor on temperature (reversible) while the latter is induced

by the same dependence of the generalized force conjugates to the internal state vector (irreversible). This phenomenon appeared on the concrete surface with a delay depending on the depth of reinforcements. Thus infrared thermography readily evidenced and localized, on the scanned wall surface, the plasticity of steel reinforcements with a delay due to heat conduction characteristics of concrete (Figure 13).

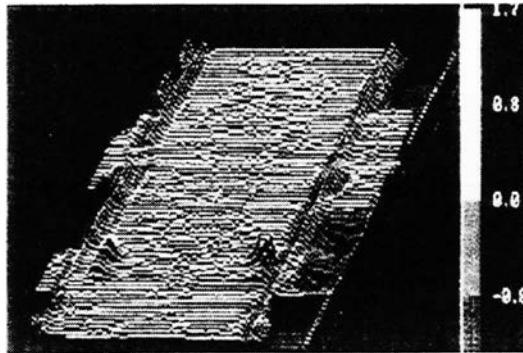
Figure 14. This figure highlights the dissipation mechanism due to plasticity of steel reinforcements

Input excitation = far-field earthquake (Nice artificial accelerogram)

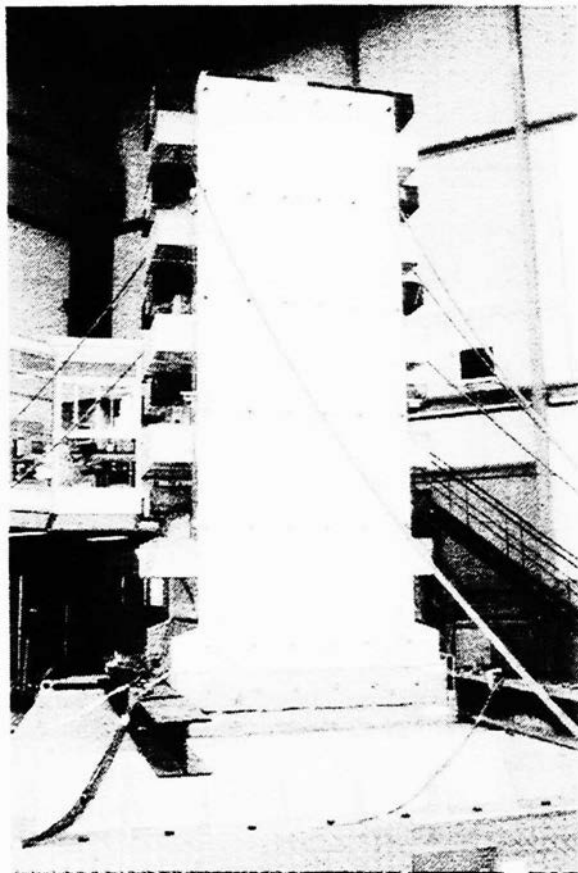
Figure 15. CAMUS IV mock-up resting on a fine sand layer on the shaking table of CEA Saclay.

The CAMUS IV specimen, composed of two lightly reinforced walls, was designed according to PS92 recommendations¹ and simply rested on a 40 cm thick sand layer (Figure 14). This test aimed to reproduce the phenomena of uplift and the fact that such a non-linear phenomenon was capable of isolating the structure from ground-borne excitation. In this case it is expected that soft boundary conditions will determine the seismic behavior of structural walls.

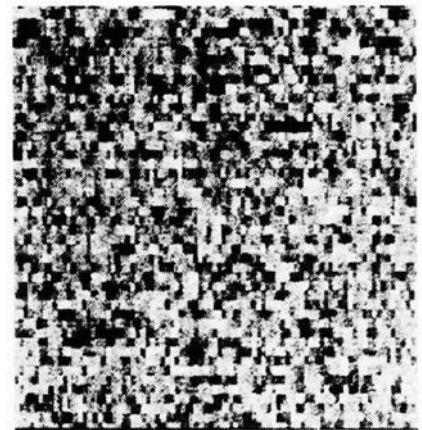
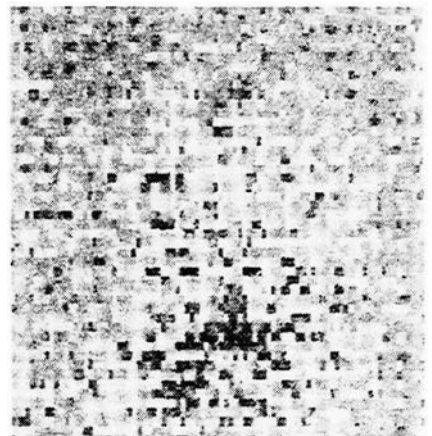
Heat changes are given in °C

Heat image taken 6 minutes after seismic test at PGA = 1.1g during 30 sec

Heat image taken 10 minutes after seismic test at PGA = 1.1g during 30 sec

Figure 16 Infrared thermographic detection of dissipation caused by slippage of steel reinforcements embedded in the concrete matrix

As in the above case, infrared thermography evidenced friction between steel reinforcements and concrete matrix with a delay necessitated by heat conduction through the concrete layer (Figure 15).
