Infrared thermography of 3D-woven fabrics subjected to service loading

S. GOROG, ISAT, Nevers France
M.P. LUONG, CNRS-LMS-EP, Palaiseau France
J.C. EYTARD, LMS-EP, Palaiseau, France

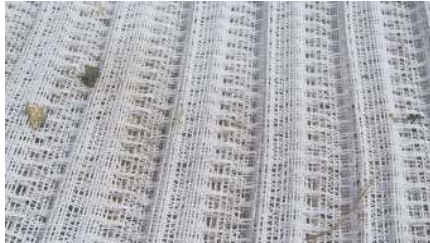
Figure 4. 3D-woven polyester mat lying on soil.

The experimental set-up consists in driving four vehicles of empty weights between 1 and 9 tons on a 2 m² specimen of geosynthetic simply lying on soil (Figure 4).

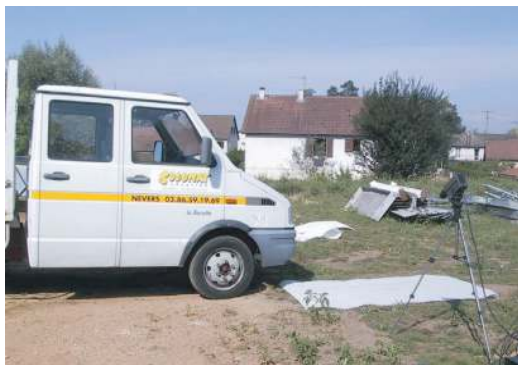
Figure 5. Heavy wheeled vehicle used as moving loading system on 3D-woven polyester mats.

Vehicles (Figure 5) are described in Table 1 and moved at constant speed of 15 km/h. The soil is not characterized from a mechanical point of view and results on the mixture of grass, gravel, ground and meteorological conditions. Field tests were conducted out during summer with high sun.
