# Observation of surface features on an active landslide, and implications for understanding its history of movement

M. Parise

M. Parise. Observation of surface features on an active landslide, and implications for understanding its history of movement. *Natural Hazards and Earth System Sciences*, 2003, 3 (6), pp.569-580. hal-00299072

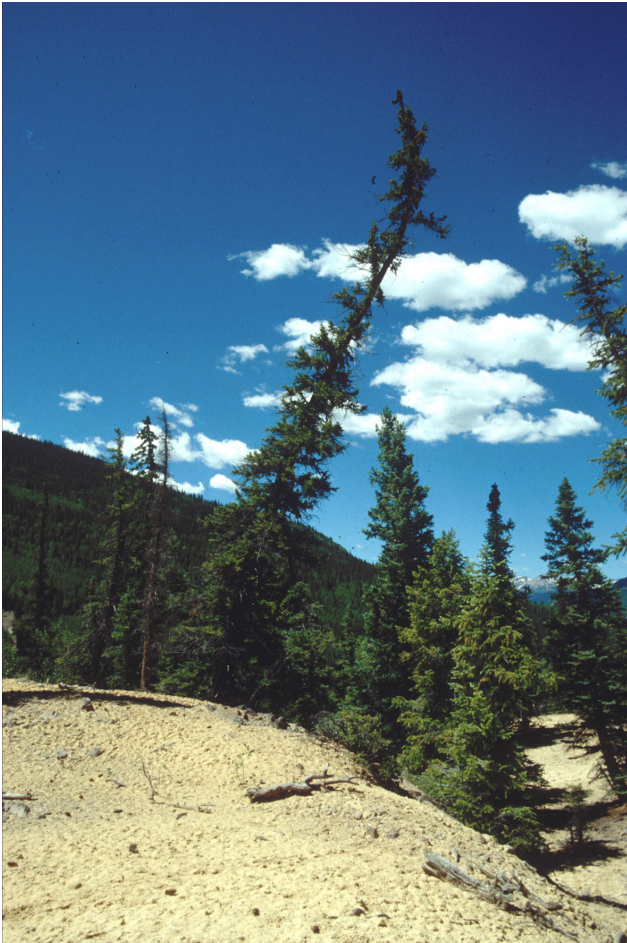
**Fig. 1.** Example of tilted tree, showing vertical growing after that displacement at the site caused the curvature in the trunk.

Further information can be obtained through the observation of trees and vegetation, since these are often affected by phases of movement and may register different episodes of displacement. The distribution of vegetation cover on the landslide, and the degree of vegetation disturbance, can be used to indicate the amounts of movement occurring across the landslide and even the relative ages of these movements. Continuously active areas are generally characterized by bare ground, or at least by the presence of relatively few trees, whilst in areas of recent movement the trees show clear signs of disturbance. Often trees are tilted during the movement, and then grow vertically during the period of inactivity, leaving a characteristic “stem bend” (Fig. 1). The relative age of the movement can then be inferred by these curvatures in the tree trunks.

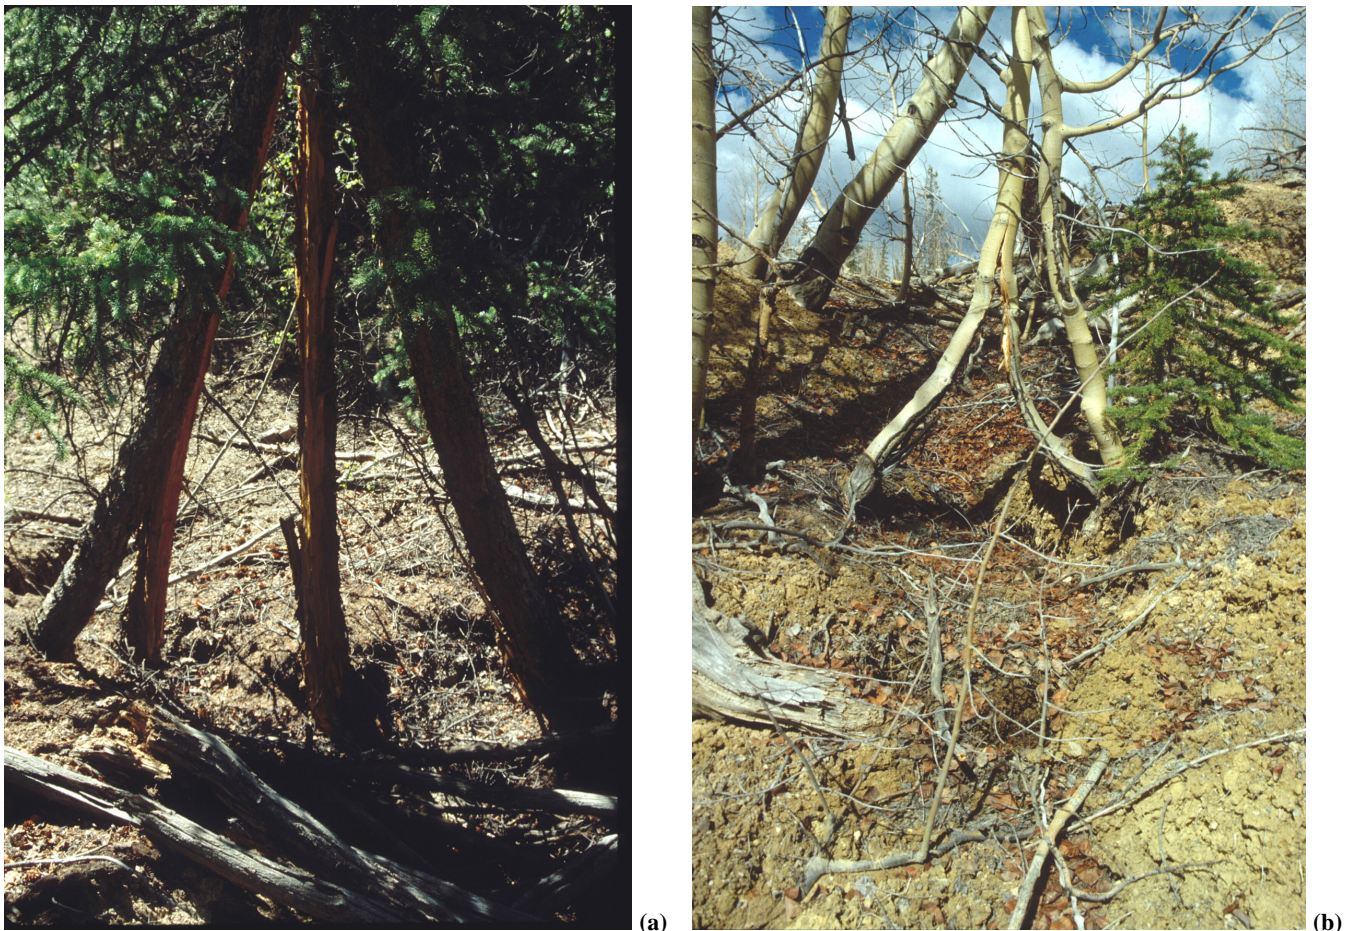
**Fig. 2.** Trees split in, respectively, four and two parts because they straddle active cracks: (a) spruce fir; (b) aspen tree. Both the trees were still alive at the time the pictures were taken.

In several areas, the observation of trees may also allow the determination of the width of tension cracks and the amount of lateral movement along shear surfaces. This is the case for trees split into two or more parts because they straddle active cracks (Fig. 2). The direction of differential movement required to produce the split can be used, together with stretching or buckling of tree roots, as an indicator of local deformation (Fleming et al., 1999). Often the trees are still alive in spite of the breaking.

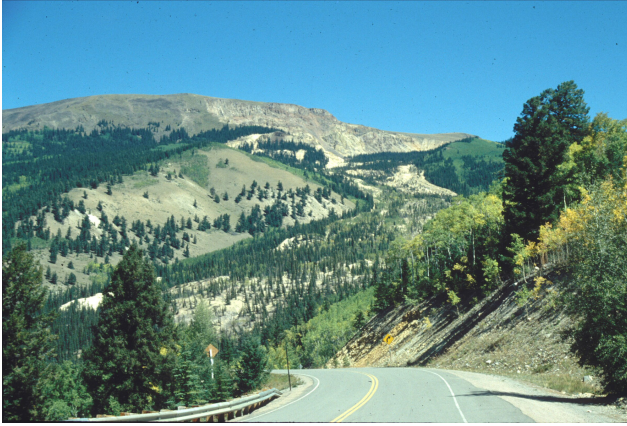
**Fig. 3.** View of the Slumgullion landslide, taken uphill from the State Highway 149.

The site of this study is the world famous Slumgullion landslide<sup>1</sup>, a large mass movement in the San Juan Mountains of Colorado (Fig. 3). It consists of a younger, active movement (3.9 km long) with an estimated volume of about  $20 \times 10^6 \text{ m}^3$  (Parise and Guzzi, 1992), which moves on and over an older, much larger (6.8 km long), inactive landslide (Fig. 4). Overall, the volume of the complete landslide system is estimated at about  $170 \times 10^6 \text{ m}^3$  (Parise and Guzzi, 1992).

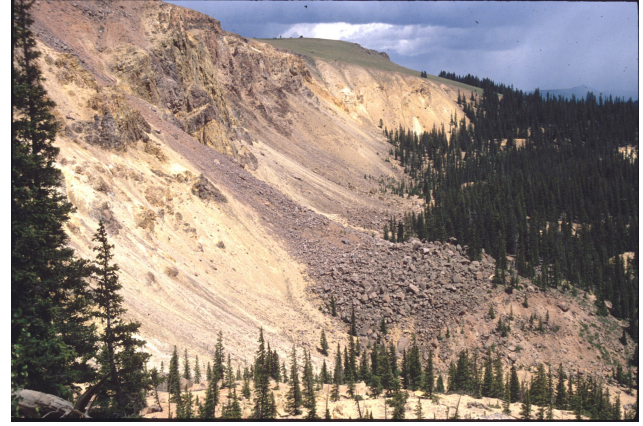
**Fig. 5.** Talus deposits at the base of the Slumgullion main scarp.

This occurs in particular at the base of the main scarp, which is mantled with continuous belt of detrital material consisting of talus cones and rock-fall deposits (Fig. 5). The talus cones are built by successive and discontinuous accumulations of debris falling from the near-vertical to over-

hanging rock walls above. Rock-fall deposits, on the other hand, form large accumulations of clast-supported angular blocks and coarse boulders, which typically show an irregular hummocky morphology (Parise and Moscariello, 1997).

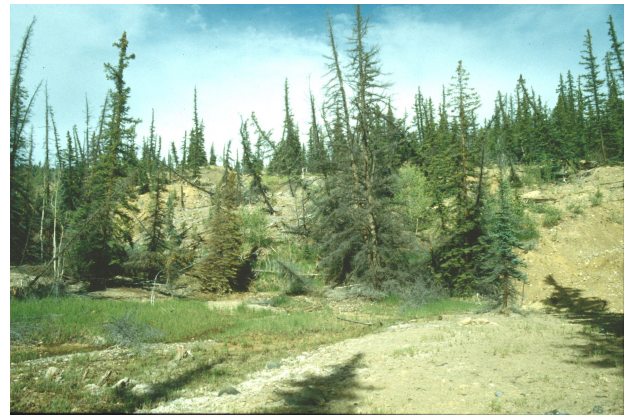
**Fig. 7.** Active toe of the Slumgullion earthflow, about 250 m upslope from the area where State Highway 149 crosses the inactive landslide deposit.

The active toe is moving along the surface of the old landslide deposits in bulldozer fashion, toppling and overriding trees as it goes (Fig. 7). It has an irregular trace along its northern half, which is probably a result of a velocity discontinuity (higher displacement rates have actually been observed at its southern half).
