## History and present state of the Slano Blato landslide

**Abstract.** The Slano Blato landslide is more than 1290 m long, 60 to 200 m wide and 3 to 11 m deep with a volume of about 700 000 m<sup>3</sup>. It is located in the Eocene flysch region of western Slovenia with a limestone overthrust in the direct vicinity, above the landslide. The landslide moves mainly as a viscous earth flow with occurrences of rapid mud flows. In dry periods or in freezing conditions it behaves as a group of several slow to moderate landslides. The landslide follows the course of the Grajšček stream and is presently only 220 m away from Lokavec village. The landslide was first mentioned about 200 years ago. In 1887 it flowed as a liquid flow and reached and destroyed the main road in the valley 2 km away. The Austro-Hungarian monarchy sent one engineer to the site and 17 years later the slide was remediated with a series of torrential check dams. The monarchy prohibited any construction works in the influence area of the landslide. During the 20th century the region changed from Austrian, Italian, Yugoslav, and finally to Slovenian government in 1991. The relevant Austrian measures and decisions wer

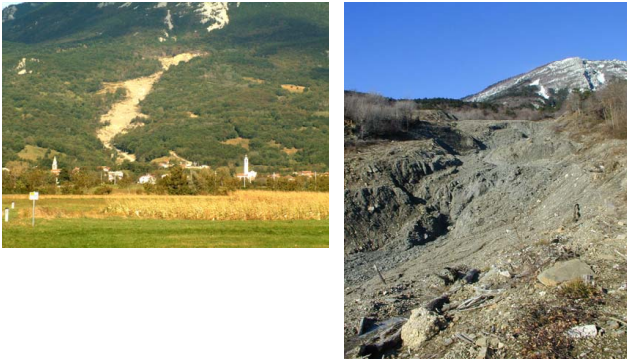
**Fig. 4.** A far and a close view of the Slano Blato landslide.

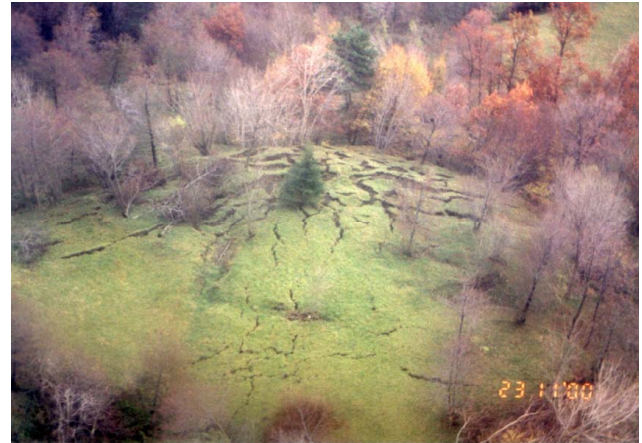
**Fig. 5.** The photo taken on 23 November 2000, at the location later on referred to as the “Lake of Mud” just before the vegetation was ripped off. Note the pronounced heave in the centre due to the pressure caused by the soil sliding.

the ground shown in Fig. 5, indicating that the ground became soft due to the water emerging from the bedrock and not from the surface) it was suggested that an important influx of water to the sliding mass came also from the lower flysch layers. Later on this was confirmed when the first two large hollow concrete shafts with a diameter of 5 m were made as a part of remediation actions. Up to  $15 \text{ m}^3$  of water per day can be collected in one shaft.

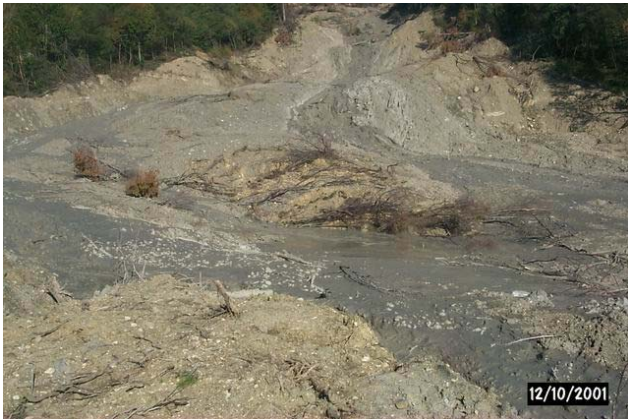
**Fig. 7.** Several minor mudflows occurred in October 2001.

4. In October 2001 several minor, very rapid to extremely rapid mudflows (according to Cruden and Varnes, 1996) generated from the lower part of the earth flow and followed the Grajšček stream bed through the village of Lokavec (Fig. 7). The mudflows were different in volume, density, and in the rate of advance.

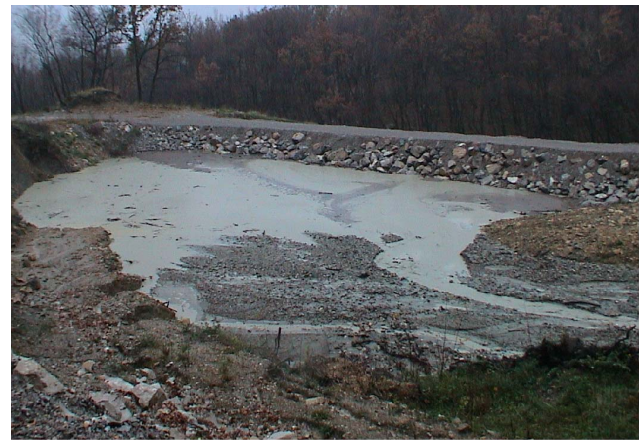
**Fig. 8.** The rockfill dam that can retain up to 5000 m<sup>3</sup> of mud and debris was constructed to protect the village of Lokavec from extremely rapid mud flows generated at the surface of the stopped earth flow masses.

5. At the beginning of 2002 a small rockfill dam with a bottom outlet was constructed in the Grajšček stream bed some 280 m from the village of Lokavec to protect it against the potential mudflows. Up to 5000 m<sup>3</sup> of debris could be retained behind the dam (Fig. 8). During the autumn and winter 2001—2002, up to 200 000 m<sup>3</sup> of mud and debris were mechanically removed from the area of the front of the earth flow and deposited on a dumping site in the valley bottom outside the village of Lokavec. The aim of this remediation measure was to protect the rockfill dam and the village of Lokavec

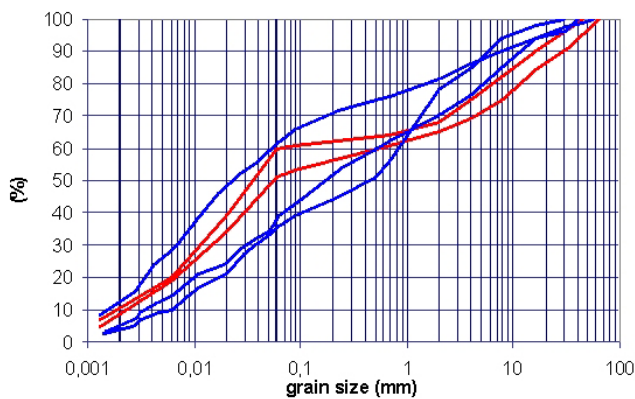
**Fig. 12.** Grain size distribution for selected samples from the landslide material.

The grain size distribution was analyzed for 20 samples. The results for 5 selected samples are presented in Fig. 12 (2 samples were tested in 2002 and 3 in 2003). The presented grain size distribution curves represent the whole range of measured grain size distributions. The majority of samples can be classified as silty clays with up to 45% gravel and sand particles. In other samples gravel and sand particles dominate (60%) over the silt and clay (40%). Such samples are found in the upper part of the landslide and at the locations where fractions of fines were partly washed away.

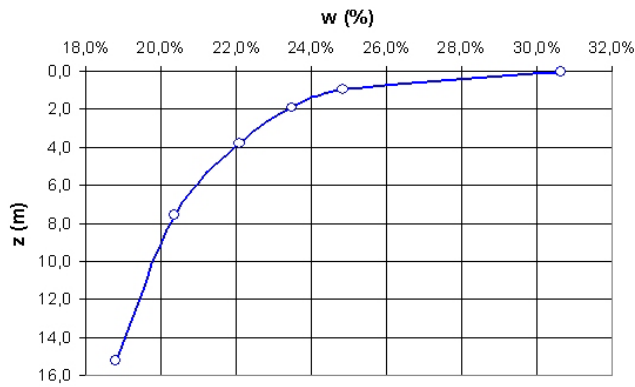
**Fig. 14.** Oedometer curve (void ratio  $e$  vs. vertical pressure  $\sigma'$ ) plotted as depth ( $z$ ) vs. water content assuming that  $z = \sigma' / \gamma$  and  $w = e\gamma_w / \gamma_s$ .

A test in a large oedometer cell (250\*120 mm=D\*H) was performed on a liquid landslide mass with initial water content of 31%, at which the fine matrix was in liquid state. Only one such test was performed on the samples with maximum grain size of 20 mm with the aim of investigating the influence of the consolidation on the reduction of water content. By loading the specimen up to 320 kPa, the water content was reduced to 19%. Figure 14 shows the result as a graph of water content vs. depth, assuming the unit weight of deposited sliding mass  $\gamma=21$  kN/m<sup>3</sup>. This result proved that the deposition of the sliding mass at locations where it can consolidate and partly dry up will cause an important increase in shear strength. At the same time, lower water contents obtained on site in 2003 mean that the material dries up eas-

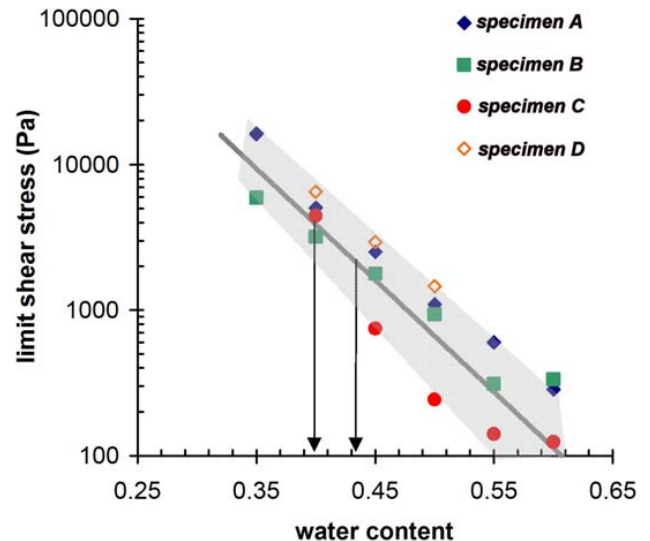
**Fig. 16.** Limit shear stress vs. water content measured in viscometer on four specimens.

The viscosity (Fig. 15) and limit shear stress (Fig. 16) were measured in viscometer on fines with grain size  $< 63 \mu\text{m}$ . It was established that the limit shear stress dropped rapidly with increasing water content, from 100 kPa at 40% water content to only a few hundred Pa at 60% water content. The coefficient of viscosity decreased from  $10^8$  to  $10^5$  Pa.s for the same increase in water content.

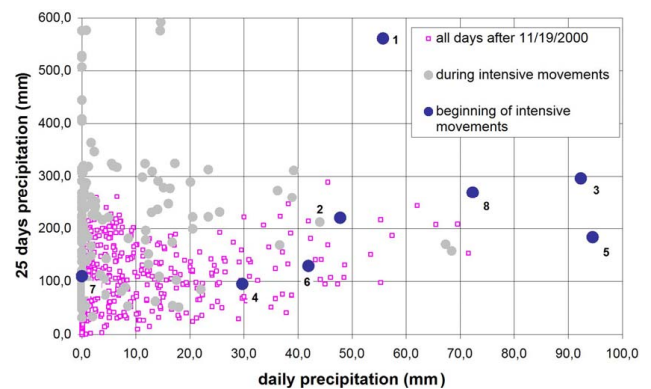
**Fig. 18.** 25-day cumulative precipitation vs. daily precipitation with triggering of 8 major sliding and/or earth flow events.

advancement of the front of the earth flow. Figure 18 shows the diagram of 25-day cumulative precipitation vs. daily precipitation. Large dark dots mark the eight days when significant earth movements started, grey dots show all days during intensive movements, whereas small dots show all other days after 19 November 2000. The eight triggering events are numbered consecutively, showing that an extremely intensive precipitation had been necessary to provoke the first sliding. Each of the next triggering events happened after less rainfall.

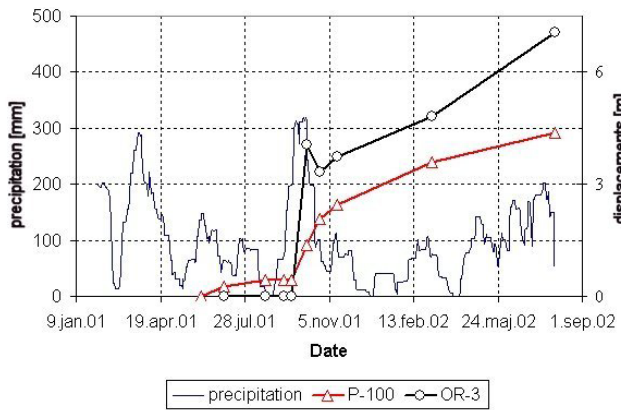
**Fig. 19.** 25-day cumulative rainfall and measured displacements of two points. (see Fig. 22 for the location of the measuring points).

In 2000, a temporary system of measuring points was set up. Displacements of the earth flow were followed, using GPS technology and with classical geodetic measurements. The displacements of some points reached the values of 150 m until they were lost from the measuring system. The majority of the measuring points was destroyed during the works on the drainage system in the part of the landslide. Until that time the largest displacements were observed in the upper part of the landslide, e.g. points OR-3 and P-100 (see Figs. 19 and 22).

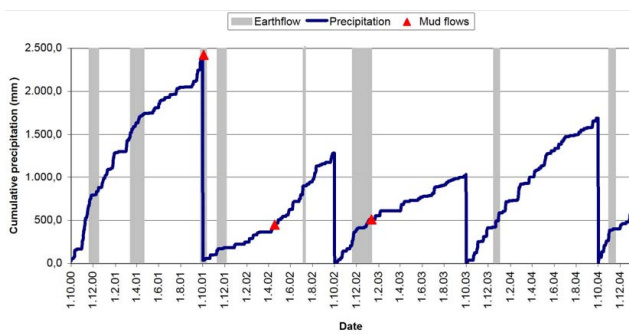
**Fig. 20.** Cumulative annual rainfall and the periods of intensive mass movements.

Figure 20 presents cumulative annual rainfall (zeroed each 1 October to keep the reasonable scale) and the periods of intensive sliding mainly connected with the progression of the earth flow towards the village of Lokavec.

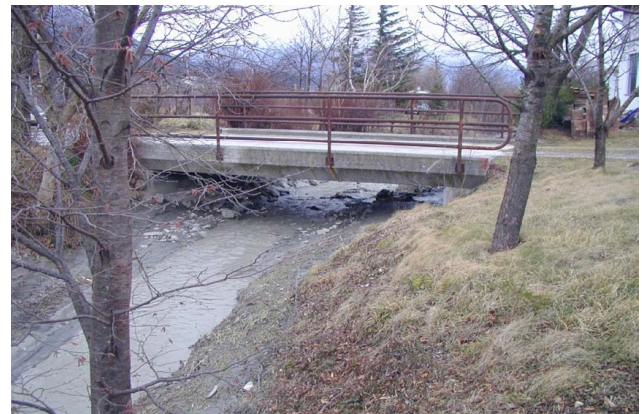
**Fig. 21.** The area of Grajšček stream cross-section under the bridge is important for the flood and mudflow safety and therefore needs constant maintenance. The photo shows the cross-section partly filled with mud, which needs intervention.

- Several drainage trenches in the upper part of the landslide were put in function in 2002, and were destroyed in 2003 due to retrogressive sliding. They were rebuilt in 2004,
- Removal of 200 000 m<sup>3</sup> of the earth flow masses in the area of its front, for which a remediation of the local road was necessary,
- A small rockfill dam against fast mudflows,
- The Grajšček streambed was enlarged, made concave and protected by rip-rap to withstand fast flowing mudflows (Fig. 21).
