Dynamics and conceptual model of the Rossena castle landslide (Northern Apennines, Italy)

A. Chelli, G. Mandrone, A. Ruffini, G. Truffelli

A. Chelli, G. Mandrone, A. Ruffini, G. Truffelli. Dynamics and conceptual model of the Rossena castle landslide (Northern Apennines, Italy). *Natural Hazards and Earth System Sciences*, 2005, 5 (6), pp.903-909. <hal-00299329>

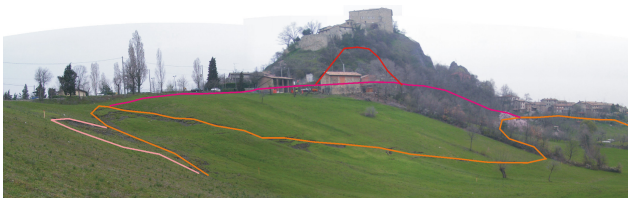
Fig. 1. Panoramic view of the higher part of the Rossena Landslide. Keys: orange line = main body (rotational), purple line = earth slide (translational), red line = rock slide, pink line = secondary landslide.

This paper describes an interesting landslide, failed during the night of 28 February 2004, that involved the village of Rossena: the failure damaged the village (Fig. 1), the road and the fields down to the stream but, fortunately, the castle just upslope the village was not involved at all.

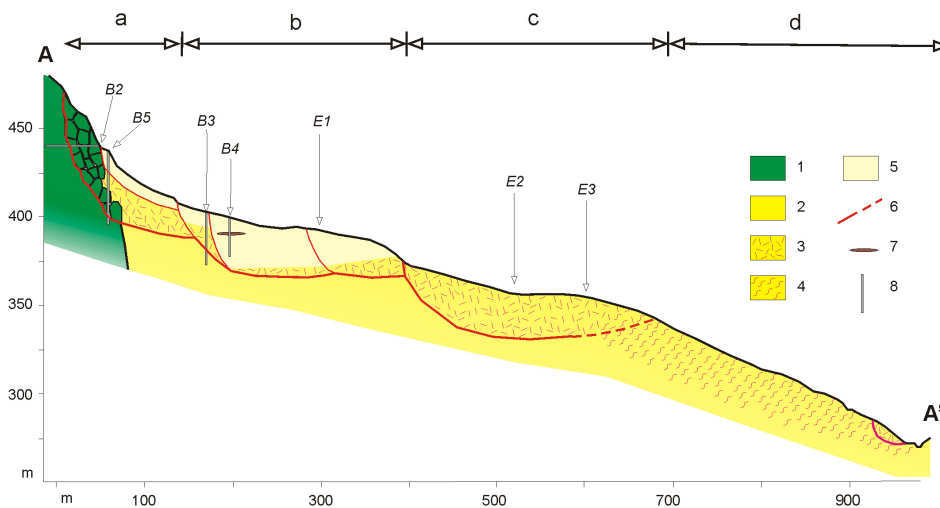
Fig. 4. Cross section of the Rossena Landslide. Keys: 1) ophiolites, 2) varicoloured shales, 3) idem, involved in the landslide, 4) idem, involved in the rock creep, 5) slope deposits, 6) slip surface, 7) organic layer of 10000 y b.p., 8) boreholes (B) and vertical electrical soundings (E). Letters at the top of the picture show the four morphological units in which the landslide can be divided.

From the top to the bottom of the slope different types of landslides were identified, with each one involving different parts of the slope (sectors A, B, C, D in Fig. 4).

The cliff of the Rossena castle (sector A) is crossed by many families of fractures, which cut the basaltic mass in different directions. They allowed the disjuncting of the mass in huge blocks that underwent differential movement in the eastern part of the cliff. During the 28 February event some blocks collapsed, with about 1 m of vertical offset (Fig. 5), just below the wall of the old building, while topplings involved the outer blocks (Fig. 6). Small rock falls and debris flows occurred respectively on the front of the cliff and in the covers that surrounds it, made of debris in a clayey matrix. A rotational-translational landslide involved the slope below the cliff, developing in the oldest part of the village. Several fractures, with offset between 1 and 2 m, widened in the ground and many small landslides occurred just after the main event, enlarging the crown and the flanks of the main landslide, and contributing to damaging the village.

The top of sector B is at about 390 m a.s.l., where there is a gentle concave area that is the morphological expression of the head of a rotational landslide. Different springs appear in this area: they likely mark the boundary between an upper layer made by material deriving from the wasting of the basaltic cliff, in which a water seepage can develop, and a lower one made up by a mainly clay-rich material, mainly

impermeable, deriving from the varicolored clay formation (both levels are involved in the landslide). The type of movement changes in the middle-lower part of the landslide, turning into a flow type and, on the whole, this part of the landslide may be classified as a complex phenomenon (rotational slide-flow).

Sector C is characterized by another concave surface where some other springs appear. On the right side of the surface, there is a very steep scarp where varicolored clay outcrops. Downslope, many series of fractures, some of them showing decimetric offset, appear in the ground, developing from the center of the slope towards northeast. On the basis of their distribution, the fractures seem to be the expression of an initial failure of this part of the slope rather than a well-defined landslide body.

An extended well-stratified and preserved outcrop of the varicolored clay formation is in correspondence of the foot of the slope (sector D). It seems to contrast the development of the landslide, playing the role of a buttress. Actually, the landslide divides into two tongues in correspondence of the change in acclivity: the first one, on the right of the outcrop, is affected by many fractures and secondary landslides, whilst the second one, on the opposite side of the varicolored clay outcrop, reaches the torrent at the foot of the slope. The features of this last part of the landslide allow to state that it is an earth-flow, but no evidence of recent movement was found. This fact proves that this specific part of the landslide was not involved in the event of 2004 and it is, at present, in a dormant state of activity. Moreover, some small landslides, mainly of complex (rotational slide-flow) type, and debris-flow affected the foot. They developed concomitantly

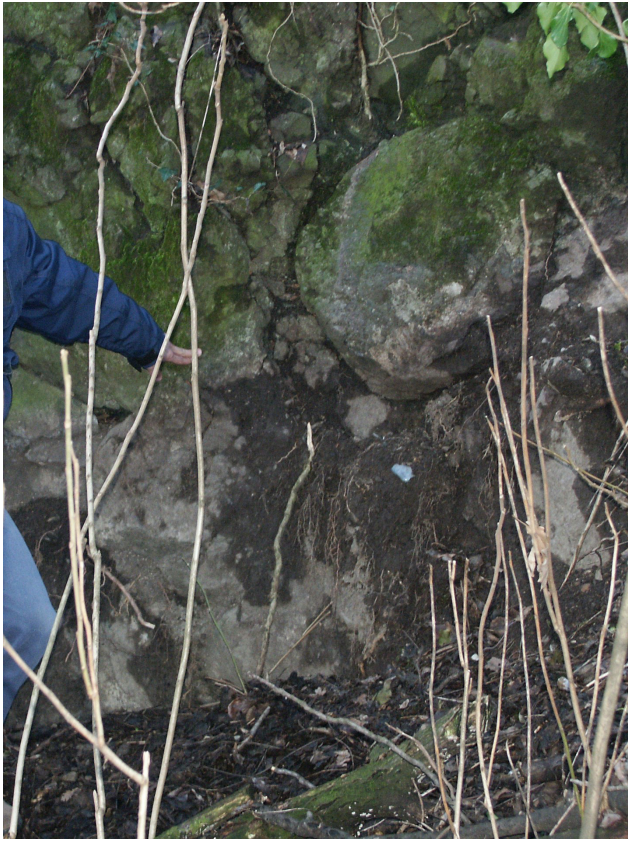
Fig. 5. Vertical offset between stable basaltic cliff and dismembered blocks.

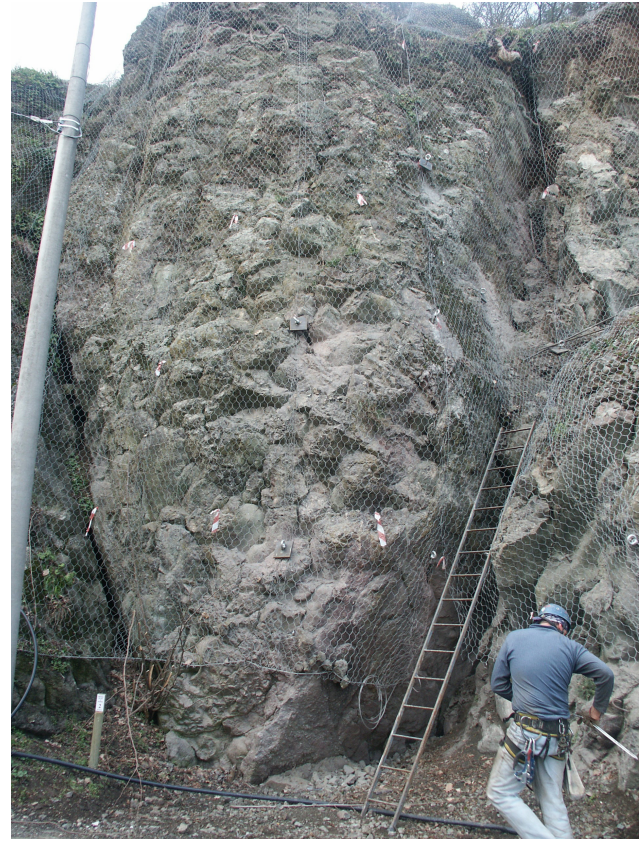
Fig. 6. Unstable basaltic block at the base of the cliff.
