The disastrous 17 February 2006 rockslide-debris avalanche on Leyte Island, Philippines: a catastrophic landslide in tropical mountain terrain

S. G. Evans, R. H. Guthrie, N. J. Roberts, and N. F. Bishop

Landslide Research Program, Department of Earth Sciences, University of Waterloo, Waterloo, Ontario, N2L 3G1, Canada

Abstract. In February 2006, a disastrous rockslide-debris avalanche occurred in tropical mountain terrain, on Leyte Island, Central Philippines. Over 1100 people perished when the village of Guinsaugon was overwhelmed directly in the path of the landslide. The landslide was initiated by the failure of a 450 m high rock slope within the damage zone of the Philippine Fault where the rock mass consisted of sheared and brecciated volcanic, sedimentary and volcanoclastic rocks. Tectonic weakening of the failed rock mass had resulted from active strike-slip movements along the Philippine Fault which have been estimated by other workers at 2.5 cm/year. The landslide involved a total volume of 15 Mm³, including significant entrainment from its path, and ran out a horizontal distance of 3800 m over a vertical distance of 810 m, equivalent to a fahrböschung of 12°. Run-out d

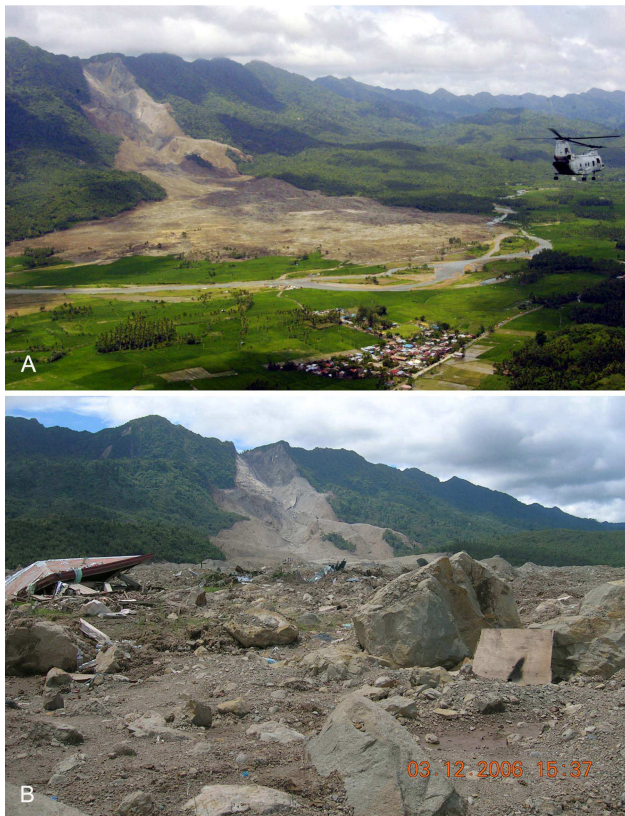
Fig. 1. (A) Oblique aerial view (to the northwest) of the Guinsaugon landslide taken on 19 February 2006. (U.S. Navy photograph by M. D. Kennedy). The Himbangao River flows from right to left. (B) View of debris toward the source area of the rockslide-debris avalanche (Photograph taken 12 March 2006).

On 17 February 2006 a disastrous landslide occurred in Southern Leyte Province, Leyte Island, the Philippines (Lagmay et al., 2006; Fig. 1). It originated on a steep 450 m high, heavily-forested rockslope and swept down into the densely-populated Himbangao River valley. The landslide overwhelmed the village of Guinsaugon resulting in the loss of over 1100 people, including 250 schoolchildren who were attending morning classes at the Guinsaugon School.

The landslide (Figs. 1, 5) occurred between 10:30 a.m. and 10:45 a.m. on the morning of 17 February 2006. An eyewitness interviewed during field work said that the landslide started with a shaking of the ground, followed by the sound

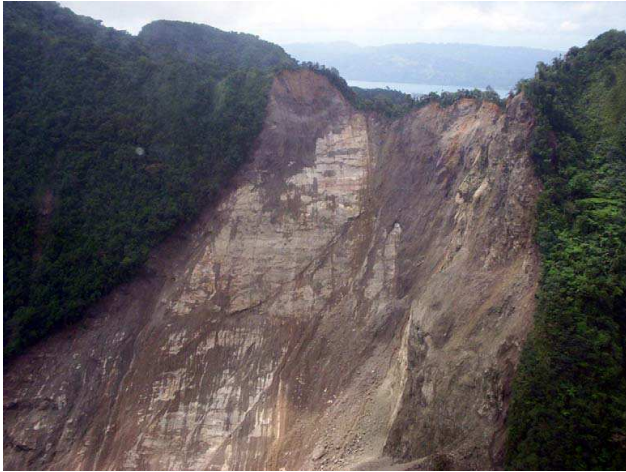
Fig. 8. Aerial view of the sliding surface showing horizontal striations consistent with strike-slip fault movement. Note also rock mass characteristics on the right of the source area resulting from movement of Philippine Fault (Photograph courtesy of Mines and Geosciences Bureau, Government of the Philippines).

8) and it appears that a splay of the fault formed the steep sliding surface of the initial rock slope failure (Figs. 5b, 8).

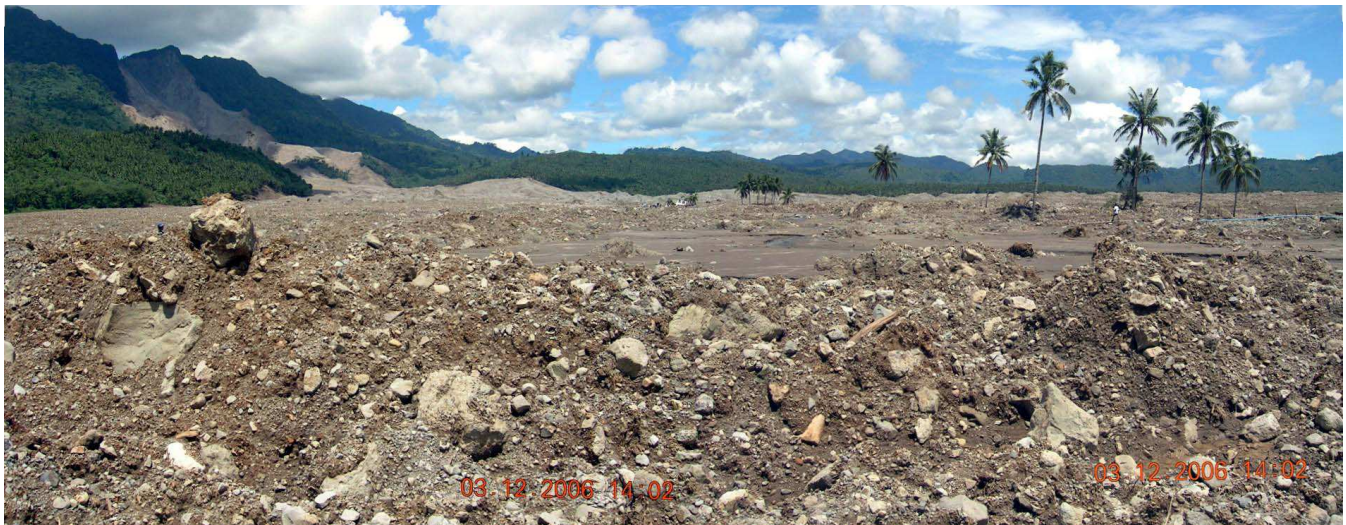
Fig. 9. View from near the distal limit of the debris toward the source area. Note matrix supported nature of the debris at this distal location and flat surface, corresponding to rice paddy fields, over which the debris ran in the distal part of its path. Debris thickness here is about 2 m.

Debris deposited on the valley floor is dominated by finer grain sizes which forms a matrix-supported deposit (Figs. 9, 10), despite the fact that large boulders are present (Fig. 11a). This may reflect the entrainment of finer-grained colluvium by the leading edge of the rockslide-debris avalanche from the base of the source slope and/or the mixing of the rockslide-debris avalanche debris with the saturated sediments from paddy fields on the valley floor. The distal limit of the debris consists of series of irregular lobes on the flat valley floor, (Figs. 10a, b) which are rimmed by a zone of dark mud. This represents the fine muds ejected from beneath the moving debris sheet during the final part of its travel over the paddy fields. In some places we noted that trees and buildings were destroyed by the ejected mud beyond the limit of the coarser debris (Fig. 11b).

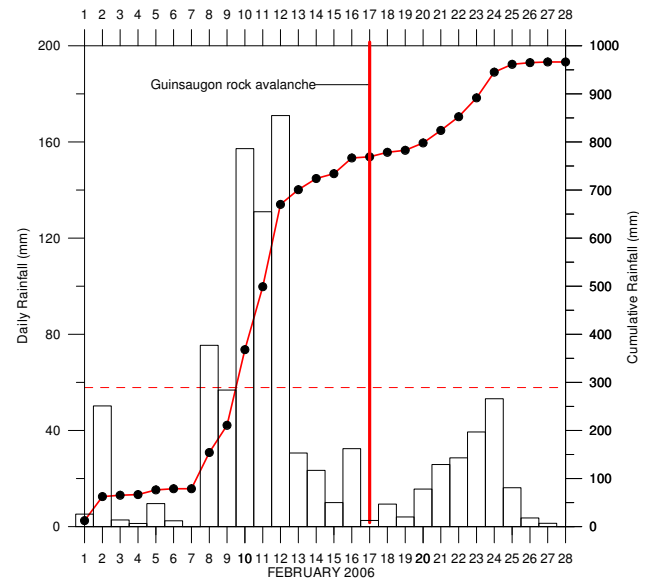
Fig. 13. Daily rainfall and cumulative rainfall measured at Otikon, Liagon (for location see Fig. 3b) for the period 1–28 February 2006. Horizontal dashed line is monthly mean rainfall. Data courtesy of Philippine Atmospheric, Geophysical, and Astronomical Services Administration.

between 8 February and 12 February 2006 cumulative rainfall reached 571.2 mm, with an average of 114 mm per day (Fig. 13). This exceeds the monthly average rainfall measured both at Libagon (by a factor of two) and Surigao (by a factor of 1.2). There was, therefore, a lag time of four days between the end of the 5 day period of heavy rainfall and the occurrence of the landslide of 17 February. No analysis of the frequency of the February rainfall magnitude has been carried out but rainfalls of this magnitude and intensity are not uncommon in the Philippines, especially those related to tropical storms (typhoons) (Hart et al., 2002).
