Stepwise mitigation of the Macesnik landslide, N Slovenia

M. Mikoš¹, R. Fazarinc², B. Pulko¹, A. Petkovšek¹, and B. Majes¹

Abstract. The paper gives an overview of the history of evolution and mitigation of the Macesnik landslide in N Slovenia. It was triggered in 1989 above the Solčava village, but it enlarged with time. In 2005, the landslide has been threatening a few residential and farm houses, as well as the panoramic road, and it is only 1000 m away from the Savinja River and the village of Solčava. It is 2500 m long and up to more than 100 m wide with an estimated volume in excess of 2 million m³. Its depth is not constant: on average it is 10 to 15 m deep, but in the area of the toe, which is retained by a rock outcrop, it reaches the depth of 30 m. The unstable mass consists of water-saturated highly-weathered carboniferous formations. The presently active landslide lies within the fossil landslide which is up to 350 m wide and 50 m deep with the total volume estimated at 8 to 10 million m³. Since 2000, the landslide has been investigated by 36 boreholes, and 28 of them were equipped with inclinometer casings, which also serve as piezometers. Surface movements have been

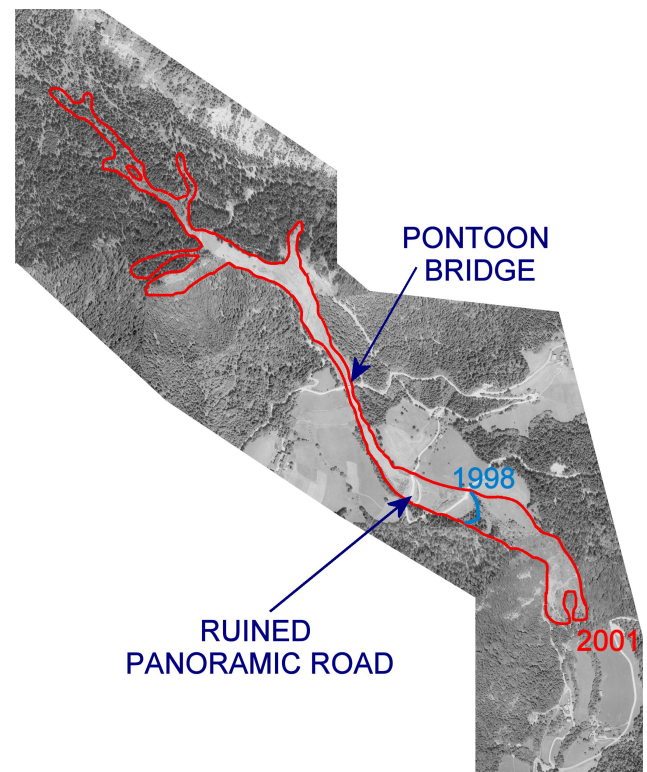
Fig. 2. Aerial view of the contours of the Macesnik landslide in 1998 and 2001.

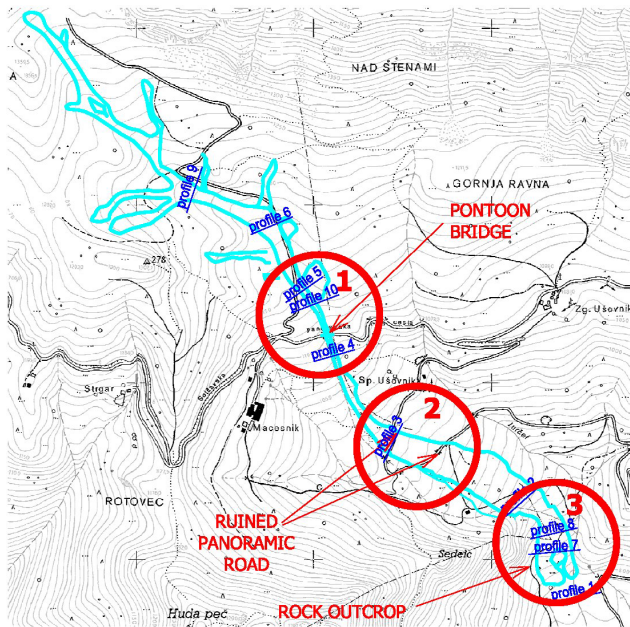
Fig. 3. Topographic map of the Macesnik landslide with the contours of the landslide and cross sections (“profiles”) for regular measurements of the surface displacements.

- Lowering of ground water pressures by deep drainage trenches filled with gravels is technologically possible (up to the depth of 8 m) only in the upper part of the landslide above the pontoon bridge.
- The sequence of restraint structures on such a long landslide should be planned in such a way that there would be no overtopping by sliding mass from above or subsidence and sliding of mass away from the structures.
- On the basis of all the executed field and study investigations, field measurements, and field experiences, the planned mitigation of the Macesnik landslide will follow the division of the landslide by restraint and drainage works into 3 areas (Fig. 3):

The Macesnik landslide is deep in its middle part (area 2 on Fig. 3), where it is twice crossed by the Panoramic road. In the place of the present upper road turn the landslide depth is more than 16 m, and in the place of the lower road turn the depth is more than 22 m, respectively. In this area, two

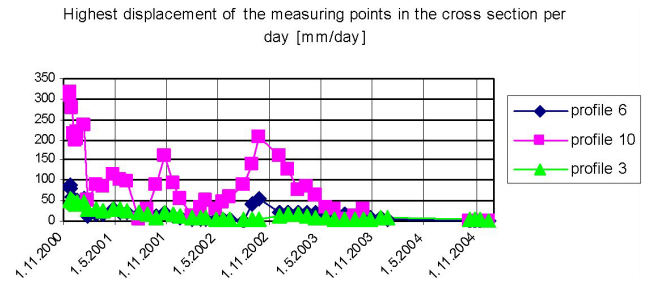
Fig. 4. Time distribution of the surface displacements of the Macesnik landslide in the period 2000–2004 in three cross sections (profile 6 – in the upper part of the landslide, profile 10 – in the area of the pontoon bridge, and profile 3 – in the area of the turn on the panoramic road).

were occasionally destroyed, and the number of measured cross sections changed in time. The time distribution of the surface displacements of the Macesnik landslide in the period 2000–2004 in selected cross sections (in the upper part of the landslide, in the area of the pontoon bridge, and in the area of the turn on the panoramic road) is given in Fig. 4. The mitigation works were made difficult in the past due to intensive landslide movements that reached up to 50 cm/day with an average value of 25 cm/day. This corresponds to the landslide moderate velocity class (4) after Cruden and Varnes (1992). An analysis of local precipitations, measured in the rainfall gauging station in the village of Solčava, showed a good correlation of the landslide displacement intensities and rainfall (Mikoš et al., 2005).

The landslide above the pontoon bridge was slowed down to such an extent (Fig. 4) that between the pontoon bridge and the lower end of the deep drainage system (Fig. 7) two 22 m deep reinforced concrete (RC) shafts were designed and installed in late 2004 and early 2005 (Fig. 16). Because each shaft should have a twofold function, i.e. a supportive function (dowel-like, Fig. 17) as well as a drainage function (like a deep water well), the following requirements had to be fulfilled during the design and execution:

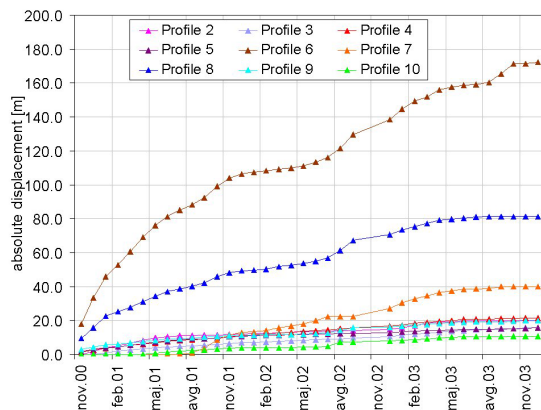
**Fig. 5.** Absolute displacements in measuring cross sections on the Macesnik landslide (see Fig. 3 for the position of cross sections).

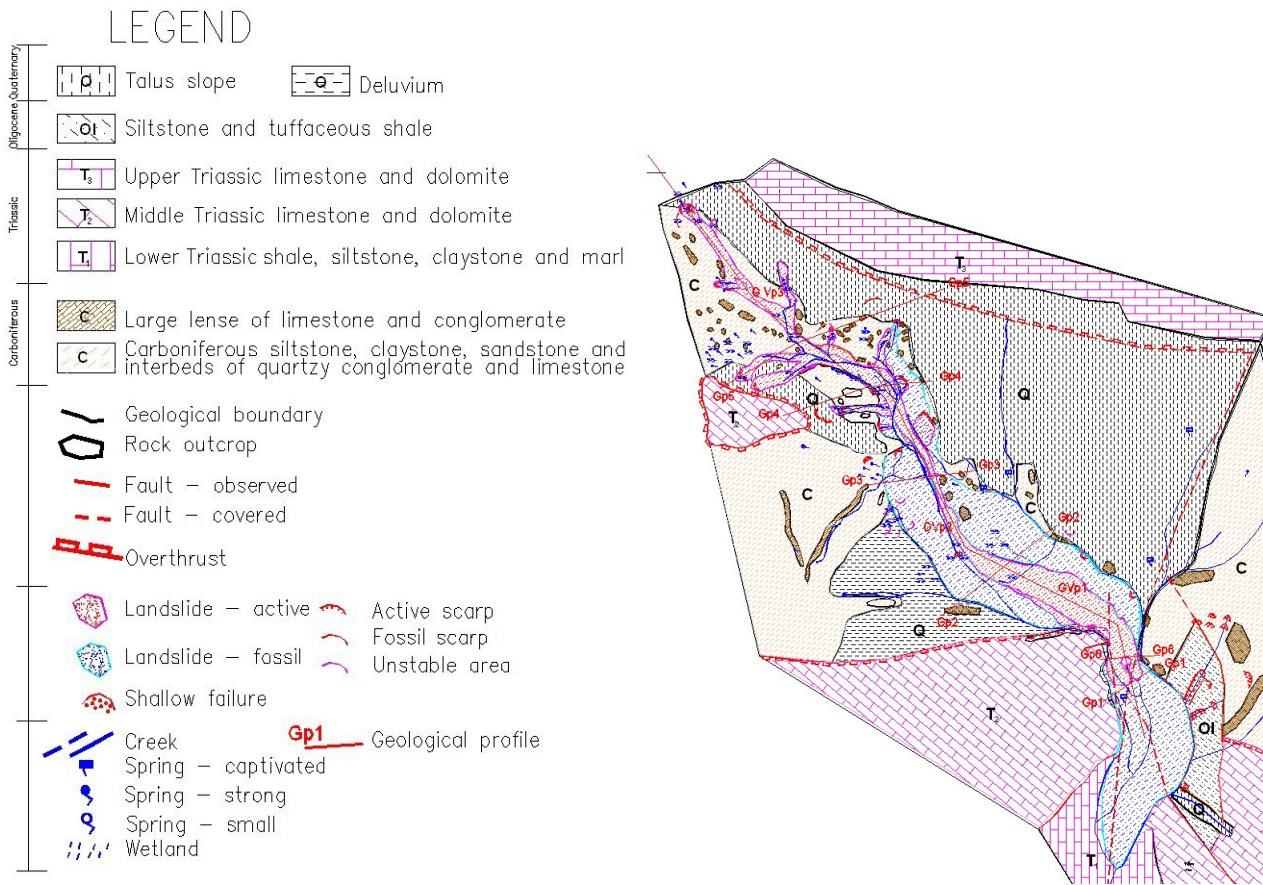
Fig. 6. Engineering geological map of the Macesnik landslide with a legend (modified from Vljaj and Žigman, 2001).

Data from the drilling cores show that the sliding mass was heterogeneous, mainly dark-grey stiff clay with layers of more permeable clayey gravels of different thicknesses at different depths. This interpretation was supported by the local engineering geologic map. In the investigated area, the following rock types were determined (Fig. 6):

1. Carboniferous siltstone, claystone, and sandstone with lenses and interbeds of quartzite conglomerate and limestone (“C”).
2. Lower Triassic shale, siltstone, claystone and mud (“T₁”); Middle Triassic (“T₂”) and Upper Triassic limestone and dolomite (“T₃”).
3. Oligocene siltstone and tuffaceous shale (“O1”).
4. Quaternary talus slope and deluvium (“Q”).

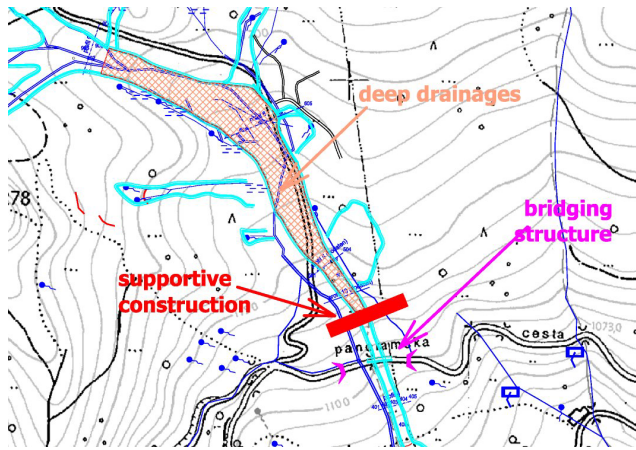
Fig. 7. Proposed remediation measures in the landslide area above and around the pontoon bridge.

1. Upper part of the landslide with the area above and around the pontoon bridge (Fig. 7);
 2. Middle part of the landslide around the road crossing with the panoramic road (Fig. 8);
 3. Lower part of the landslide around and above the rock outcrop that temporarily stopped further landslide advancement (Fig. 9).
- Support structures should be formed by grouping several deep shafts made of reinforced concrete with supportive (as dowels founded in the stable ground below the slide plane) and drainage functions (as deep water wells). The supportive function of such a structure is well known in road construction (i.e. as part of a bridge), where it has so far been used only on stable slopes, taking only axial loads and no bending moments of a sliding mass.

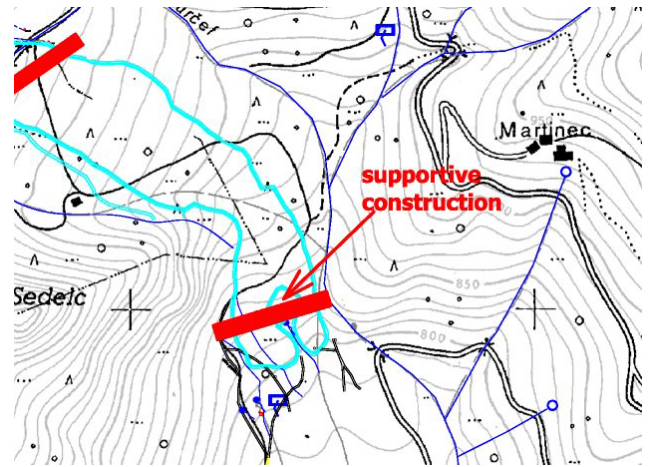
Fig. 9. The proposed location of a supportive construction around the rock outcrop at the toe of the Macesnik landslide.

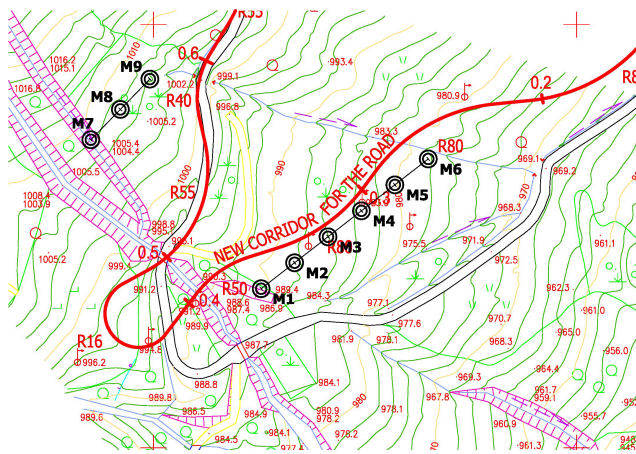
Fig. 8. Ground map of the middle part of the Macesnik landslide with a new corridor for the panoramic road and the proposed wells in two lines (M1–M6 & M7–M9).

lines of support structures made of reinforced concrete shafts are proposed. In order to stabilise the part of the landslide where the road crosses it twice, 3 RC shafts are planned in a line above the upper road turn (M7, M8, and M9) and 6 RC shafts are planned in a line below the lower road turn (M1 through M6). The new road corridor in this area (Figs. 21, 22) is a prerequisite for an optimal depth of the planned RC shafts. The technical characteristics of these RC shafts will be quite the same as for those executed earlier above the pontoon bridge.

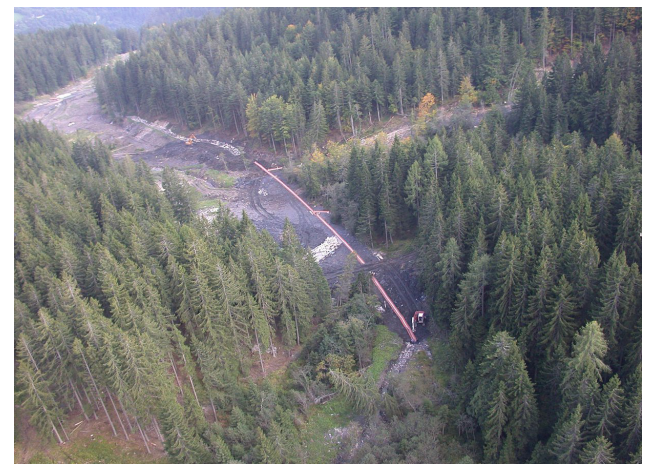
Fig. 10. Executed peripheral surface drainage at the western landslide edge above the prefabricated bridge.

In 2002, the execution of the proposed mitigation measures mentioned above started from the upper part of the landslide in the downslope direction. In the upper part of the landslide above the pontoon bridge surficial peripheral surface drainage works were constructed, when possible, on stable ground around the landslide body (Fig. 10). On stable grounds a riprap made of up to 4 m³/m’ of pitched stones

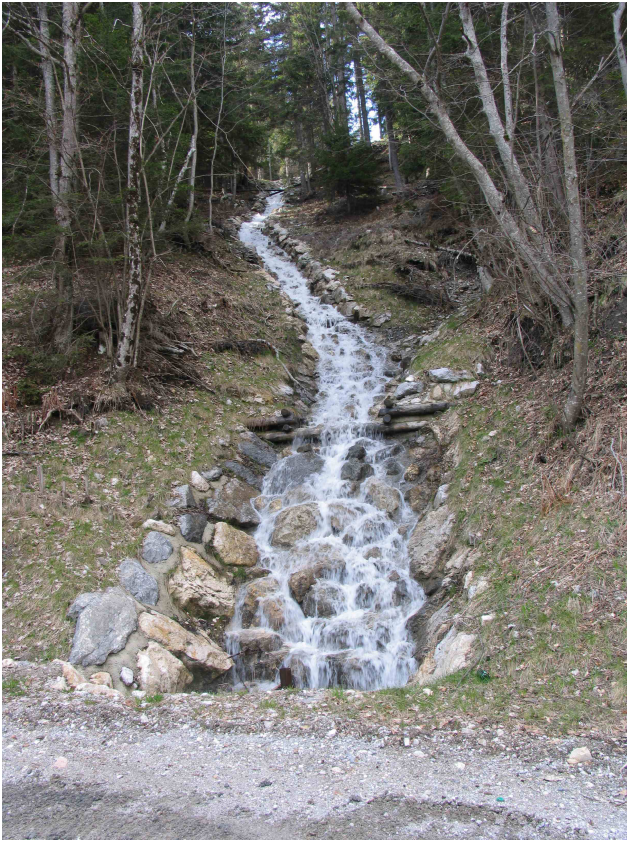
Fig. 11. Detail of the surface dewatering system on the stable grounds above the panoramic road – channel with a longitudinal slope of around 30%, protected with rip rap.

larger than 0.8 m was used to protect the drainage channel works, both on the channel bottom and on the channel banks, from high shear stresses of torrential flow at longitudinal slopes in excess of 60%. The conveyance of these channels was between 9 m³/s and 15 m³/s and was designed to be higher than the 100-year discharge (up to 6 m³/s). Mainly the constant slope of the channel parallel to the ground was chosen, and only locally low sills were built for additional energy dissipation (Fig. 11). Due to the natural turbidity of water conveying fine silt fractions no impermeability of the drainage channels was sought for. On unstable grounds, half concrete sewer pipes and PEHD pipes were installed as a combination of drainage collection works and drainage channel works. They were sufficiently flexible to make the occasional but necessary maintenance easier. During the final phase of the mitigation these half pipes will be removed and replaced by ordinary riprap protecting the drainage channels. The collected surficial drainage water was conveyed to the natural channels of the Jurčef Torrent and its branches in its headwaters.

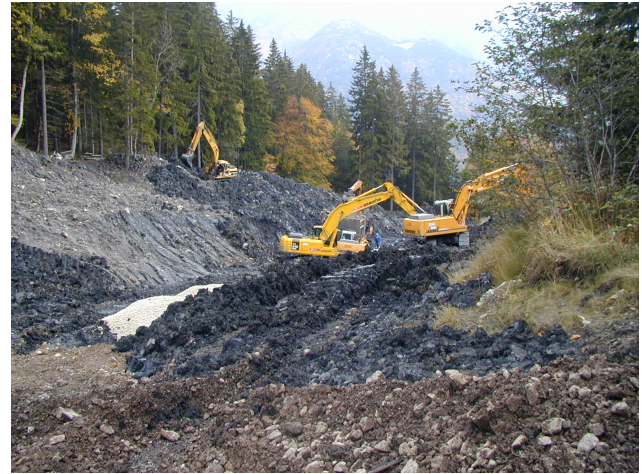
Fig. 12. Execution of deep drain trenches.

In summer 2003, above the pontoon bridge, subsurface drainage works in the form of 3 parallel deep drainage trenches filled with gravels (Figs. 12 and 13) were constructed to collect ground water and decrease the ground water table. The main aim was to slow down the landslide displacements in the area and to make possible the execution of planned restraint constructions above the pontoon bridge. In spring 2004, in the upper part of the landslide two additional deep drainage trenches were constructed (Fig. 14).

The deep drainage trenches were excavated to a depth of ~8 m, that is, to the impermeable rock layer. First, longitudinal trenches 3 m deep and 5 m wide at the bottom were dug with the slope of 1:1. Part of the removed material was transported to a dumping site, and part of it was stored close to the construction site and later used for the levelling of the landslide surface (Fig. 15). The digging of the trenches to the final depth of 8 m was executed in 6 m long sections. The vertical excavation was protected using 1-m wide hydraulic panning. The drainage was executed using PEHD pipes

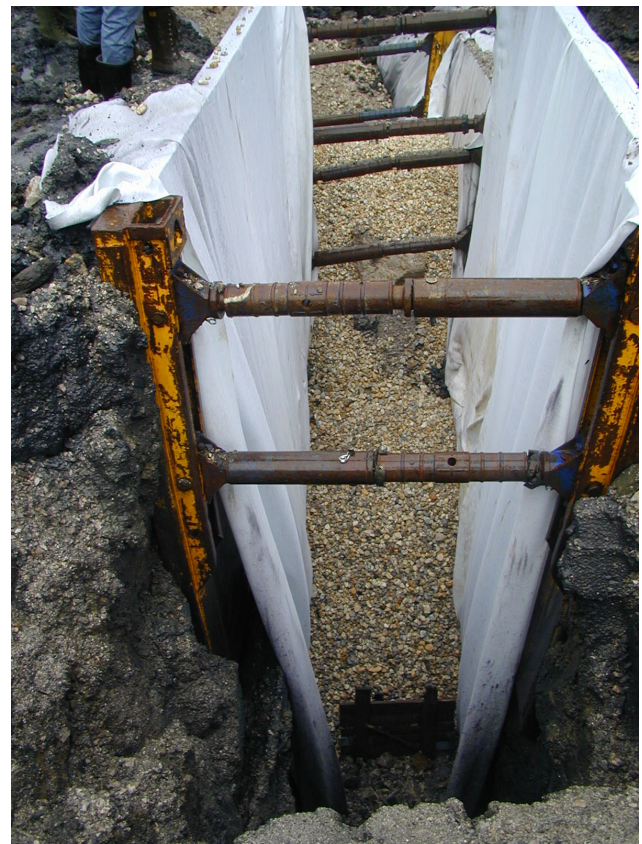
Fig. 13. Detail of deep drain trenches.

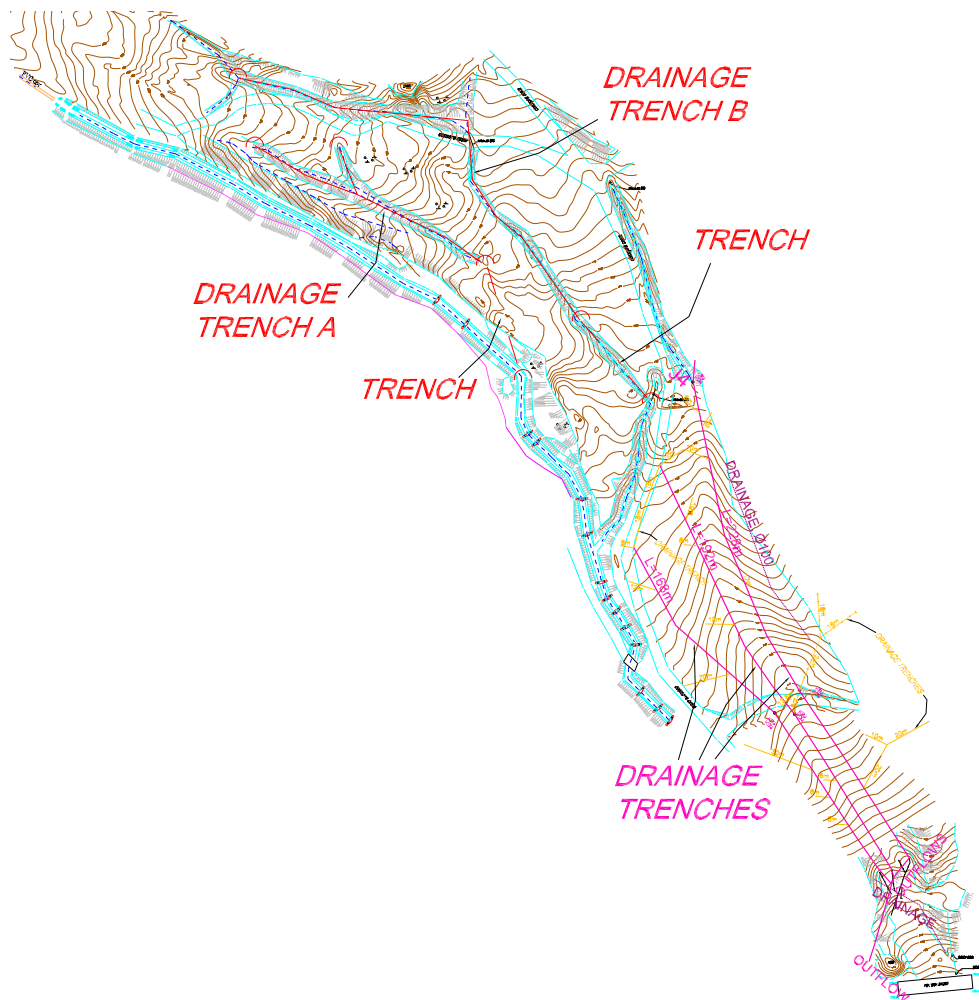
Fig. 14. Deep drainages built in 2003 and 2004 to slow down the landslide displacements and to make possible installation of a supportive construction (isolines are given for 1 m).

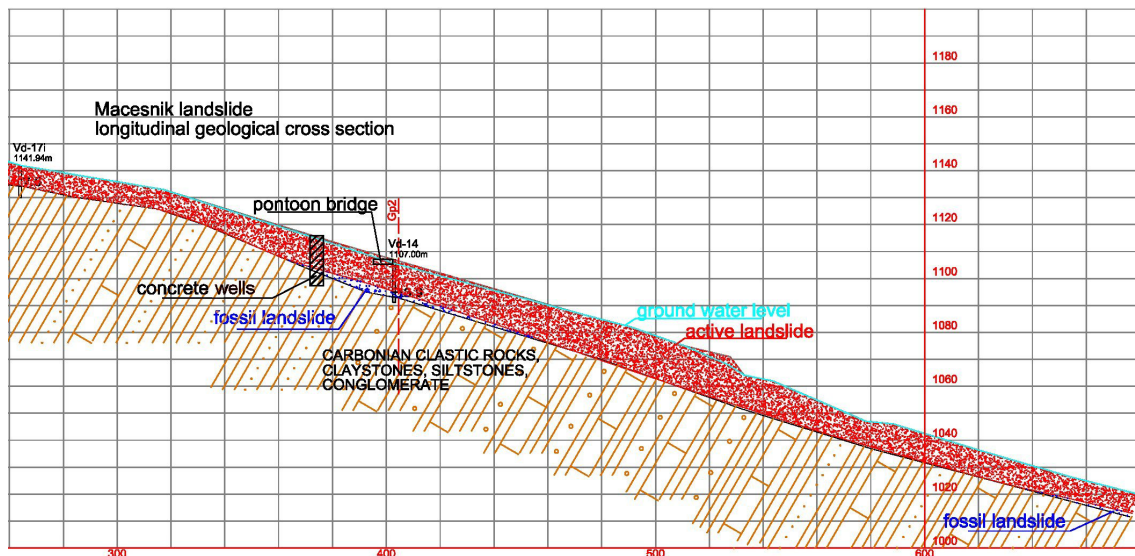
Fig. 17. The Macesnik landslide geological longitudinal profile “Gvp2” (see Fig. 6 for location) in the area of the pontoon bridge.

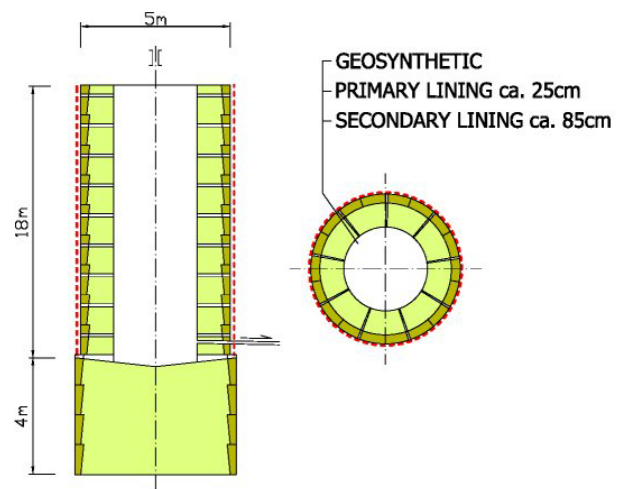
Fig. 18. Vertical cross section of the RC well.

- The depth into the solid rock below the sliding surface should be at least 20% of the total shaft's depth (Fig. 18).
- The primary coating (during digging) should take all loads of the landslide ($F \cong 1.10$).

a diameter of 5 m, concrete walls of the thickness of 25 cm (primary lining) respectively 80 cm (secondary lining), and the length of 22 m (18 m of the landslide mass and 4 m of rock base) the following maximum loads were determined:

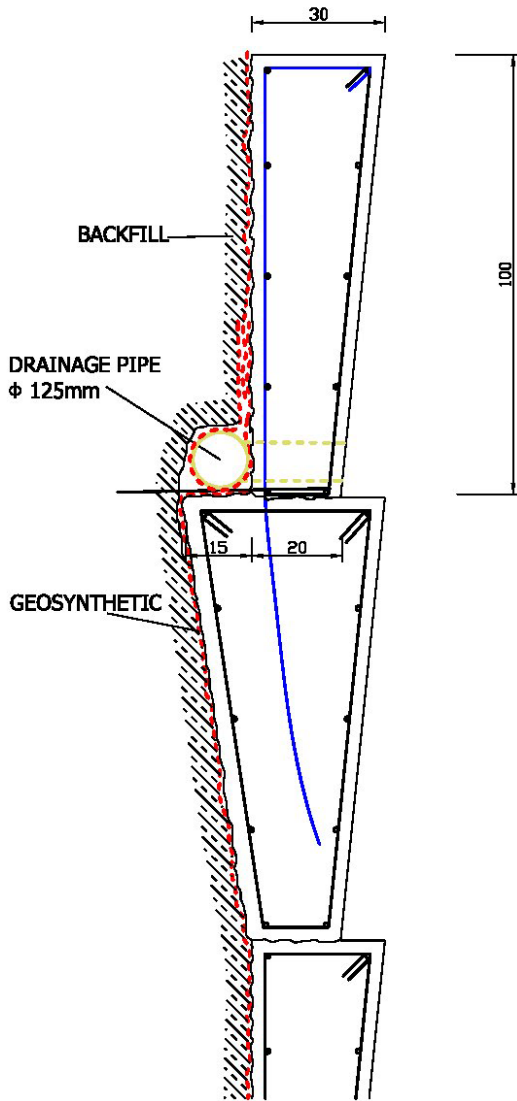
Fig. 19. Detail of the RC well.

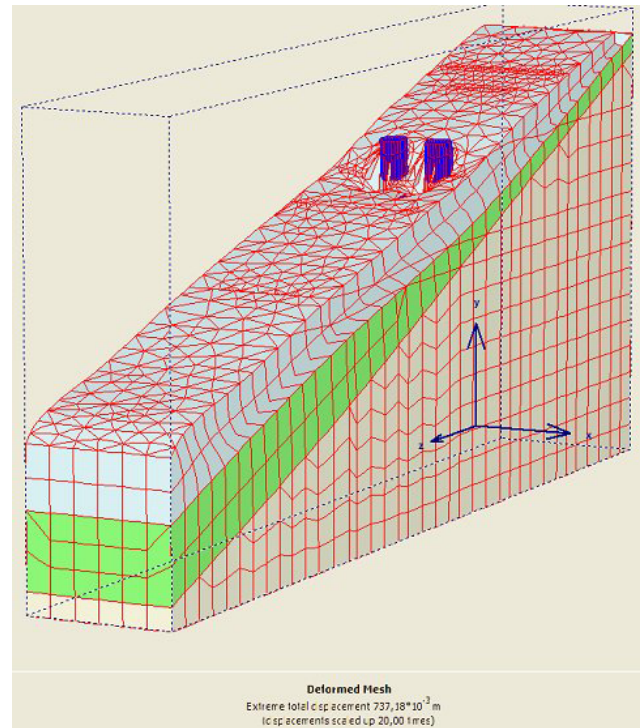
Fig. 20. Computational mesh and deformation of the RC well.

On the basis of the performed stability analyses (Plaxis[®] 3-D; computational mesh on Fig. 20), for each RC shaft with

- axial forces 4350 kN
- bending moments 37 650 kNm
- shear forces 9160 kN
- maximum contact (compressive) stresses 1540 kN/m^2 .

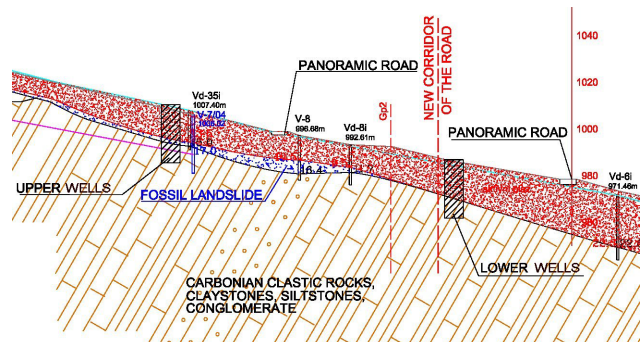
Fig. 21. The central longitudinal section of the Macesnik landslide with the new corridor for the panoramic road and the proposed wells.

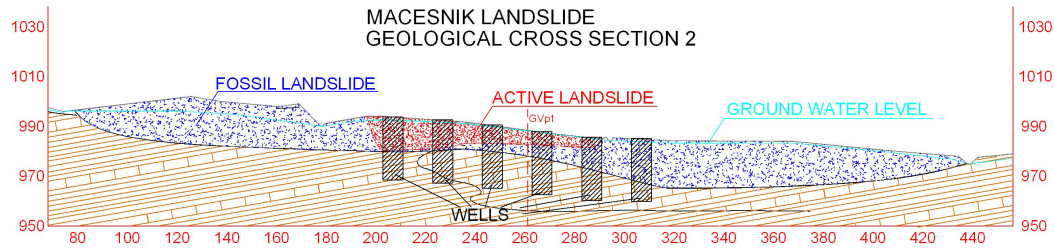
Fig. 22. Cross section of the Macesnik landslide just above the proposed lower line of wells M1–M6.
