Stepwise mitigation of the Macesnik landslide, N Slovenia

M. Mikoš¹, R. Fazarinc², B. Pulko¹, A. Petkovšek¹, and B. Majes¹

Abstract. The paper gives an overview of the history of evolution and mitigation of the Macesnik landslide in N Slovenia. It was triggered in 1989 above the Solčava village, but it enlarged with time. In 2005, the landslide has been threatening a few residential and farm houses, as well as the panoramic road, and it is only 1000 m away from the Savinja River and the village of Solčava. It is 2500 m long and up to more than 100 m wide with an estimated volume in excess of 2 million m³. Its depth is not constant: on average it is 10 to 15 m deep, but in the area of the toe, which is retained by a rock outcrop, it reaches the depth of 30 m. The unstable mass consists of water-saturated highly-weathered carboniferous formations. The presently active landslide lies within the fossil landslide which is up to 350 m wide and 50 m deep with the total volume estimated at 8 to 10 million m³. Since 2000, the landslide has been investigated by 36 boreholes, and 28 of them were equipped with inclinometer casings, which also serve as piezometers. Surface movements have been

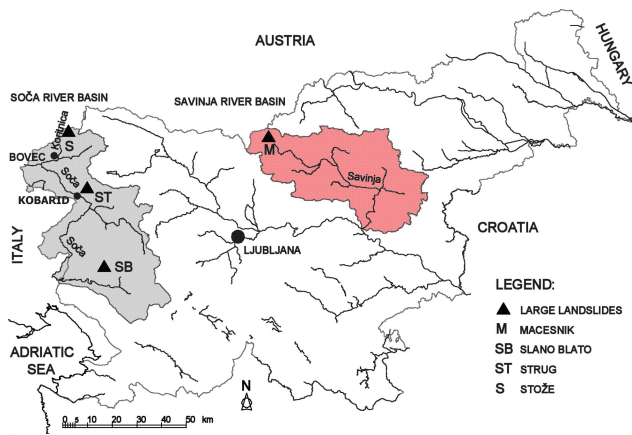
Fig. 1. The position of the Macesnik landslide in the Savinja River basin.

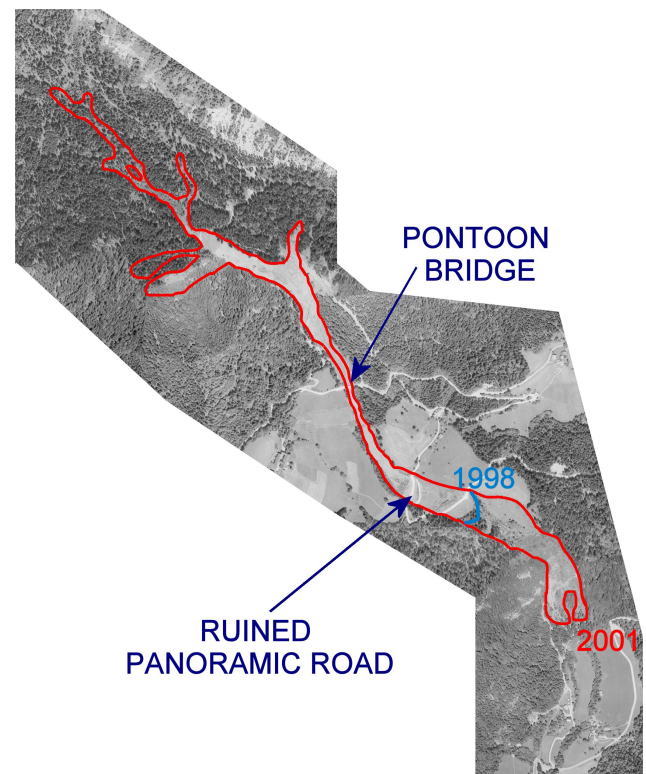
Fig. 2. Aerial view of the contours of the Macesnik landslide in 1998 and 2001.

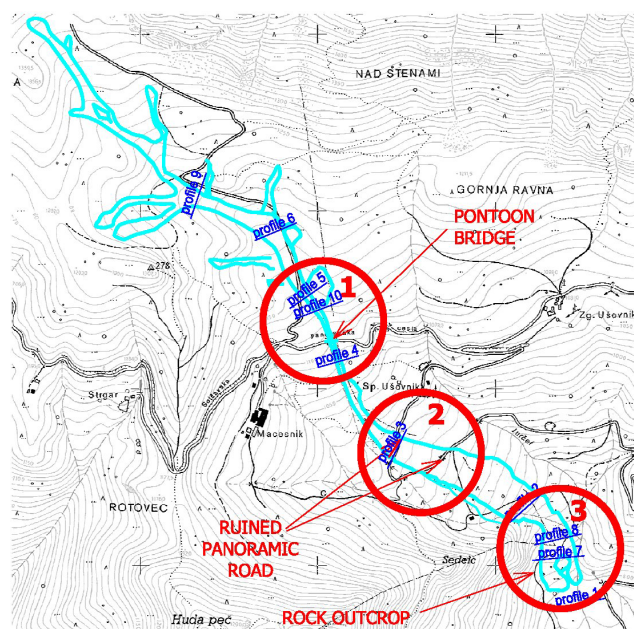
Fig. 3. Topographic map of the Macesnik landslide with the contours of the landslide and cross sections (“profiles”) for regular measurements of the surface displacements.

- Lowering of ground water pressures by deep drainage trenches filled with gravels is technologically possible (up to the depth of 8 m) only in the upper part of the landslide above the pontoon bridge.
- The sequence of restraint structures on such a long landslide should be planned in such a way that there would be no overtopping by sliding mass from above or subsidence and sliding of mass away from the structures.
- On the basis of all the executed field and study investigations, field measurements, and field experiences, the planned mitigation of the Macesnik landslide will follow the division of the landslide by restraint and drainage works into 3 areas (Fig. 3):

The Macesnik landslide is deep in its middle part (area 2 on Fig. 3), where it is twice crossed by the Panoramic road. In the place of the present upper road turn the landslide depth is more than 16 m, and in the place of the lower road turn the depth is more than 22 m, respectively. In this area, two

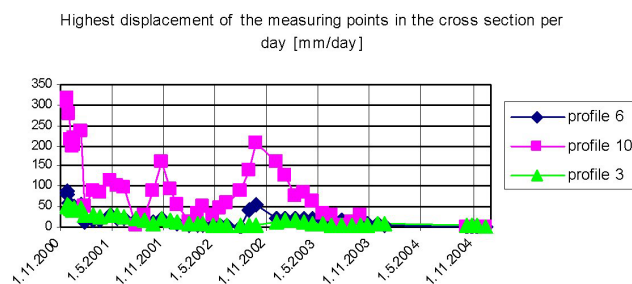
Fig. 4. Time distribution of the surface displacements of the Macesnik landslide in the period 2000–2004 in three cross sections (profile 6 – in the upper part of the landslide, profile 10 – in the area of the pontoon bridge, and profile 3 – in the area of the turn on the panoramic road).

were occasionally destroyed, and the number of measured cross sections changed in time. The time distribution of the surface displacements of the Macesnik landslide in the period 2000–2004 in selected cross sections (in the upper part of the landslide, in the area of the pontoon bridge, and in the area of the turn on the panoramic road) is given in Fig. 4. The mitigation works were made difficult in the past due to intensive landslide movements that reached up to 50 cm/day with an average value of 25 cm/day. This corresponds to the landslide moderate velocity class (4) after Cruden and Varnes (1992). An analysis of local precipitations, measured in the rainfall gauging station in the village of Solčava, showed a good correlation of the landslide displacement intensities and rainfall (Mikoš et al., 2005).

The landslide above the pontoon bridge was slowed down to such an extent (Fig. 4) that between the pontoon bridge and the lower end of the deep drainage system (Fig. 7) two 22 m deep reinforced concrete (RC) shafts were designed and installed in late 2004 and early 2005 (Fig. 16). Because each shaft should have a twofold function, i.e. a supportive function (dowel-like, Fig. 17) as well as a drainage function (like a deep water well), the following requirements had to be fulfilled during the design and execution:

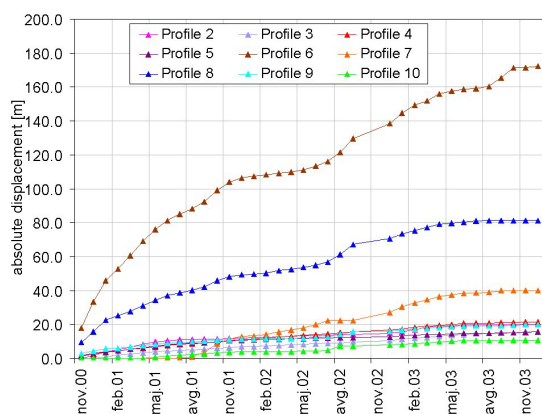
**Fig. 5.** Absolute displacements in measuring cross sections on the Macesnik landslide (see Fig. 3 for the position of cross sections).

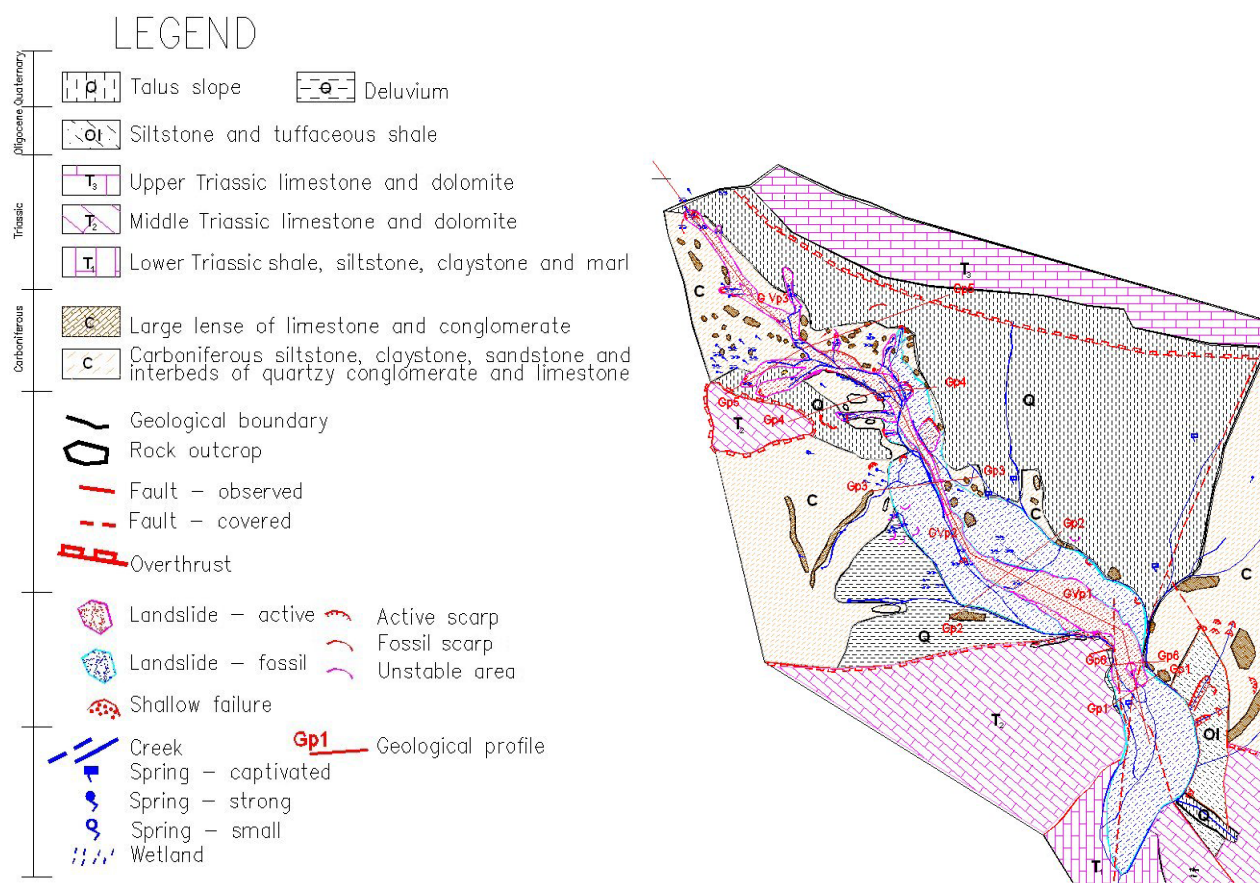
Fig. 6. Engineering geological map of the Macesnik landslide with a legend (modified from Vlaj and Žigman, 2001).

Data from the drilling cores show that the sliding mass was heterogeneous, mainly dark-grey stiff clay with layers of more permeable clayey gravels of different thicknesses at different depths. This interpretation was supported by the local engineering geologic map. In the investigated area, the following rock types were determined (Fig. 6):

1. Carboniferous siltstone, claystone, and sandstone with lenses and interbeds of quartzite conglomerate and limestone (“C”).
2. Lower Triassic shale, siltstone, claystone and mud (“T₁”); Middle Triassic (“T₂”) and Upper Triassic limestone and dolomite (“T₃”).
3. Oligocene siltstone and tuffaceous shale (“O1”).
4. Quaternary talus slope and deluvium (“Q”).

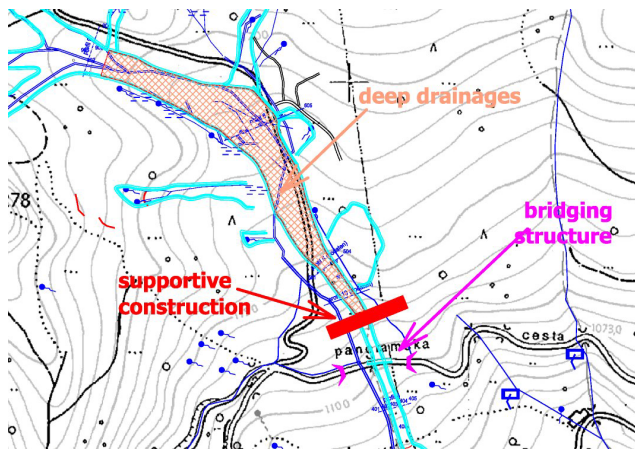
Fig. 7. Proposed remediation measures in the landslide area above and around the pontoon bridge.

1. Upper part of the landslide with the area above and around the pontoon bridge (Fig. 7);
2. Middle part of the landslide around the road crossing with the panoramic road (Fig. 8);
3. Lower part of the landslide around and above the rock outcrop that temporarily stopped further landslide advancement (Fig. 9).

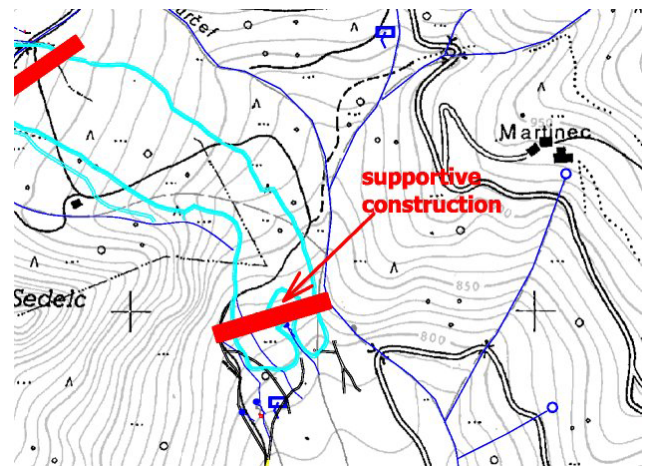
Fig. 9. The proposed location of a supportive construction around the rock outcrop at the toe of the Macesnik landslide.

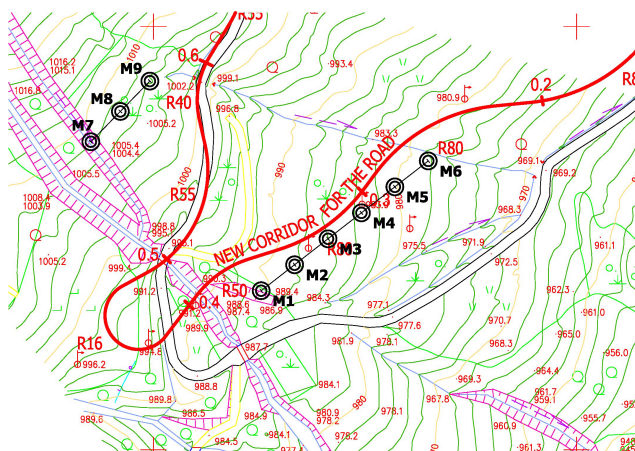
Fig. 8. Ground map of the middle part of the Macesnik landslide with a new corridor for the panoramic road and the proposed wells in two lines (M1–M6 & M7–M9).

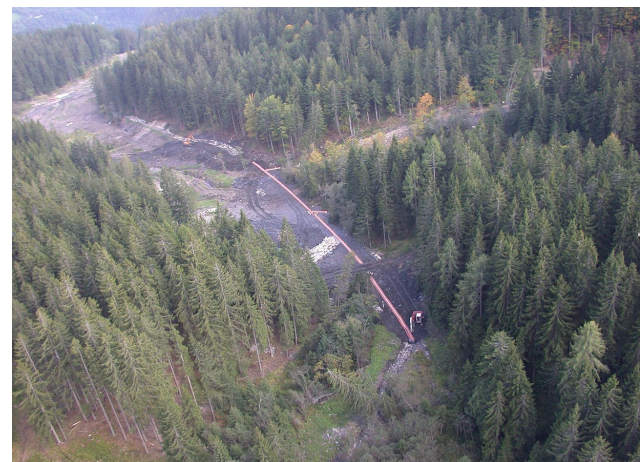
Fig. 10. Executed peripheral surface drainage at the western landslide edge above the prefabricated bridge.

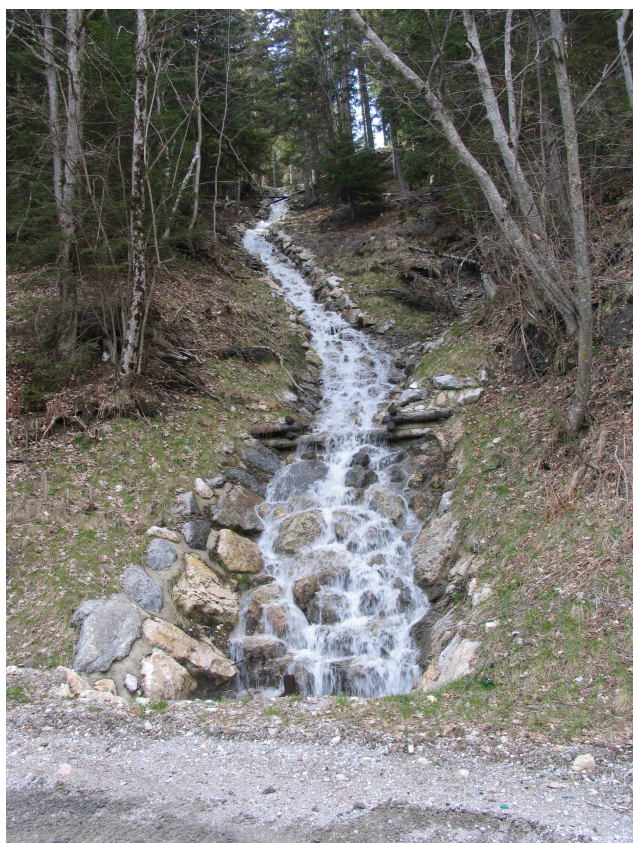
Fig. 11. Detail of the surface dewatering system on the stable grounds above the panoramic road – channel with a longitudinal slope of around 30%, protected with rip rap.

larger than 0.8 m was used to protect the drainage channel works, both on the channel bottom and on the channel banks, from high shear stresses of torrential flow at longitudinal slopes in excess of 60%. The conveyance of these channels was between $9 \text{ m}^3/\text{s}$ and $15 \text{ m}^3/\text{s}$ and was designed to be higher than the 100-year discharge (up to $6 \text{ m}^3/\text{s}$). Mainly the constant slope of the channel parallel to the ground was chosen, and only locally low sills were built for additional energy dissipation (Fig. 11). Due to the natural turbidity of water conveying fine silt fractions no impermeability of the drainage channels was sought for. On unstable grounds, half concrete sewer pipes and PEHD pipes were installed as a combination of drainage collection works and drainage channel works. They were sufficiently flexible to make the occasional but necessary maintenance easier. During the final phase of the mitigation these half pipes will be removed and replaced by ordinary riprap protecting the drainage channels. The collected surficial drainage water was conveyed to the natural channels of the Jurčef Torrent and its branches in its headwaters.

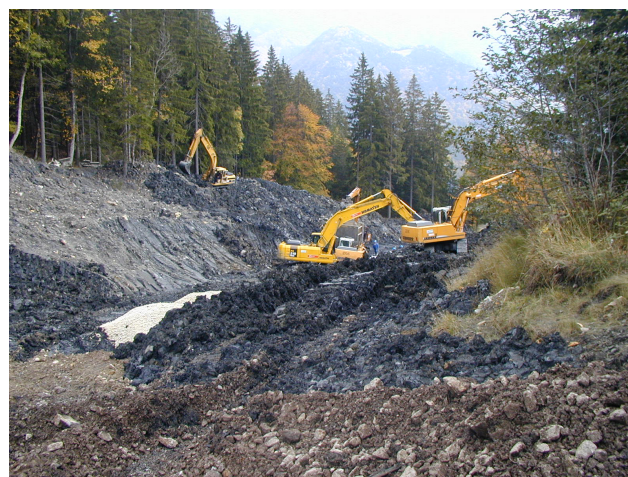
Fig. 12. Execution of deep drain trenches.

In summer 2003, above the pontoon bridge, subsurface drainage works in the form of 3 parallel deep drainage trenches filled with gravels (Figs. 12 and 13) were constructed to collect ground water and decrease the ground water table. The main aim was to slow down the landslide displacements in the area and to make possible the execution of planned restraint constructions above the pontoon bridge. In spring 2004, in the upper part of the landslide two additional deep drainage trenches were constructed (Fig. 14).

The deep drainage trenches were excavated to a depth of $\sim 8 \text{ m}$, that is, to the impermeable rock layer. First, longitudinal trenches 3 m deep and 5 m wide at the bottom were dug with the slope of 1:1. Part of the removed material was transported to a dumping site, and part of it was stored close to the construction site and later used for the levelling of the landslide surface (Fig. 15). The digging of the trenches to the final depth of 8 m was executed in 6 m long sections. The vertical excavation was protected using 1-m wide hydraulic panning. The drainage was executed using PEHD pipes

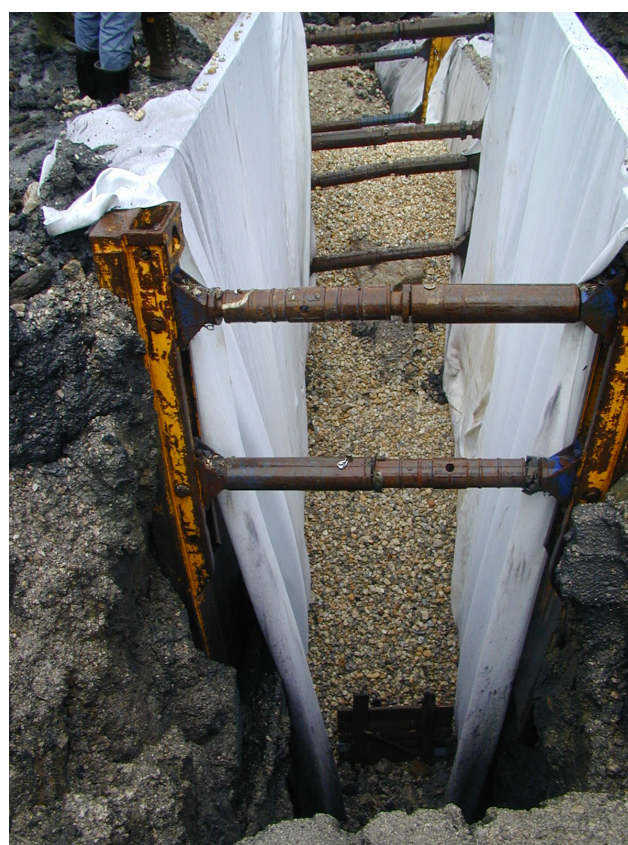
Fig. 13. Detail of deep drain trenches.

DN 400, filled with a gravel filter of 32–64 mm. The filter material together with the pipe was wrapped into a filter geotextile with a minimum tensile strength of 20 kN/m and with pores <0.15 mm. Near to the local springs, additional transversal drainage ribs were introduced. The measured average amount of drained water from the completed drainage trenches was between 1.5 and 3 l/min or between 2.16 and 4.32 m³/day.

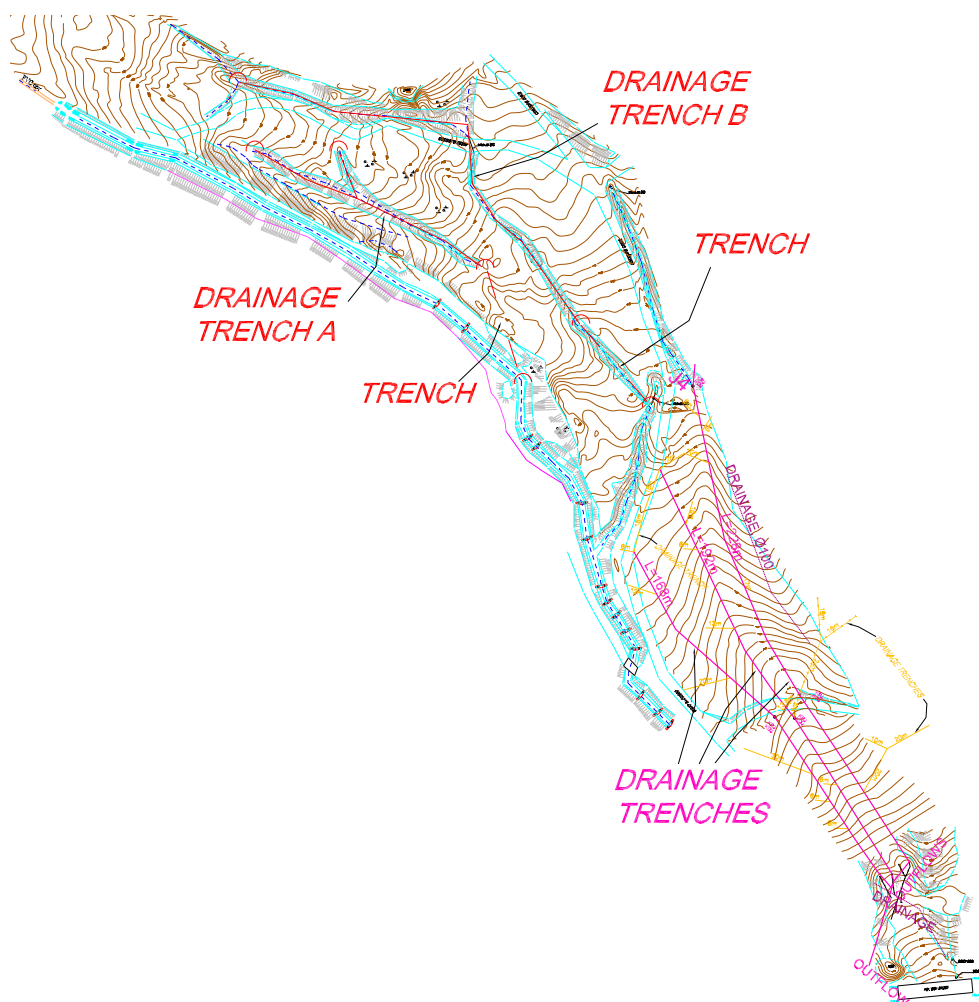
Fig. 14. Deep drainages built in 2003 and 2004 to slow down the landslide displacements and to make possible installation of a supportive construction (isolines are given for 1 m).

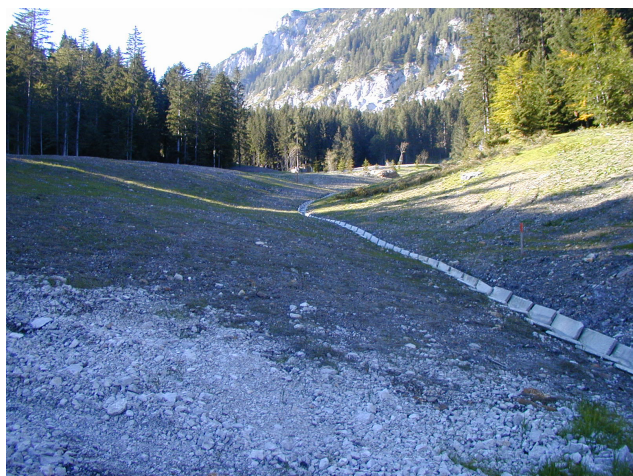
Fig. 15. Stabilised part of the Macesnik landslide above the pontoon bridge by introducing several deep drainages and peripheral and central surface drainage.

The executed remediation (stabilisation) measures in the upper part of the Macesnik landslide (above the pontoon bridge) made it possible for the landslide displacements in this part to be slowed down to less than 1 cm/day. This corresponded to the landslide slow velocity class (3) after Cruden and Varnes (1992). Furthermore, also displacements in the lower two parts of the landslide effectively slowed down, but stayed in the moderate velocity class.

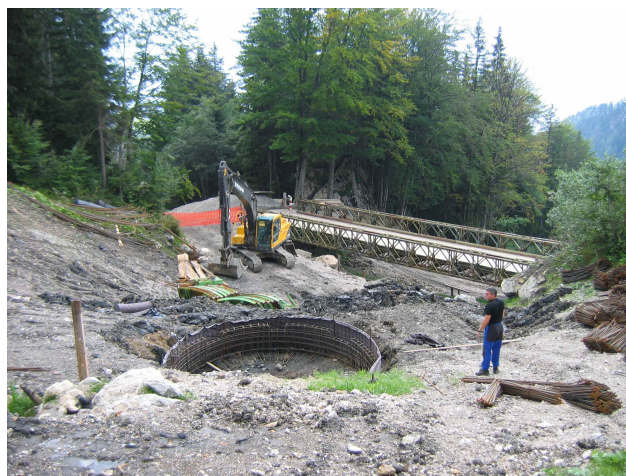
Fig. 16. Execution of a RC well just above the pontoon bridge.

The RC shafts were executed in two phases. First, from the ground surface to a depth of 22 m in steps of 1 m, the primary coating was done. This was separated from the landslide mass by a drainage composite (Enkadrain). The outflow of the drained water from the drainage composite into the shaft was enabled through openings in the primary coating and at every 5 m of the depth to a separate circumferential drainage (Fig. 19). For the drainage PEHD pipes DN 125 were used and reinforced by steel rings. The height of a single ring of the primary coating was 1 m, the thickness of the ring was 30 cm at its top and 20 cm at its bottom, respectively. The dimensions of the rings of the primary coating, the concrete quality and the reinforcement were computed in such a way that the primary coating would take over all the loads from the landslide mass at the computed safety factor $F=1.05$. In the second phase, the 4 m thick concrete foundation plate and the 80 cm thick concrete secondary coating of the shaft were completed.

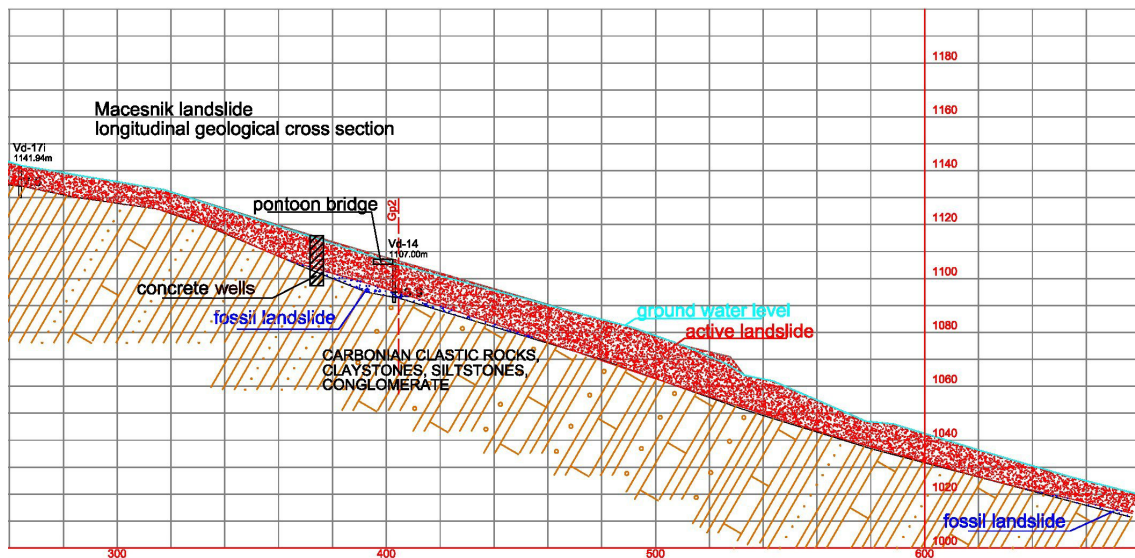
Fig. 17. The Macesnik landslide geological longitudinal profile “Gvp2” (see Fig. 6 for location) in the area of the pontoon bridge.

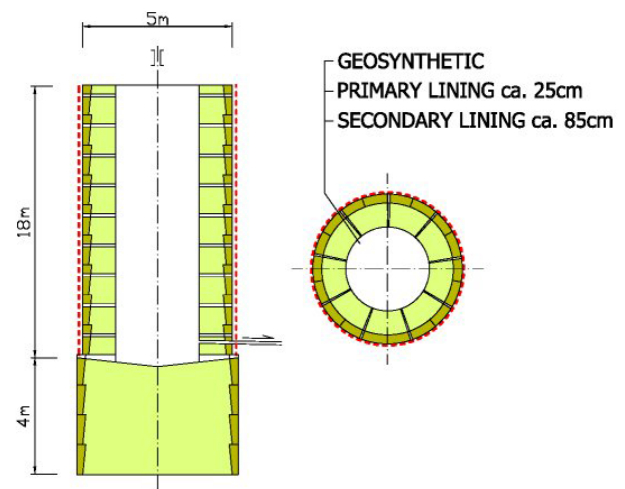
Fig. 18. Vertical cross section of the RC well.

- The depth into the solid rock below the sliding surface should be at least 20% of the total shaft's depth (Fig. 18).
- The primary coating (during digging) should take all loads of the landslide ($F \cong 1.10$).

- After digging out the shaft and completing its primary coating with a thickness between 30 and 50 cm to the prescribed depth, the installation of a reinforced concrete foundation plate would follow.
- The prescribed safety factor for the shaft ($F > 1.25$) will be reached only after the execution of the reinforced concrete secondary coating with the thickness of 80 cm.
- From the central part of the shaft an outlet pipe (horizontal drainage) should be installed in order to make possible the gravitational outflow of infiltrated water from the well.

a diameter of 5 m, concrete walls of the thickness of 25 cm (primary lining) respectively 80 cm (secondary lining), and the length of 22 m (18 m of the landslide mass and 4 m of rock base) the following maximum loads were determined:

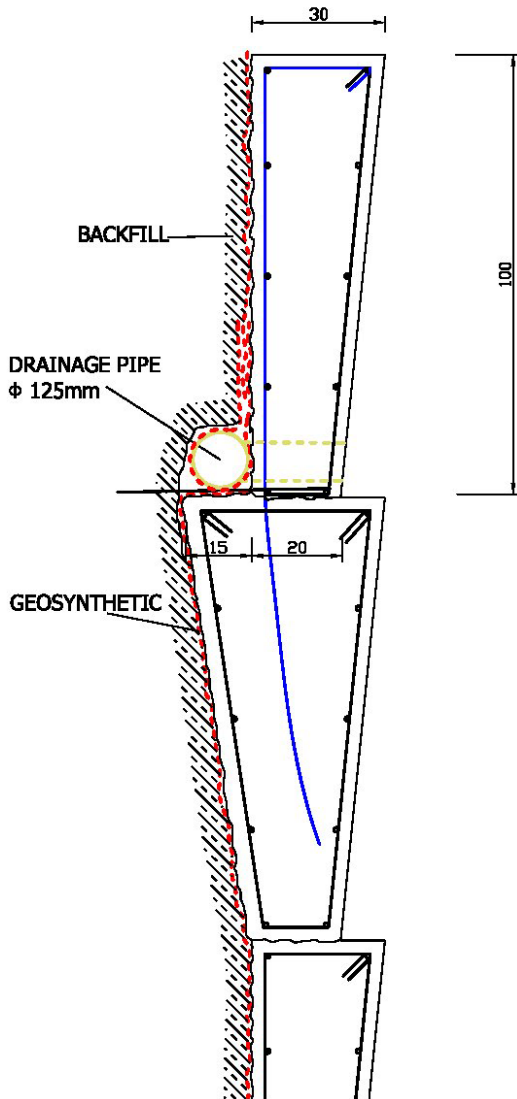
Fig. 19. Detail of the RC well.

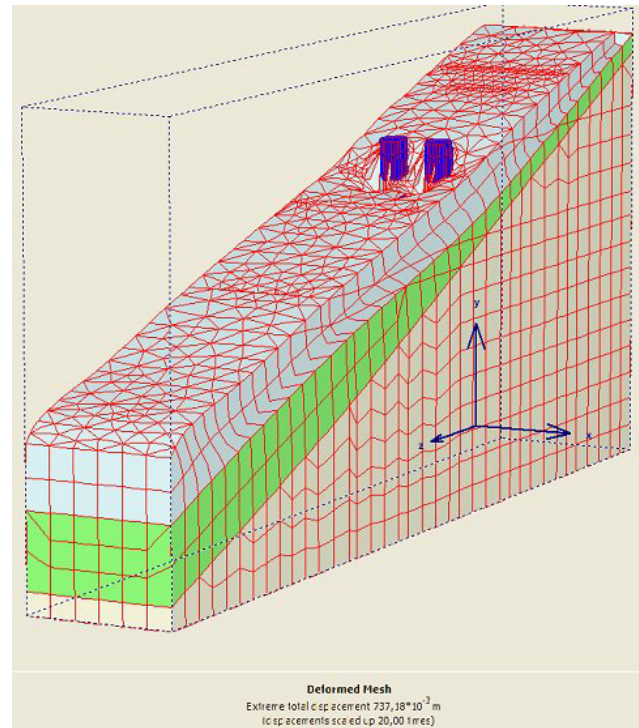
Fig. 20. Computational mesh and deformation of the RC well.

On the basis of the performed stability analyses (Plaxis[®] 3-D; computational mesh on Fig. 20), for each RC shaft with

- axial forces 4350 kN
- bending moments 37 650 kNm
- shear forces 9160 kN
- maximum contact (compressive) stresses 1540 kN/m².

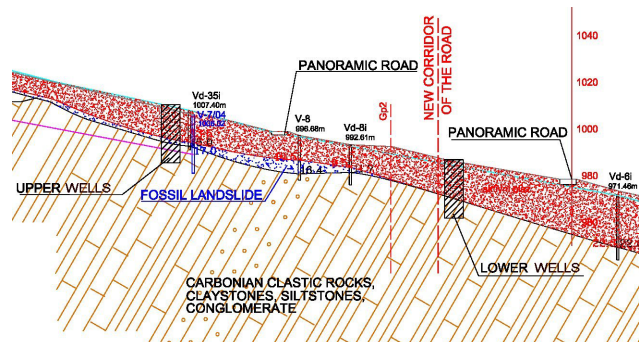
Fig. 21. The central longitudinal section of the Macesnik landslide with the new corridor for the panoramic road and the proposed wells.

lines of support structures made of reinforced concrete shafts are proposed. In order to stabilise the part of the landslide where the road crosses it twice, 3 RC shafts are planned in a line above the upper road turn (M7, M8, and M9) and 6 RC shafts are planned in a line below the lower road turn (M1 through M6). The new road corridor in this area (Figs. 21, 22) is a prerequisite for an optimal depth of the planned RC shafts. The technical characteristics of these RC shafts will be quite the same as for those executed earlier above the pontoon bridge.

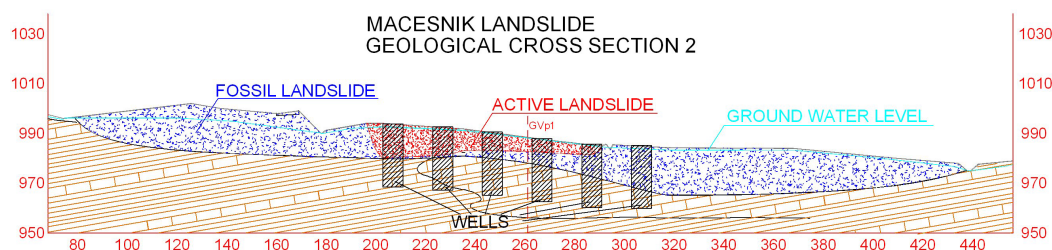
Fig. 22. Cross section of the Macesnik landslide just above the proposed lower line of wells M1–M6.
