Using geophysics on a terminal moraine damming a glacial lake: the Flatbre debris flow case, Western Norway

I. Lecomte^{1,2}, I. Thollet^{3,*}, H. Juliussen^{4,**}, and S.-E. Hamran⁴

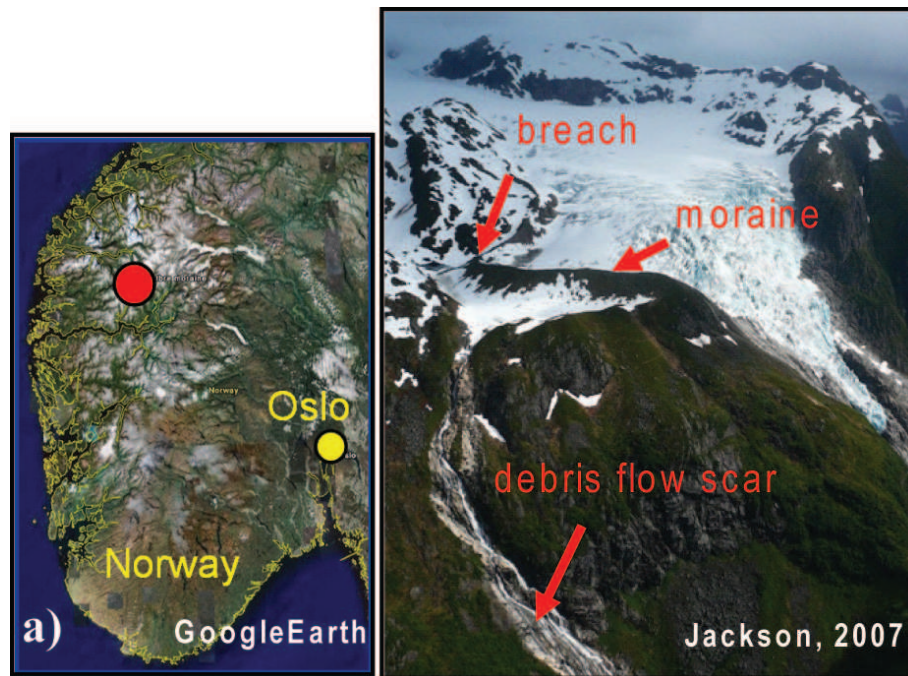
Fig. 1. (a) Location of the site in Western Norway. (b) Overview of the site.

The site is located in Western Norway, in the Fjaerland region (Fig. 1a, red dot). The terminal moraine of Flatbre at about 1000 m a.s.l. (Fig. 1b) was probably formed in the Little Ice Age and was damming a small lake due to the last hundred years of glacier retreat (Jackson, personal communication). The moraine is about 650 m long, with heights between 25 and 50 m, and a slope from about 30° downstream to more than 35° upstream. The material of the moraine is from the Late Holocene and has minimal clay content, hence is easily eroded. The scar of the debris flow is still visible on a picture taken 3 years later (Fig. 1b). Figure 2 shows the moraine right after the 2004 GLOF with a clear breach through which water from both the lake and from below the glacier escaped. Note also an old moraine in the background, and a small new moraine against the principal one. The new moraine is ice-cored, as easily observable in the field, with ice just beneath the moraine surface.

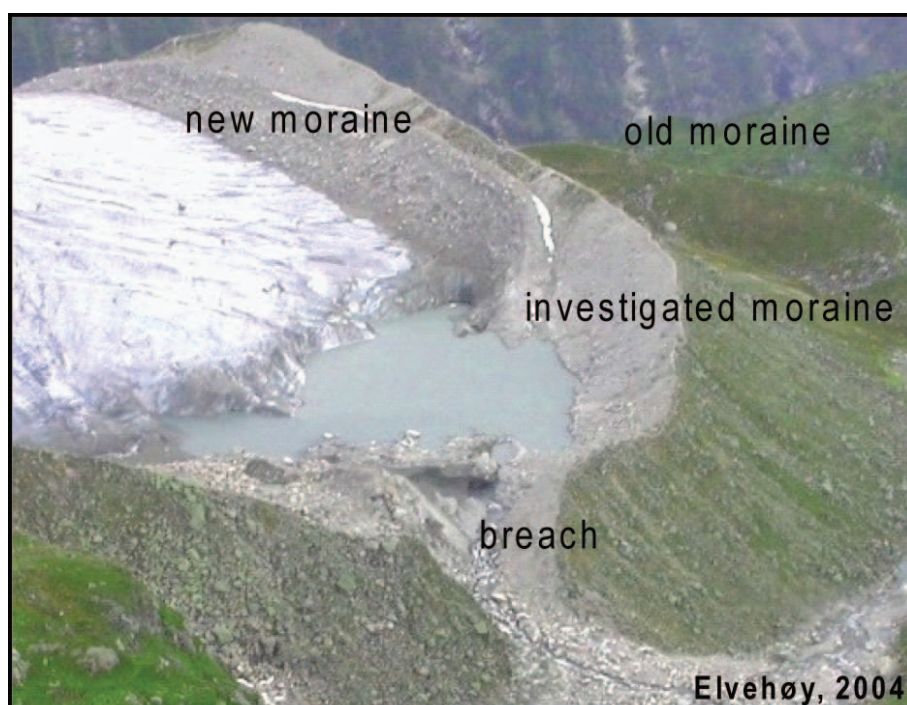
Fig. 2. Aerial photography of the moraine site after the 2004 GLOF.

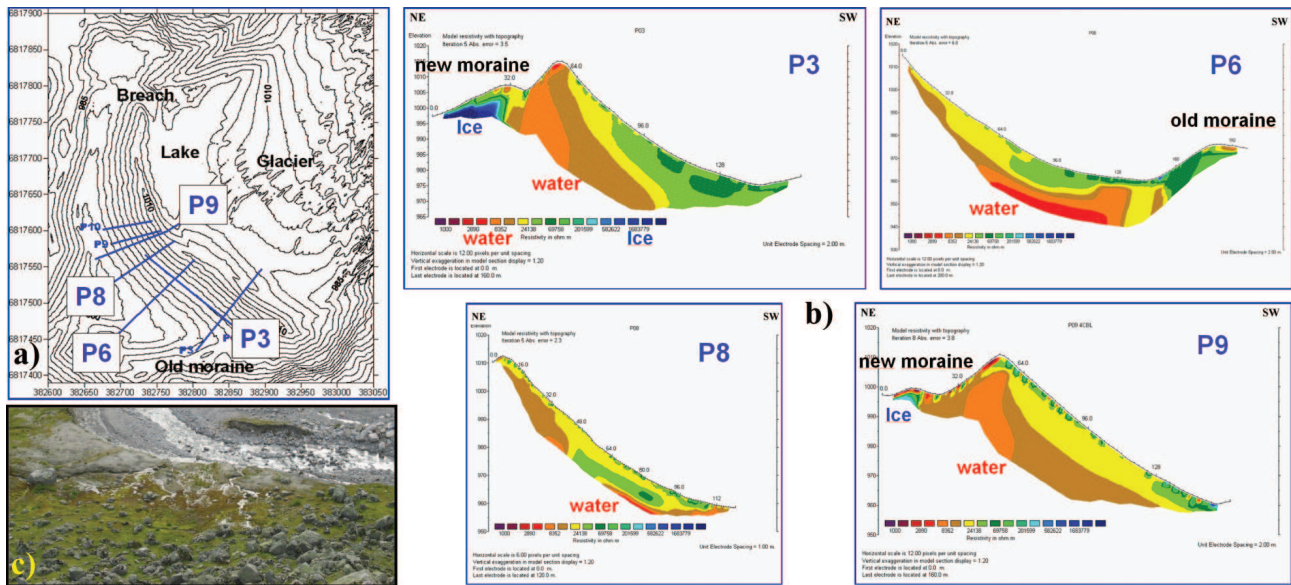
Fig. 4. Electrical resistivity data. **(a)** Location of the profiles. **(b)** Examples of electric tomography profiles, with P3 and P9 showing both very low resistivity down in the main moraine (high water saturation) and very high resistivity (ice in the new moraine). The old moraine shows intermediate values.

the installation, only 7 profiles were acquired during the 3 days on site (Fig. 4a).

Figure 4b shows four of the profiles. On both profiles P3 and P9, the acquisition line went through the new moraine, which explains the very high observed resistivity values (above 200 000 Ohm m, blue colors), characteristic of ice. As one of the questions to be answered by using geophysics was the presence of ice in the moraine, the resistivity profiles gave us a quick answer, i.e., no ice core observed in the penetrated area, observation later confirmed by both GPR and seismic refraction. On the contrary, the inner part of the main moraine is characterized by rather low resistivity values (the opposite side of the scale, red-brownish colors) indicating a progressive water saturation of the moraine material with depth. Profiles P6 to P8 show the lowest resistivity value, and this corresponds to a zone of the moraine where water seepage is observed at its foot (Fig. 4c). Note that this zone is away from the breach and may indicate a preferential path of water flow through the moraine.

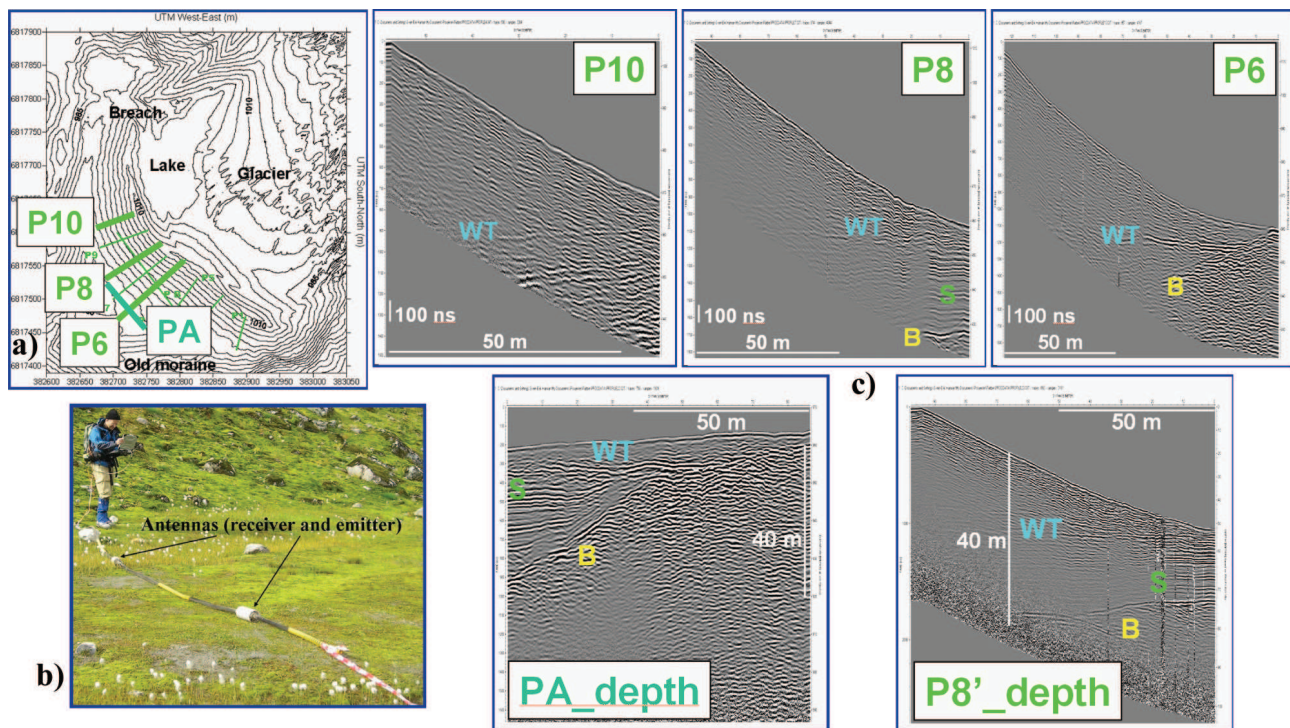
Fig. 5. GPR. (a) Location of the profiles. (b) 50 MHz acquisition system with both emitting and receiving antennas on the same rod and pulled by an operator (c) Examples of processed profiles, the upper ones being in time, and the lower ones obtained after depth conversion. Water-table like reflectors (WT), bedrock (B) and lake-deposit sediments (S) are identified.

We had both standard non-shielded antennas (25 and 50 MHz) and a new rough-terrain 50 MHz antenna of Malå (Fig. 5b). We quickly found out that the latter was the perfect tool to use on the moraine due to numerous and often large boulders covering it and preventing the use of the long antennas. The acquisition was so efficient compared to the standard antennas that all profiles in Fig. 5a were more or less acquired within a day.

The data were processed using ReflexW. Though the structure inside the moraine is quite heterogeneous, with different grain sizes from rather fine sand to large boulders, the GPR results showed several interesting features with clear reflectors down to 30–40 m in depth (Fig. 5c). Some are associated with water-table like features (strong and near horizontal reflectors, see P6). Others are typical layered structures (in PA and P8) believed to be lake deposits in an older lake trapped by the older moraine. In addition, bedrock is clearly reached in several profiles. Strong diffractions at dipping bedrock can be seen along Profile PA at the foot of the moraine, thus giv-

ing the possibility to estimate velocities at several depths in order to properly convert from time to depth (bottom profiles in Fig. 5c). A velocity in the main moraine and a different one in the lake deposits were then used.

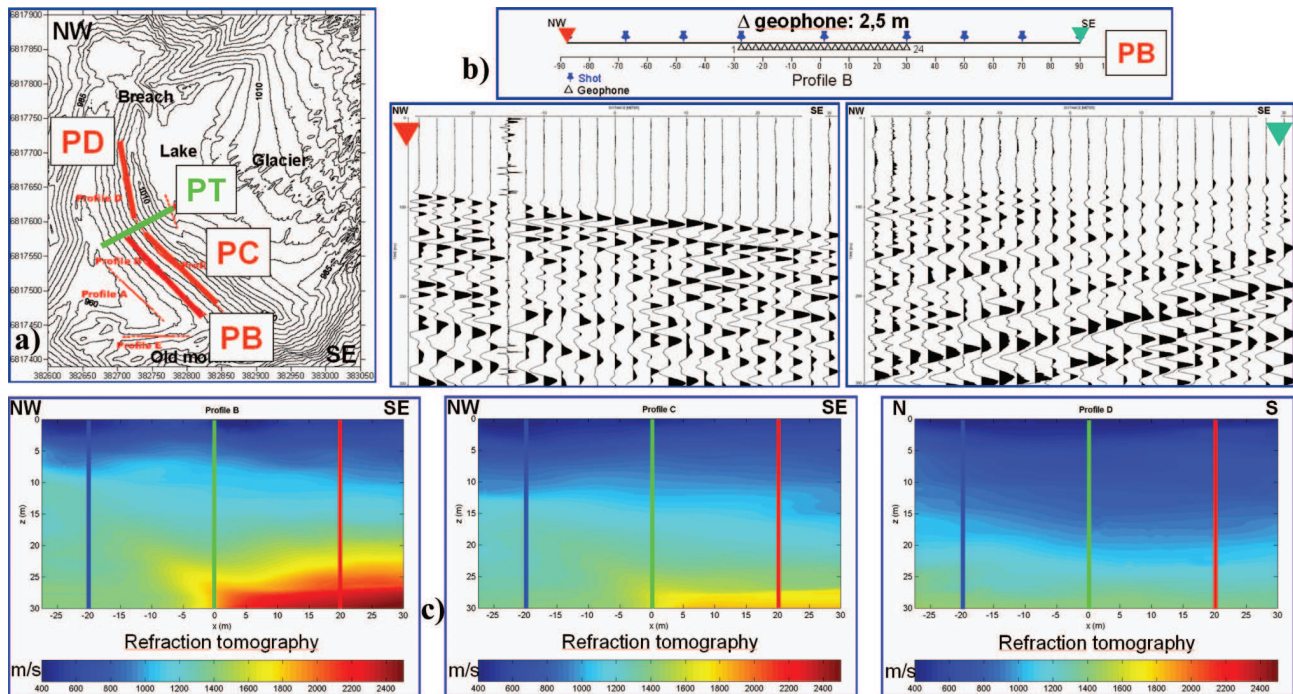
Fig. 6. Seismic refraction data. (a) Location of the profiles. (b) Example of 2 shots for one of the profile (PB). (c) Refraction tomography results for 3 profiles.

comparison with a seismic gun (Betsy gun). The use of the latter was difficult, slowing down significantly the acquisition without giving better results. Five standard refraction profiles were acquired, three on the main moraine, one on the old one and one at the foot of the moraine, all along the corresponding moraine axis, the sampling between geophones being 2.5 m (Fig. 6a). In addition, a line across the main moraine was acquired with denser shots and with the 24 geo-

phones located on the distal side every 3 m (PT in Fig. 6a with a cross-section given in Fig. 7a; one day was needed for that profile only).

The seismic refraction data were of very good quality and hammer blows were sufficient for offsets up to 80 m from the receiving line extremities (Fig. 6b). The data were

systematically of better quality above the wetter zone identified by both resistivity and GPR, while showing weaker first-arrivals away from that zone, either towards the breach or on the South-East side. We used the wavefront-based tomography approach of ReflexW to produce tomograms, as in Fig. 6c and Fig. 7b. No ice-velocity is found within the moraine, in agreement with resistivity. Within the moraine, the velocity increases with a rather linear gradient (compaction and/or capillarity-induced water content) up to water-like velocities, followed by a transition zone believed to correspond to the highly water-saturated sediment package, before reaching the bedrock (Fig. 7c). The good quality of the data, also shown in Fig. 7d, was unexpected and a denser acquisition in lines, receivers and shots, would have permitted a 3-D tomography.

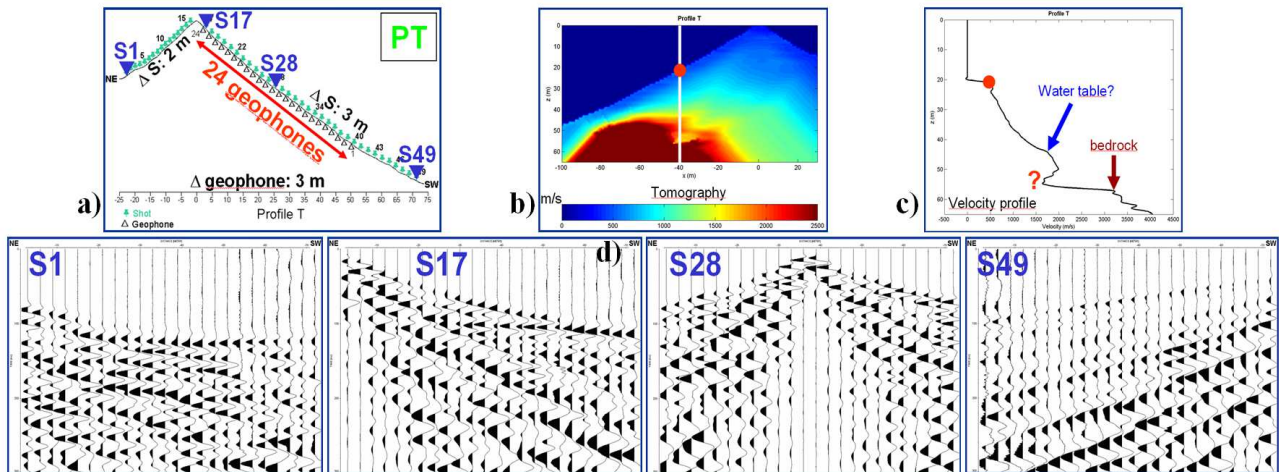
Fig. 7. Seismic refraction data (2). (a) Geometry of the transverse profile (see location in Fig. 6a) with 24 fixed geophones and 49 hammer-blow positions. (b) Final tomography result. (c) Vertical velocity profile at the lateral position given in (b). (d) Examples of shot recordings.
