## **Identification of the physical signatures of CDM induced latent defects into a DC-DC converter using low frequency noise measurements**

# Identification of the physical signatures of CDM induced latent defects into a DC-DC converter using low frequency noise measurements

## Abstract

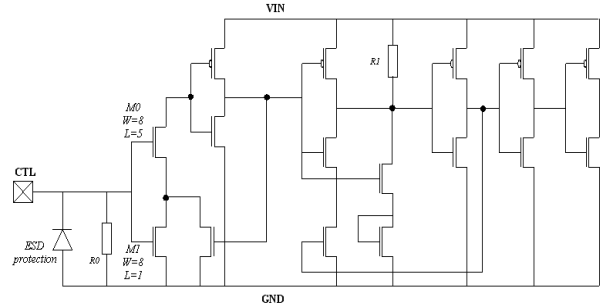
Fig.1. Electrical schematic of CTL pin input circuit.

Six chips, P1 to P6, are stressed using a Field Induced CDM tester from +/-500V to +/-2000V on the CTL pin, the Enable pin of the chip, which is directly connected to two NMOS gates (Fig. 1) (*M0* and *M1*). The gate of *M0* is five times longer than the one of *M1*. Each part receives a single voltage stress level (3 zaps) [2] as shown in Table 1. This input pin is protected by a localized ESD protection using a self-biased NPN transistor.

EMMI (EMission Microscopy) analysis did not allow detecting any defect location in P1 and P2. However, as shown in Fig. 2, P6 part that is stressed at a higher CDM level, exhibits an emitting defect located into the gate oxide of the input NMOS, M1 (in Fig.1). During the CDM stress on CTL pin, M1 and M0 are both exposed to a high electrical field, but having a five times smaller gate surface, M1 is more susceptible than M0.

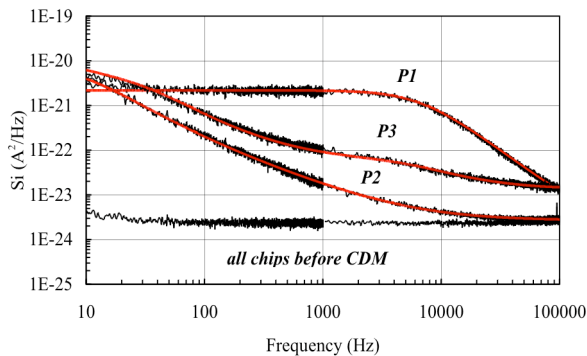
Fig.3. LFN measurements before and after CDM stress. (CTL=GND, VIN=3.6V,  $I_{ddq}$ =270nA before CDM,  $I_{ddq}$  = 600nA after CDM). The solid lines correspond to the model.

LFN measurements are performed between 10 Hz and 100 kHz using a dedicated test set using a transimpedance amplifier [3]. They are realized before and after CDM stress on the power supply pin (VIN) under the standby mode (CTL=0V). Fig.3 represents the frequency variations of the power spectral density (PSD) of the noise current ( $S_i$ ) associated to the leakage current  $I_{ddq}$  for the different investigated circuits.

Before CDM stress, the PSD of the noise current of all the circuits is less than the noise level of the experimental setup ( $2.3 \cdot 10^{-24} \text{ A}^2/\text{Hz}$ ) and is found almost constant over the frequency range. After CDM stress, the circuits with the smallest leakage currents (P1, P2 and P3) have been chosen to undergo LFN measurements.  $I_{ddq}$  on VIN of P1 and P2 is in the range of 600nA at 3.6V and should be compared to 270nA before stress.

We can observe in Fig.3, a strong increase of the low frequency noise after CDM stress for the different circuits. All the different spectra have been modeled with the following equation represented by solid lines (Fig.3):

As can be seen in Fig.3, CDM stress induces an increase of the low frequency noise for all the investigated devices. The noise coefficients obtained from the simplified model given by Eq.(1) are reported in Table 2.

The noise PSD of P1 part is largely dominated by a G-R noise source for frequencies up to 7 kHz. Concerning the part referenced as P2, flicker noise and a G-R noise source with  $f_{c1}$  close to 10 Hz are present. The behavior of P3 after the CDM stress is different since the noise PSD is now characterized by several G-R noise sources up to a few tenth of kHz.

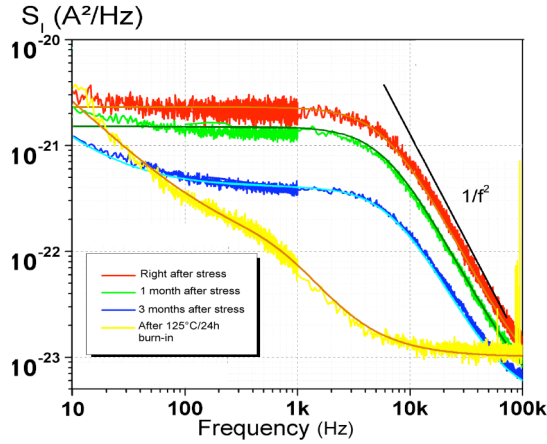
Fig. 4. LFN evolution of P1 after CDM stress and burn-in treatment. Solid lines are the fitting curves.

On P1 part, LFN measurements were also carried out after a period of storage (one, two and three months) after the CDM stress to study the noise evolution. As shown in Table 1, the leakage current decreases gradually. However, the G-R noise source always exists in P1 part (Fig.4). Given this behavior over time, it can be assumed that this noise source is generated by the presence of traps located into the MOS gate oxides. The thermally de-trapped charges results in a decrease of G-R noises created by the carriers injected into the gate oxide by the field enhanced at the rough polysilicon/SiO<sub>2</sub> interface [11].

The fit of the measured LFN curves in Fig.4 requires that the parameter  $\frac{\Delta N^2}{n^2 V^2}$  associated to the trap density decreases from a value of  $7.2 \cdot 10^{-5}$  right after CDM stress down to  $1.2 \cdot 10^{-5}$  three months later.

To confirm that such behavior can be attributed to traps into the oxides, we carried out a burn-in at  $125^\circ\text{C}$  during 24 hours and performed again the noise measurement. After the burn-in treatment, the LFN signature of P1 (Fig. 4) greatly evolved: first, the G-R noise source with a 7 kHz corner frequency disappeared. This could be attributed to the de-trapping of trapped charges into gate oxides of the circuit [6]. Secondly, a new G-R source featuring an 800 Hz corner frequency is now visible. In addition, a  $1/f$  noise source previously hidden by a strong G-R noise component before burn-in, now clearly appears on the spectrum for frequencies below 100Hz.

Nevertheless, despite the burn-in treatment, the noise level did not return to its initial value. At high frequencies, the original value was in the range of  $2.0 \cdot 10^{-24} \text{ A}^2/\text{Hz}$  whereas after stress and burn-in, it increased by one decade ( $10^{-23} \text{ A}^2/\text{Hz}$ ) and by three decades at 10Hz. This result means that CDM-related latent defects are remaining after the cure of oxide-

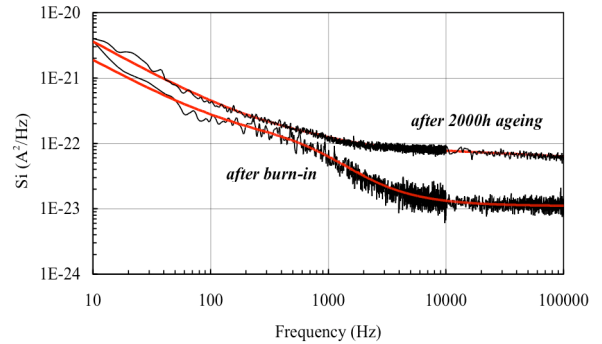
Fig. 5. LFN evolution of P1 after 2000h ageing experiment at  $85^\circ\text{C}$  and biasing for DC-DC conversion activated. Comparison with the LFN spectrum after burn-in. Solid lines correspond to the fitting curves.

LFN measurements were performed again on P1 after the ageing experiment and results are plotted in Fig.5. The noise PSD has evolved and increased mainly in the high frequency range of the spectrum. The noise coefficient obtained from the fitting are summarized in Table 3.

Firstly, the  $1/f$  noise component (B parameter) exhibits a slight increase and the G-R noise source around 1 kHz is still present. Secondly, additional G-R centers (C2, C3) appear after ageing. It is also interesting to notice that after ageing, the noise PSD of P1 is now similar to the one of P3 which underwent a

CDM stress with the same polarity but at a higher voltage level (1kV). Although the DC characteristic ( $I_{ddq}$ ) is still within the specifications, this result demonstrates that the CDM induced defect has evolved during the ageing experiment.

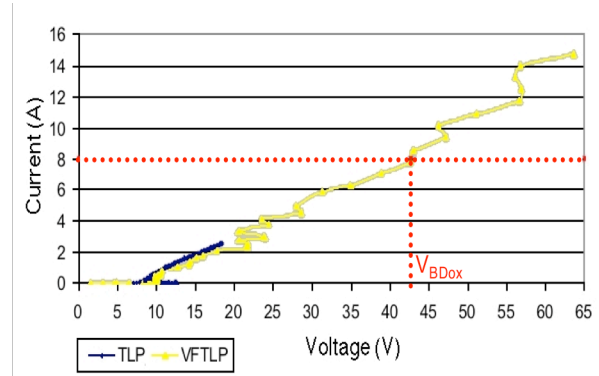
Fig.7 TLP and VF-TLP measurements in the reverse mode of the ESD protection that is implemented on the CTL pin.

Under TLP stress, both in direct and reverse mode, the ESD protection that is a self-biased transistor, correctly protects the gate monitor. Under VF-TLP stress, in direct mode, the ESD protection also efficiently protects the gate monitor. However, in reverse mode, the gate monitor fails. We also performed TLP and VF-TLP testing on a standalone protection (Fig. 7). It resulted that the TLP failure current  $I_{I2-TLP}$  is higher than 3A thus easily guaranteeing a 2kV HBM robustness whereas the VF-TLP failure current  $I_{I2-VFTLP}$  is higher than 15A. This means that the ESD protection is very robust under a fast ESD transient such as a CDM one. However, it can be noticed that the on-resistance of the structure is such that at 8A, the VF-TLP oxide breakdown is reached. Such high currents can be reached during a CDM stress. Thus, during a CDM stress, the gate oxide could

The red dashed line indicates the maximum current at oxide breakdown ( $V_{BDox}$ ) under VF-TLP.

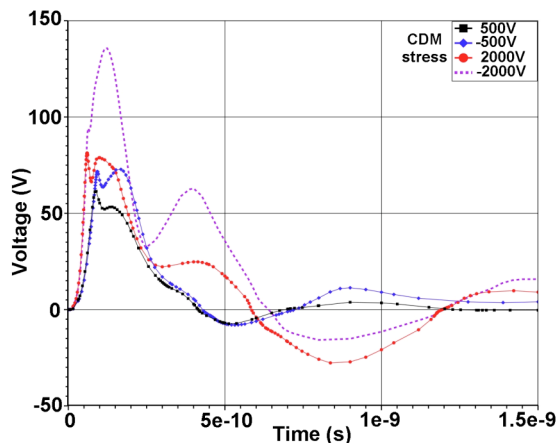
Fig.8. Voltage across the gates of M0 and M1 NMOS transistors obtained through mixed mode simulation for positive and negative 500V and 2kV CDM stresses.

To confirm these assumptions, we carried out mixed-mode simulations of the positive and negative CDM stress configurations on the CTL pin for 500V and 2kV stress levels. In these simulations, only the ESD protection device is 2D-simulated. Access resistances extracted via TLP measurement are added:  $2.2\Omega$  for the device in forward bias (positive CDM stress) and  $5\Omega$  for the device in reverse bias (negative CDM stress). As shown in Fig.8, the voltage across M0 and M1 is particularly high for both positive and negative stresses. As expected the positive stress is less stressful since it involves a forward biased diode. However, even for the lower stress level, the maximum voltage is in the range of the VF-TLP oxide breakdown value or higher (but just during few hundreds of ps). These qualitative results confirm that the protection device does not protect the input during a CDM stress and that gate oxides undergo very high electric fields susceptible to generate charge trapping. The observed trends are also in agreement with the measured post-stress  $I_{ddq}$ : for positive and negative 500V CDM

stress, it is in the same range whereas for 2000V, the negative stress is much more stressful than the positive one (P6 was the only device where the gate oxide breakdown could be localized).
