Identification of the physical signatures of CDM induced latent defects into a DC-DC converter using low frequency noise measurements

Abstract

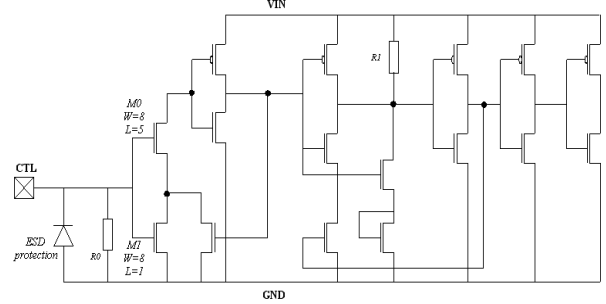
Six chips, P1 to P6, are stressed using a Field Induced CDM tester from +/-500V to +/-2000V on the CTL pin, the Enable pin of the chip, which is directly connected to two NMOS gates (Fig. 1) ($M0$ and $M1$). The gate of $M0$ is five times longer than the one of $M1$. Each part receives a single voltage stress level (3 zaps) [2] as shown in Table 1. This input pin is protected by a localized ESD protection using a self-biased NPN transistor.

Fig.1. Electrical schematic of CTL pin input circuit.

EMMI (EMission Microscopy) analysis did not allow detecting any defect location in P1 and P2. However, as shown in Fig. 2, P6 part that is stressed at a higher CDM level, exhibits an emitting defect located into the gate oxide of the input NMOS, M1 (in Fig.1). During the CDM stress on CTL pin, M1 and M0 are both exposed to a high electrical field, but having a five times smaller gate surface, M1 is more susceptible than M0.

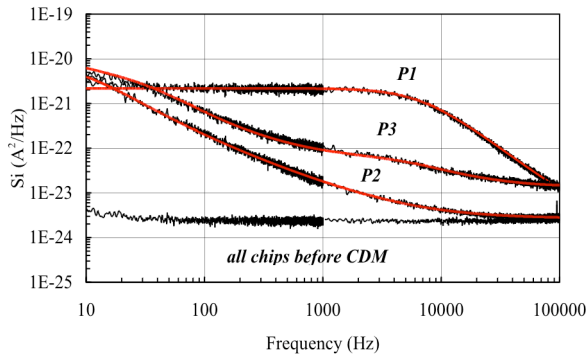
LFN measurements are performed between 10 Hz and 100 kHz using a dedicated test set using a transimpedance amplifier [3]. They are realized before and after CDM stress on the power supply pin (VIN) under the standby mode (CTL=0V). Fig.3 represents the frequency variations of the power spectral density (PSD) of the noise current (S_i) associated to the leakage current I_{ddq} for the different investigated circuits.

Before CDM stress, the PSD of the noise current of all the circuits is less than the noise level of the experimental setup ($2.3 \cdot 10^{-24} \text{ A}^2/\text{Hz}$) and is found almost constant over the frequency range. After CDM stress, the circuits with the smallest leakage currents (P1, P2 and P3) have been chosen to undergo LFN measurements. I_{ddq} on VIN of P1 and P2 is in the range of 600nA at 3.6V and should be compared to 270nA before stress.

Fig.3. LFN measurements before and after CDM stress. (CTL=GND, VIN=3.6V, I_{ddq} =270nA before CDM, I_{ddq} = 600nA after CDM). The solid lines correspond to the model.

We can observe in Fig.3, a strong increase of the low frequency noise after CDM stress for the different circuits. All the different spectra have been modeled with the following equation represented by solid lines (Fig.3):

As can be seen in Fig.3, CDM stress induces an increase of the low frequency noise for all the investigated devices. The noise coefficients obtained from the simplified model given by Eq.(1) are reported in Table 2.

The noise PSD of P1 part is largely dominated by a G-R noise source for frequencies up to 7 kHz. Concerning the part referenced as P2, flicker noise and a G-R noise source with f_{c1} close to 10 Hz are present. The behavior of P3 after the CDM stress is different since the noise PSD is now characterized by several G-R noise sources up to a few tenth of kHz.

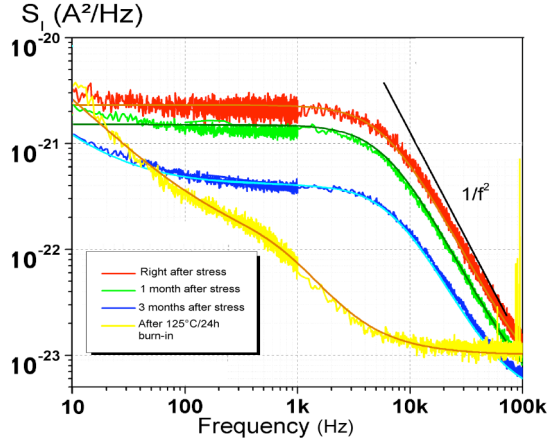
On P1 part, LFN measurements were also carried out after a period of storage (one, two and three months) after the CDM stress to study the noise evolution. As shown in Table 1, the leakage current decreases gradually. However, the G-R noise source always exists in P1 part (Fig.4). Given this behavior over time, it can be assumed that this noise source is generated by the presence of traps located into the MOS gate oxides. The thermally de-trapped charges results in a decrease of G-R noises created by the carriers injected into the gate oxide by the field enhanced at the rough polysilicon/SiO₂ interface [11].

Fig. 4. LFN evolution of P1 after CDM stress and burn-in treatment. Solid lines are the fitting curves.

The fit of the measured LFN curves in Fig.4 requires that the parameter $\frac{\Delta N^2}{n^2 V^2}$ associated to the trap density decreases from a value of $7.2 \cdot 10^{-5}$ right after CDM stress down to $1.2 \cdot 10^{-5}$ three months later.

To confirm that such behavior can be attributed to traps into the oxides, we carried out a burn-in at 125°C during 24 hours and performed again the noise measurement. After the burn-in treatment, the LFN signature of P1 (Fig. 4) greatly evolved: first, the G-R noise source with a 7 kHz corner frequency disappeared. This could be attributed to the de-trapping of trapped charges into gate oxides of the circuit [6]. Secondly, a new G-R source featuring an 800 Hz corner frequency is now visible. In addition, a $1/f$ noise source previously hidden by a strong G-R noise component before burn-in, now clearly appears on the spectrum for frequencies below 100Hz.

Nevertheless, despite the burn-in treatment, the noise level did not return to its initial value. At high frequencies, the original value was in the range of $2.0 \cdot 10^{-24} \text{ A}^2/\text{Hz}$ whereas after stress and burn-in, it increased by one decade ($10^{-23} \text{ A}^2/\text{Hz}$) and by three decades at 10Hz. This result means that CDM-related latent defects are remaining after the cure of oxide-

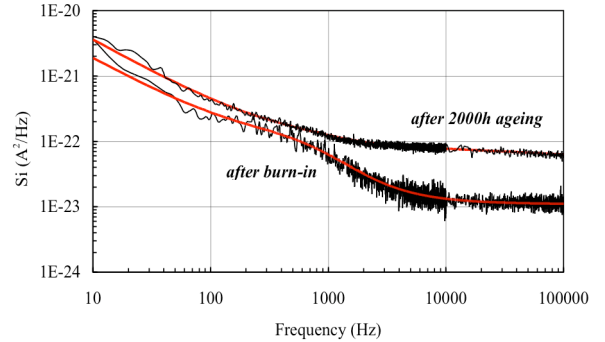
LFN measurements were performed again on P1 after the ageing experiment and results are plotted in Fig.5. The noise PSD has evolved and increased mainly in the high frequency range of the spectrum. The noise coefficient obtained from the fitting are summarized in Table 3.

Fig. 5. LFN evolution of P1 after 2000h ageing experiment at 85°C and biasing for DC-DC conversion activated. Comparison with the LFN spectrum after burn-in. Solid lines correspond to the fitting curves.

Firstly, the $1/f$ noise component (B parameter) exhibits a slight increase and the G-R noise source around 1 kHz is still present. Secondly, additional G-R centers (C2, C3) appear after ageing. It is also interesting to notice that after ageing, the noise PSD of P1 is now similar to the one of P3 which underwent a

CDM stress with the same polarity but at a higher voltage level (1kV). Although the DC characteristic (I_{ddq}) is still within the specifications, this result demonstrates that the CDM induced defect has evolved during the ageing experiment.

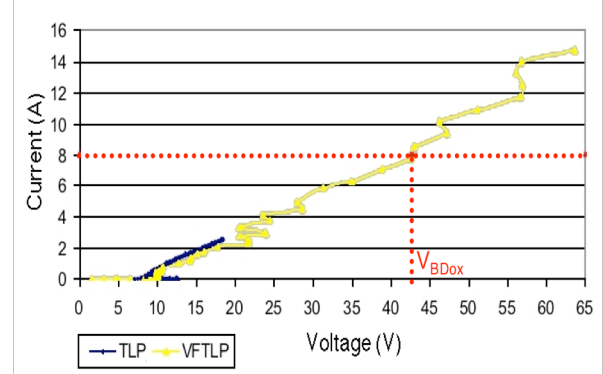
Under TLP stress, both in direct and reverse mode, the ESD protection that is a self-biased transistor, correctly protects the gate monitor. Under VF-TLP stress, in direct mode, the ESD protection also efficiently protects the gate monitor. However, in reverse mode, the gate monitor fails. We also performed TLP and VF-TLP testing on a standalone protection (Fig. 7). It resulted that the TLP failure current I_{f2-TLP} is higher than 3A thus easily guaranteeing a 2kV HBM robustness whereas the VF-TLP failure current $I_{f2-VFTLP}$ is higher than 15A. This means that the ESD protection is very robust under a fast ESD transient such as a CDM one. However, it can be noticed that the on-resistance of the structure is such that at 8A, the VF-TLP oxide breakdown is reached. Such high currents can be reached during a CDM stress. Thus, during a CDM stress, the gate oxide could

Fig.7 TLP and VF-TLP measurements in the reverse mode of the ESD protection that is implemented on the CTL pin. The red dashed line indicates the maximum current at oxide breakdown (V_{BDox}) under VF-TLP.

P1 part was stressed under a positive CDM stress whereas P2 was stressed under a negative one. For the failure of P2, the localized ESD protection on the CTL pin is clearly at the origin of the failure. For P1, it works in forward mode and then should efficiently protect the input circuit. In this case, the full protection strategy is probably not correctly sized for such high currents. As a result, resistive paths may induce high voltage drops and then the generation of electric fields high enough to induce charge trapping into the oxides.

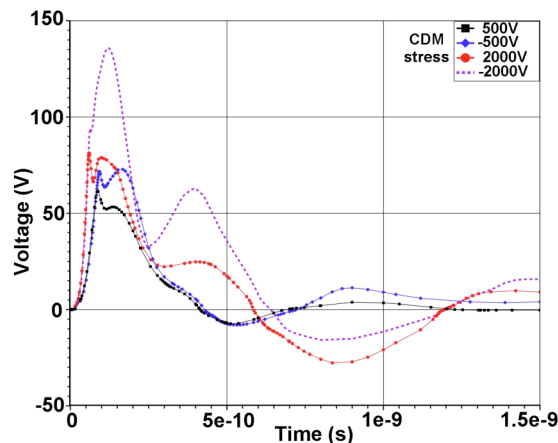
To confirm these assumptions, we carried out mixed-mode simulations of the positive and negative CDM stress configurations on the CTL pin for 500V and 2kV stress levels. In these simulations, only the ESD protection device is 2D-simulated. Access resistances extracted via TLP measurement are added: 2.2Ω for the device in forward bias (positive CDM stress) and 5Ω for the device in reverse bias (negative CDM stress). As shown in Fig.8, the voltage across M0 and M1 is particularly high for both positive and negative stresses. As expected the positive stress is less stressful since it involves a forward biased diode. However, even for the lower stress level, the maximum voltage is in the range of the VF-TLP oxide breakdown value or higher (but just during few hundreds of ps). These qualitative results confirm that the protection device does not protect the input during a CDM stress and that gate oxides undergo very high electric fields susceptible to generate charge trapping. The observed trends are also in agreement with the measured post-stress I_{ddq} : for positive and negative 500V CDM

Fig.8. Voltage across the gates of M0 and M1 NMOS transistors obtained through mixed mode simulation for positive and negative 500V and 2kV CDM stresses.

stress, it is in the same range whereas for 2000V, the negative stress is much more stressful than the positive one (P6 was the only device where the gate oxide breakdown could be localized).
