# Mechanical response of oxidized Zircaloy-4 cladding material submitted to a ring compression test

Vincent Busser<sup>a,\*</sup>, Marie-Christine Baidetto-Dubourg<sup>b</sup>, Jean Desquines<sup>a</sup>, Christian Duriez<sup>a</sup>, Jean-Paul Mardon<sup>c</sup>

The ring compression test method has been evaluated as a tool to assess Zircaloy-4 cladding mechanical properties and to analyze oxide layer damage evolution with applied strain. For sufficient axial length, the test is shown to develop plane strain conditions at the most deformed location. The test analysis requires finite element calculations. The aim of the paper is to highlight the potentialities of the ring compression test method.

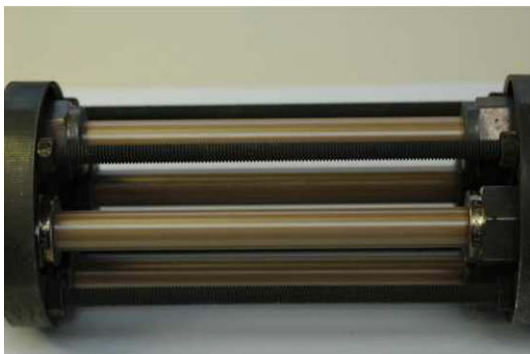
**Fig. 1.** Sample holder with four 12 cm-long oxidized claddings.

A sample holder was designed to simultaneously oxidize four 12 cm-long samples (see Fig. 1). Claddings have been oxidized in air-laboratory at 470  $^{\circ}\text{C}$ , in a horizontal tubular furnace. Moreover, the tubes were equipped with end-caps to avoid internal oxidation. The end-caps were not fully gas-tight. An inner layer formed at the inner diameter but with a much thinner thickness (75%) than the outer oxide layer.

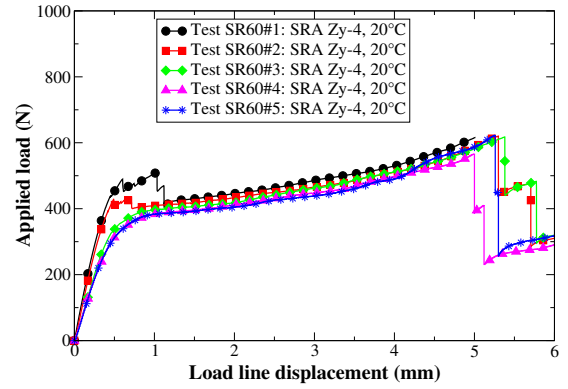
Fig. 5. Load-displacement curves for oxidized SRA Zy-4 ring compression test at room temperature.

The load-displacement curves for these tests are shown in Fig. 5.

Comparison between SR60#4 and SR60#5 tests (see Fig. 5) highlights that a large region of outer oxide layer has no main influence on the mechanical response of the ring. It also means that only zirconia layer submitted to compressive stresses improves significantly the strength of oxidized samples during RCT.

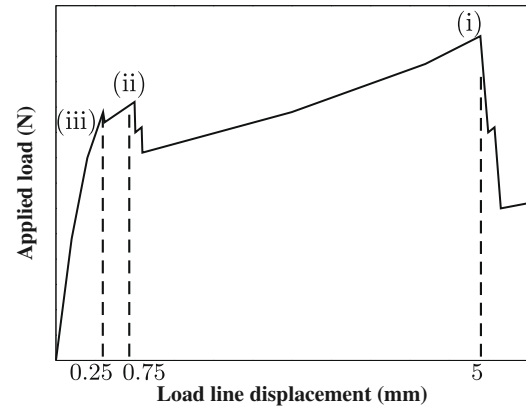
Fig. 6. Typical mechanical load-displacement curve of an oxidized ring compression test. Mentioned values concern results of RCT performed on ring covered by a 60 μm thick outer oxide layer.

Similar load-displacement curves are observed for specimens with different oxide layer thickness. The typical mechanical response of an oxidized ring submitted to RCT is characterized by three losses of load carrying capacity events, as schematized in Fig. 6:

1. The greatest loss of load carrying capacity appears at load-line displacement comprised between 4.5 mm and 5 mm. Indeed, this event corresponds to the cladding failure at both equatorial azimuth as already observed on non oxidized rings. All tested rings failed for quite similar strain level (see Fig. 5), except the specimen SR60#1, which was likely not far from crack initiation. After this failure, two halves rings remain. The post failure behavior will not be further considered.

2. Another event appears at load-line displacement close to 0.75 mm. This event is related to buckling failure of the inner oxide layer at the equatorial azimuths (see Fig. 7). Buckling failures at opposite azimuths are not simultaneous, thus two similar events are observed at very close displacement values. To confirm this assessment, specimen SR60#2 was polished over its entire inner surface to remove inner oxide layer. No loss of load carrying capacity is also observed for similar load-line displacement. Influence of the inner oxide layer on the mechanical response of an oxidized ring submitted to compression test is thus evidenced.

3. A small failure-event is observed at a displacement corresponding approximately to the beginning of plasticity, when the load-line displacement reaches about 0.25 mm. Visual examination during the test enables to conclude that the small loss of load carrying capacity is the consequence of oxide cracking under both device-specimen contact surfaces (at polar locations). Pole cracking is followed by the spallation of very small oxide fragments at these regions. This is confirmed by the test on sample SR60#3, for which outer oxide has been removed at both poles.

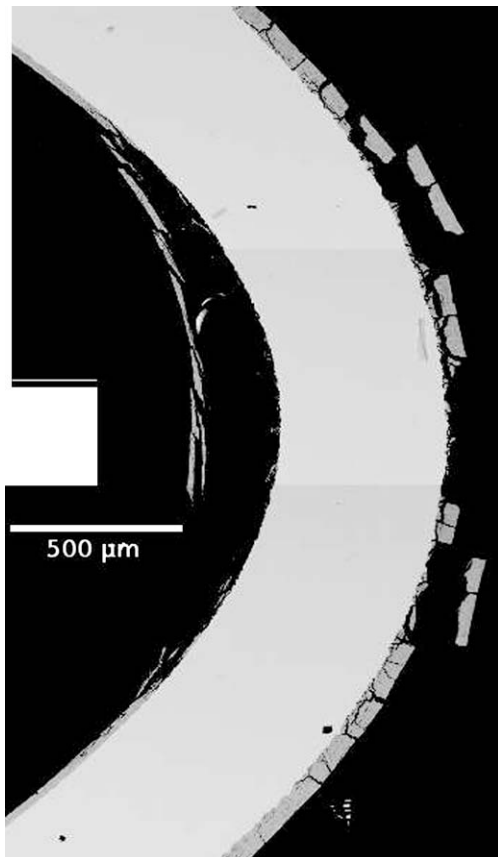
**Fig. 8.** SEM micrographs after RCT, on cross-section in the ring mid-section, in backscattered electron mode of RXA Zircaloy-4 samples oxidized in air at 470 °C. The outer oxide layer is 60 μm thick. The corresponding load-line displacement is 5 mm.

Figs. 7 and 8 evidence undoubtedly inner oxide spallation at equatorial azimuth: the oxide cracking is created by tensile strains

on the external skin and inner-side oxide buckling induced by compressive stresses is observed. On the outer surface, many oxide fragments are spalled or close to spallation. The above-mentioned zirconia layer cracking at outer locations is related to the high strain level locally reached at the end of RCT [6]. On regions far from the equatorial azimuth, oxide damages are much more limited since most of the radial cracks do not fully propagate up to the metal-oxide interface. Ring compression tests appear to be particularly interesting to study oxide cracking and spallation under mechanical load. This study is underway and will not be further detailed here.

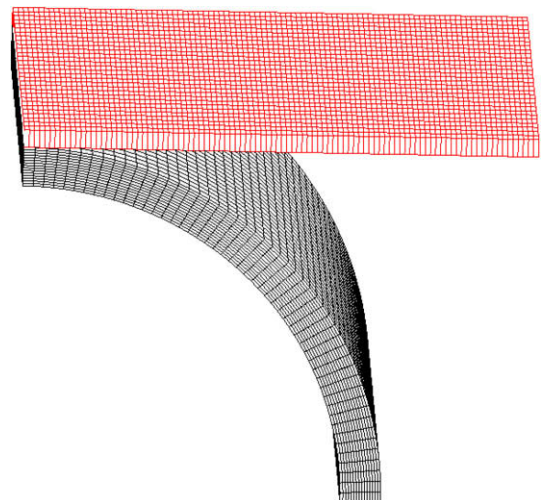
**Fig. 9.** Three-dimensional finite element method mesh.

Three-dimensional finite element method (FEM) simulations of the ring compression were run with the Cast3m software [10]. Only 1/8th of the ring is meshed because of the symmetries. The loading device is modeled by meshing a thick sheet. 22500 8-nodes cubic finite elements with linear interpolation were used for the ring meshing (see Fig. 9).

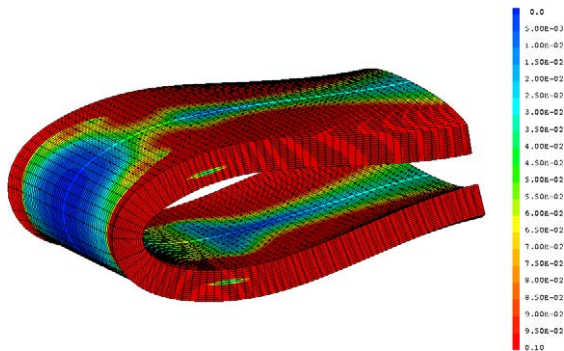
**Fig. 10.** Evolution of the calculated plane strain criterion for a 7 mm load-line displacement.  $\eta$  is calculated at any nodes of the mesh. Only half of the ring is shown.

The smaller  $\eta$  is, the closer to plane strain state the strain distribution is. The evolution of  $\eta$  is calculated at each node of the mesh (see Fig. 10). It can also be plotted along the axial direction at equatorial location (see Fig. 11). Considering a load-line displacement equal to 7 mm,  $\eta$  remains smaller than 0.05 over a 7 mm distance. It means that the plane strain state assumption is valid with a 5% accuracy along about 70% of the ring length. Remaining 30% is thus affected by three-dimensional edge effect.

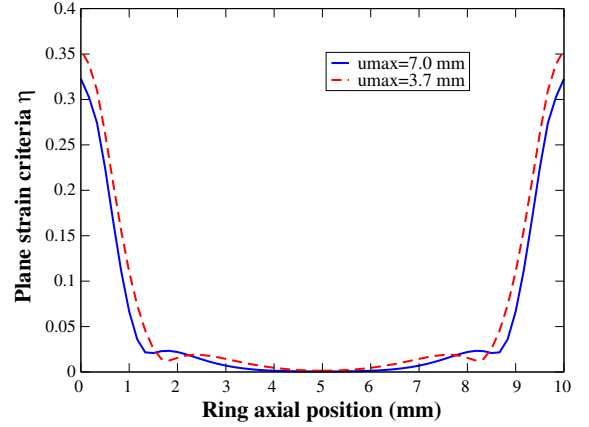
**Fig. 11.** Evolution of the calculated plane strain criterion at the equatorial azimuth versus the axial position of the ring for two maximum load-line displacements.

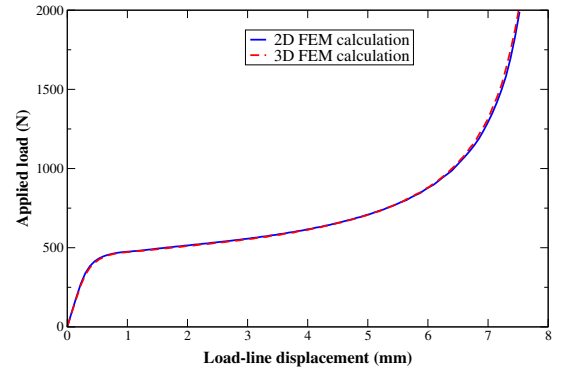
**Fig. 13.** Comparison of the calculated applied load versus load-line displacement for 3D and 2D plane strain FEM simulations.

Consequently, the two-dimensional plane strain is an approximation of the three-dimensional real behavior (see Fig. 13). The computation time is thus strongly reduced.

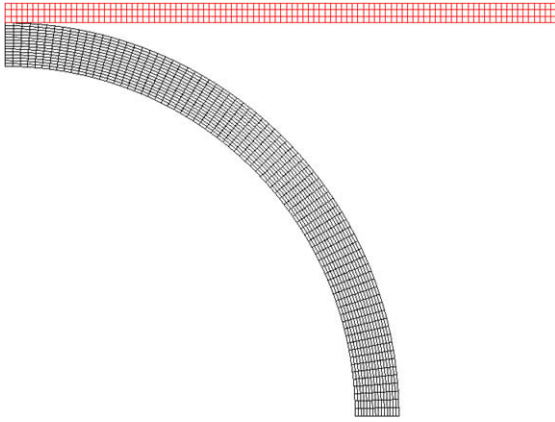
Fig. 14. Two-dimensional finite element mesh.

Two-dimensional plane strain FEM numerical calculations are performed in order to identify the mechanical properties of the cladding (see Fig. 14). Fresh Zircaloy-4 anisotropic model is not perfectly known in the entire range of strains and strain rates. As a consequence, authors have chosen to model Zircaloy-4 behavior

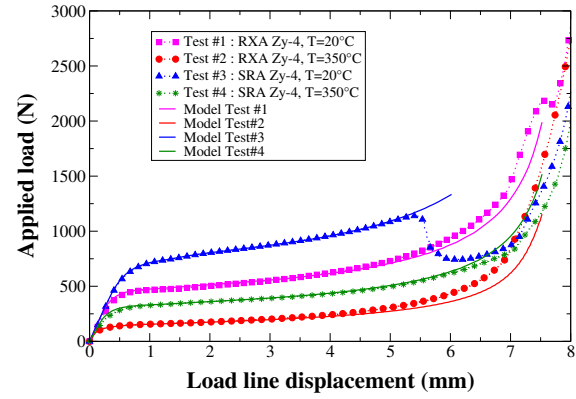
Fig. 16. Load-displacement curves of ring submitted to RCT.

Numerical results are consistent with the experimental ones (see Fig. 16) and 0.2% Yield Stress and Uniform Elongation are thus assessed by identification. Results are shown in Table 4.

ble 4. For example, concerning SRA Zircaloy-4 tests performed at room temperature, failure is obtained at 5.5 mm-load-line displacement (see Fig. 16) and the corresponding plastic failure strain is 26% (see Fig. 17).

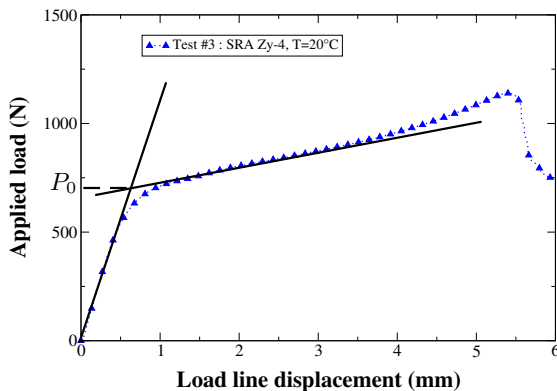
Fig. 15. Definition of the initial collapse load, as mentioned in [3,5].

Previous works [3,5] have shown that it is possible to assess the UTS value, assuming elastic perfectly plastic material properties, with the following correlation:

$$UTS = \frac{\alpha P_0 R_0}{t_0^2 l}, \quad (3)$$

where  $\alpha$  equals  $\frac{\sqrt{3}}{2}$  for rings (longer than one diameter),  $R_0$ ,  $t_0$ ,  $l$  are respectively the initial outer radius, the tube thickness and the length of the ring.  $P_0$  is the initial collapse load, which can be obtained by the intersection of the extrapolation of elastic and plastic parts of the load-displacement curve (see Fig. 15). As a conclusion, the UTS is geometrically derived from load-displacement curve.

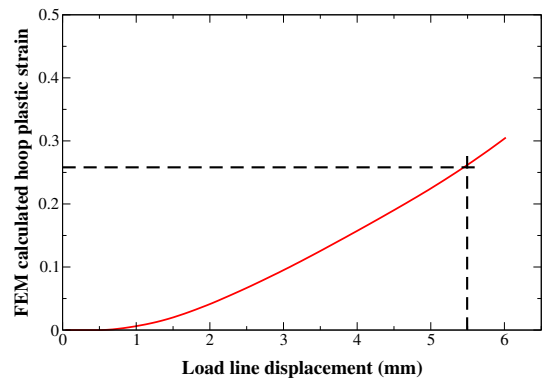
Fig. 17. Evolution of hoop plastic strain at the equatorial location during RCT for SRA Zy-4 at room temperature.

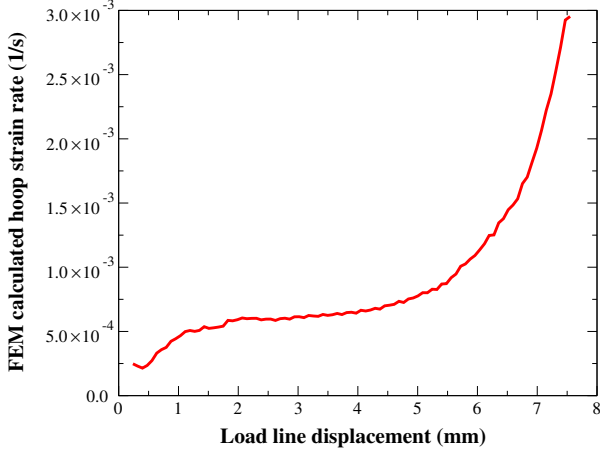
Fig. 18. Evolution of the hoop strain rate at the equatorial location during RCT.

FEM calculations enable hoop strain rate calculation at the point of the ring where failure is expected (middle of equatorial line). The assessment of strain rate is obtained in a two step process: the derivative of the strain versus displacement (see Fig. 18) is first calculated, and then multiplied by the load-line displacement rate. During tests with load-line displacement rate of 1 mm/min, the strain rate remains rather constant and close to  $5 \times 10^{-4} \text{ s}^{-1}$  before significant deformation of the ring. During the last steps of deformation, corresponding approximately to situation with contact between opposite sides of the inner-diameter of the ring, a sudden

increase of strain-rate is calculated. The strain rate plateau can be easily adjusted to any value by choosing the relevant load-line displacement rate. Apart from this study, an experimental sensitivity study of the strain rate influence has been performed on non oxidized cladding (from  $5 \times 10^{-4} \text{ s}^{-1}$  to  $5 \times 10^{-1} \text{ s}^{-1}$ ). Limited strain rate hardening is observed at room temperature.

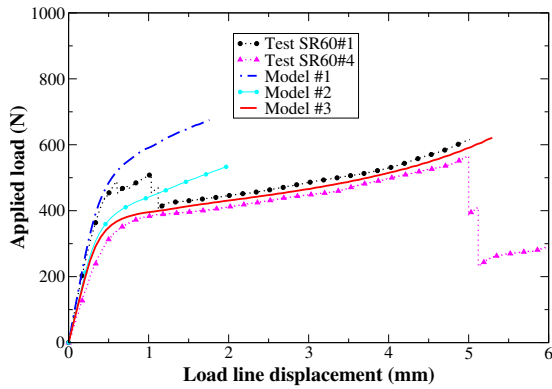
Fig. 20. Experimental and calculated load-displacement curves of Zircaloy-4 RCT.

Numerical results consistently describe the main steps of the oxide damage that were observed during experiments (see Fig. 20). Actually, model #1 is valid at the very beginning of the test until the outer oxide layer fails near the contact area with the loading device. After this first event, model #2 is expected to reproduce the load evolution until the inner oxide layer failure. Experimental results exhibit higher stiffness than numerical ones. It could be explained by the fact that the polar outer oxide cracking does not occur exactly at 45°. Actually, apart from regions in close vicinity with the loading-device-sample contact surface, most of the outer oxide layer remains undamaged. Concerning model #3, numerical results are consistent with experimental data. As a conclusion, FEM calculations confirm the different oxide layer cracking mechanisms identified experimentally.

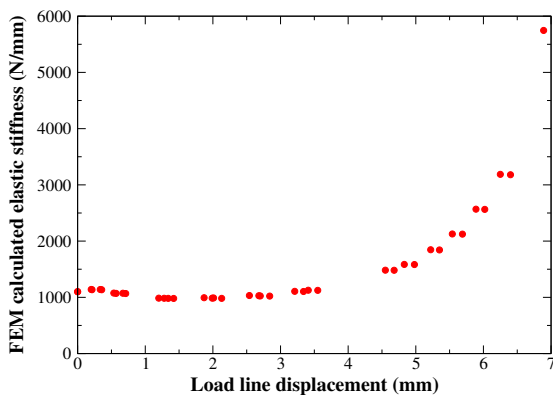
Fig. 21. Evolution of FEM calculated ring elastic-stiffness versus load-line displacement.

FEM calculations, with a set of loading and unloading during the test at several steps, have been performed to evaluate the evolution of the ring elastic-stiffness during the test (see Fig. 21). The ring elastic-stiffness remains quite constant for the first 4 mm load-line displacement, then a large increase is predicted. Thus plastic displacement can be easily calculated for the beginning of the test taking into account initial elastic-stiffness. However, it needs to be calculated carefully for load-line displacements exceeding 4 mm.
