High velocity geomorphological processes in a tropical area: the Remparts River case study (Réunion Island, Indian Ocean)

Manuel Garcin, Blanche Poisson, Richard Pouget

Manuel Garcin, Blanche Poisson, Richard Pouget. High velocity geomorphological processes in a tropical area: the Remparts River case study (Réunion Island, Indian Ocean). *Geomorphology*, 2004, 67, pp.335-350. 10.1016/j.geomorph.2004.11.002 . hal-00407287

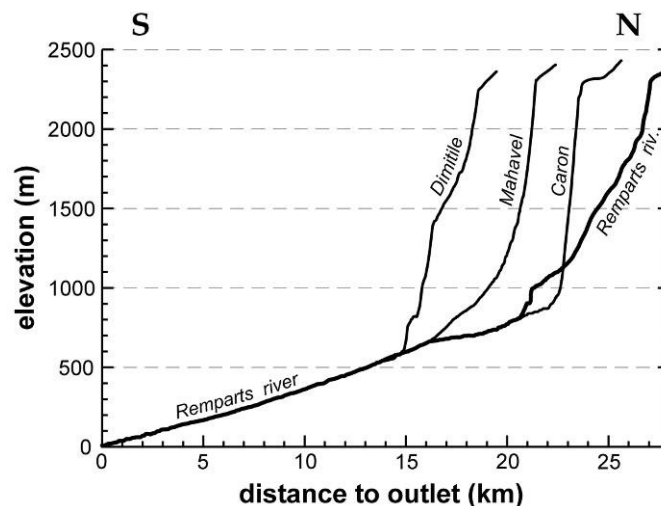
Figure 3. Longitudinal topographic profiles of Remparts River and tributaries (extracted from IGN 25-m DEM).

Longitudinal topographic profiles of the Remparts River, Dimitile reach and Mahavel reach are presented in Figure 3. This figure shows the steep profile of the river channel (4% gradient for the Remparts River downstream of the confluence with Mahavel reach, 11% for the lower part of Mahavel reach) and the obvious steepness of both Mahavel and Dimitile reaches compared to the Remparts River. The impact of the debris dam resulting from the 1965 collapse is still noticeable through the gentle slope upstream from the confluence. Also, the Remparts River upstream from the confluence with Mahavel reach was partially buried by a recent lava flow stemming from the Commerson crater (Billard and Vincent, 1974). This river bed is therefore partially “fossilized” and protected from rapid incision.

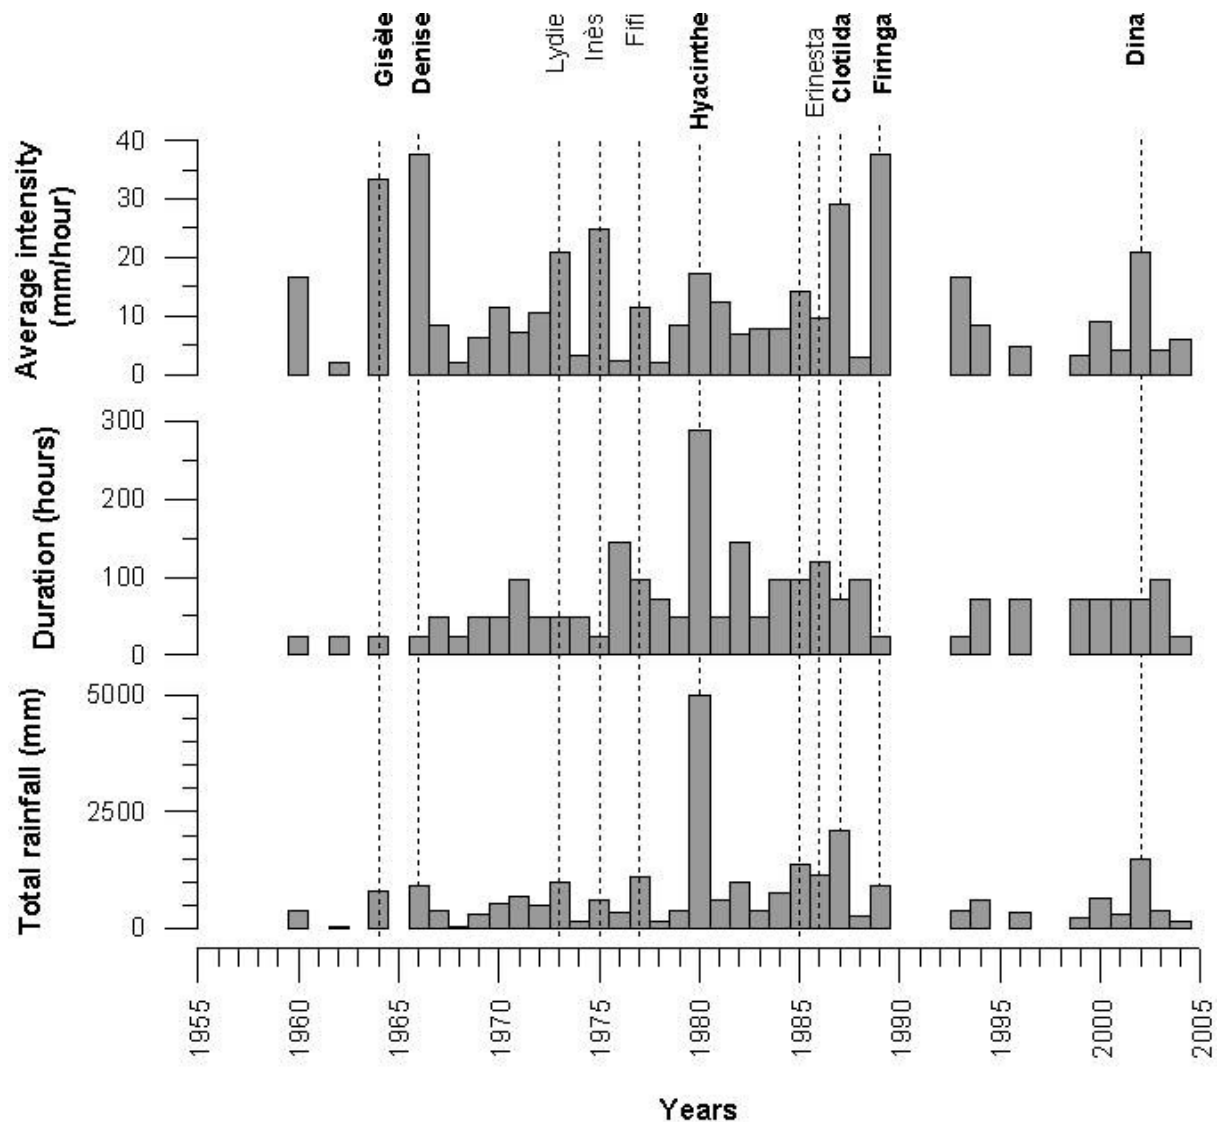
Figure 4. Climatological characteristics of main cyclonic events during the last 40 years (data from Météo France).

The observed lack of landscape evolution between two successive wet seasons shows that only intense and/or long periods of rainfall can shape the valley through the transport of coarse materials downstream. So, major cyclones and tropical depressions for the last 40 years have been reported in Figure 4 if total rainfall exceeds 300 mm and if one or both of the following criteria is reach:

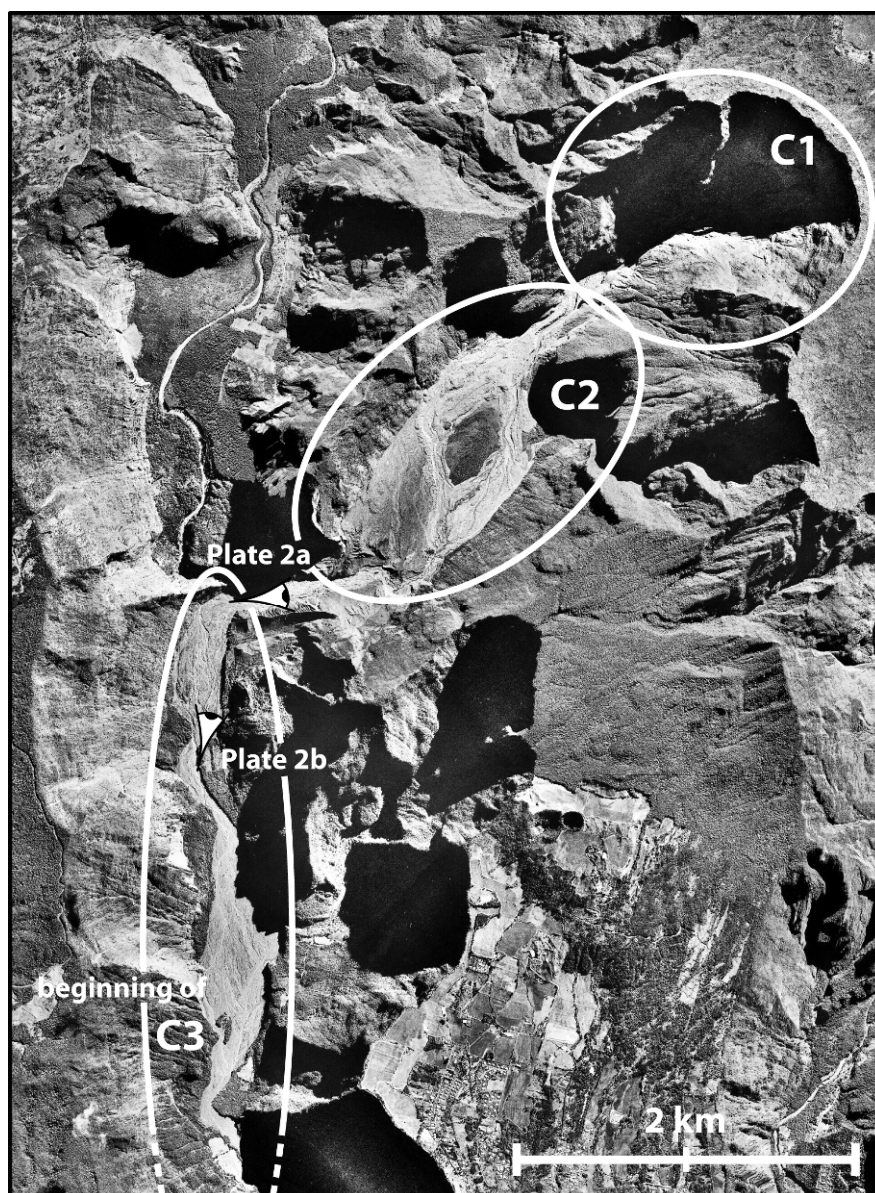
Plate 1. Aerial view (1997 orthophoto) of the confluence between the Mahavel reach and the Remparts River, helping to distinguish the three compartments of the “active” hydrosystem (eyes correspond to points of view for plate 2).

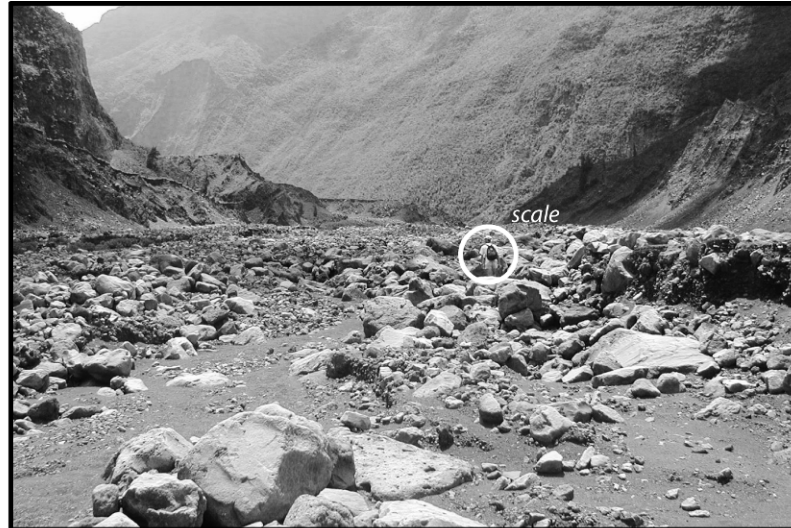
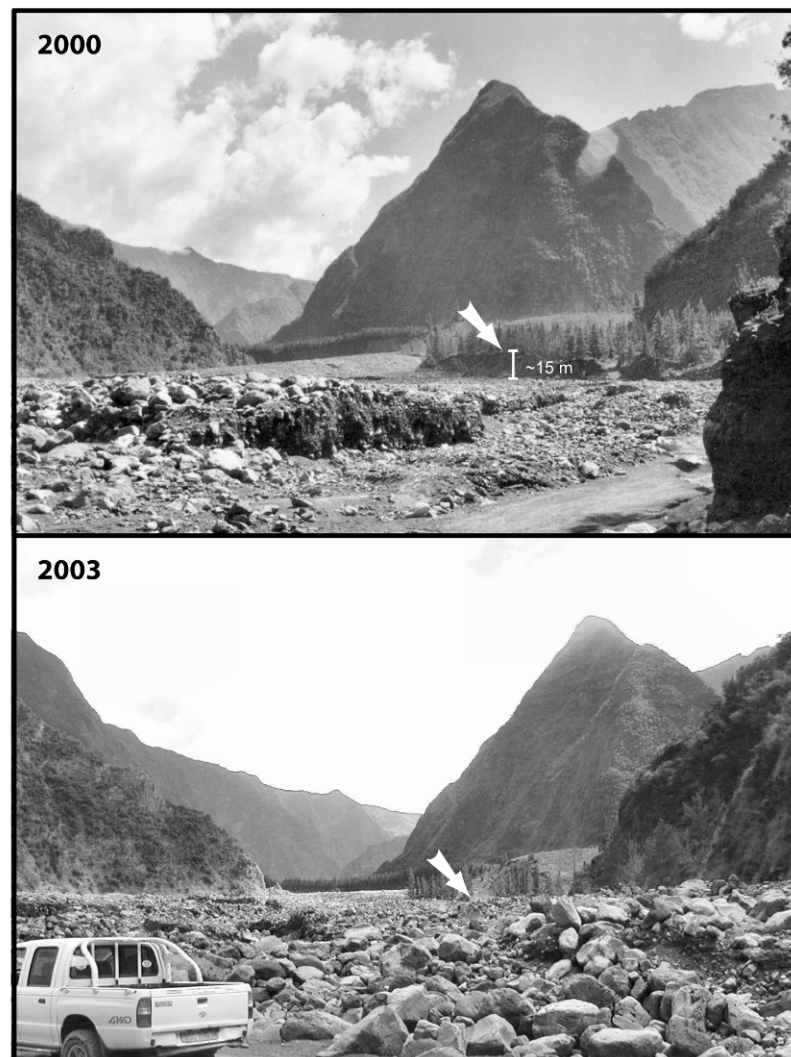
Plate 2. Field photographs: a. view of the Mahavel reach, towards upstream (2003); b. view of the left bank of the Remparts River, where a terrace (white arrow) disappeared between 2000 and 2003.

This compartment extends from the Oiseaux Verts Cape to the confluence with the Remparts River (Figure 2, Plate 2a). Surface processes operating in this compartment are of two types (Table 3):

This compartment is only affected by torrential processes, transporting materials downstream from the Mahavel reach (Table 3). Net aggradation and/or erosion depend on the balance between transport capacity and sediment yield (Plate 2b).

Field work and geomorphological mapping was carried out in 2000 and 2003 (thus bracketing cyclone Dina). Comparison between field observations and geomorphological maps (Garcin and Cruchet, 2001) allows *in situ* verification of major evolution and aggradation of the river bed. This aggradation is highly noticeable as numerous vegetated low terraces which were present in 2000 are now buried by several meters of alluvium (Plate 2b). As an example, the Grand Ilet Terrace (downstream of the Mahavel-Remparts confluence, label "g" on plate 4) which was settled until the 1990's has been submerged by sediment even though this islet had been preserved from the 1965 event. Further downstream, a few lateral terraces are today settled and are threatened by aggradation. A coarsening of the river bed sediment is observed between 2000 and 2003 along the whole length of the bed. The only source of material is the Mahavel reach, as the upstream part of the Remparts River supplies no sediment and no landslide is observed in the bordering cliff. The sediment source is mainly C1, but some is produced from river incision in the surface of C2. This incision is clearly visible both in the field and on the aerial photographs (Plates 2a and 3).

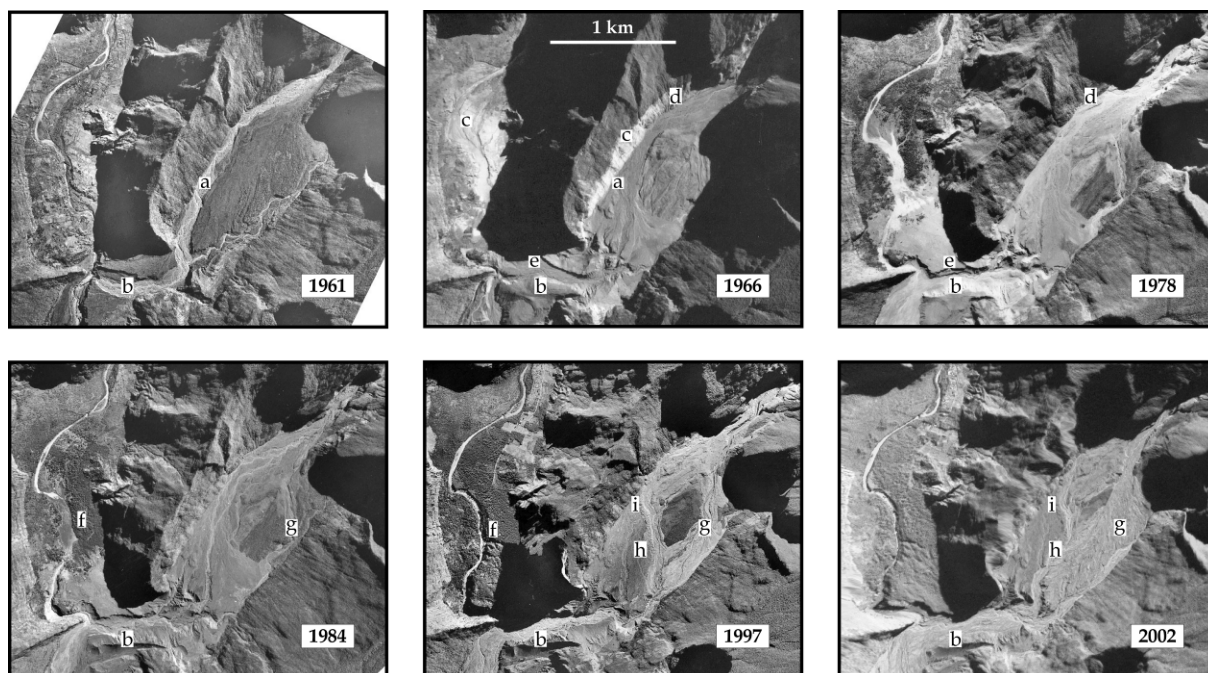
Plate 3. Remparts River evolution on aerial photographs (1961 to 1997) and SPOT5 image (2002), focused on Mahavel reach and confluence with Remparts River (see location on figure 2).

Plate 3 shows that in 1961, an active channel is eroding through an old morphological surface, probably resulting from a former exceptional event ("a" and "b"). According to oral sources, massive sediment supply occurred in 1904. Following the exceptional Mahavel event that occurred in 1965, around $50 \times 10^6 \text{ m}^3$ of rock collapsed from the cliff into C1. A part of this huge volume immediately slid into C2, reached the confluence and dammed the river. A few months later, cyclone Denise hit Reunion Island, causing intense precipitation (Figure 4, BRGM, 1966). Consequences of this succession of events may be observed on the 1966 aerial view. This photo shows evidences of the passage of an enormous wave of sediments through the reach, which likely burst as it collided with the stiff spur at the confluence. White deposits on the right side of the reach and much further upstream (1966, "c") may be remnants of splashes of fine sediments. Former channel "b" has been filled in, and a drift of fresh sediments now deviates the channel further north (1966, "e"). Fresh sediments cover the whole surface of the reach. In particular, the former bed of a braided channel "a" has completely vanished beneath the new sediment layer. The reach surface rises further during following years, as observed near "d", and generally across all of the upper part of the reach (1978). During the same period, the drift "b" underwent erosion, that is still going on. At the confluence, regressive erosion also appears to remove the northern part of the 1965 deposits (1978, "e"). The dam of the river upstream, which resulted from the 1965 event, remained intact until between 1984 and 1997 ("f"). A major event occurred in 1996, supplying around $5 \times 10^6 \text{ m}^3$ of rock material to C1. Consecutive debris flows through the reach renewed the surface on the left side (1997, "g"). Labels "h" and "i" (1997, 2002) indicate a levee of solidified mud, testifying to the passage of debris flow in the reach, which likely happened in 1996. Sediment supply from C1 gradually fed C2, as the surface texture of the reach seems to indicate further burying between 1997 and 2002 ("g", "h" and "j").

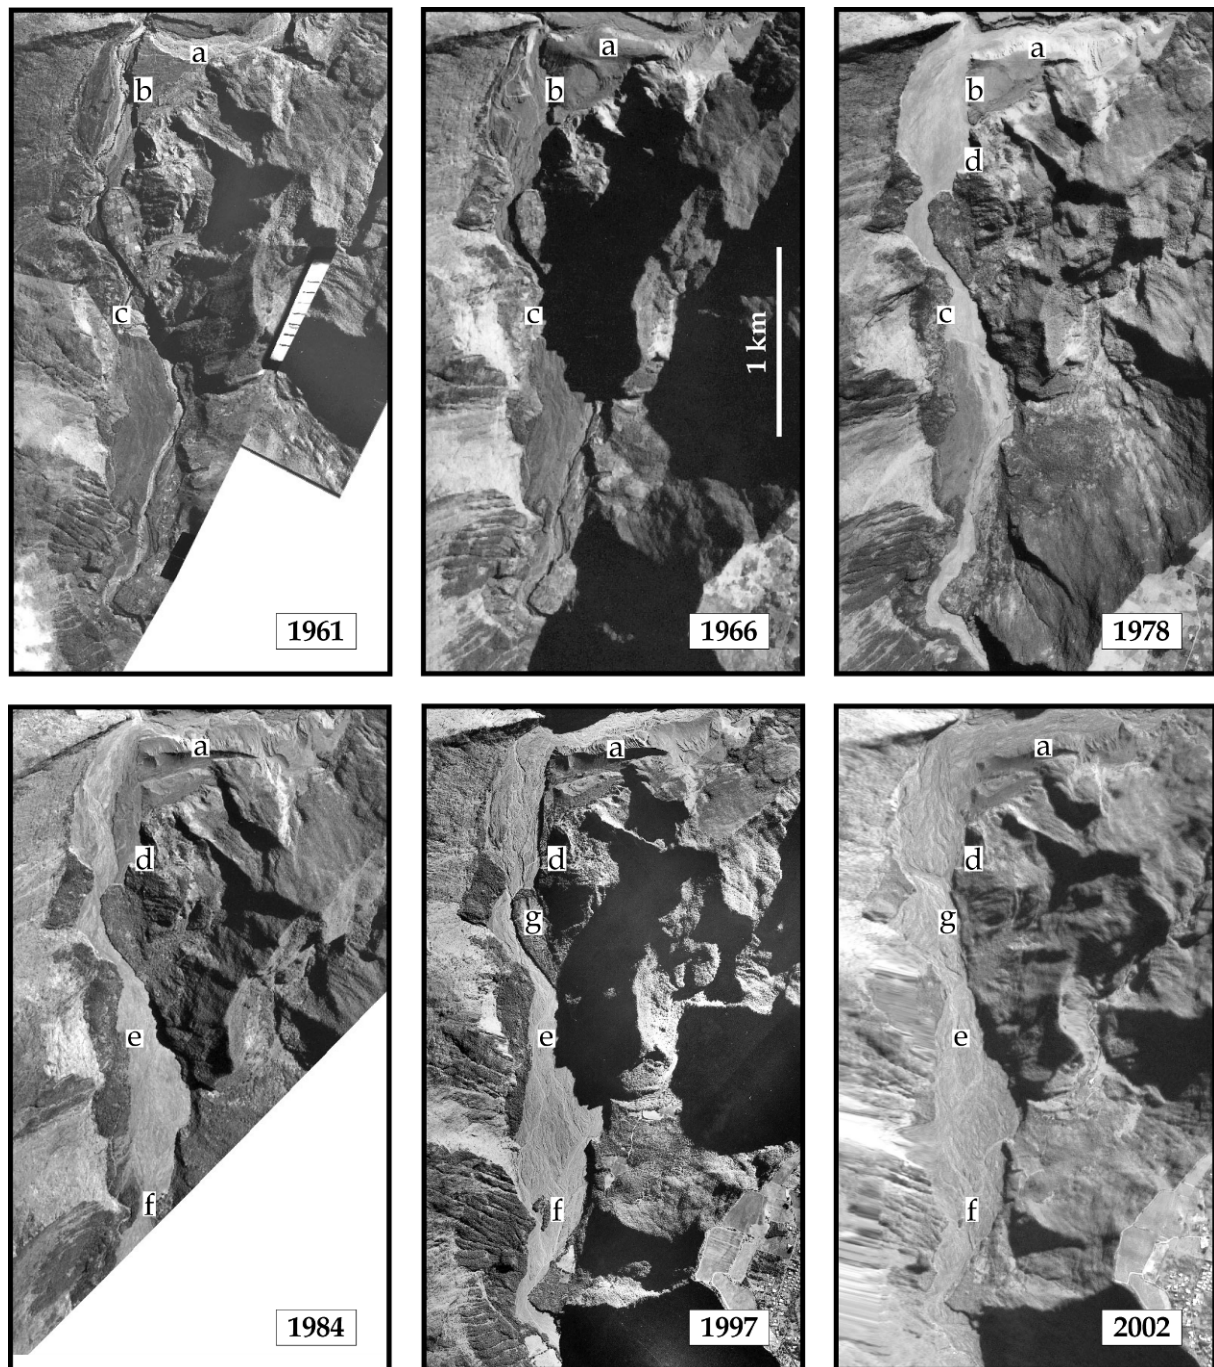
Plate 4. Remparts River evolution on aerial photographs (1961 to 1997) and SPOT5 image (2002), focused on the area downstream of confluence with the Mahavel reach (see location on figure 2).

Plate 4 shows the Remparts River just downstream of its confluence with the Mahavel reach. Sediment drift ("a") resulting from the Mahavel event and subsequent erosion can be recognized. At location "b", a preexisting channel less than 100 m wide in 1961 is partly filled by 1966, leading to the 400 m valley bottom being fully covered by sediments between 1966 and 1978. Further downstream meander "c" is also buried during this period. After 1978, the 400 m wide sediment-covered river bed is partially abandoned, thus forming a terrace ("d"). The terrace edge retreats towards the East between 1984 and 1997, because of local erosional activity of the river. In the same period, sediment supply leads to valley infilling and burying of vegetated banks downstream ("e" and "f"). This material may come from either local erosion upstream or sediment transfer from C2. Afterwards, a new sedimentation phase affects the whole river reach, in response to the 1996 major event. Terraces "d" and "g" are submerged beneath fresh sediments (see also Plate 2b), as the valley infill thickens at locations "e" and "f".

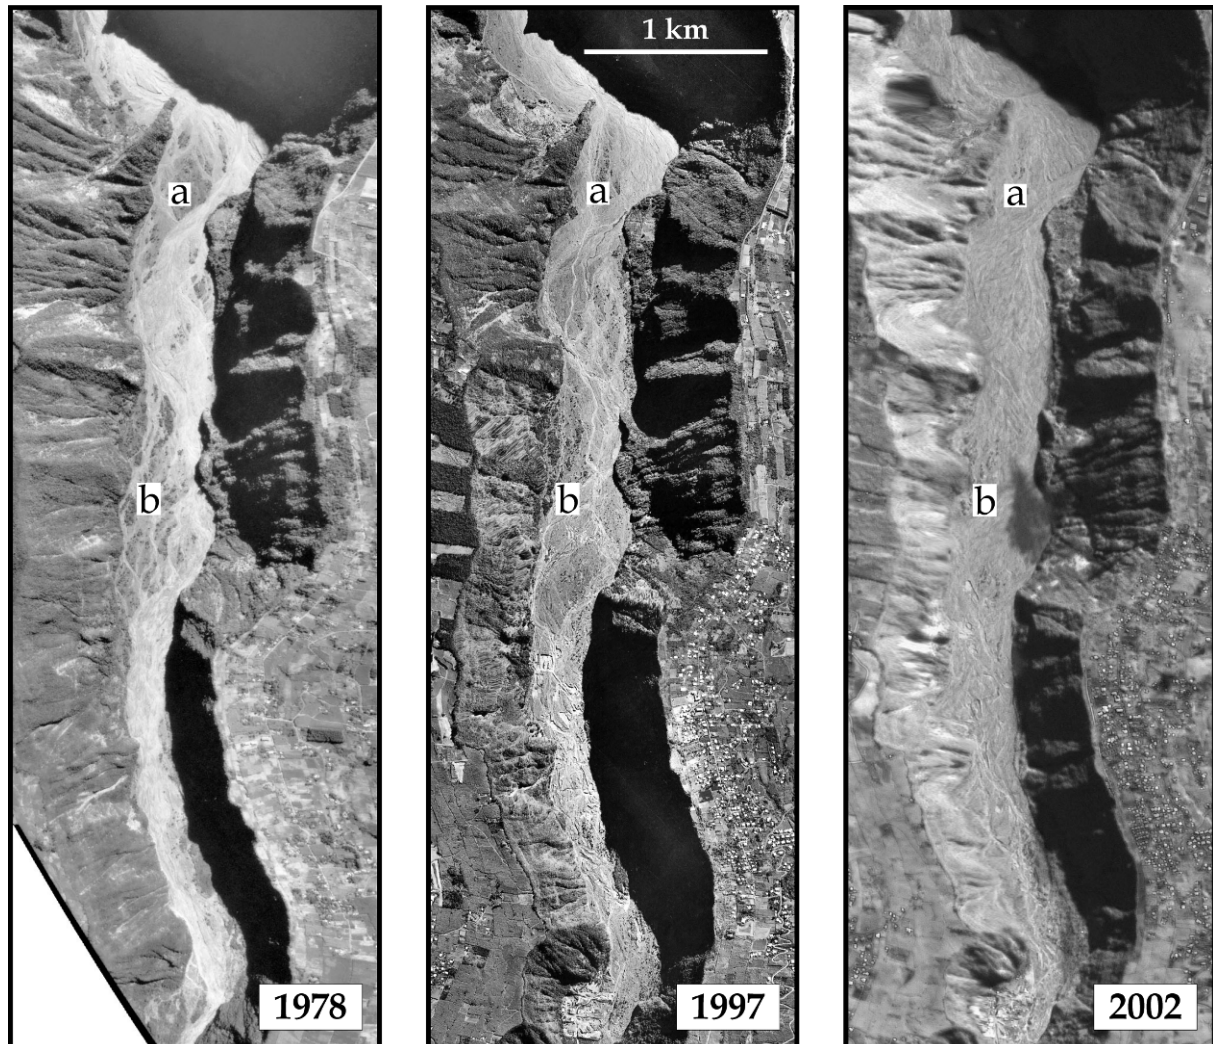
Plate 5. Remparts River evolution on aerial photographs (1978 and 1997) and SPOT5 image (2002), focused on the downstream part of Remparts River (see location on figure 2).

Plate 5 shows sediment transfer further downstream in the river (C3, not covered by the 1961 flight). Islets (local term for small islands) in the valley bottom which were still vegetated in 1978 (“a” and “b”) have been progressively submerged by sediment supply from upstream, until becoming barely visible on the 2002 image.

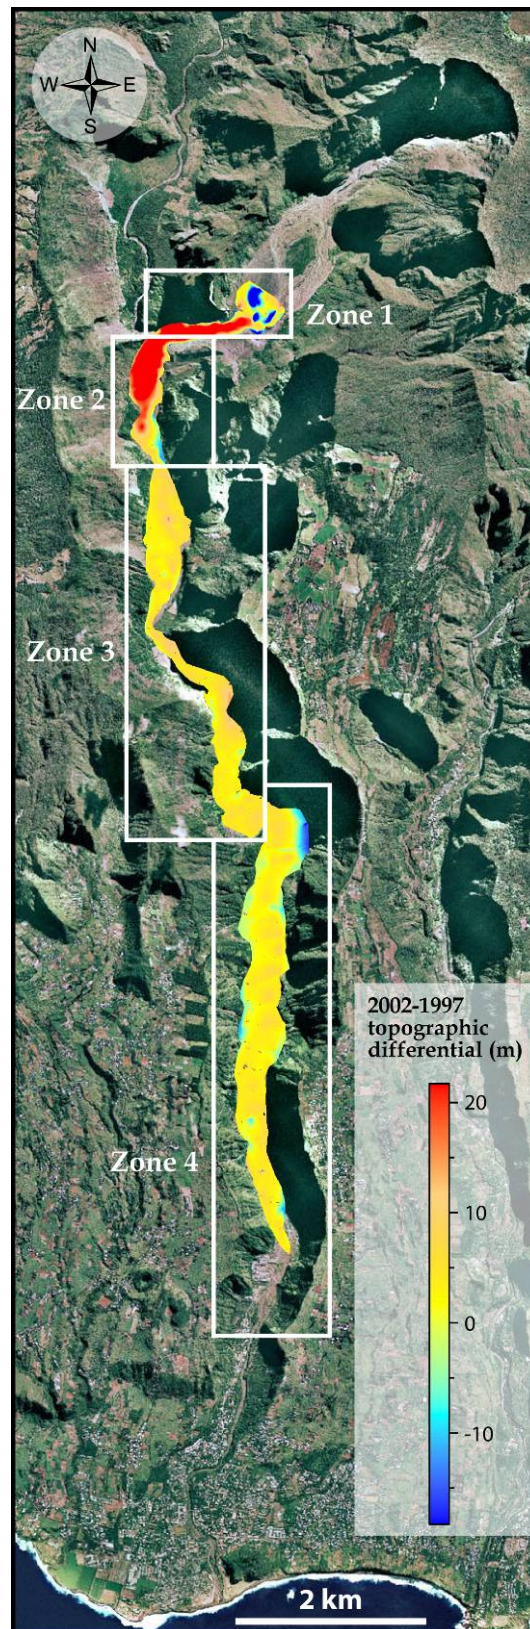
Figure 5. Map of interpolated differential topography between 1997 and 2002, superimposed to 1997 aerial orthophoto of the Remparts watershed. The area of calculation is splitted in 4 zones, a sediment budget being estimated for each (see table 4).

River bed topographical variation between 1997 and 2002 ranges from -18m to $+22\text{m}$. The global volume of sediment deposition on the study area reaches $8.9 \times 10^6 \text{ m}^3$, compared to an eroded volume of $0.85 \times 10^6 \text{ m}^3$. Eroded zones mainly correspond to places where fluvial incision or bank erosion prevails. Zone 1 especially, which covers the measured part of Mahavel Reach, corresponds to 41% of total eroded sediments, for a surface area of only 9% of the total area studied. On the contrary, the biggest volume of aggraded sediment border the confluence, and zones 1 and 2 correspond thus to 61% of total aggraded sediments, as they only cover 20% of total area. Erosion is almost not noticeable in zone 3, but still affects notably zone 4, the most downstream part of C3. Uncertainty on these volume estimations is very difficult to evaluate, as the uncertainty associated with the topographic data is unknown. However, comparison between several methods of surface interpolation show that uncertainties on volume estimations should not exceed 10%.

Table 4 : Estimated sediment budget for zones 1 to 4 (see location on figure 5); ΔZ is the variation in elevation between 1997 and 2002
