## **Tracing locations of new coating material during spark anodizing of titanium**

Endzhe Matykina, Frederic Louis Monfort, Ahmed Berkani, Peter Skeldon, George Thompson, Patrick Chapon

Endzhe Matykina, Frederic Louis Monfort, Ahmed Berkani, Peter Skeldon, George Thompson, et al.. Tracing locations of new coating material during spark anodizing of titanium. Philosophical Magazine, 2005, 86 (01), pp.49-66. <10.1080/14786430500300066>. <hal-00513598>

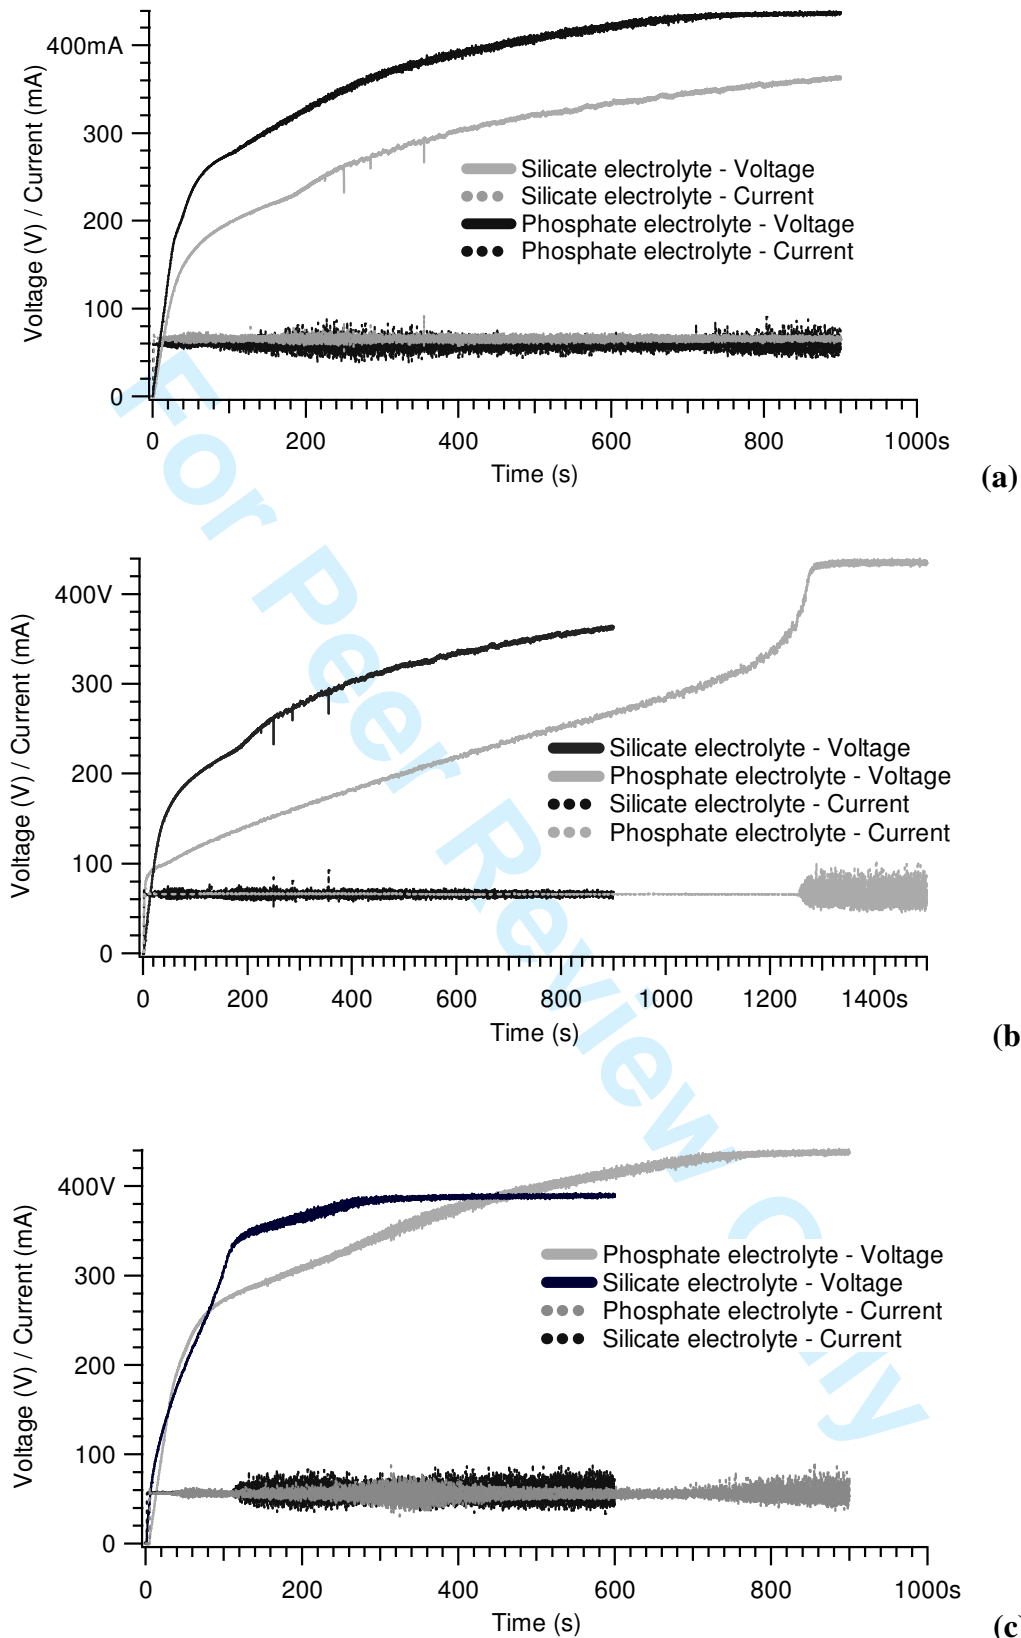
Figure 1. Voltage-time responses for titanium anodized at 2 A/dm<sup>2</sup> and 293 K (a) in individual silicate and phosphate electrolytes for 900 s; (b) in silicate electrolyte to 360 V for 1200 s, then in phosphate electrolyte to 435 V for 1500 s; (c) in phosphate electrolyte to 435 V for 900 s, then in silicate electrolyte to 380 V for 600 s.

The voltage-time behaviour for anodizing titanium in silicate electrolyte revealed an approximately linear region to 100 V, with a slope of about  $5 \text{ V s}^{-1}$ , followed by a

1  
2  
3 region of decreasing slope (Figure 1(a)). Visible sparking commenced at about 222 V,  
4  
5 with a pronounced inflection on the voltage-time curve evident shortly afterwards.  
6  
7 Fluctuations in the current record as early as 100 V suggested preceding film  
8  
9 breakdown without sparking. Such fluctuations follow sudden changes in coating  
10  
11 resistance due to the breakdown events. Gas evolution was observed soon after the  
12  
13 start of anodizing and persisted thereafter, with significant increase following onset of  
14  
15 sparking. A broadly similar voltage-time response was found for anodizing in  
16  
17 phosphate electrolyte, with sparking being observed from about 290 V (Figure 1(a)).  
18  
19 Both coatings were of uniform matt grey appearance, the coating from phosphate  
20  
21 electrolyte being slightly lighter. The difference in sparking voltages in the two  
22  
23 electrolytes can be attributed to the specific influences of the electrolyte constituents,

Figure 1(a). Voltage-time responses for titanium anodized at 2 A/dm<sup>2</sup> and 293 K: (a) in individual silicate and phosphate electrolytes for 900 s; (b) in silicate electrolyte to 360 V for 1200 s, then in phosphate electrolyte to 435 V for 1500 s; (c) in phosphate electrolyte to 435 V for 900 s, then in silicate electrolyte to 380 V for 600 s.

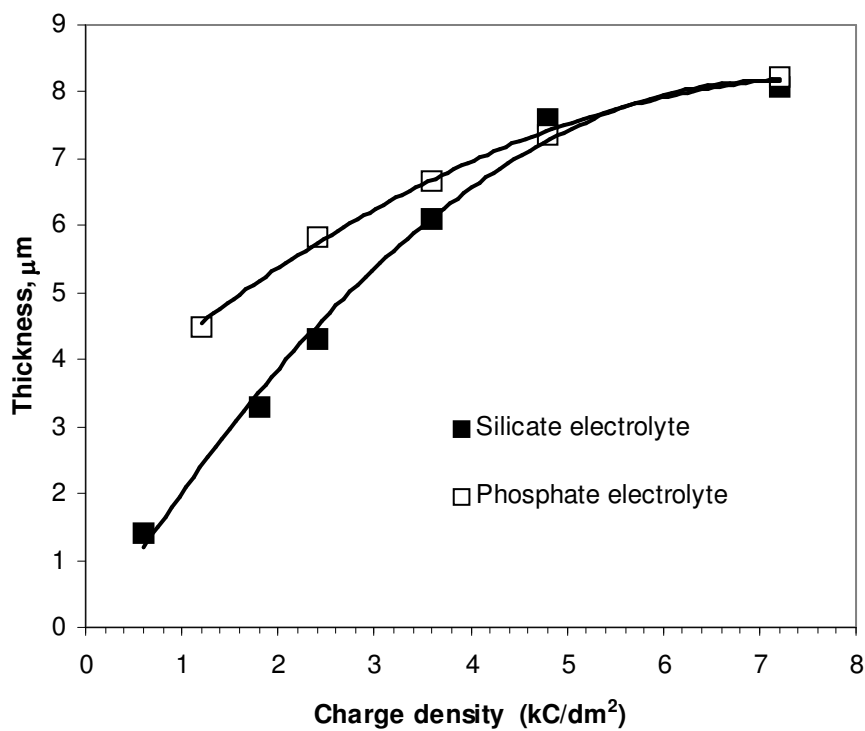
Figure 2. Dependence of coating thickness on charge density for titanium anodized at 2 A/dm<sup>2</sup> in silicate and phosphate electrolytes at 293 K

39 The coatings revealed a decreasing rate of thickening with progress of anodizing in  
40  
41 both phosphate and silicate electrolytes (Figure 2). The efficiency of coating growth,  
42  
43 estimated from the coating thickness and the charge passed during anodizing, with the  
44  
45 assumption of formation of anatase, decreased with progress of anodizing, with  
46  
47 average efficiencies in both electrolytes of about 20 % for the thickest coatings  
48  
49 investigated, about 8  $\mu\text{m}$  (Table 1).  
50  
51  
52  
53  
54

Figure 2. Dependence of coating thickness on charge density for titanium anodized at 2 A/dm<sup>2</sup> in silicate and phosphate electrolytes at 293 K

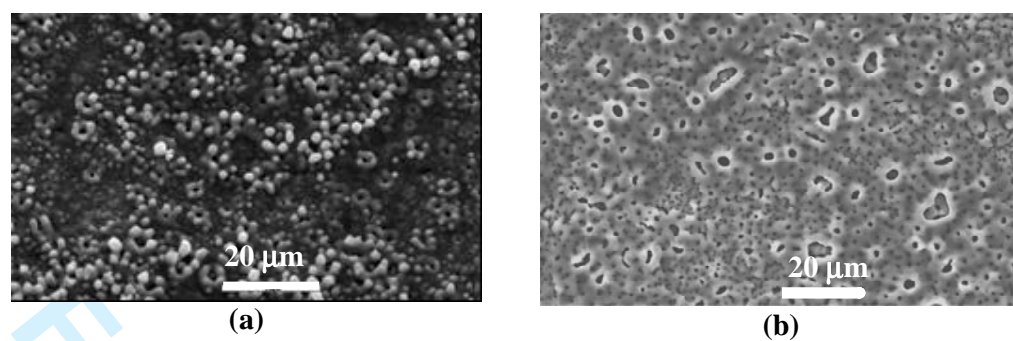
Figure 3. Scanning electron micrographs of titanium anodized at  $2 \text{ A/dm}^2$  and 293 K: a) in silicate electrolyte to 360 V for 900 s; b) in phosphate electrolyte to 435 V for 900 s.

The surfaces of coatings developed in the sparking regions of both electrolytes revealed usual pores, typically in the micron size range, associated with breakdown sites (Figure 3). Nodular and raised ring-like features were conspicuous around pores of the coatings formed in silicate electrolyte, but not for the coatings produced in the phosphate electrolyte, which also exhibited some elongated pores.

Figure 3. Scanning electron micrographs of titanium anodized at 2 A/dm<sup>2</sup> and 293 K: a) in silicate electrolyte to 360 V for 900 s; b) in phosphate electrolyte to 435 V for 900 s.

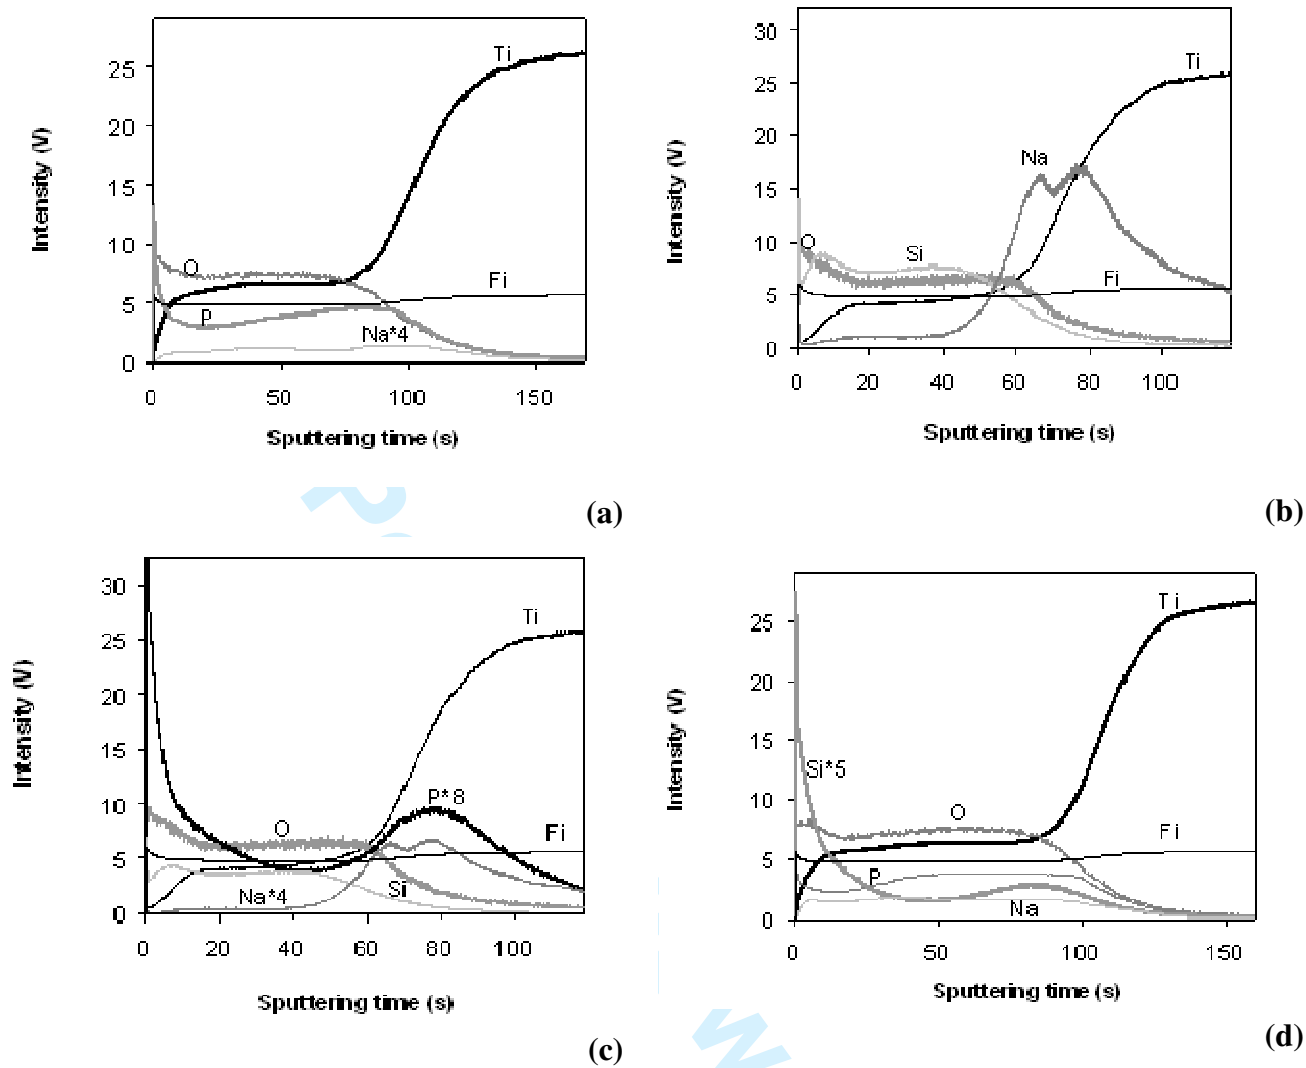
Figure 4. GDOES depth profiles of titanium anodized at 2 A/dm<sup>2</sup> and 293 K: a) in phosphate electrolyte to 435 V for 900 s; b) in silicate electrolyte to 360 V for 900 s; c) in silicate electrolyte to 360 V for 1200 s followed by anodizing in phosphate electrolyte to 435 V for 1200 s; d) in phosphate electrolyte to 435 V for 900 s, followed by anodizing in silicate electrolyte to 380 V for 600 s. The line labeled Fi characterizes change of the sputtering rate.

GDOES profiles for the coating formed in phosphate electrolyte revealed oxygen, phosphorus and titanium in most regions of the coating at the available depth and lateral resolutions (Figure 4(a)). Similarly, oxygen, silicon and titanium were distributed throughout the thickness of coatings formed in silicate electrolyte (Figure 4(b)). Both coatings also contained sodium species, which appeared to be present in most regions of the coating, with an increased amount near to the metal. Potassium, which was not determined in the present analyses, is probably distributed similarly to sodium. The time to reach the metal/coating interface, estimated from the half-height of the back edge of the oxygen signal, was about 96 s, compared with about 68 s for the coating formed in silicate electrolyte, due to differences in sputtering rates and coating thicknesses (Figure 2, Table 1). For these and for later specimens, the oxygen signal increased near to the coating surface, while the titanium signal decreased, which may be related to the presence of either increased amounts of silicon and phosphorus species or surface contamination by hydrocarbons.

GDOES depth profiles revealed phosphorus and silicon species at the coating surface and throughout most of the coating depth, along with the expected oxygen and titanium species (Figure 4(c)). The phosphorus signal, which is magnified to ease observation, falls steeply during the initial 7 s of sputtering, i.e. in about 10 % of the time for sputtering to the average thickness of the coating, indicative of a comparatively thin phosphorus-enriched outer layer, consistent with SEM. The phosphorus signal also rises near the metal/coating interface, with the peak intensity lying below the depth of the average location of the interface, suggesting locally thicker phosphorus-containing material. The ratio of the silicon and oxygen signals in the coating formed sequentially was reduced compared with that for the coating formed in the individual silicate electrolyte. The time to sputter through the coating formed sequentially, about 72 s, was similar to that for the coating formed in silicate electrolyte. Sodium was distributed throughout the coating, with a significant increase near the metal. The sodium signal near the metal appeared to comprise two peaks, the inner peak correlating with the location of the phosphorus peak. XRD indicated the presence of anatase and rutile in the coating, with about 65% amorphous material (Figure 5).

The magnified GDOES profile for silicon disclosed a relatively high concentration the near surface region (Figure 4(d)). Phosphorus and silicon species were present throughout the remainder of the coating thickness, at the available resolution, with silicon increasing near to the metal/coating interface. The ratio of intensities of the phosphorus and oxygen signals was similar to the value for the coating formed in the individual electrolyte, while the corresponding ratio for silicon and oxygen was much reduced. The silicon peak near to the metal was not displaced below the depth of the main coating, contrary to findings for the phosphorus peak for the reverse sequence of electrolytes. Sodium was found at all depths in the coating. The time to sputter through the coating was increased to about 102 s, compared with 72 s for the previous experiment, correlating with the enhanced coating thickness determined in cross-sections. The SEM and GDOES data are consistent with relatively uniform growth of coating material in the second stage of anodizing, unlike the incomplete surface coverage achieved previously when anodizing lastly in the phosphate electrolyte.

Figure 4. GDOES depth profiles of titanium anodized at 2 A/dm<sup>2</sup> and 293 K: a) in phosphate electrolyte to 435 V for 900 s; b) in silicate electrolyte to 360 V for 900 s; c) in silicate electrolyte to 360 V for 1200 s followed by anodizing in phosphate electrolyte to 435 V for 1200 s; d) in phosphate electrolyte to 435 V for 900 s, followed by anodizing in silicate electrolyte to 380 V for 600 s. The line labeled Fi characterizes change of the sputtering rate.

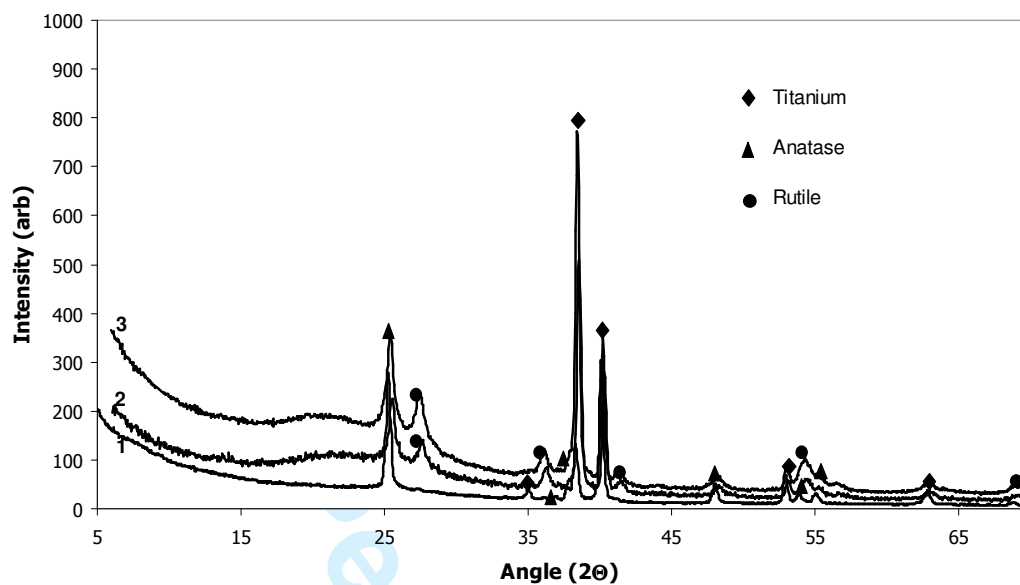
Figure 5. X-ray diffraction data of titanium anodized at 2 A/dm<sup>2</sup> and 293 K: 1) in phosphate electrolyte to 435 V for 900 s; 2) in silicate electrolyte to 360 V for 1200 s followed by anodizing in phosphate electrolyte to 435 V for 1500 s; 3) in silicate electrolyte to 360 V for 1200 s.

X-ray diffraction indicated coatings formed in silicate and phosphate electrolytes comprised about 35 and 94 % crystalline phases, consisting of anatase and rutile, with the remainder being amorphous material (Figure 5). Anatase was the main phase in the coating formed in phosphate electrolyte, with a shorter anodizing time, 900 s, than that of the coating formed in silicate electrolyte, 1200 s, which contained relatively more rutile.

Figure 5. X-ray diffraction data of titanium anodized at 2 A/dm<sup>2</sup> and 293 K: 1) in phosphate electrolyte to 435 V for 900 s; 2) in silicate electrolyte to 360 V for 1200 s followed by anodizing in phosphate electrolyte to 435 V for 1500 s; 3) in silicate electrolyte to 360 V for 1200 s.

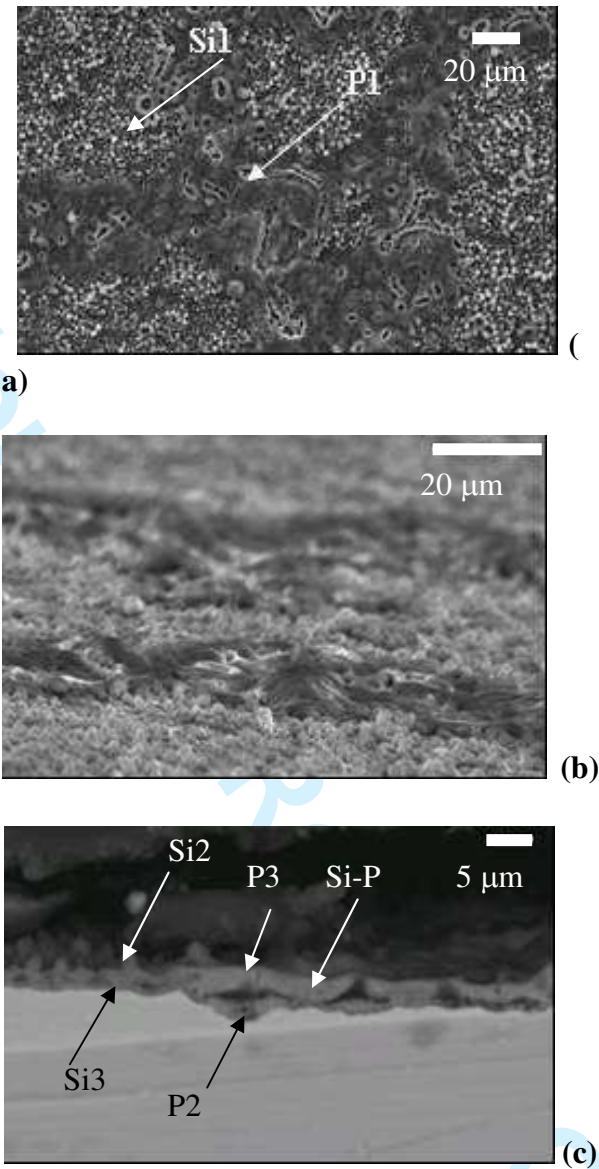
Figure 6. Scanning electron micrographs of titanium anodized at  $2 \text{ A/dm}^2$  in silicate electrolyte to 360 V for 1200 s followed by anodizing in phosphate electrolyte to 435 V for 1500 s: a) plan view; b)  $75^\circ$  tilt; c) ultramicrotomed cross-section.

Scanning electron micrographs of the coating surface disclosed two distinct regions of breakdown morphologies characteristic of the individual silicate and phosphate electrolytes, i.e. nodular features formed in silicate electrolyte and a flatter surface formed in phosphate electrolyte (Figure 6(a)). Evidently, the re-anodizing period in phosphate electrolyte was too short to produce a uniform surface characteristic of the phosphate electrolyte. In accordance with the morphological evidence, EDX analysis confirmed the presence of silicon, but little or no phosphorus, in the nodular region, while phosphorus and a reduced amount of silicon were detected in the relatively flat region (Figures 6(a) and 7, Table 3, in which the point analyses at phosphorus-rich and silicon-rich regions are labeled P and Si, followed by a number, respectively). Thus, about 22 at.% silicon, and less than about 0.3 at.% phosphorus, were identified at the nodular regions, compared with respective values of 0.6 at.% silicon and 7.6 at.% phosphorus at flat regions, with no major influence of the accelerating voltage. Titanium and oxygen were also identified at both regions, in amounts consistent with the presence of titanium oxide, and other oxygen-containing species, although the accuracy of the analyses was not sufficiently high to provide stoichiometric relationships. The analysis over the whole of the imaged area indicated reduced concentrations of phosphorus and silicon, 4.5 and 6.7 at.% respectively, compared with the phosphorus- and silicon-rich regions respectively, as expected (Figure 7, Table 3). At the edge of the phosphorus-containing material, silicon-rich nodules stand proud, indicating a low thickening of the coating by growth at the coating/electrolyte interface (Figure 6(b)). The distribution of surface breaking pores, with dark appearance, suggests that the regions of breakdown in phosphate electrolyte are made up of surface elements comprising a central pore and surrounding flat material extending to about 10  $\mu\text{m}$ .

EDX analyses of a cross-section prepared by ultramicrotomy disclosed regions of the coating where, in addition to titanium and oxygen, mainly silicon was present throughout the coating thickness, with increased levels of silicon in nodules (Figures 6(c) and 7, Table 3). Thus, analysis of a nodule revealed 11 at.% silicon, while about 10 at.% silicon was detected in underlying material. Phosphorus levels were usually

Figure 6. Scanning electron micrographs of titanium anodized at  $2 \text{ A/dm}^2$  in silicate electrolyte to 360 V for 1200 s followed by anodizing in phosphate electrolyte to 435 V for 1500 s: a) plan view; b)  $75^\circ$  tilt; c) ultramicrotomed cross-section.

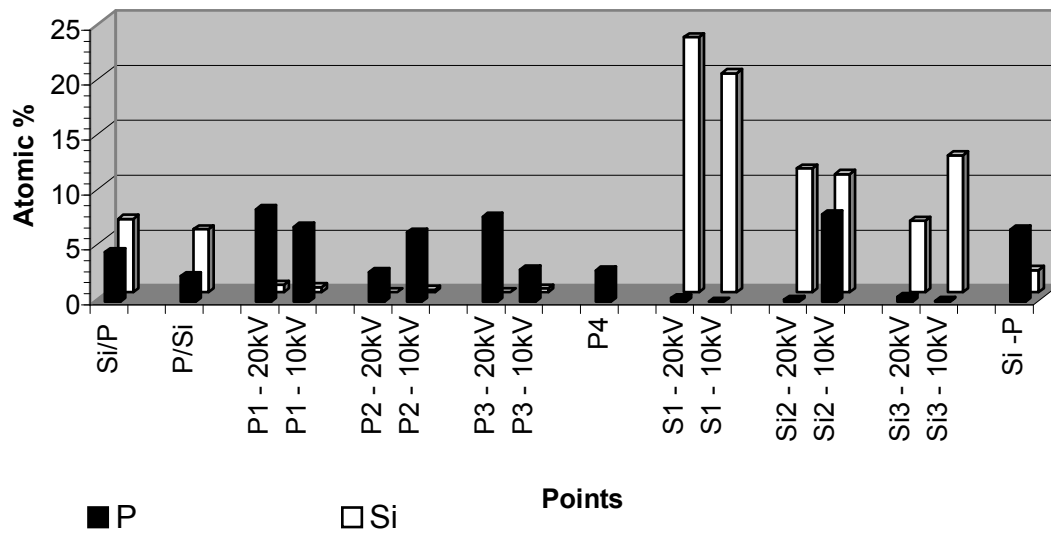
Figure 7. Results of EDX analysis of the coatings at the points specified in Figs 6 and 8.

below 0.4 at.%, although an increased value was indicated at the nodule at an accelerating voltage of 10 kV. In adjacent parts of the coating, where the thickness increased locally, mainly phosphorus was detected, at levels of about 5 at.%, including near to the metal, while silicon was a comparatively negligible constituent, below about 0.3 at.%. The dependence of analyses on accelerating voltage, is probably due to roughness, the possible presence of cavities, and non-uniformity of coating composition with depth. Notably, cavities of size up to several microns were evident particularly in the inner part of the coating, with some cavities connecting to the pores at the coating surface. At a region located between two adjacent, phosphorus-rich sites, associated with breakdown in phosphate electrolyte, both phosphorus and silicon were detected at levels of about 2.0 and 6.6 at.% respectively (Figure 7, Table 3).

formed in phosphate electrolyte. EDX analysis of the imaged area revealed about 2.3 at.% phosphorus and 5.7 at.% silicon (Figure 7, Table 3).

Figure 7. Results of EDX analyses of the coatings at the points specified in Figs 6 and 8.

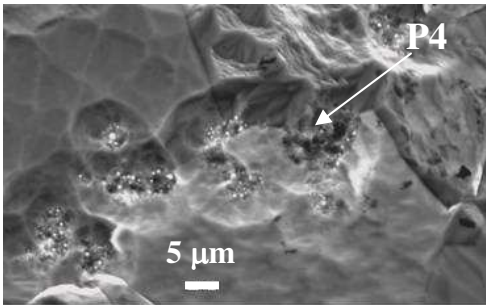
Figure 8. Scanning electron micrograph titanium after sputtering of the coating produced by anodizing at 2 A/dm<sup>2</sup> and 293 K to 360 V at in silicate electrolyte for 1200 s followed by anodizing to 435 V in phosphate electrolyte for 1200 s.

EDX analyses were also carried out at residues of the coating material observed in scanning electron micrographs of the bottom of the sputtering crater created during GDOES profiling, disclosing phosphorus, but not silicon, species (Figure 8, Table 3). The apparent phosphorus concentration was 2.8 at.%, although the electron beam penetrated to the underlying metal, as evident by the enhanced signal from titanium. The pattern of regions containing residual coating material was similar to that of the breakdown tracks formed in the phosphate electrolyte at the coating surface. The finding indicates that the location of the interfacial phosphorus peak in the GDOES profile is due to locally deeper regions of phosphorus-containing coating material.

Figure 8. Scanning electron micrograph titanium after sputtering of the coating produced by anodizing at  $2 \text{ A/dm}^2$  and 293 K to 360 V at in silicate electrolyte for 1200 s followed by anodizing to 435 V in phosphate electrolyte for 1200 s.

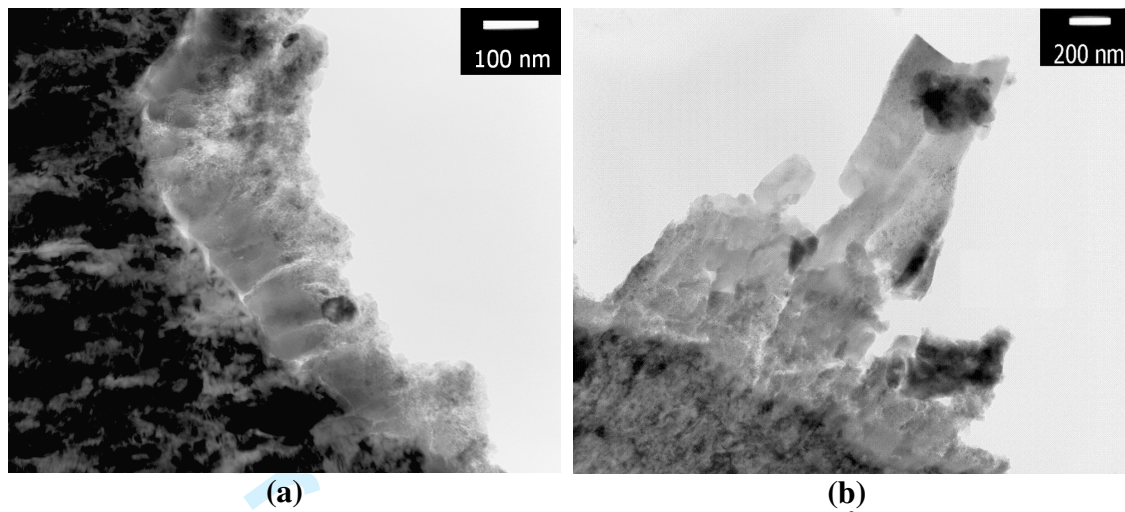
Figure 9. Transmission electron micrographs of titanium anodized at 2 A/dm<sup>2</sup> and 293 K to 360 V in silicate electrolyte for 1200 s followed by anodizing to 435 V in phosphate electrolyte for 1500 s. (a, b) – different areas of the section.

Transmission electron micrographs of the coating revealed amorphous and crystalline material, located both next to the metal and at more remote regions (Figure 9). The sectioning resulted in mechanical damage to the coating, which limited observations mainly to the inner material of the coating layer.

Examination, by TEM, of the coating formed sequentially in silicate then phosphate electrolytes revealed amorphous and crystalline regions of oxide near the metal. During anodizing near 293 K in the absence of sparks, amorphous titania forms by migration of  $\text{Ti}^{4+}$  ions outward and  $\text{O}^{2-}$  ions inwards, with a transport number of about 0.35 for the cations [17]. The migration process involves movements of ions by atomic distances, without short-circuit transport. Growth of crystalline anodic titanium oxide may be associated with increased anion transport by a largely short-circuit mechanism, according to the evidence of other oxides [18]. Ionic transport in the coating material formed under sparking is likely to be affected by high current densities and temperatures produced by the localization of the current at the breakdown sites, as well as the modification of the oxide by incorporation of phosphorus and silicon species. Oxygen is also generated at sites of crystallinity in anodic titania, the gas initially being retained within the oxide prior to its release as the film ruptures [19]. Incorporation of foreign species into amorphous titania from either the electrolyte or from the metal can inhibit the transformation of amorphous material to a crystalline form and hence, suppress generation of oxygen [16]. Silicon species appear to be more effective than phosphorus species in stabilizing amorphous phases of the present coatings. In addition to generation associated with crystalline oxide, oxygen, together with peroxide, can also be formed in the discharge channel, possibly by plasma-chemical reactions or dissociation of water [20]. Further, altered near-surface pH through generation of hydrogen ions during growth of anodic oxide can lead to changes in the chemistry of the solution and deposition of gels [21]. Such altered surface chemistries may facilitate incorporation of electrolyte species into the coating material by reaction with either ionic or molecular entities in the solution or deposits

Figure 9. Transmission electron micrographs of titanium anodized at  $2 \text{ A/dm}^2$  and 293 K to 360 V in silicate electrolyte for 1200 s followed by anodizing to 435 V in phosphate electrolyte for 1500 s. (a,b) – different sections.

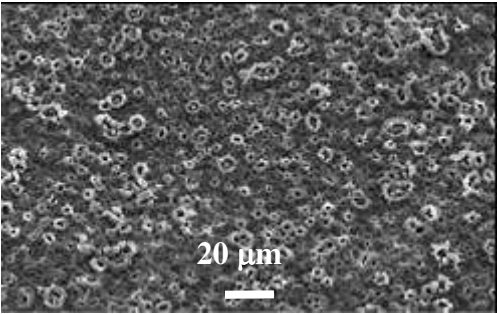
Figure 10. Scanning electron micrograph of titanium anodized at 2 A/dm<sup>2</sup> and 293 K to 435 V in phosphate electrolyte to 435 V for 900 s followed by anodizing to 380 V in silicate electrolyte for 600 s.

The surface of the coating contained raised features around pores, reminiscent of breakdown in silicate electrolyte, although nodules were absent, possibly associated with the increased final voltage and influence of pre-existing phosphorus-containing material (Figure 10). There was no obvious coating material characteristic of a surface

Figure 10. Scanning electron micrograph of titanium anodized at  $2 \text{ A/dm}^2$  and 293 K to 435 V in phosphate electrolyte to 435 V for 900 s followed by anodizing to 380 V in silicate electrolyte for 600 s.
