Rupture de fibre : comparaison entre un modèle écrit a l'échelle microstructural et une détection du phénomène par tomographie très haute résolution

Fibre fracture : comparison between a multi-scale microstructural model and high resolution computed tomography experimental

A.E. Scott¹, I. Sinclair¹, S.M. Spearing¹, M. Mavrogordato¹, A. Bunsell², A. Thionnet^{2,3}

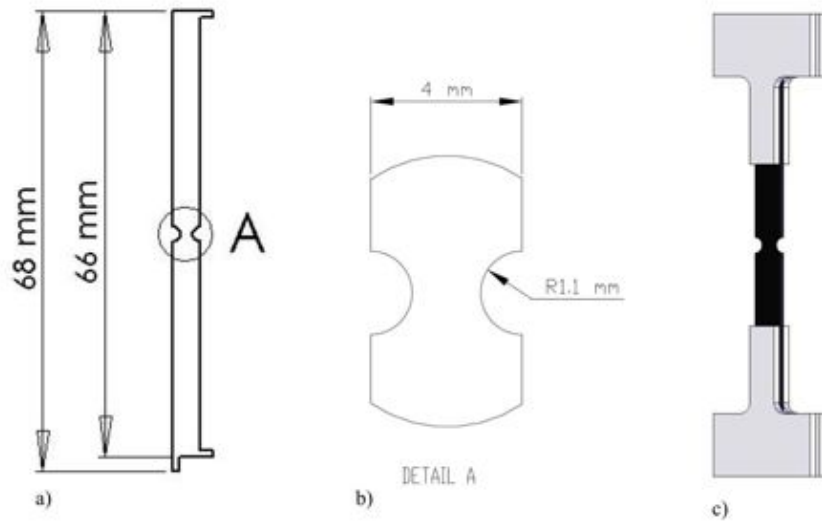
Laminated $[0^\circ/90^\circ]_s$ T700 aerospace grade carbon fibre pre-preg specimens were provided by Airbus and prepared by Wright *et al.* [8] for tensile loading. The double edge notches were machined using an abrasive waterjet to the geometry shown in Figure 1. The notched samples were used to ensure all damage mechanisms close to final failure could be captured. A sparse population of small aluminium particles ($\approx 4\mu m$) were embedded into the laminates for fiducial markers.

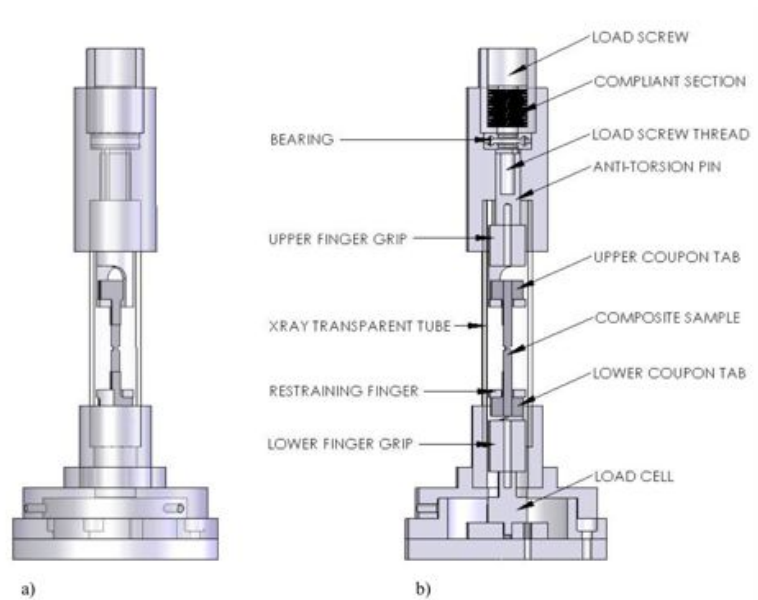
A screw driven load frame, Figure 2 was used to load the samples in situ to failure. The samples were taken to incremental loads up to final failure. At each load step the samples were imaged at ID19 beamline at the European Synchrotron Radiation Facilities (ESRF) in Grenoble.

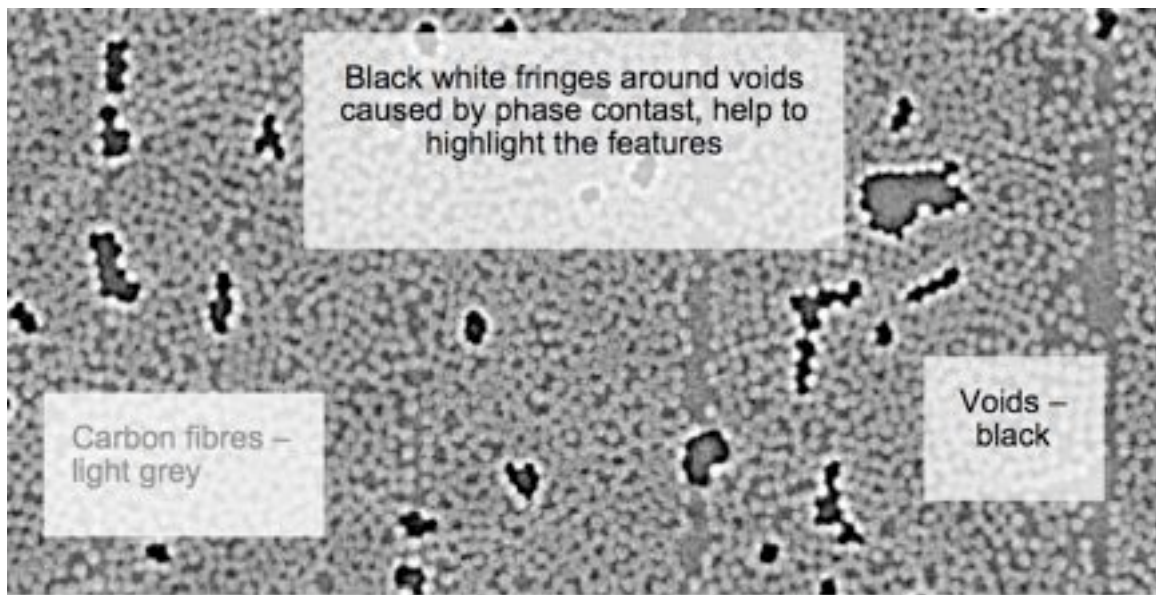
FIG. 3 – Example of absorption and phase contrast imaging.

ID19 beamline routinely achieves resolutions of $300nm$ and with specialised optics can achieve even high resolutions. The optics used in this studied enabled a voxel resolution of $1.4\mu m$ to be achieved. The coherent beam available from the synchrotron makes it possible for phase contrast imaging to be used, so an edge detection method can be exploited. This enables a crack opening of $1/10$ th of the voxel size to be distinguishable and assists in finding small features such as fibre breaks.

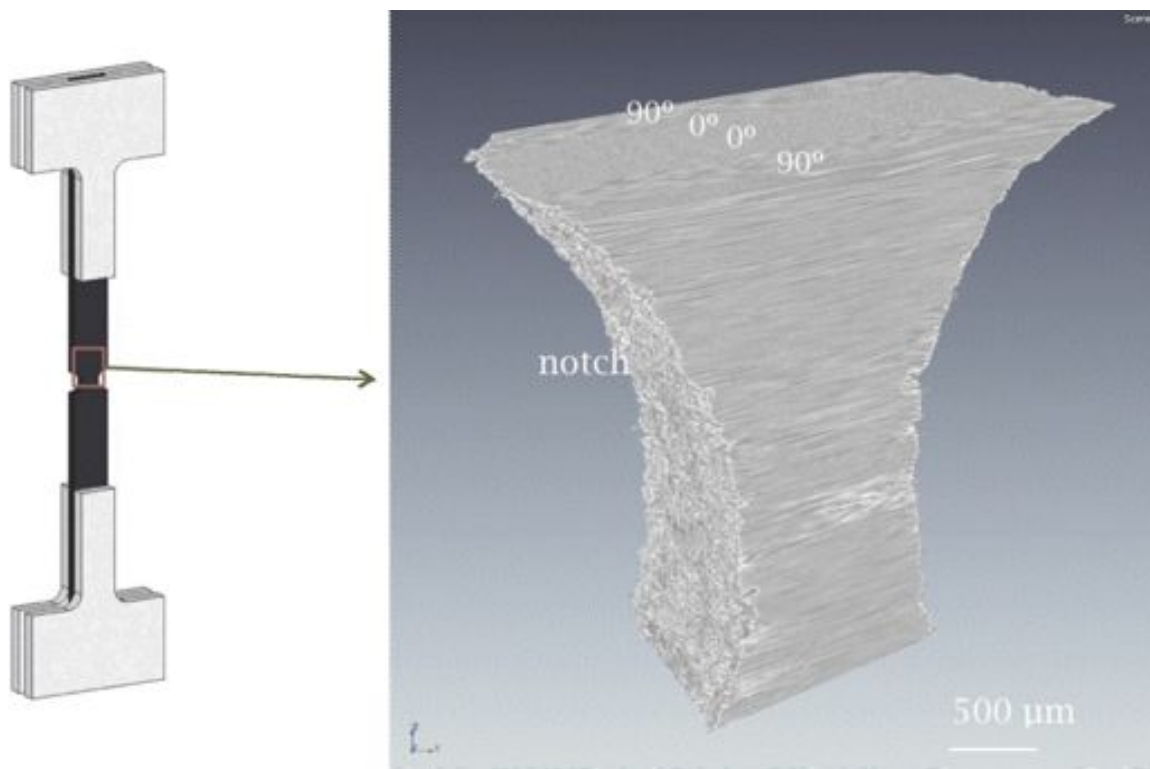
FIG. 4 – 3D reconstruction of notched sample.

Figure 4 shows the location in which the sample has been analysed and identifies the ply layup on a 3D reconstructed volume. The in-situ loading enables the damage progression to be identified up to failure, where Figure 5 shows the crack propagation in the same sample taken up to failure at 10% increments of the ultimate tensile strength, UTS. The transverse ply cracks occur early on in loading at 30% of the UTS. Further loading induces 0° splits which are then followed by delaminations.

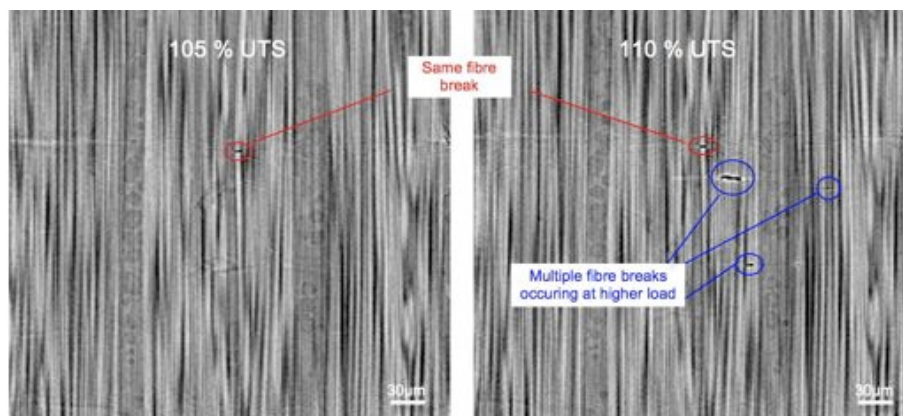
FIG. 6 – Fibre break accumulation in the same sample at different load increments.

The 3D capabilities of the CT imaging enables all fibre breaks to be identified in the sample through out the whole imaged volume. Figure 6 shows fibre breaks in exactly the same sample at two load increments. The same locations can be found in both samples using the marker particles. It is possible to see the accumulation of fibre breaks occurring with increasing load. Figure 9 shows a graph of the accumulation fibre breaks occurring in the samples with increasing load. The results show a

The accumulation of fibre breaks with load can be captured, where an acceleration of fibre breaks occurs beyond 90% of the failure load. The formation of fibre clusters is also identified, where the largest cluster was found to be 12 neighbouring fibre breaks at 94% of the failure load.

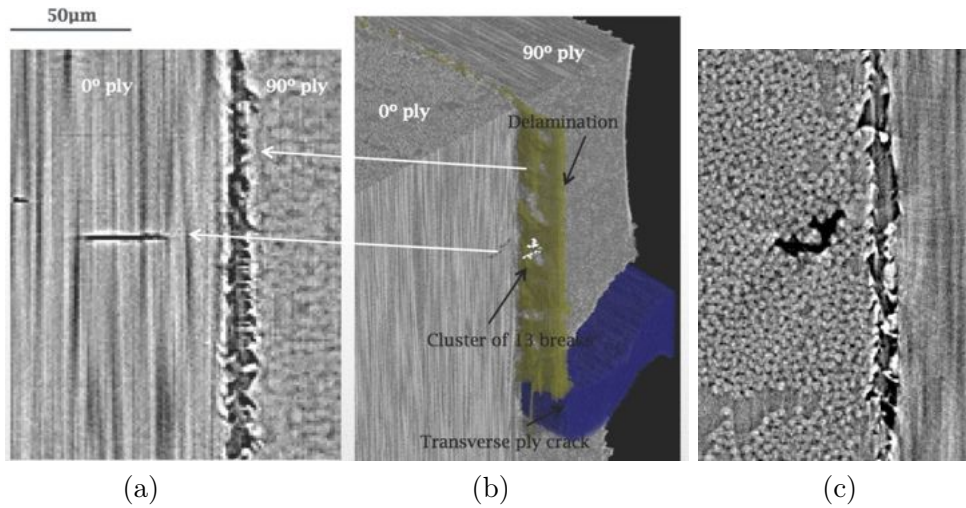
FIG. 7 – Fibre break identification, a) view of cluster aligned with fibres, b) 3D view, part of composite made transparent to reveal cluster, c) view of cluster face onto fibres.

It has also been possible to capture the growth of fibre clusters. Table 1 shows the cluster formation with increasing load. At 94% of the failure load 3 large clusters were found, consisting of 6, 8 and 12 neighbouring fibres. The largest of which can be seen in Figure 7. Where it is possible to view the clusters at all orientations and in 3 dimensions.

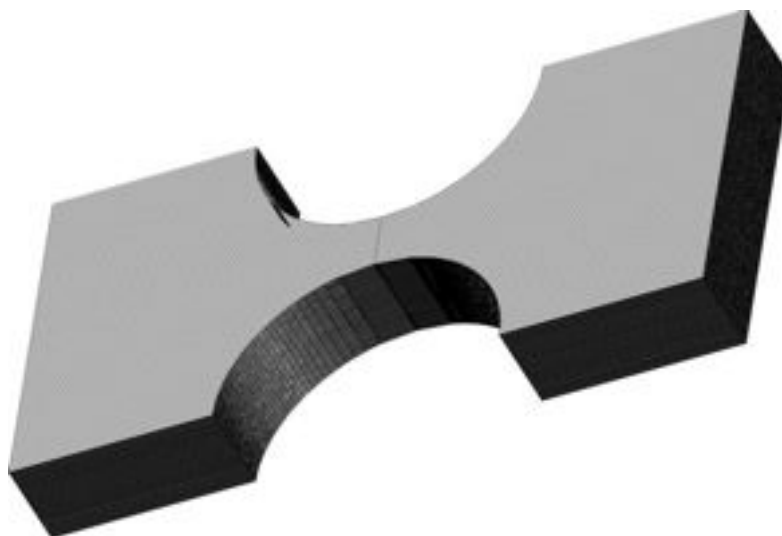
FIG. 8 – Mesh of the notched specimen.

The simulations have been carried out by the Finite Element Method (Figure 8) employing the Zebulon code developed at the Mines Paristech using a simplified FE^2 multiscale process [37]. There is good correlation between the observations and simulations. In addition, the simulations show that close to the final fracture of the sample, the fibre breaks no longer appear at random but group to form clusters which indicate the beginning of (unstable) rupture of the sample [37].
