A thermographic study of the on-off behavior of an all-refrigerator

1. Abstract

Keywords: household refrigerator; thermography; heat exchanger; cooling system

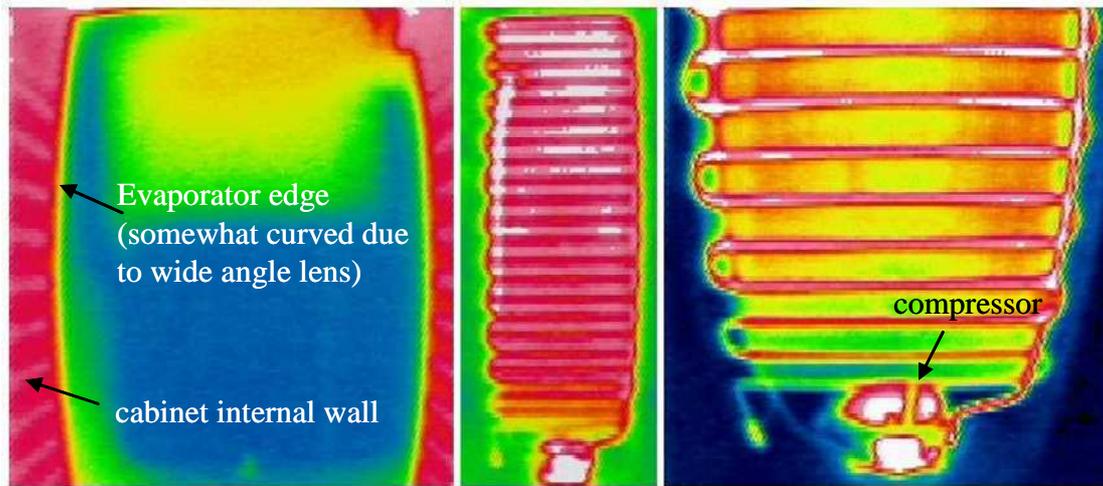
Figure 1 Images from the infrared films five minutes after a compressor start. From the left: evaporator, the entire condenser and a close-up of the lower half of the condenser. The compressor is seen as a large warm object at the bottom of the condenser.

(each on-off period at similar length) the variations in the surface temperatures of the evaporator and condenser were recorded. The temperatures of the lower half part of the condenser were also separately recorded from close range to give a more detailed picture. The experiments were carried out in the following way: At 25°C ambient temperature and the refrigerator thermostat set to warmest possible (averaged air temperature in the cabinet 7.2 °C) the refrigerator was running until it was steadily cycling. Then the evaporator was filmed during one on-off period. Next, the video camera was repositioned to capture one on-off period of the whole condenser and thereafter the lower part of the condenser. Finally, the three video recordings (evaporator, overall condenser and condenser close-up) were synchronised so that images of the evaporator and condenser could be viewed side by side displaying the same moment in the on-off period. This was done by synchronising the condenser films to the evaporator film. They were synchronised at two moments in the on-off period; the moment when the compressor started, and the moment when the compressor stopped. This means that the images showing the evaporator and condenser comes from similar, but not the same, on-off period. However, the temperature recordings and the evaporator films come from the same on-off period. Figure 1 shows an example of the synchronised videos.

Figure 1 Images from the infrared videos captured five minutes after a compressor start. From the left: evaporator, the entire condenser and a close-up of the lower half of the condenser. The compressor is seen as a large warm object at the bottom of the condenser.

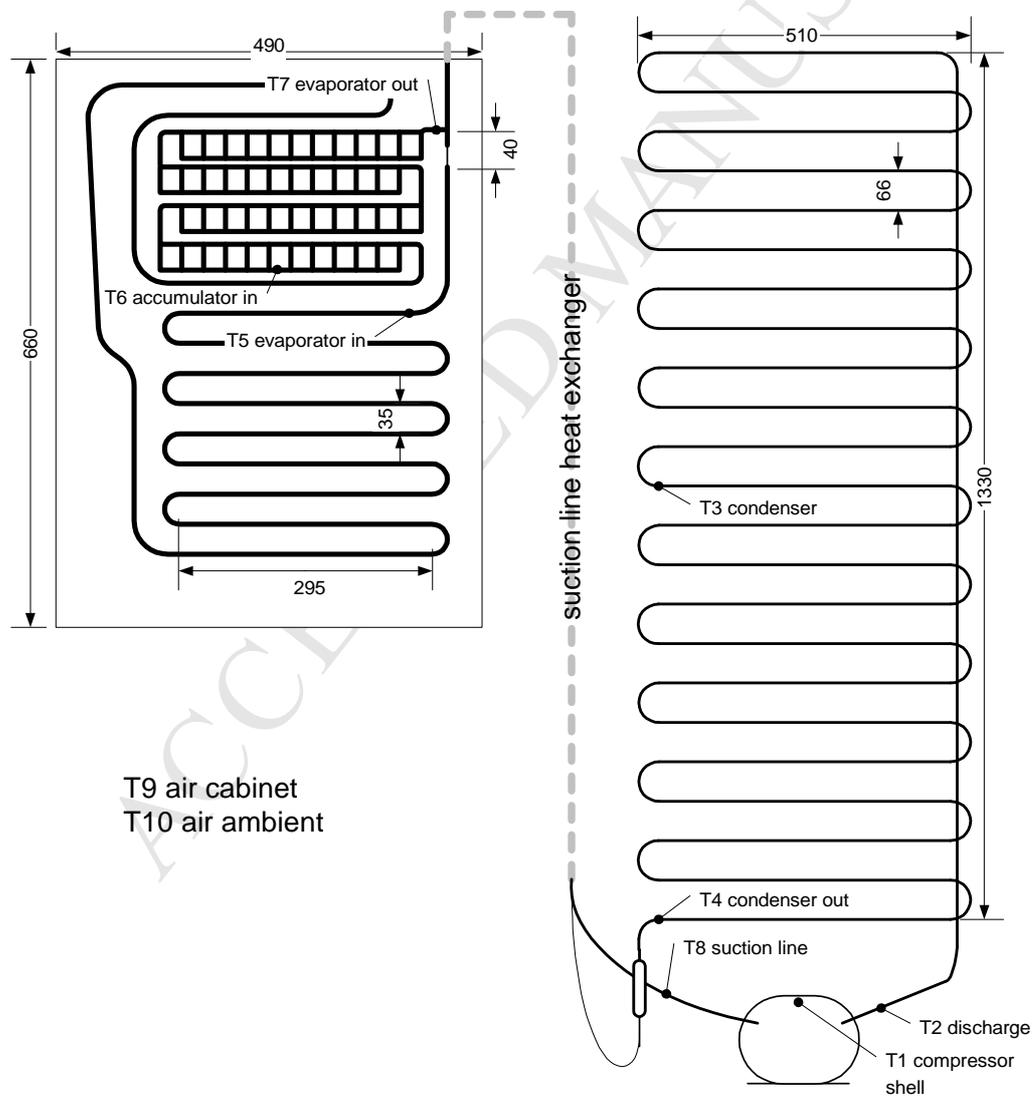
Figure 2 Cooling system and thermocouple locations

Figure 2 Cooling system and thermocouple locations

In Figure 2 the overall cooling system is displayed in a schematic view together with the thermocouple locations.

The experimental set-up with the IR-camera pointing through the inspection opening in the door can be seen in Figure 3 and Figure 4. Temperatures were measured by thermocouples located as seen in Figure 2.

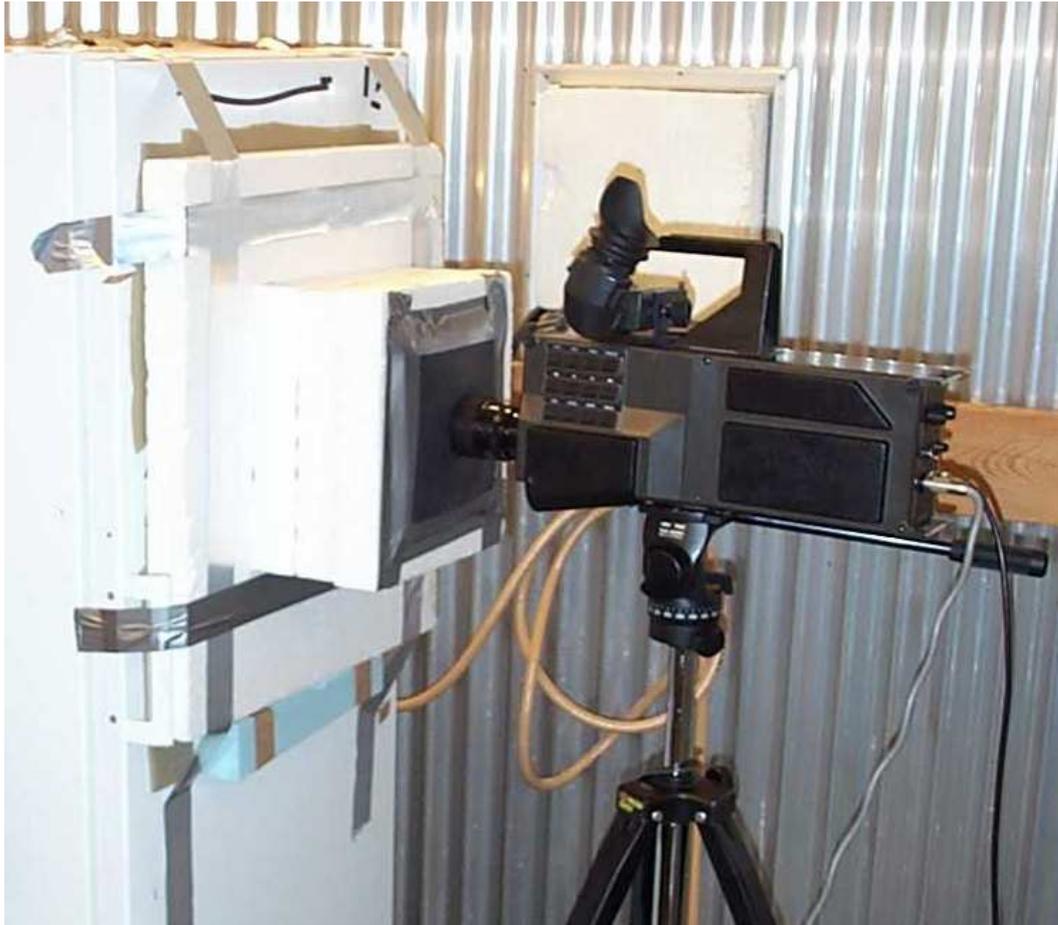
Figure 3 IR-camera in position for evaporator filming

Due to the rather narrow angle 40° lens, the camera needed to be at some distance to capture the entire evaporator. Therefore an inspection opening was made in the refrigerator door and some insulation material was used to locate the camera at the

needed distance from the evaporator. This is why the insulation material sticks out somewhat from the door (Figure 3). Even though this opening was as much as possible insulated, an increased heat leakage was unavoidable. The result of this was a prolonged cycle length in comparison to the unmodified system. The on-period was extended from about 700 s to about 1000 s, the cycle length from about 2700 s to about 3200 s.

Figure 3 IR-camera, AGEMA Thermovision 400 with a 40 mm/40° lens, in position for recording of the evaporator temperatures.

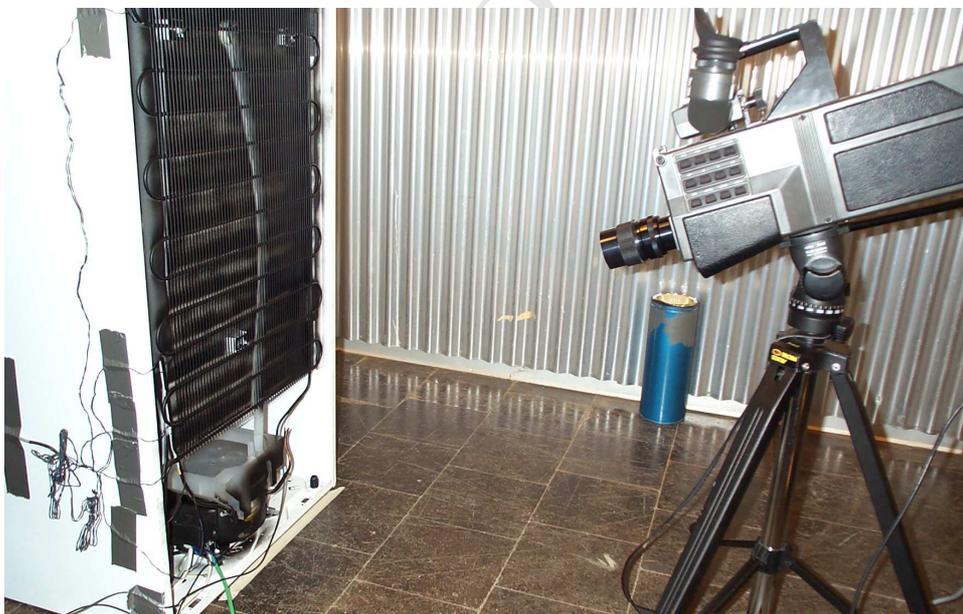
Figure 4 IR-camera in position for condenser filming (close-up of lower part)

Figure 4 IR-camera in position for recording the condenser temperatures (close-up recording of condenser lower part)

The compressor temperature (T_1) varies between 35 and 45 °C during the complete on-off cycle. It is worth noting, that this thermally heavy component will always stay significantly above the ambient temperature. The heat dissipated from the compressor shell is used to evaporate the defrost water collected in a plastic container on top of the compressor (see also Figure 4).

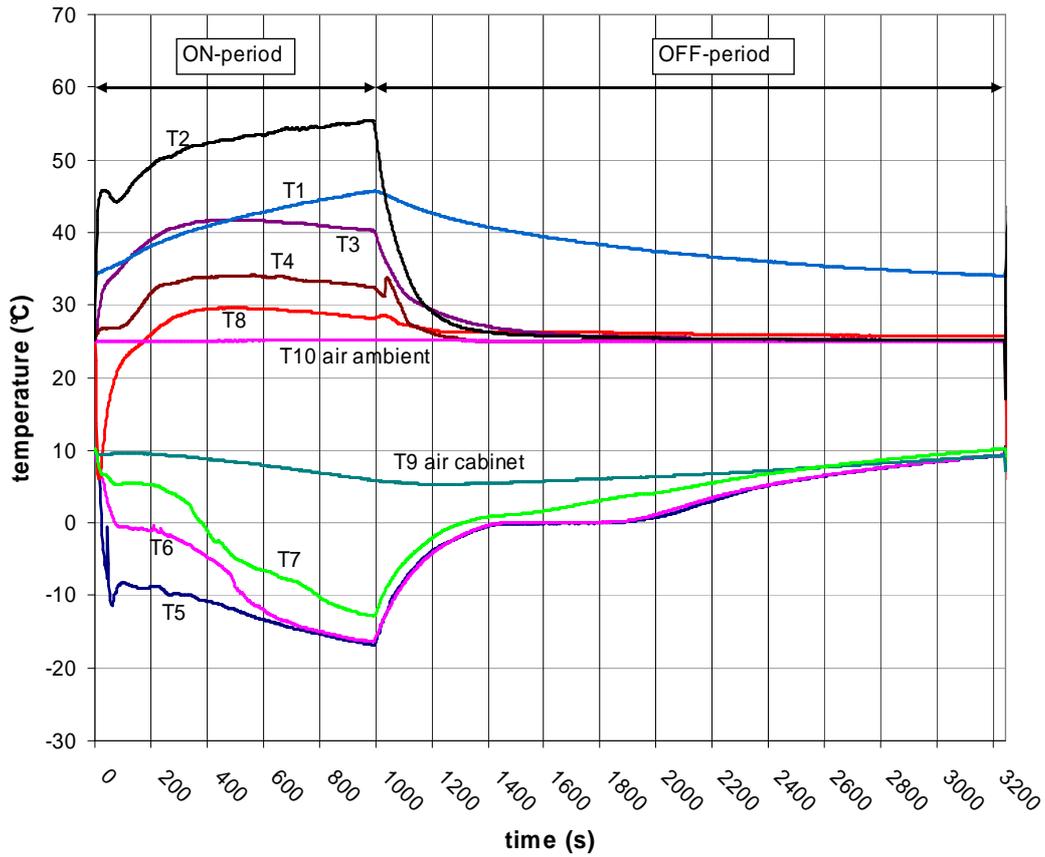
Figure 2 Temperatures during one on-off cycle. For thermocouple locations see Figure 2.

Figure 2 Temperatures during one on-off cycle. For thermocouple locations see Figure 2.

In Figure 5 the temperatures during one on-off cycle are shown. It is seen that the cycle length is more than 3200 s (3240 s). It is also seen that the on-period is approximately 1000 s (994 s).

Following a startup, the suction line temperature (T8) immediately falls from 25°C to below 10 °C, after which it increases to above the ambient temperature. This temperature dip is caused by liquid refrigerant, accumulated in the evaporator during the off-period, is being drawn into the suction line where it evaporates on its way towards the compressor. This liquid suction, occurring at compressor startup, was previously observed by Rubas and Bullard [18], Krause et al. [15] and Björk and Palm [3]. It is explained by the initially “overcharged” evaporator and the initially high

The condenser temperature (T_3) first rises sharply. It reaches a peak value of just above $40\text{ }^\circ\text{C}$ in the middle of the on-period after which it slowly decreases to $40\text{ }^\circ\text{C}$ just before the compressor stops. This decrease follows upon a steadily decreasing evaporation temperature which lowers the compressor capacity. The condenser outlet temperature (T_4) parallels the condenser temperature (T_3) but at a lower value. This is a clear sign of condenser sub-cooling.

On the evaporator side the inlet temperature (T_5) falls sharply at startup, whereas the accumulator inlet temperature (T_6) is at a higher temperature until almost 700 s when they coincide. This is the time needed for the refrigerant liquid to reach the accumulator inlet thus “activating” the evaporator after the initial starving at the compressor startup. In other words, this is the time needed for the dry-out point to move the distance from the evaporator inlet to the accumulator inlet. The evaporator outlet temperature (T_7) is at a higher temperature than T_5 and T_6 throughout the on-period. This superheat is almost 3 K at the moment when the compressor stops.

In the off-period the condenser temperatures (T_2 - T_4) asymptotically approaches the ambient temperature. The evaporator temperatures (T_5 - T_7) first increase to $0\text{ }^\circ\text{C}$, where they level out while the evaporator defrosts. Then they increase again to slowly approach the cabinet air temperature. It is seen that the defrost time at the T_7 location is shorter compared to T_5 and T_6 . This may be explained with less frost at this location. The temperature at this location is higher during the on-period which means

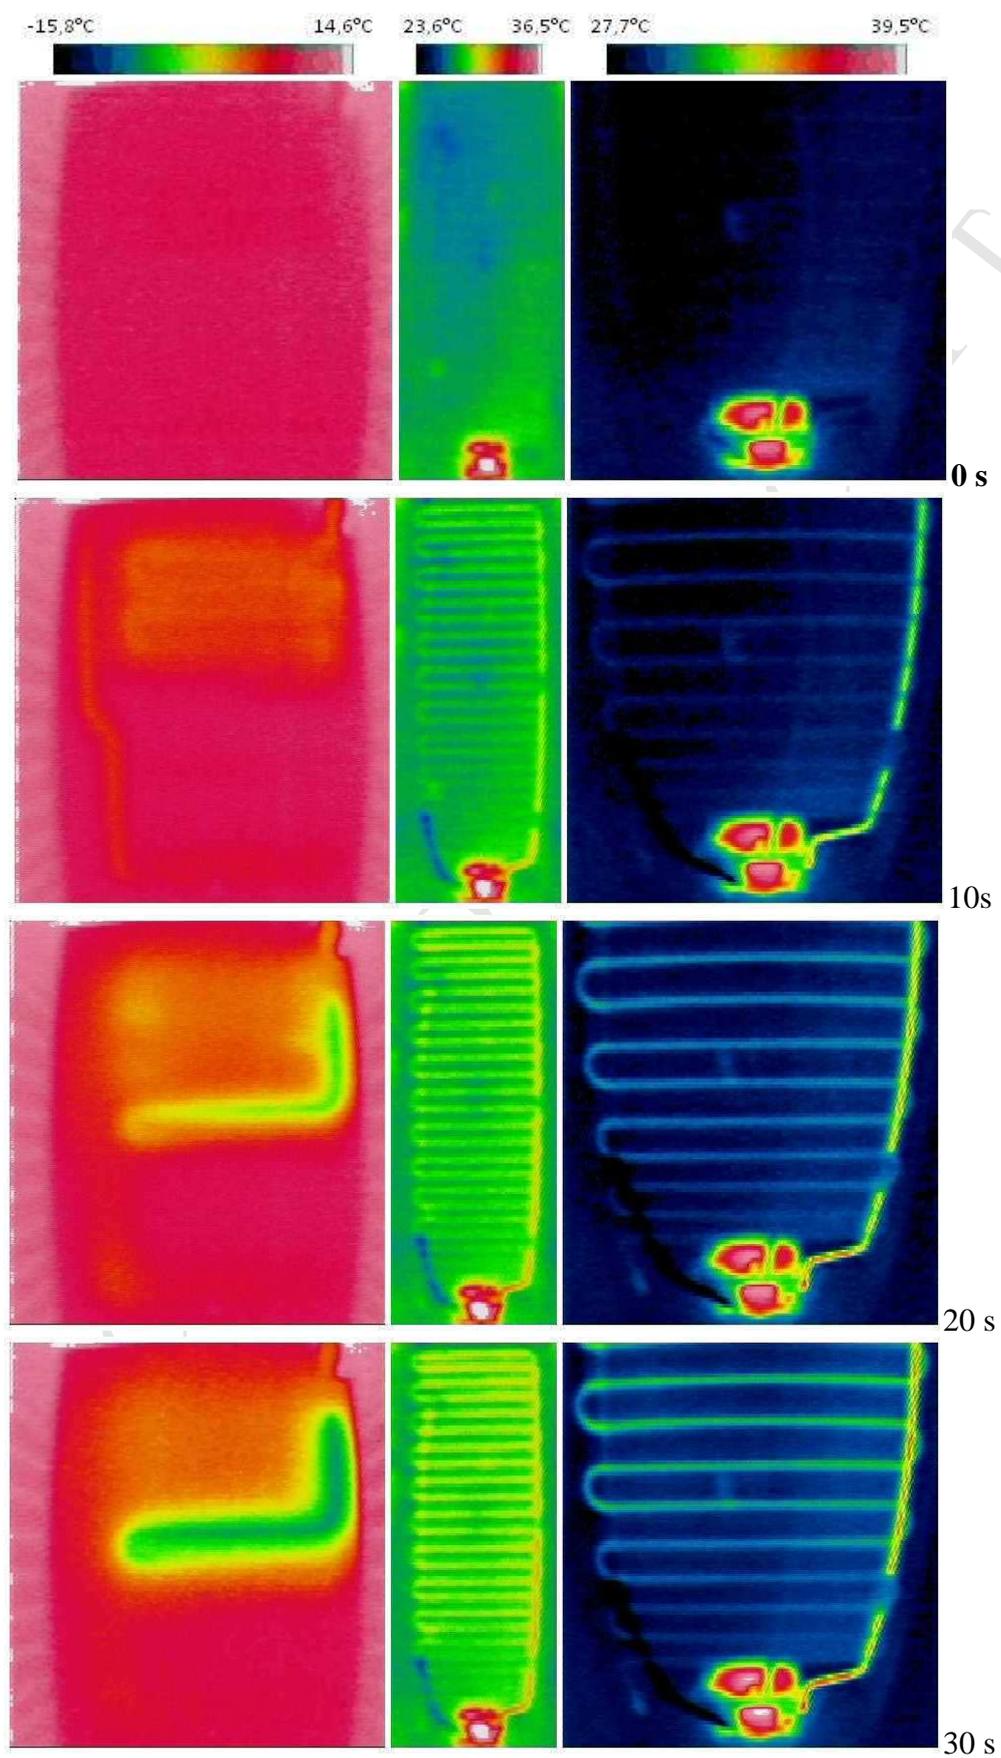
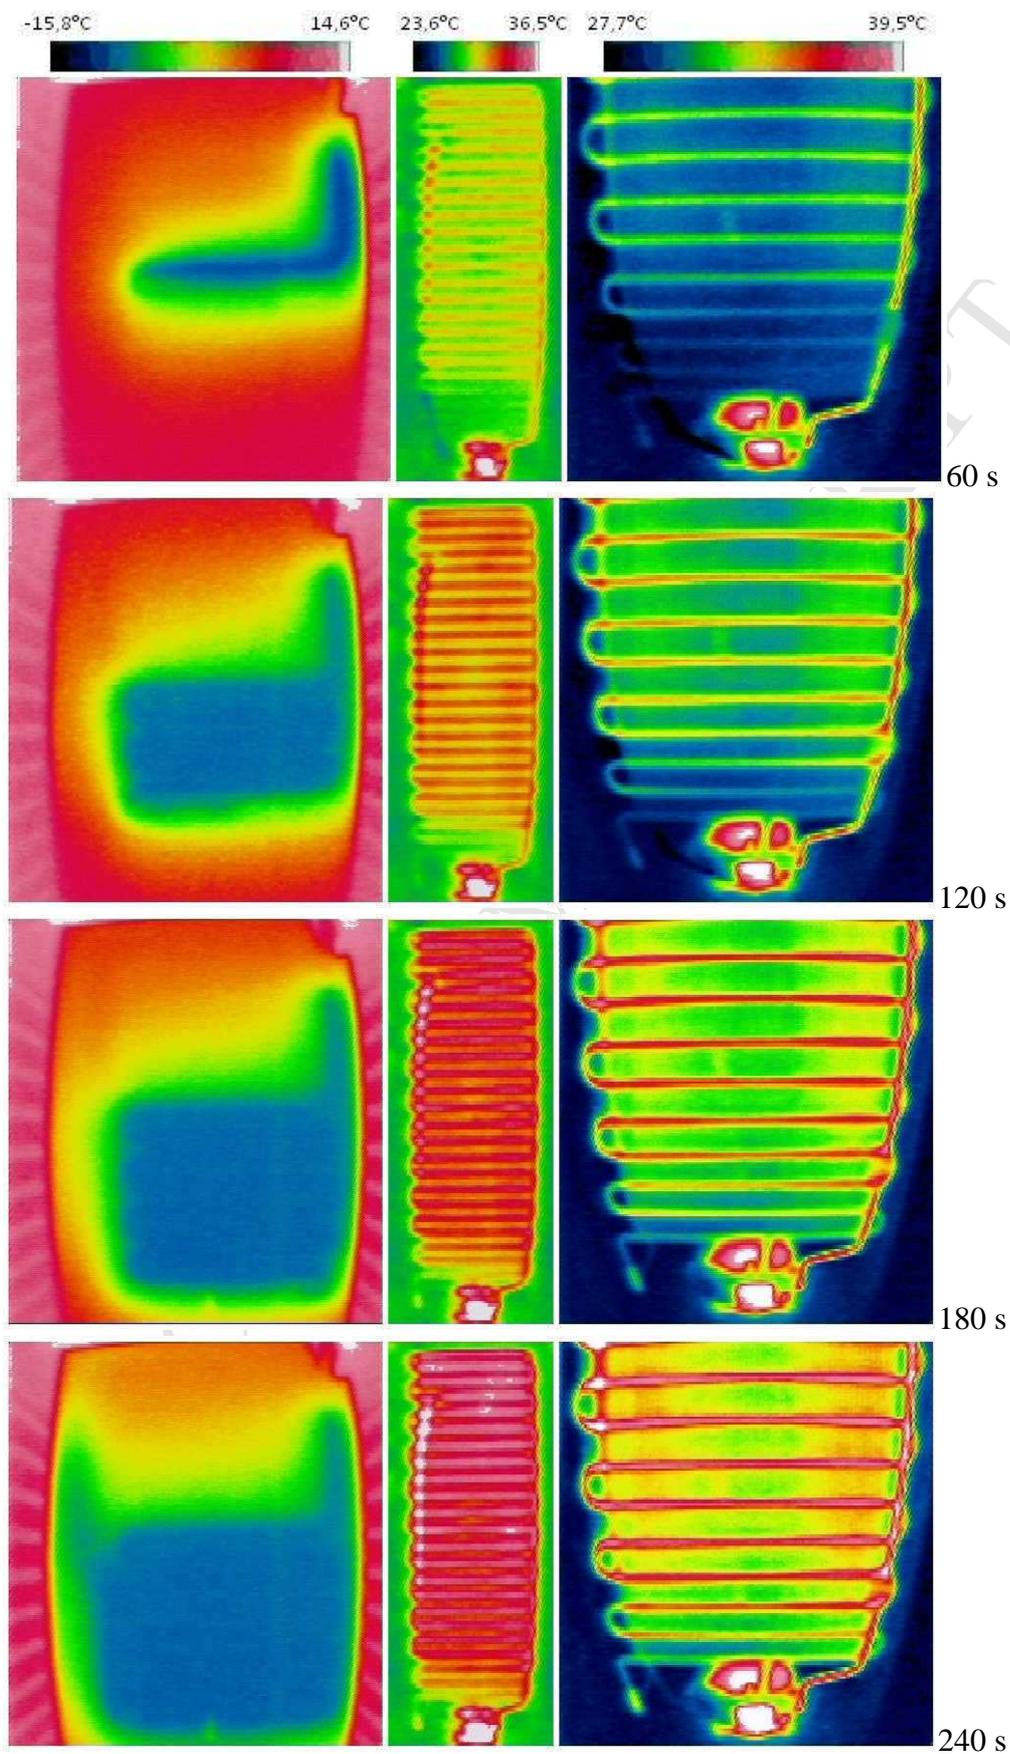
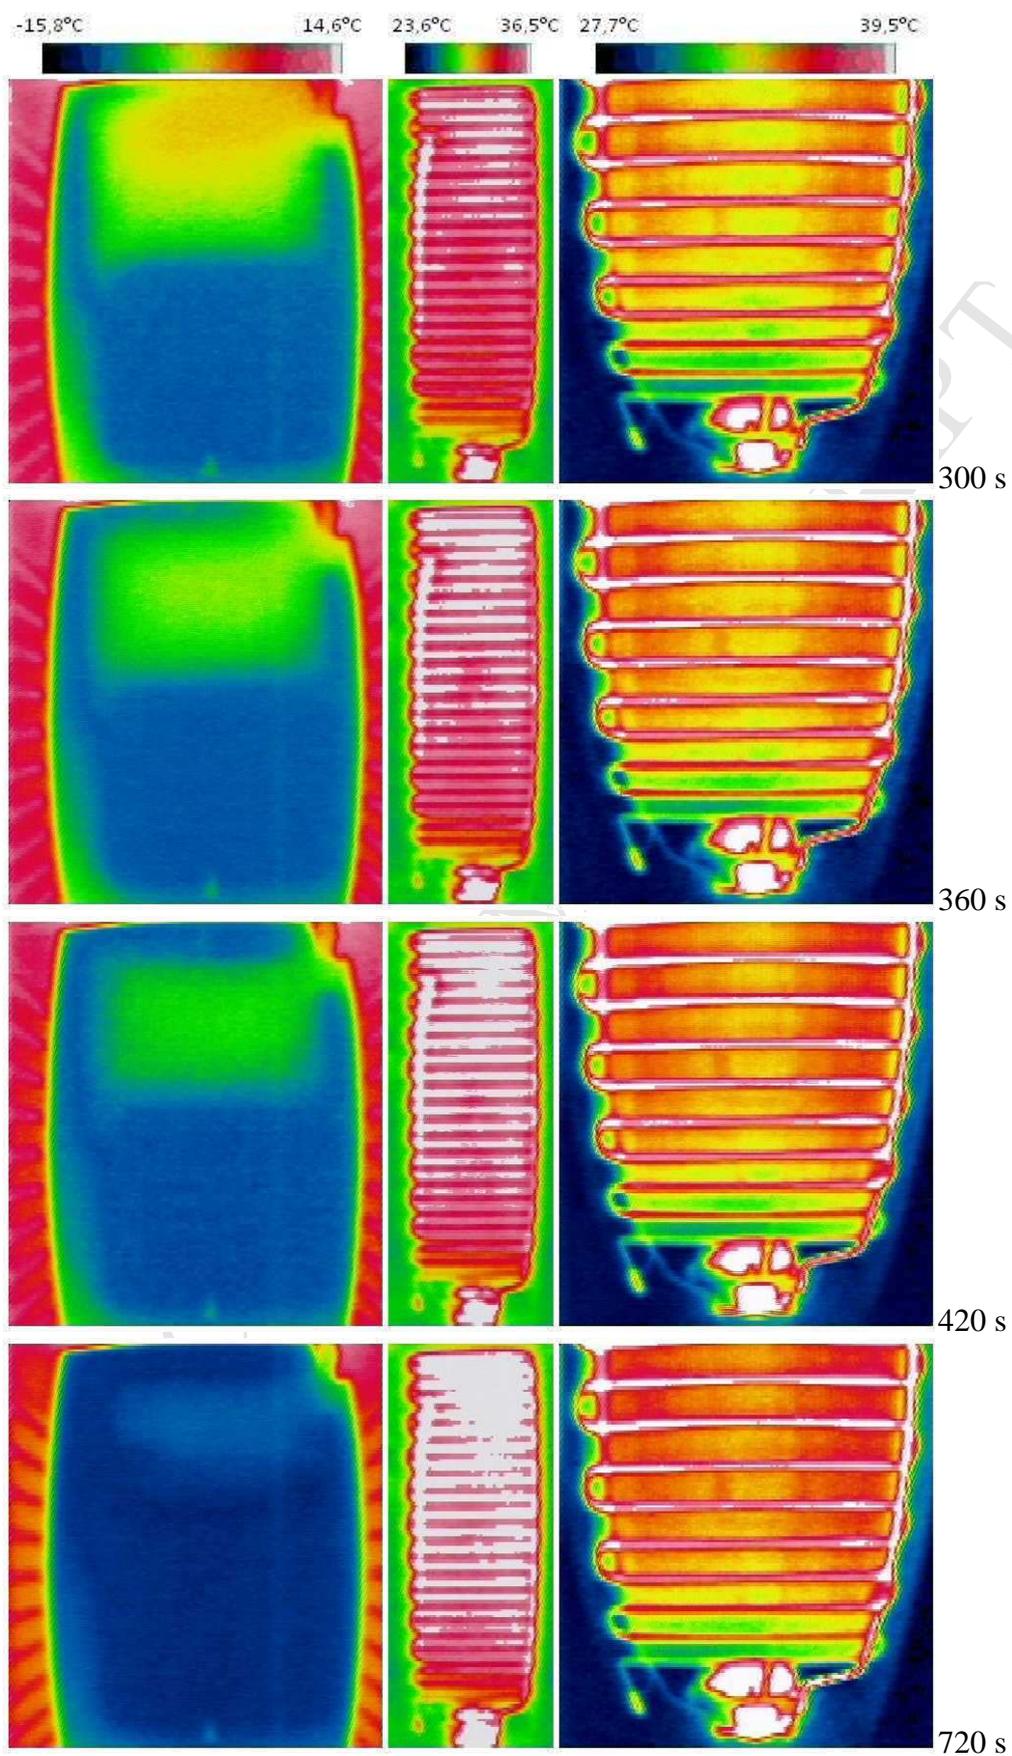
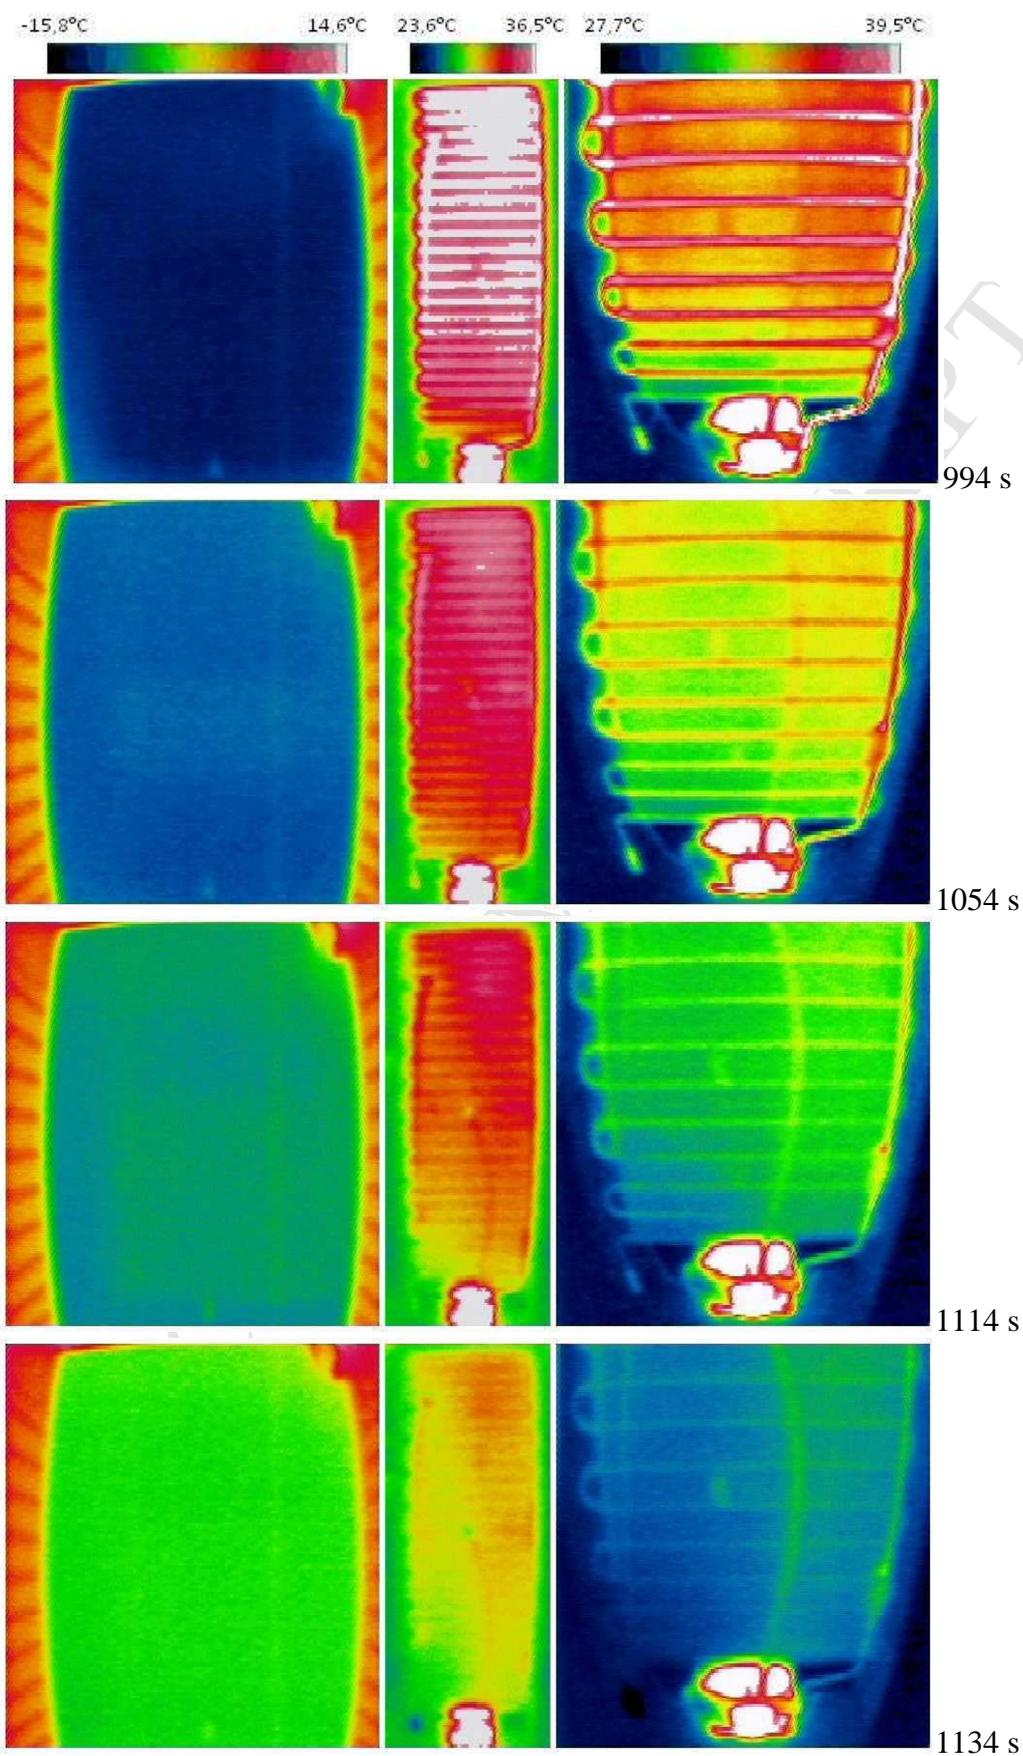
Appendix A

Images from the IR video recordings are displayed in Appendix A. On the right side of the images the time is shown referring to the same time scale as in Figure 5. For instance, 0 s is the time when the compressor starts (frame picked out at the moment before any thermal change due to the compressor start can be seen). 994 s is the time when the compressor stops (frame picked out at the moment before any thermal change due to the compressor stop can be seen).

At 0 s the evaporator is isothermal (within the resolution of the measurements). The condenser is also more or less isothermal. The compressor can be seen as a warm object at the bottom of the condenser images. Since this image shows the temperatures at the moment when the compressor starts but just before any thermal change is visible the compressor heat stems from the previous on-period.

At 10 s it is seen that cooling occurs in parts of the evaporator. One can identify the location of the accumulator and the vertical tube at the left side of the evaporator. Obviously this is liquid which is accumulated in the evaporator during the off-period that evaporates as soon as the compressor starts. Apparently, part of this liquid was accumulated in the bottom part of the evaporator and most likely the rest in the accumulator itself.

At 20 s refrigerant has made the full loop from the evaporator, through the condenser and back to the evaporator again. This can be seen at the evaporator inlet which cools down rapidly. From now on it is possible to see the dry-out point moving downstream gradually activating the evaporator. The accumulator is cold but not as cold as the evaporator inlet. Furthermore, in the following images (30 and 60 s) the accumulator will heat up. Apparently all liquid remaining in the accumulator from the off-period, has already exited the evaporator.

At 60 s sub-cooling is seen in the condenser approximately covering the four lowest horizontal pipes. From 60 to 180 s this sub cooling area decreases. At the same time the dry-out point advances forward in the evaporator. Apparently liquid is being transferred from this sub-cooled part of the condenser to the evaporator. After 180 s the sub-cooled area is no longer changing, and covering approximately the lowest two horizontal pipes in the condenser. This is in agreement with the T.C. temperature recordings (Figure 5) which revealed a constant sub-cooling in the later on-period. Apparently, the liquid needed to further refill the evaporator is not taken from the condenser. Previous studies [3, 12] have shown that this liquid comes from the compressor oil, where it is dissolved during the off-period, and from the low side vapor whose pressure (density) decreases with the decreasing evaporator temperature.

At 1134 s (the last image) a design weakness is revealed in the mid picture. Even though the condenser design admits a free fall towards the condenser outlet to avoid liquid pockets during the off-period, the filter dryer (lower left side) is at a significantly lower temperature than other parts of the condenser. Apparently some liquid is trapped in this device where it is evaporating during the off-period. It was estimated, based on the IR-films and the physical size of the filter dryer, that less than 0.3 kJ of heat was transferred to the filter dryer during the ten minutes period when this cooling effect existed. This heat will add to the cabinet thermal load in the following way. When the liquid seal at the capillary tube inlet is broken so that the capillary tube only contains vapor, any liquid left in the condenser will evaporate and, just like in a thermo-siphon, the corresponding heat of evaporation will be released during condensation at the coldest point in the evaporator. This thermal transport is obviously an energy loss. In previous articles [3,18] this phenomenon was estimated to result in an additional heat load of 2–7%.

At 720 s the accumulator can still be seen as an area of somewhat higher temperature than the rest of the evaporator. At this time the T.C. temperature recordings (Figure 5) show that the dry-out point has moved into the lower part of the accumulator.

At 994 s, which is the moment when the compressor stops, the evaporator is more or less isothermal. A vague color difference indicates the accumulator which at this time has a 3 K superheat at its outlet (Figure 5). It is possible that the temperature range (lower limit set to $-15.8\text{ }^{\circ}\text{C}$) was selected too high making this superheat difficult to spot. It is also seen that the evaporator edges on the lower left side are at a higher temperature. Apparently the refrigerant channels (see Figure 2) are too distant from the edges. The result is that the evaporator plate is poorly used for heat transfer which leads to lowered system efficiency.

At 1054 s, which is 60 s after the compressor has stopped, the heat exchanger temperatures have changed significantly. It is interesting to note that there is no local heating at the evaporator inlet as a result of refrigerant migrating from the condenser into the evaporator. Intuitively it may feel like “hot” refrigerant liquid coming from the condenser would cause a heating effect. However, any liquid passing the capillary tube will depressurize to the evaporator pressure and enter as a two-phase mixture at the saturation temperature corresponding to the pressure in the evaporator. The result is that the entering vapor increases the evaporator pressure so that some condensation occurs in the evaporator. This heating will not affect the evaporator locally at the evaporator inlet but rather globally all over the evaporator where condensation occurs.

At 1114 s the image shows a higher temperature, evenly distributed, where the refrigerant lines are located. This can be attributed to heating by condensing refrigerant in the channels, as was explained above.

Secondly, the IR-images show that the evaporator's edges were at higher temperatures than the central part of the evaporator. Thus, the edges were poorly used for heat transfer. To overcome this, the refrigerant channels should be moved closer towards the edges. Björk [2] estimated the fin efficiency, calculated as the ratio between actual heat transfer and the heat transfer that would occur if the evaporator was isotherm at the refrigerant channel temperatures, of a similar evaporator to be 97%. This can be recalculated to a temperature loss of about 0.6 °C which corresponds to an efficiency loss of approximately 1.2% (1K added temperature difference is about 2% lowered efficiency for the given compressor).
