## Local damage in a 5 - harness satin weave composite under static tension: part i - experimental analysis

S. Daggumati, I. de Baere, W. van Paepegem, J. Degrieck, J. Xu, S.V. Lomov,  
I. Verpoest

*<sup>a</sup>Ghent University, Dept. of Materials Science and Engineering, Sint-Pietersnieuwstraat 41, 9000 Gent, Belgium*

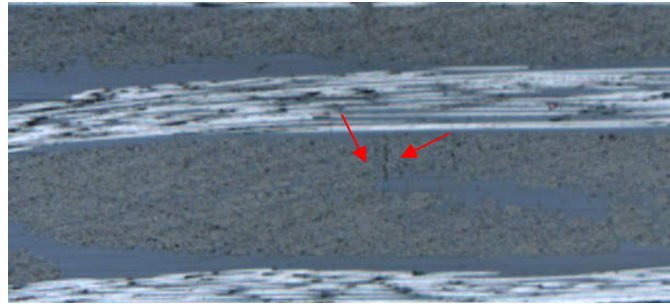
Damage location at 2-1(nested yarn)

Damage location at 2-2 (nested yarn)

Damage location 3-1 (Surface yarn) top view

Damage location 3-1(Surface yarn) side view

Damage at location 4-1

Figure 4. Microscopic sequential damage analysis : a) laminate at 100 MPa tensile stress; b) tensile stress between 100 - 400 MPa; c) tensile stress between 400 - 500 MPa; d) tensile stress between 500 - 680 MPa (Size bar is 1 mm).

Due to the sensitivity of the initial damage, up to 100 MPa stress, the load on the INSTRON machine is increased in two steps. After the initial damage, the load is increased with a step size of 100 MPa until the final failure. Damage developed in the 5-harness satin weave under tensile load takes the form of weft yarn cracking, which is

perpendicular to the loading direction (Figure 4a). Moreover, damage initiation occurs at the yarn crimp location and then propagates into the matrix. This type of weft yarn cracking began early in the loading process and almost all weft yarns possess this kind of damage before the final failure of the composite.

During the loading process of the composite, initial damage is detected at around the 100MPa stress level on the polished edges of the composite. At these low stress levels, damage occurs at the edges of the weft yarn inside the laminate, in the region where there is no contact between the load carrying warp yarn and the perpendicular weft yarn (Figure 4a). By increasing the stress level from 100 to 400 MPa in three steps, the damage is observed at the nested yarn configurations at various locations in the laminate (Figure 4b). Moreover, the number of cracks between these stress levels can be compared to the event count obtained from AE. By increasing the stress from 400 to 500 MPa, the

next new damage location is observed on the surface of the laminate (Figure 4c). Moreover, 80% of the microscopic images on the surface (top and bottom) of the laminate show the occurrence of intra-yarn damage at the centre of the weft yarn. At this stress level (400-500 MPa), along with the damage on the surface layers, the crack density in the nested yarns inside the laminate is increased at various locations. Finally, between the stress levels of 500-680MPa, the next damage is observed at the edges of the weft yarn, where it is tightly packed by load carrying warp yarns (Figure 4d). Any further loading causes the catastrophic failure of the composite specimen. From the above discussed sequential damage analysis, it can be observed that the local fabric geometry whose local bending is restricted tends to show the initial damage. In contrast, the yarn crimps on the surface layers are relatively more free to deform in the out-of-plane direction, which causes the damage on the surface weft yarns at later stages of the loading.
