## Shock machine for the mechanical behaviour of hip prostheses: a description of performance capabilities

# **Shock machine for the mechanical behaviour of hip prostheses: a description of performance capabilities.**

Juliana Uribe<sup>1</sup>, Jean Geringer<sup>1</sup>, Bernard Forest<sup>1</sup>

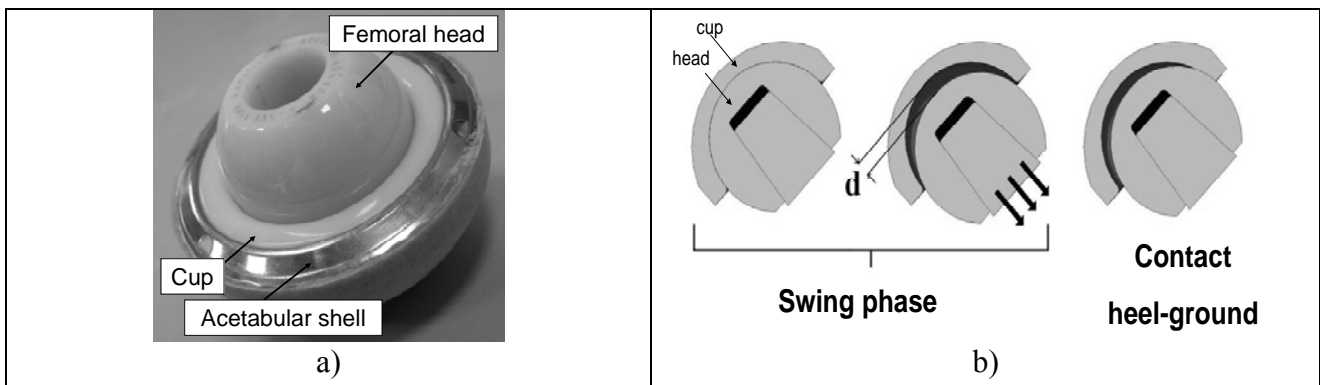
Figure 1. a) Hip prosthesis and b) Microseparation phenomena, d represents the distance of microseparation<sup>3,4</sup>.

Total hip arthroplasty consists of replacing hip joint with an artificial femoral head, cup and acetabular shell, Figure 1a. Because of the increasing life expectancy, there is a need of prostheses with a longer lifetime. Ceramics are submitted to lower friction and more reduced wear than the ones of metal or polymer (Ultra High Molecular Weight PolyEthylene) bearing surfaces.<sup>1,2</sup> Aseptic loosening with accompanying osteolysis is less frequent for ceramics cups compared to polymer ones, therefore better long term results are obtained. However, ceramics could be worn and, in some cases fractured, when subjected to shocks.

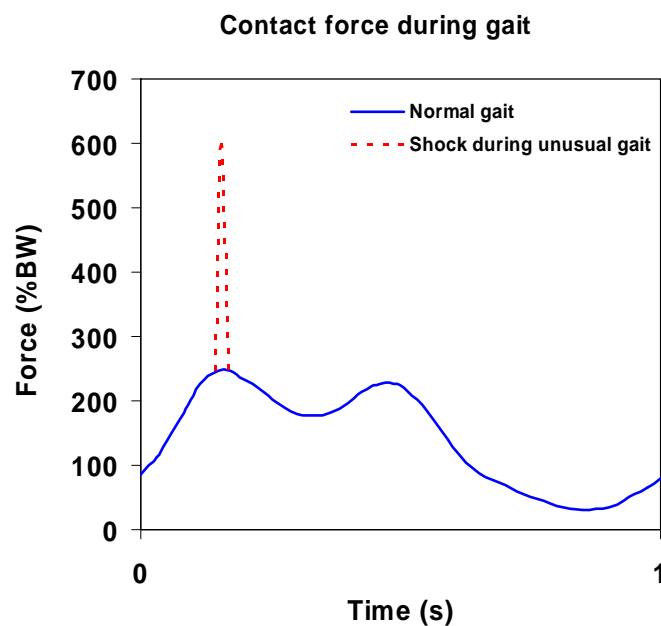
Figure 2. Hip contact force in %BW. Gait cycle showing the maximum of force when the heel hits the ground, BW: Body Weight<sup>5</sup>.

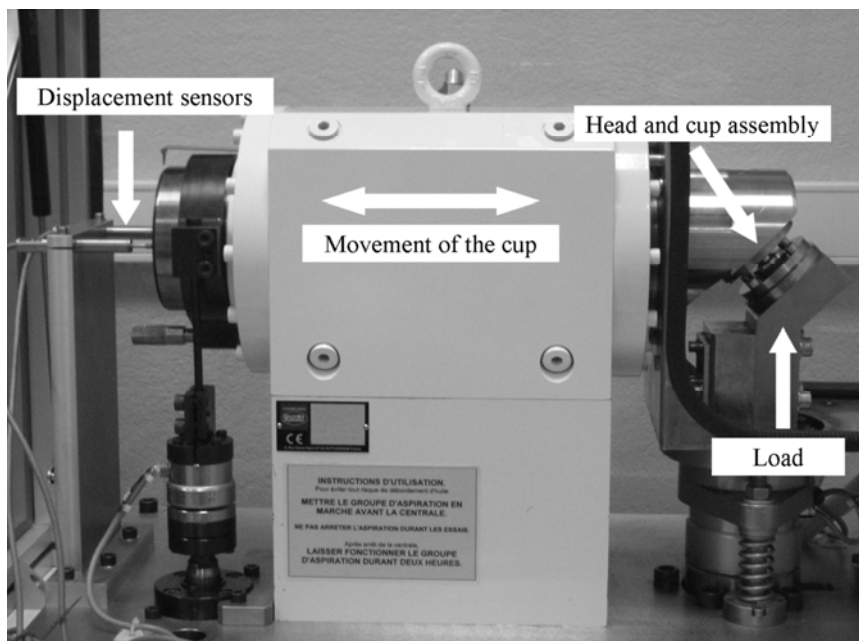
The shock machine (QUIRI Hydromecanique) is shown in Figure 3. This device was designed specially for testing hip prostheses, head and cup assembly, subjected to shocks.

Figure 3. Shock machine

Force varies between from 0 to 10kN with an adjustable duration from 20 to 100ms and a frequency between 0.1 and 5Hz. Tests in both dry and wet conditions are possible. The main feature that makes this machine different from usual hip simulators is the opportunity to impose a microseparation. A control by displacement is possible. Microseparation between cup and head was controlled.

Displacements signals from LVDT, see Figure 3, were recorded and analysed in order to determine the mechanical behaviour of the cup after the impact. The cup response was described as a damped spring-mass system. The cup oscillates during 0.2s which is about seven times the duration of the peak of force. Positive sign means the cup moves in the positive x direction.

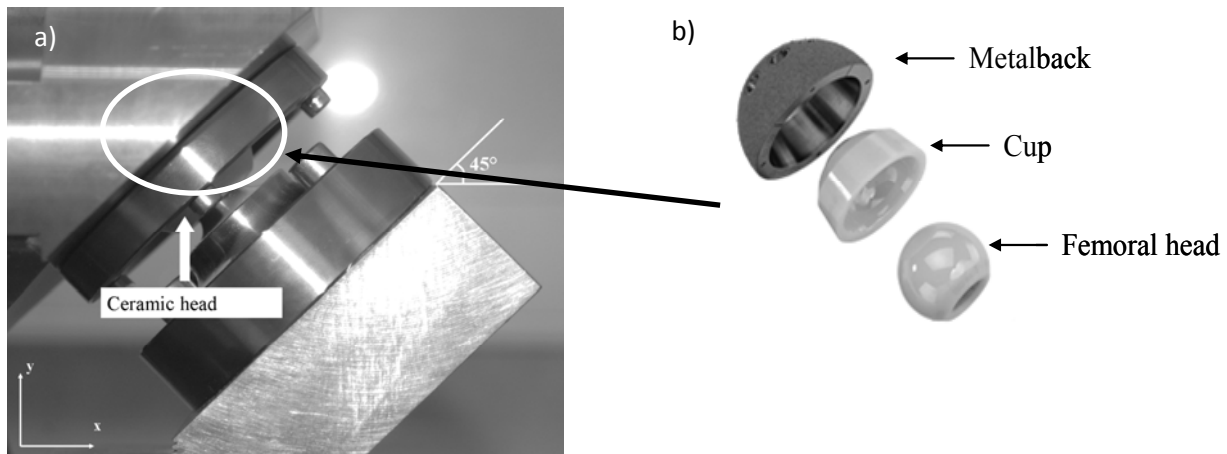
Figure 4. a) Head and cup assembly inclined at 45°; b) head/cup/metal back assembly

Cups and heads were manufactured from alumina of diameter 32mm. The radial clearance between the head and the cup is ranging between 50 and 100 $\mu$ m. The actual value of radial clearance will not be exposed due to confidential agreement with the manufacturer (SERF company). Grain size, density and Young's modulus were in agreement with the ISO 6474-1 standard requirements, Table I. The ceramic cups were sheathed in an acetabular shell. In order to accelerate degradations, the tests were carried out in severe conditions; no lubrication and a 30ms load of 9kN at 2Hz<sup>4</sup>. Assembly was inclined at 45° to respect standard anatomic position, Figure 4. The cup was fixed and the head was maintained into a cone.

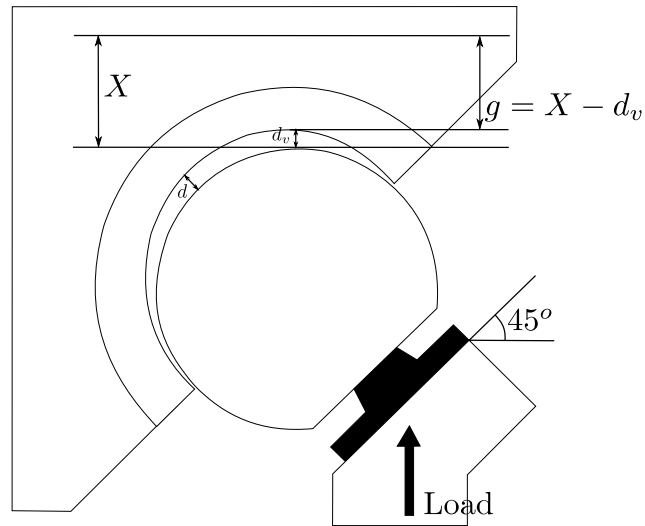
Figure 5. Virtual distance  $g=X-d_v$ .  $d$ : microseparation,  $d_v$ : vertical distance to obtain the value  $d$ .  $X$  is the displacement imposed to the head

Several values of microseparations ( $d$ ), Figure 5, were tested: 0, 0.7, 1, 1.3, 1.6 and 1.9mm. They are related to the *in vivo* behaviour. To each microseparation corresponded a vertical distance, ( $dv$ ). For each microseparation, a displacement of  $X$  was imposed to the head. Since the distance between the head and the cup was  $dv$ , a force is applied when  $X > dv$  and increased with  $X$ . The distance  $g = X - dv$  was defined as "relative distance", Figure 5.

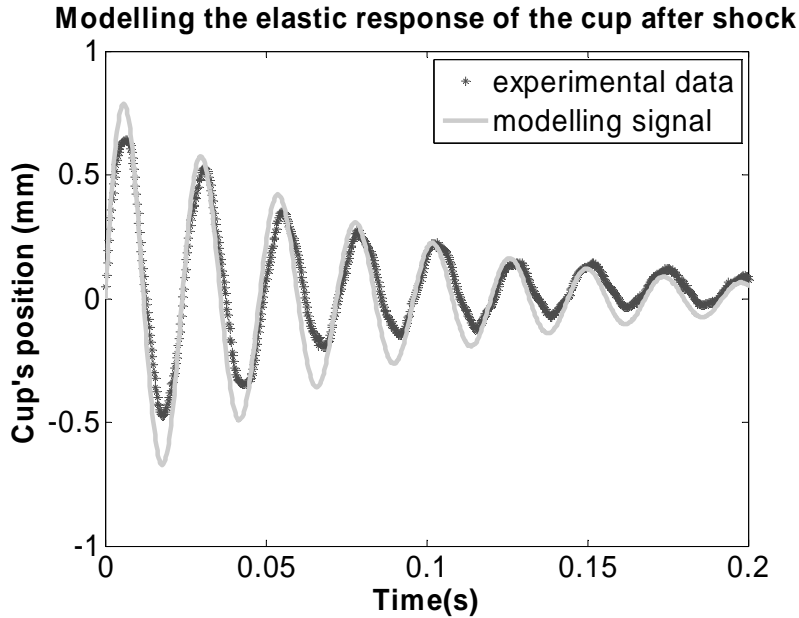
Figure 6. Results for a square signal, with a microseparation of 1.3mm and a force of 9kN, black dotted line: the elastic response of the cup after the shock, gray continued line: the modelling signal.

Since the response of the cup was similar regardless the signal studied, we decided calculating the parameters  $k$  and  $c$  using only one type of signal. As an example, the parameters were calculated using Matlab<sup>®</sup> for a square signal, with a load of 9kN and a microseparation of 1.3mm.

As can be seen in Figure 6, the underdamped oscillator model fits experimental data well. The  $k$  and  $c$  values will be adopted in a finite element modelling, further investigations not mentioned in this work, for reproducing the movement of the cup after a shock and studying stresses distribution on the assembly cup-head.

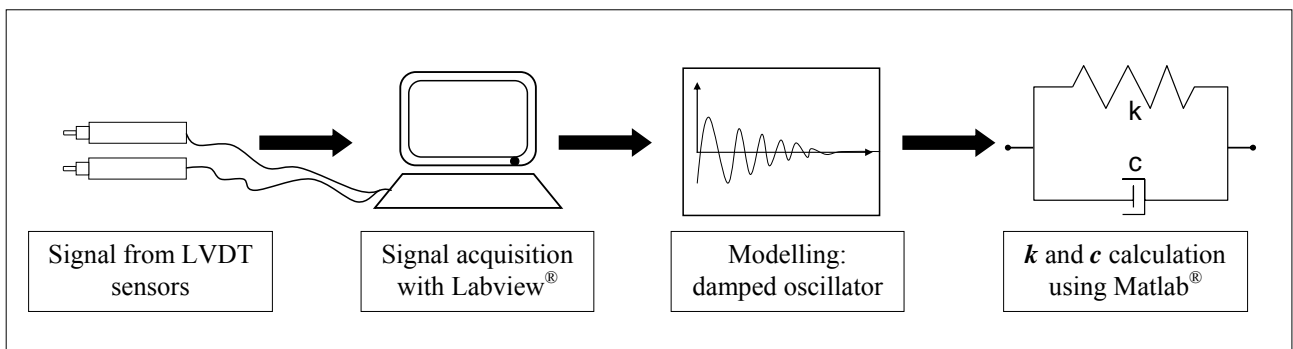
Figure 7. Diagram of data acquisition and postprocessing

The process of data acquisition, processing and modelling is summarized in Figure 7. Spring constant,  $k$ , and damping coefficient,  $c$ , were determined by fitting using Matlab<sup>®</sup>.

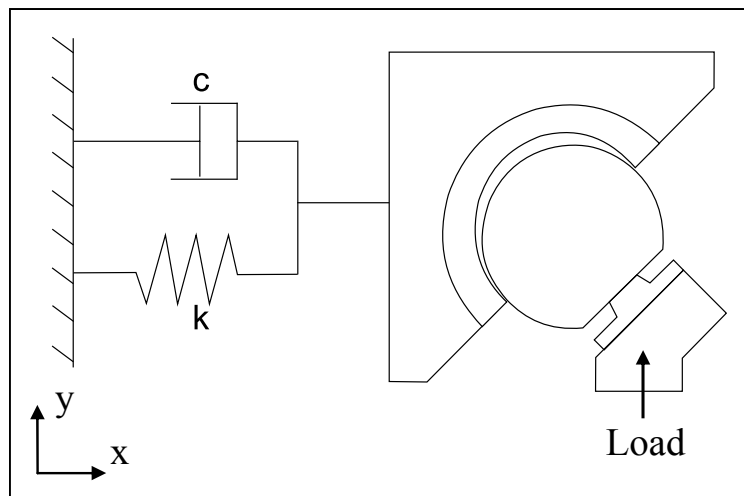
Figure 8. Scheme of shocks machine. The movements of the cup and the device are represented by a damped spring system.

Finally, the shocks device could be described in a more simplified manner as shown in Figure 8.

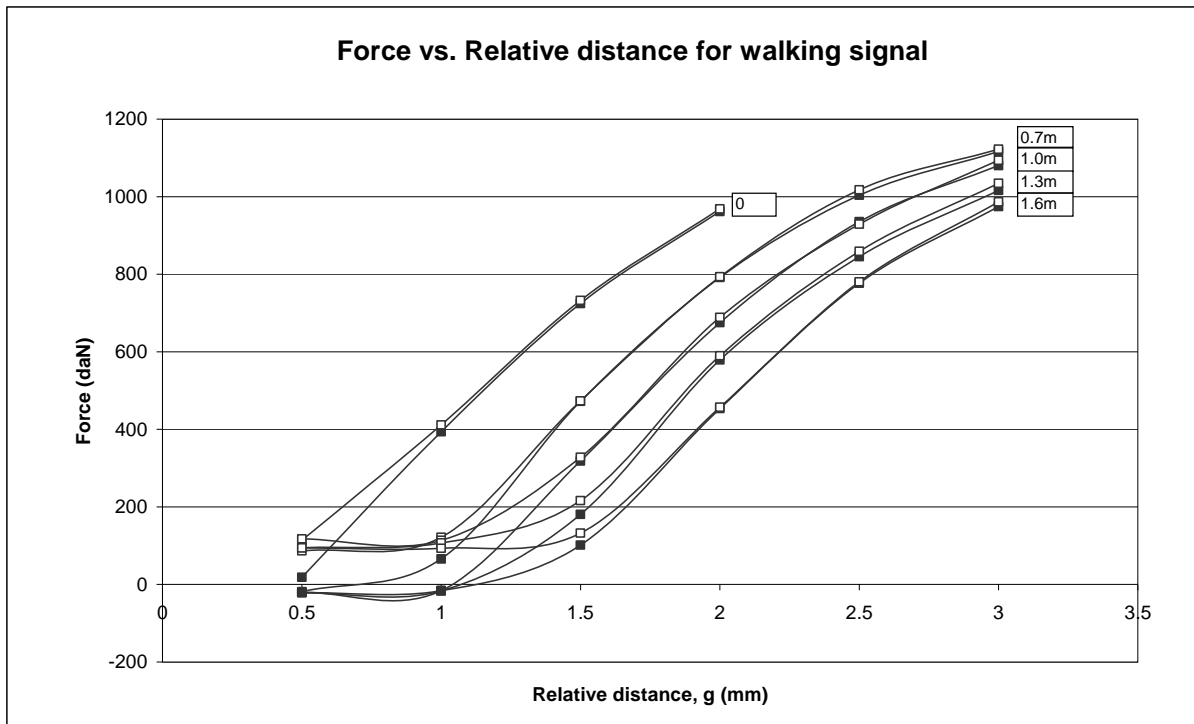
Figure 9. Force on the assembly cup-head as a function of relative distance of the head, for different values of microseparation; □: Ni-DAQ, ■: machine software

The validation tests were made to determine the range of operating conditions to reach a force of 9kN, and 3 signals were studied: sinus, triangle and walking. The signals from Ni-DAQ™ and machine software, Quiri™ did not show significant difference for sinus and triangle. On the other hand, for walking signal, recorded signals were considerably different for forces under 2kN. Above 2kN, signals are similar and may be modelled by a linear curve which slope is calculated for each microseparation value (Figure 9 and Table III).

Tests had duration of 20s and were stopped when force was greater than 11kN to avoid fracture of ceramic components and to be consistent with device capabilities. The results in Figure 9 show that a relative distance of 1.8mm has to be imposed to the head for reaching 9kN, without

microseparation. Hence, from Figure 9, an equation was established for microseparation of 1.3mm, the typical microseparation for *in vivo* tests:

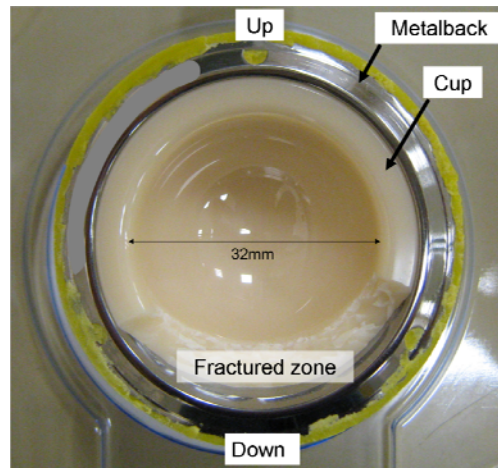
Figure 10. Alumina cup tested in dry conditions. Fracture at the lower rim.

Tests and cycles at fracture are summarized in Table IV. The three cups from dry tests fractured at the lower rim of the cup, Figure 10. Cup fracture occurred at  $254,000 \pm 43,000$  cycles. Fractured bearing surfaces observed by Scanning Electron Microscopy, SEM, revealed intergranular and transgranular fractures, Figure 11. The size of debris from fractured cups was less than 1mm to several mm. There was no fracture for wet tests.

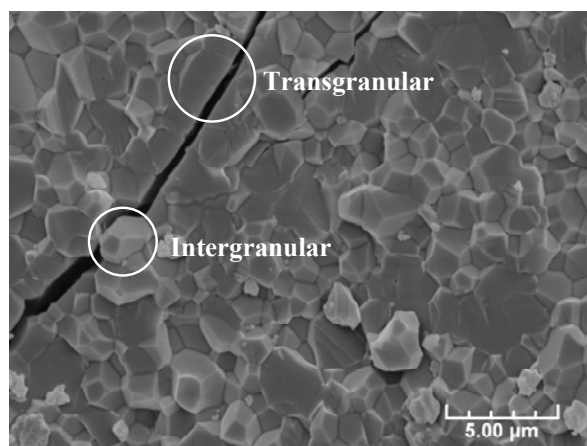
Figure 11. SEM image from alumina debris. Intergranular and transgranular fracture.

Figure 11 shows that debris could be mostly about 1µm of diameter. Shocks induce these typical debris. This experimental result involves some expectations about the reactions of cells. Studies on the biological tolerance of alumina and zirconia nanosized powder on rats suggested that the inflammatory response is similar to those reported for polyethylene or metal particles<sup>23</sup>. Nevertheless, testing composites under shocks could lead to intergranular and transgranular fracture and smaller nanometric debris could be found, which might induce an inflammatory response.

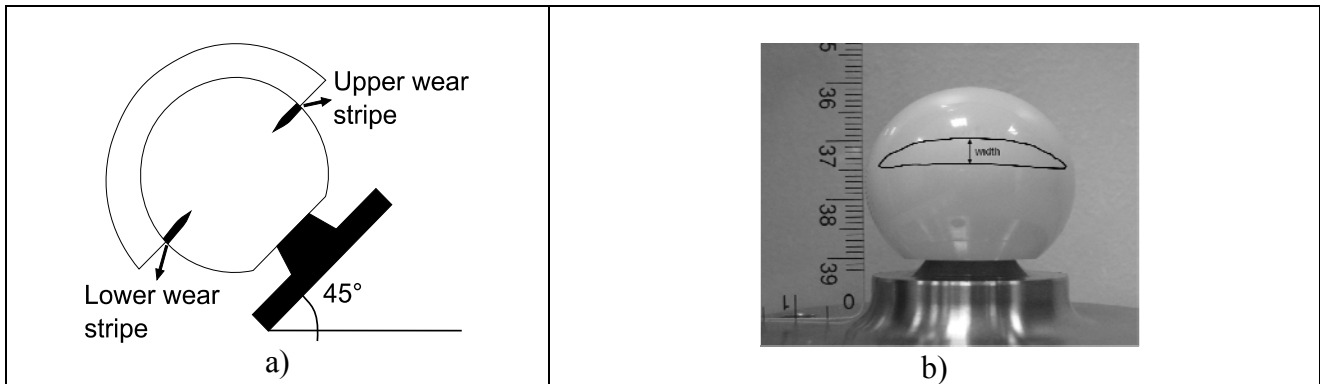
Figure 12. a) Location of wear stripes and b) Wear stripe on a head tested in dry conditions.

Wear stripes were observed for all heads in the contact zone of the head with the rim of the cup, Figure 12a. There were no visible macroscopic cracks.

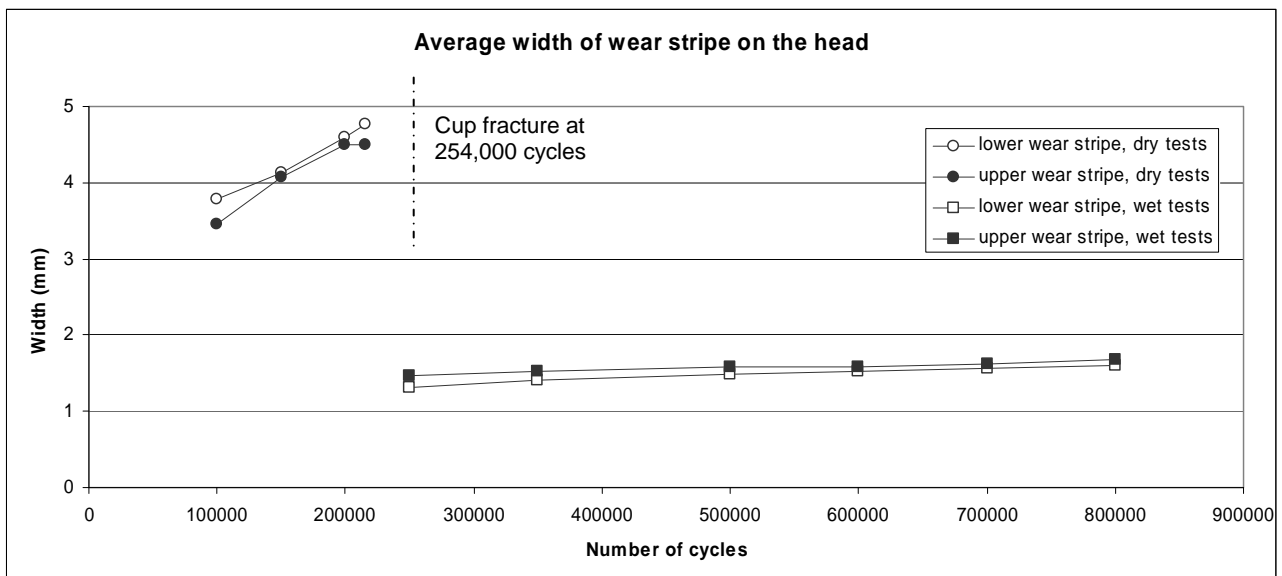
Figure 13. Width of wear stripes on the head for dry and wet tests.  
 Enlever lignes horizontales

Average width of wear stripe was strongly different for heads tested in dry and wet conditions; wear stripes were wider than 4mm in dry conditions while it was less than 2mm for wet conditions, Figure 13. However, at a macroscopic scale, the worn surfaces from the dry tests and wet tests were morphologically indistinguishable. Since wear stripes did not reached 4mm and had a small growth rate, tests were stopped at 800,000 cycles in wet conditions.

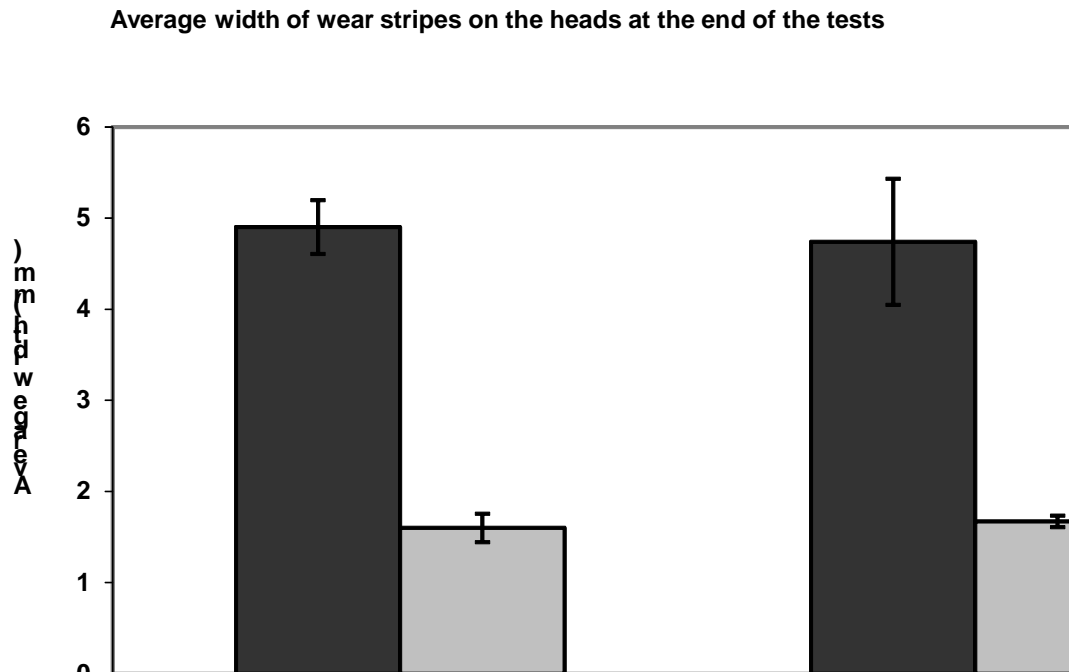
Figure 14. Width of wear stripes for heads in dry and wet conditions.

In both dry and wet conditions there was an accelerate growth in the first 150,000 cycles; the slope is bigger for dry than the one for wet. After 200,000 cycles the width of the wear stripe of heads increased slowly. Figure 14 shows the average width of the wear stripes at the end of the tests.

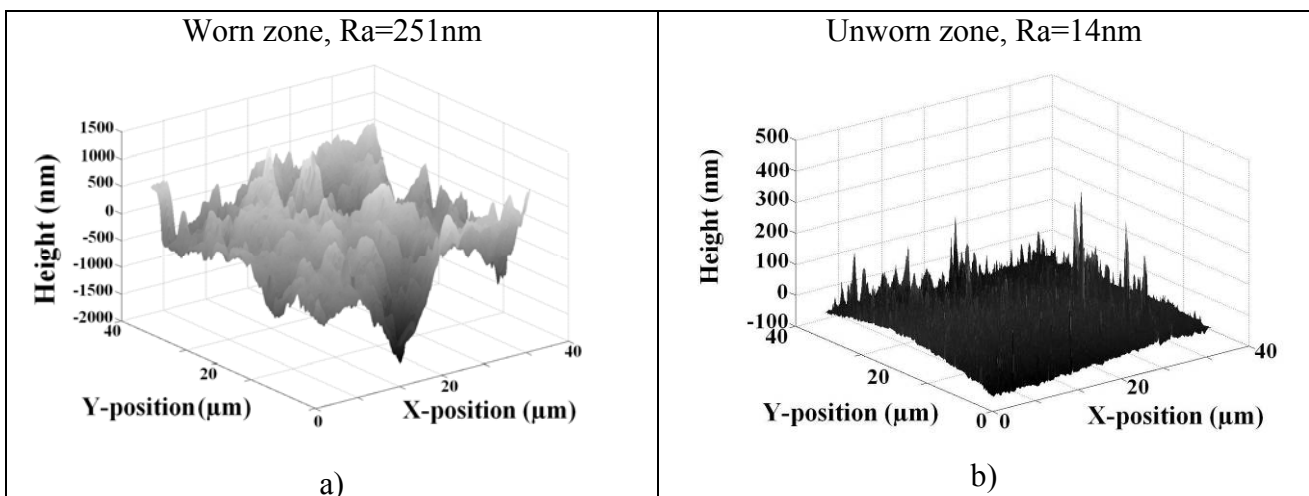
Figure 15. Three- dimensional reconstruction of a roughness profile for both a) worn and b) unworn zones studied by AFM.

After the shock tests, heads were cut carefully and analysed by Atomic Force Microscopy (AFM, Software 6.13) to determine surface roughness evolution. A first order flatten filter was applied to suppress the effect of the spherical shape. 3D-roughness was of  $9.1 \pm 5.1$  nm in unworn zones whereas it was measured to be  $277.9 \pm 29.4$  nm in worn zones. Roughness in worn zones is 20 to 30-fold higher than in unworn zones. These values are comparable with retrieved heads<sup>12</sup>. A three dimensional reconstruction of the surface was made using Matlab<sup>®</sup>. Figure 15 shows surface for a worn and unworn zone from the same head.

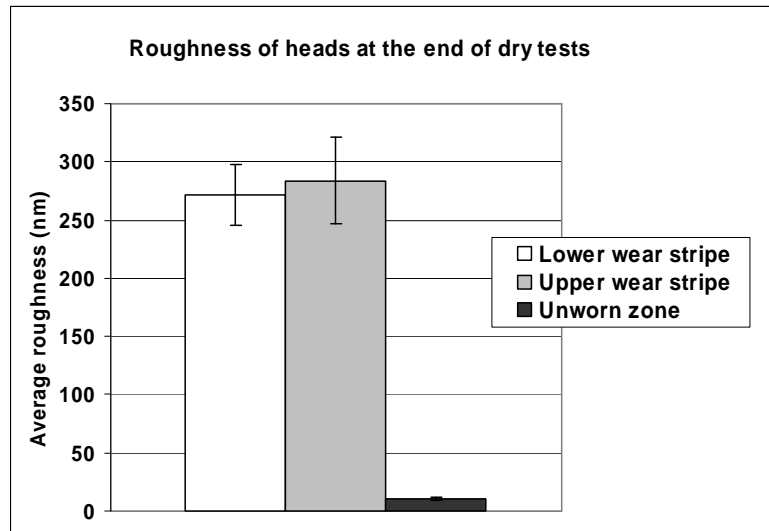
Figure 16. Wear stripe roughness from heads tested in dry conditions.

Analyses by AFM showed a similar roughness for the upper and lower wear stripe, showed in Figure 16.
