# Shock machine for the mechanical behaviour of hip prostheses: a description of performance capabilities

Juliana Uribe, Jean G  ringer, Bernard Forest. Shock machine for the mechanical behaviour of hip prostheses: a description of performance capabilities. *Lubrication Science*, 2012, 24 (2), pp.45-60. 10.1002/lis.167 . hal-00682226

# **Shock machine for the mechanical behaviour of hip prostheses: a description of performance capabilities.**

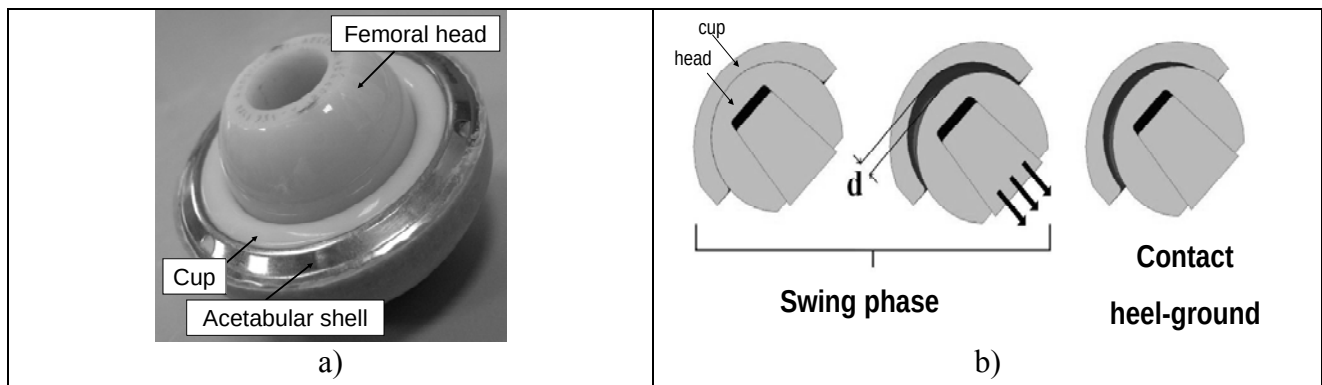
Figure 1. a) Hip prosthesis and b) Microseparation phenomena, d represents the distance of microseparation<sup>3,4</sup>.

Total hip arthroplasty consists of replacing hip joint with an artificial femoral head, cup and acetabular shell, Figure 1a. Because of the increasing life expectancy, there is a need of prostheses with a longer lifetime. Ceramics are submitted to lower friction and more reduced wear than the ones of metal or polymer (Ultra High Molecular Weight PolyEthylene) bearing surfaces.<sup>1,2</sup> Aseptic loosening with accompanying osteolysis is less frequent for ceramics cups compared to polymer ones, therefore better long term results are obtained. However, ceramics could be worn and, in some cases fractured, when subjected to shocks.

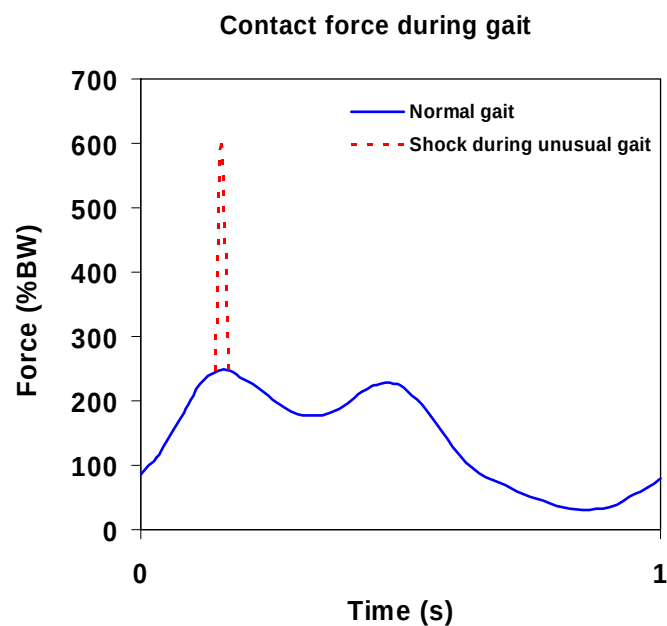
Figure 2. Hip contact force in %BW. Gait cycle showing the maximum of force when the heel hits the ground, BW: Body Weight<sup>5</sup>.

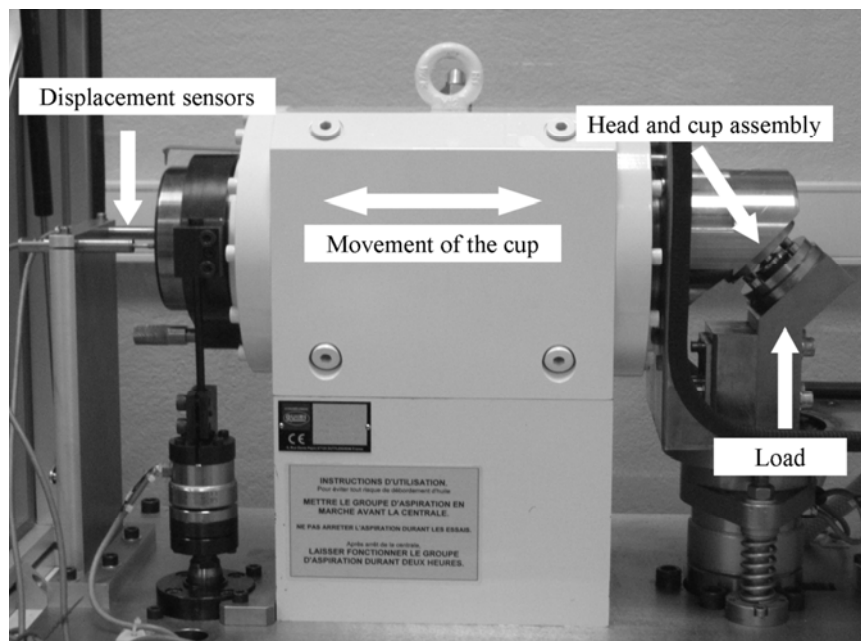
Figure 3. Shock machine

The shock machine (QUIRI Hydromecanique) is shown in Figure 3. This device was designed specially for testing hip prostheses, head and cup assembly, subjected to shocks.

Force varies between from 0 to 10kN with an adjustable duration from 20 to 100ms and a frequency between 0.1 and 5Hz. Tests in both dry and wet conditions are possible. The main feature that makes this machine different from usual hip simulators is the opportunity to impose a microseparation. A control by displacement is possible. Microseparation between cup and head was controlled.

Displacements signals from LVDT, see Figure 3, were recorded and analysed in order to determine the mechanical behaviour of the cup after the impact. The cup response was described as a damped spring-mass system. The cup oscillates during 0.2s which is about seven times the duration of the peak of force. Positive sign means the cup moves in the positive x direction.

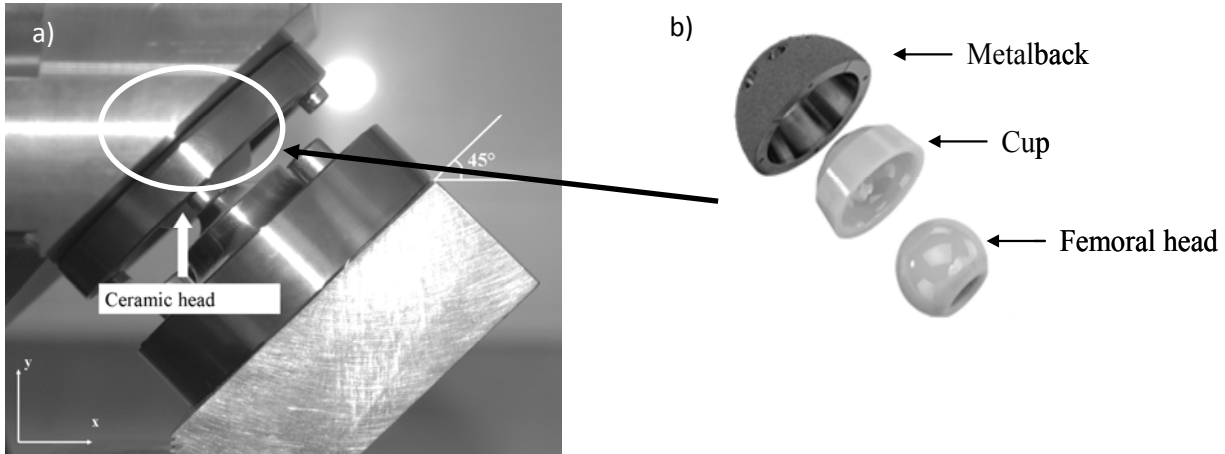
Figure 4. a) Head and cup assembly inclined at 45°; b) head/cup/metal back assembly

Cups and heads were manufactured from alumina of diameter 32mm. The radial clearance between the head and the cup is ranging between 50 and 100 $\mu$ m. The actual value of radial clearance will not be exposed due to confidential agreement with the manufacturer (SERF company). Grain size, density and Young's modulus were in agreement with the ISO 6474-1 standard requirements, Table I. The ceramic cups were sheathed in an acetabular shell. In order to accelerate degradations, the tests were carried out in severe conditions; no lubrication and a 30ms load of 9kN at 2Hz<sup>4</sup>. Assembly was inclined at 45° to respect standard anatomic position, Figure 4. The cup was fixed and the head was maintained into a cone.

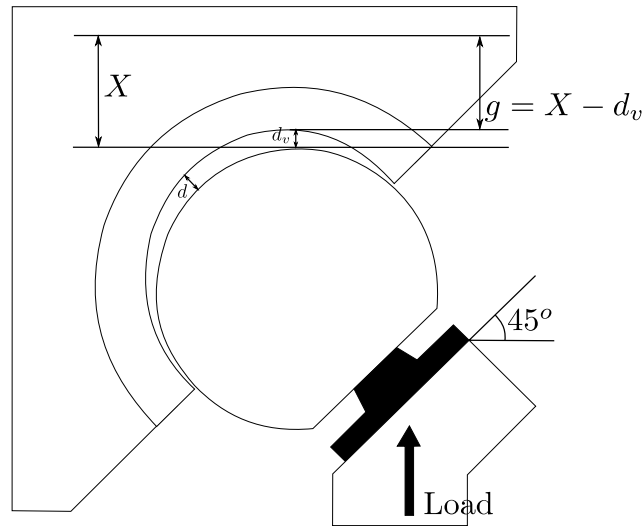
Figure 5. Virtual distance  $g=X-d_v$ .  $d$ : microseparation,  $d_v$ : vertical distance to obtain the value  $d$ .  $X$  is the displacement imposed to the head

Several values of microseparations (d), Figure 5, were tested: 0, 0.7, 1, 1.3, 1.6 and 1.9mm. They are related to the *in vivo* behaviour. To each microseparation corresponded a vertical distance, (dv). For each microseparation, a displacement of X was imposed to the head. Since the distance between the head and the cup was dv, a force is applied when  $X > dv$  and increased with X. The distance  $g = X - dv$  was defined as "relative distance", Figure 5.

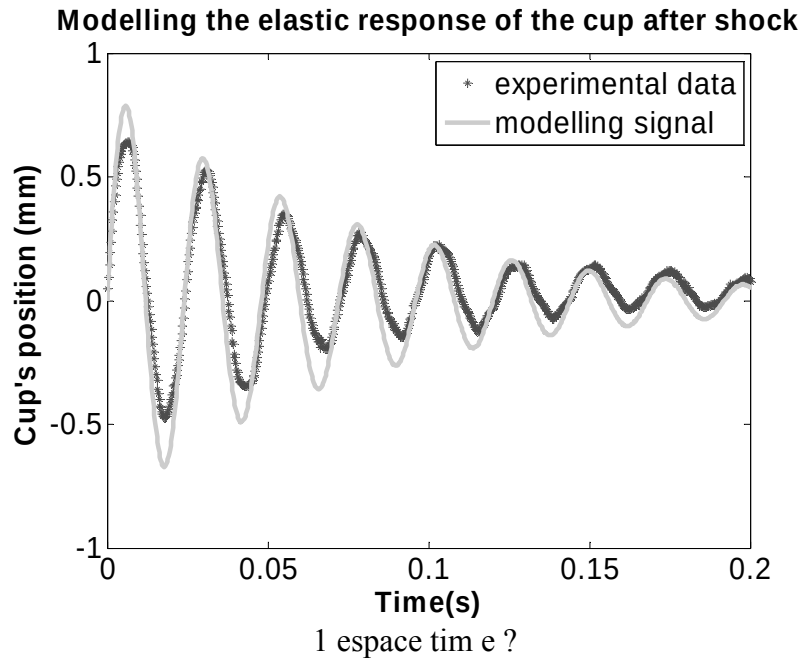
Figure 6. Results for a square signal, with a microseparation of 1.3mm and a force of 9kN, black dotted line: the elastic response of the cup after the shock, gray continued line: the modelling signal.

As can be seen in Figure 6, the underdamped oscillator model fits experimental data well. The  $k$  and  $c$  values will be adopted in a finite element modelling, further investigations not mentioned in this work, for reproducing the movement of the cup after a shock and studying stresses distribution on the assembly cup-head.

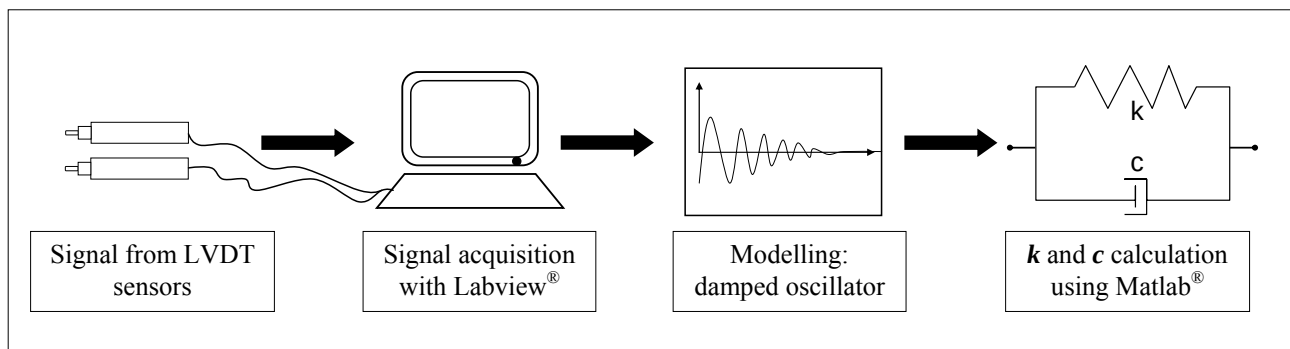
Figure 7. Diagram of data acquisition and postprocessing

The process of data acquisition, processing and modelling is summarized in Figure 7. Spring constant,  $k$ , and damping coefficient,  $c$ , were determined by fitting using Matlab<sup>®</sup>.

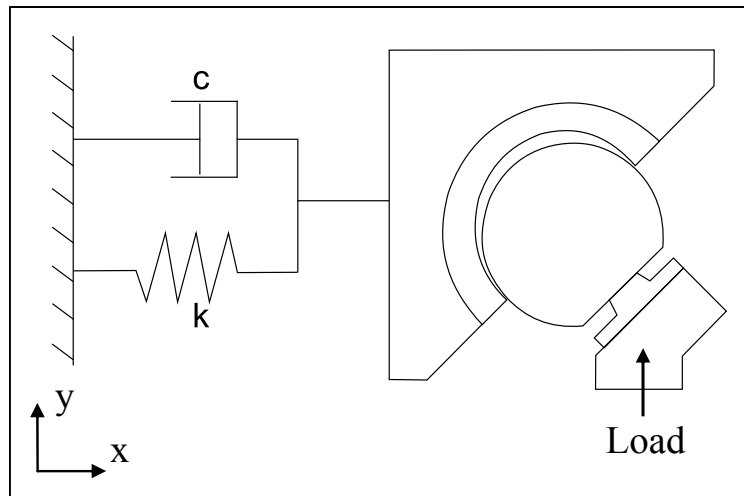
Figure 8. Scheme of shocks machine. The movements of the cup and the device are represented by a damped spring system.

Finally, the shocks device could be described in a more simplified manner as shown in Figure 8.

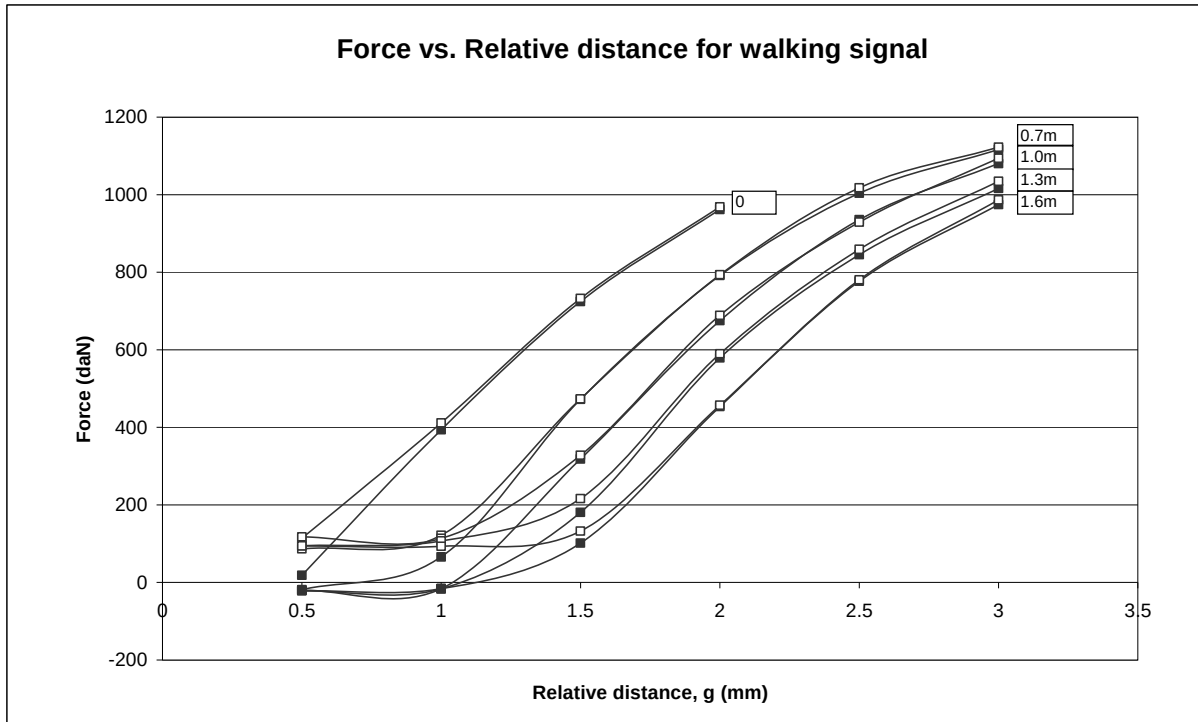
Figure 9. Force on the assembly cup-head as a function of relative distance of the head, for different values of microseparation; □: Ni-DAQ, ■: machine software

The validation tests were made to determine the range of operating conditions to reach a force of 9kN, and 3 signals were studied: sinus, triangle and walking. The signals from Ni-DAQ<sup>TM</sup> and machine software, Quiri<sup>TM</sup> did not show significant difference for sinus and triangle. On the other hand, for walking signal, recorded signals were considerably different for forces under 2kN. Above 2kN, signals are similar and may be modelled by a linear curve which slope is calculated for each microseparation value (Figure 9 and Table III).

Tests had duration of 20s and were stopped when force was greater than 11kN to avoid fracture of ceramic components and to be consistent with device capabilities. The results in Figure 9 show that a relative distance of 1.8mm has to be imposed to the head for reaching 9kN, without

microseparation. Hence, from Figure 9, an equation was established for microseparation of 1.3mm, the typical microseparation for *in vivo* tests:

Six heads and cups manufactured from alumina, diameter 32mm, were tested: three in dry conditions and three using a calf serum as lubricant. The load was 9kN with an initial microseparation of 1.3mm. From Figure 9, a virtual distance of g=2.7mm was imposed. After characterizing the machine, this part aims at analyzing two typical wear zones on the head.

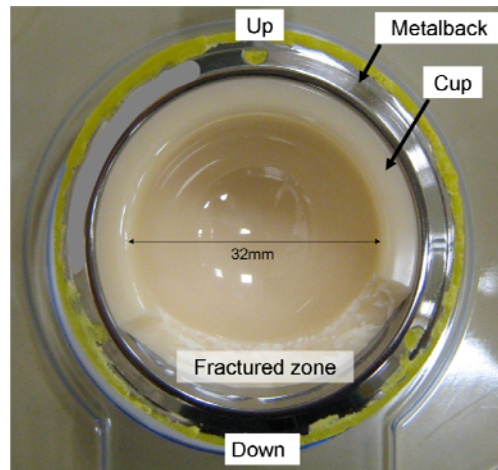
Figure 10. Alumina cup tested in dry conditions. Fracture at the lower rim.

Tests and cycles at fracture are summarized in Table IV. The three cups from dry tests fractured at the lower rim of the cup, Figure 10. Cup fracture occurred at  $254,000 \pm 43,000$  cycles. Fractured bearing surfaces observed by Scanning Electron Microscopy, SEM, revealed intergranular and transgranular fractures, Figure 11. The size of debris from fractured cups was less than 1mm to several mm. There was no fracture for wet tests.

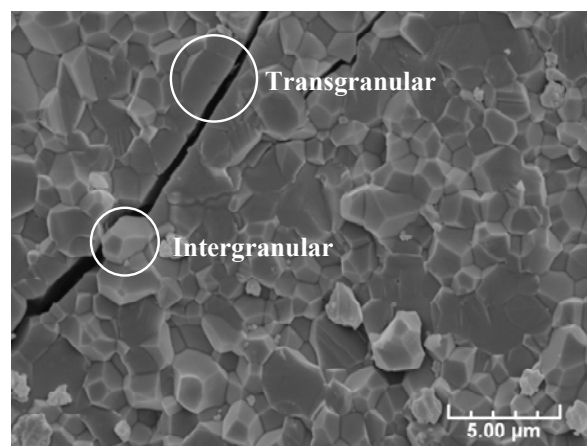
Figure 11. SEM image from alumina debris. Intergranular and transgranular fracture.

Figure 11 shows that debris could be mostly about 1µm of diameter. Shocks induce these typical debris. This experimental result involves some expectations about the reactions of cells. Studies on the biological tolerance of alumina and zirconia nanosized powder on rats suggested that the inflammatory response is similar to those reported for polyethylene or metal particles<sup>23</sup>. Nevertheless, testing composites under shocks could lead to intergranular and transgranular fracture and smaller nanometric debris could be found, which might induce an inflammatory response.

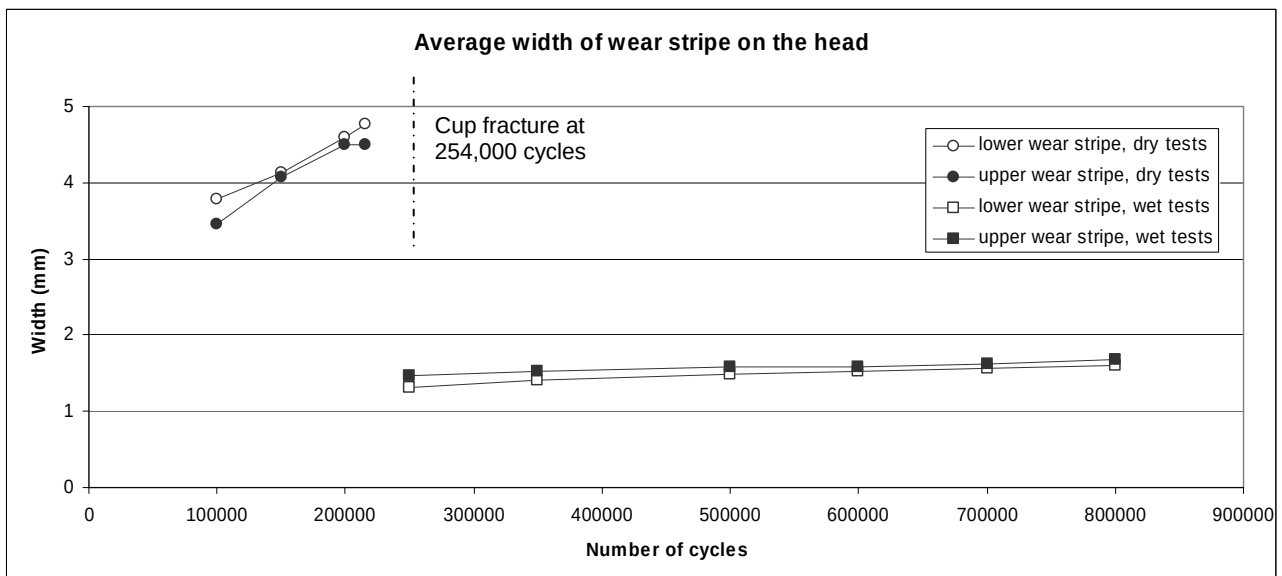
Figure 13. Width of wear stripes on the head for dry and wet tests.  
Enlever lignes horizontales

Average width of wear stripe was strongly different for heads tested in dry and wet conditions; wear stripes were wider than 4mm in dry conditions while it was less than 2mm for wet conditions, Figure 13. However, at a macroscopic scale, the worn surfaces from the dry tests and wet tests were morphologically indistinguishable. Since wear stripes did not reached 4mm and had a small growth rate, tests were stopped at 800,000 cycles in wet conditions.

In both dry and wet conditions there was an accelerate growth in the first 150,000 cycles; the slope is bigger for dry than the one for wet. After 200,000 cycles the width of the wear stripe of heads increased slowly. Figure 14 shows the average width of the wear stripes at the end of the tests.

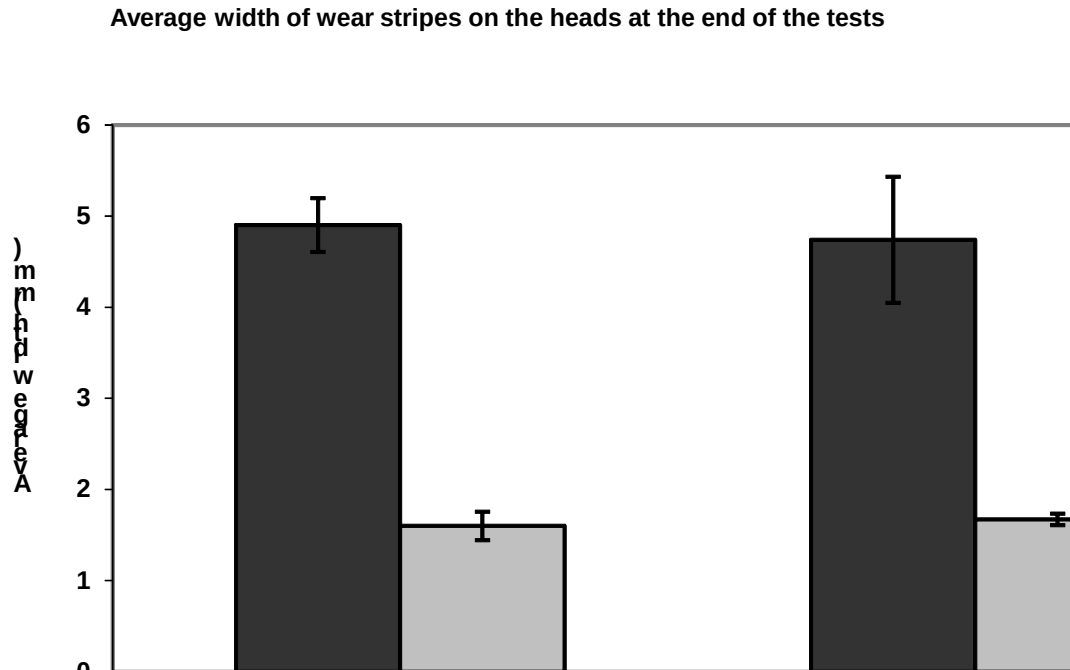
Figure 14. Width of wear stripes for heads in dry and wet conditions.

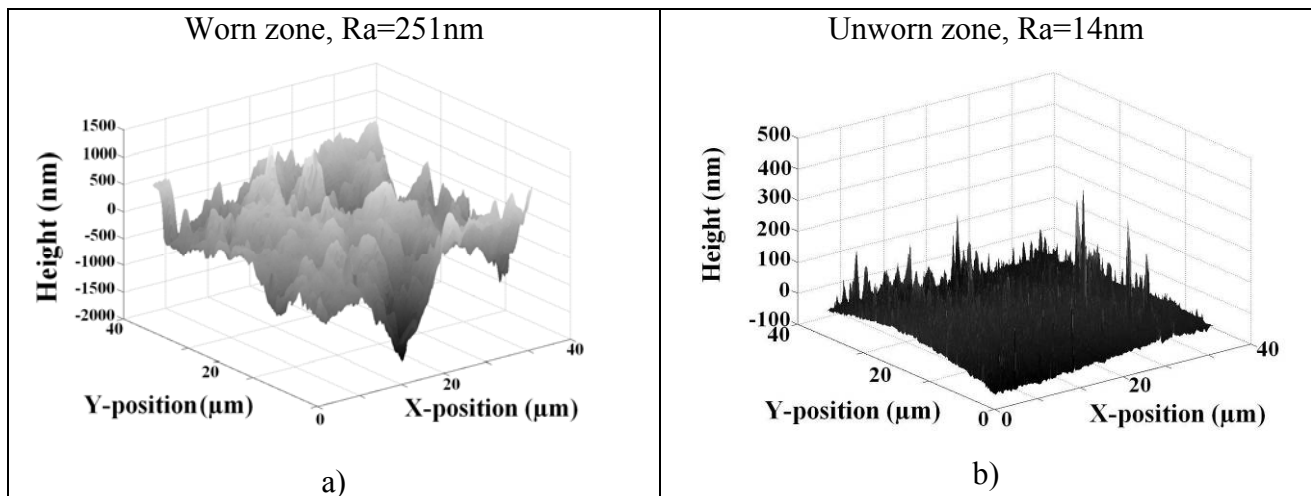
Figure 15. Three- dimensional reconstruction of a roughness profile for both a) worn and b) unworn zones studied by AFM.

After the shock tests, heads were cut carefully and analysed by Atomic Force Microscopy (AFM, Software 6.13) to determine surface roughness evolution. A first order flatten filter was applied to suppress the effect of the spherical shape. 3D-roughness was of  $9.1 \pm 5.1$  nm in unworn zones whereas it was measured to be  $277.9 \pm 29.4$  nm in worn zones. Roughness in worn zones is 20 to 30-fold higher than in unworn zones. These values are comparable with retrieved heads<sup>12</sup>. A three dimensional reconstruction of the surface was made using Matlab<sup>®</sup>. Figure 15 shows surface for a worn and unworn zone from the same head.

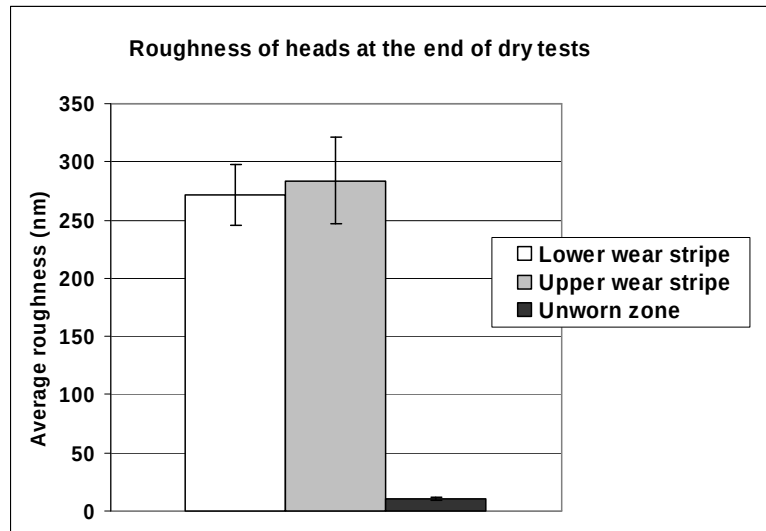
Figure 16. Wear stripe roughness from heads tested in dry conditions.

Analyses by AFM showed a similar roughness for the upper and lower wear stripe, showed in Figure 16.
