Effects of Electric Partial Discharges on the Rheological and Chemical Properties of Polymers Used in HV Composite Insulators after Railway Service

Jean-Pierre Habas, Jean-Marie Arrouy, Fabrice Perrot

The origin and the consequences of the electric failure of in-service composite hollow insulators used in railway transportation were investigated. Direct electrical measurements made it possible the detection of partial discharges (PD) and UV emissions allowed of identifying the location of the PD at the interface between metal braids and a silicone liner. To investigate the effects of the damaging PD activity, physicochemical properties of the different polymers were investigated and compared to new samples. The thermomechanical properties of the HTV and RTV silicones showed important alterations in the polymers structure. The chemical analyses of the silicones and nitrile rubber conducted using ATR-FTIR spectroscopy revealed that the polymers were oxidized after electrical failure. The results indicated that the ozone production and UV emission were due to the surface electrical activities. The breakdown of alumina trihydrate (ATH) in the inner HTV silicone liner demonstrated tha

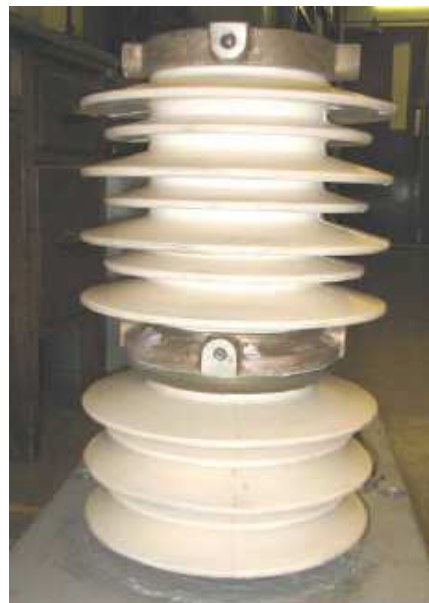
The hollow composite insulators studied in this research were used in an outdoor railway transportation application (Figure 1). The design relied on a structural GRP composite manufactured by a glass filament winding technique (Figure 2). The external housing was made by a High Temperature Vulcanized (HTV) silicone rubber. The primary function of the HTV was to protect the GRP tube from moisture ingress. It also provided the external voltage creepage distance by increasing the composite resistance against pollution and the

Figure 1. Overall view of the hollow insulator.

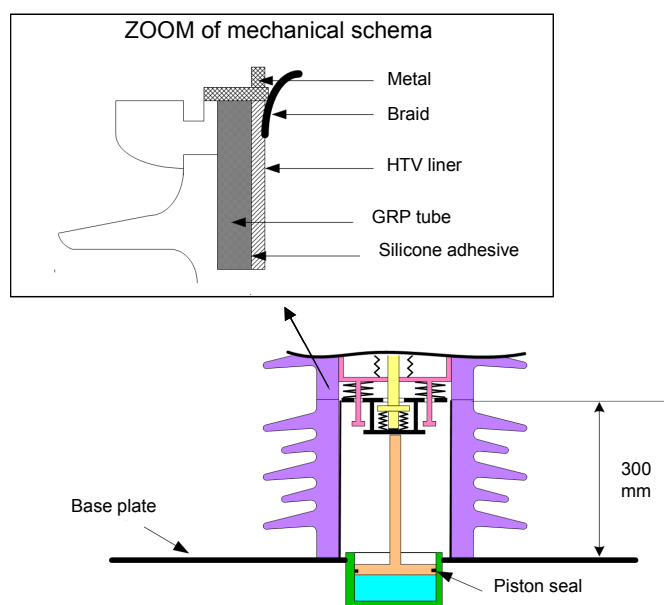
Other internal elements of the insulator included metal braids, Room Temperature Vulcanized (RTV) silicone and an elastomeric nitrile seal. On the basis of the above description, the construction of the composite hollow insulator had undeniably added complexity in terms of the range of materials used. It was evident that the insulator reliability would be dependent not only on the properties of the different elements but also it was likely to be affected by the numerous interfaces present including the enclosed airspace [22].

Figure 2. Cross-sectional representation of the hollow insulator studied in this research.

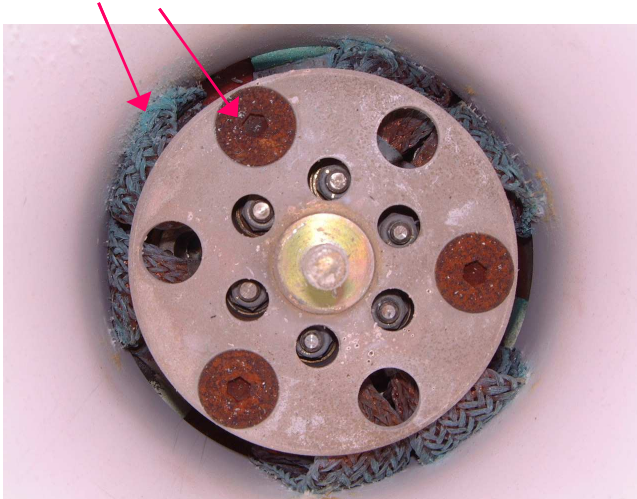
All the polymer samples studied in this research were directly collected from failed insulators after service conditions and from new production units. A comparative investigation of both types revealed significant differences. In particular, the examination of the internal parts of failed hollow insulators showed extensive oxidation of all metallic elements such as copper connecting braids, electrodes and fasteners (Figure 3).

Strong oxidation of metallic elements

Figure 3. Visual inspection of the inner part of a failed insulator.

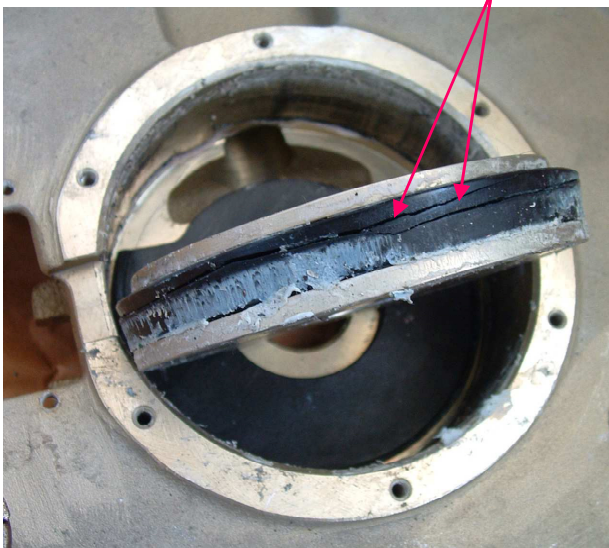
Further observations also indicated that several polymeric elements had severely degraded. Firstly, the elastomeric piston seal initially flexible had become hard and brittle and was now failing to seal efficiently (Figure 4).

Cracks

Figure 4. Evidence of cracks formation in the nitrile piston seal taken down from failed insulator.

On the basis of our first experimental results, the premature failure of the hollow insulators has been related to the formation of corona discharges. These discharges were found at triple points formed by the air space surrounding the metal electrodes and the silicone elastomer liner. This undesirable electrical activity is well-known to inducing ozone production [17, 20, 21, 34, 35]. Moreover, the presence of this highly oxidizing gas within the hollow insulator was thought to be responsible for the corrosion observed on the metallic parts. It was also thought to induce the mechanical breaking of the nitrile piston seal, known for poor ozone resistance [36-38].

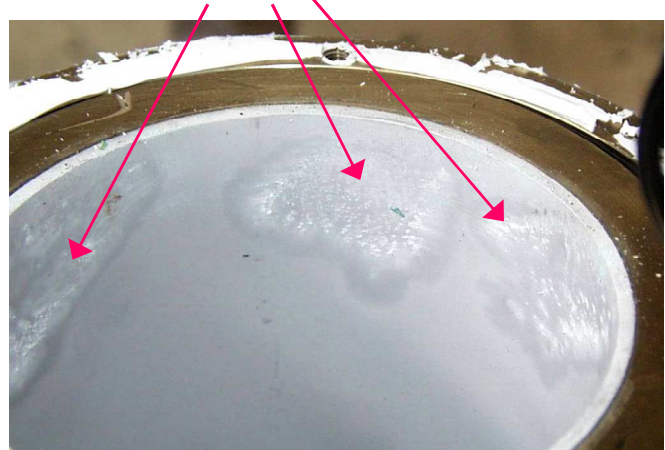
Secondly, the inner HTV silicone liner was discolored from its original grey color to white. The discoloration was found to be inhomogeneous, it was much more pronounced on the surface in direct contact with the enclosed air (Figure 5).

Discoloration of HTV silicone liner

Figure 5. Evidence for HTV liner discoloration on failed insulator

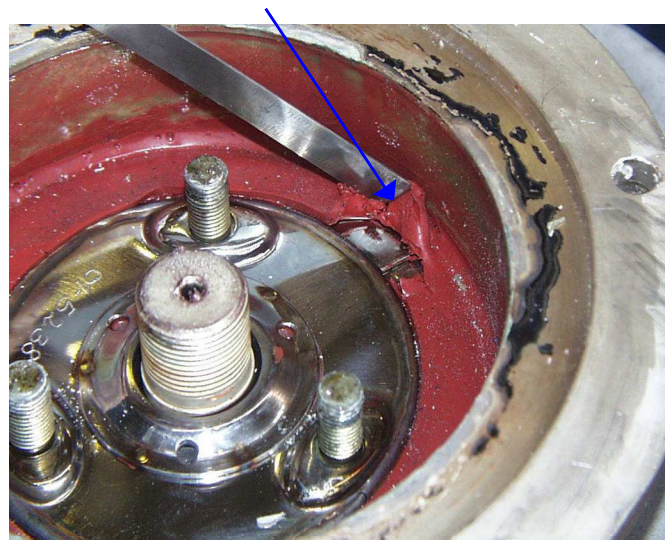
Finally, the encapsulating RTV silicone was found to be tacky and could be easily torn compared to the initial elasticity of the polymer (Figure 6). These discrepancies supported the evidence that the deviation in the polymers' properties could not be attributed to differences in the chemical formulations.

RTV gasket : change from elastic to pasty state

Figure 6. Examination of RTV gasket in failed insulator

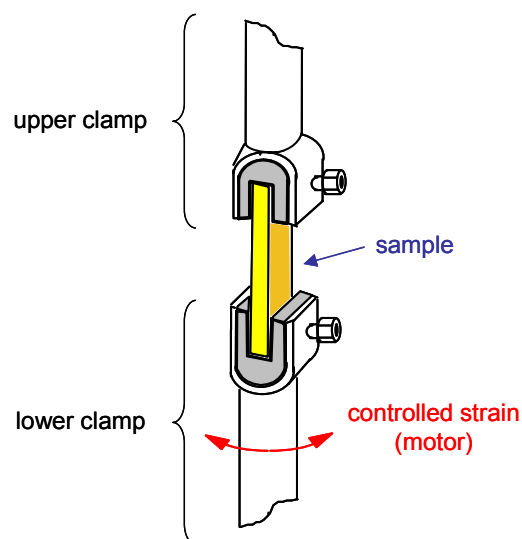
The viscoelastic behaviour of HTV and RTV silicone samples were investigated as a function of temperature using a Rheometric Scientific ARES rheometer equipped with torsion fixtures. This configuration represented in Figure 7, required the preparation of the solid samples in rectangular form (40 mm × 10 mm × 2 mm). The lower part of the tablet was attached to an actuator that forced an oscillating shear (dynamic mode). The upper part was attached to a sensor that measured the resulting stress due to the mechanical shearing of the sample.

Figure 7. Schematic representation of rectangular torsion geometry used for thermomechanical analyses.

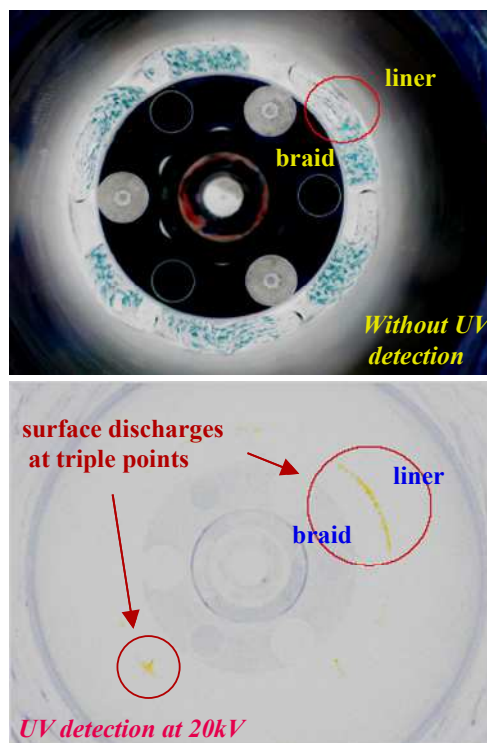
It is universally accepted that electric field enhancement near an HV electrode is often responsible for the initiation of corona discharges or surface discharge activity. Many factors can be responsible for this electric field enhancement, such as, electrode geometry, surface roughness, protrusions and also macroscopic impurities [24]. In the present study, the optical measurements pinpointed the exact location of the corona and surface discharges (Figure 9). The undesirable electrical activity was detected between a metal braid and the HTV silicone liner which was defined as a triple point “metal-dielectric-air” [25].

Figure 9. Optical PD measurements within the hollow insulator: experimental evidence of UV emission at “metal-dielectric-air” interfaces.

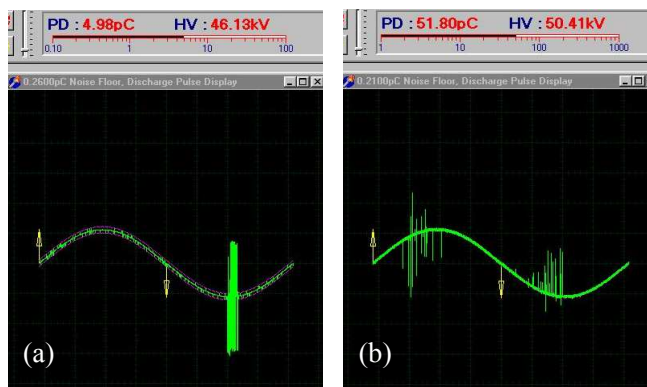
Direct electrical PD detection was also carried out in conjunction with the previously described optical measurements on the same hollow insulators. Each PD pattern represented the PD activity recorded over ten 50 Hz cycles. On one hand, the composite insulators that exceeded qualification voltage, produced corona discharges on the metal electrode system connected to the HV side of the hollow insulator. This phenomenon referred as “negative corona” is depicted by Figure 10a.

Figure 10. Direct PD Detection within the hollow insulator. Negative corona discharge (a), Internal / Surface PD activity (b).

On the other hand, failing hollow insulators produced an asymmetric PD pattern as shown in Figure 10b. This result was thought to be consistent with previous optical PD

measurements that detected surface discharges in the vicinity of the metal electrode and the dielectric boundary (triple point). The shape of the PD pattern also suggested electrical discharges may be occurring in voids in either the HTV liner, its interface or within the composite tube.

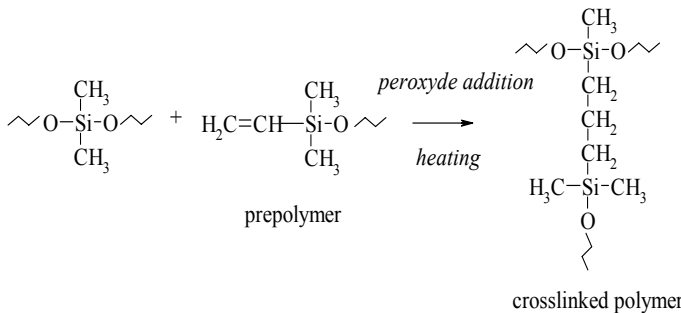
In order to investigate the origin and consequences of the damaging PD activity, the viscoelastic properties of the polymeric materials in direct contact with the inner part of the GRP tube were assessed. The first experiments concentrated on the HTV silicone liner. This elastomer was processed by the crosslinking of the uncured silicone resin previously poured in a cylindrical mould. The heating at $T = 170^{\circ}\text{C}$ enabled the transition from a viscous paste to a solid by formation of a three-dimensional polymeric network according the reaction diagram described in Figure 11.

Figure 11. Polymerization mechanism of HTV thermosetting silicone resin.

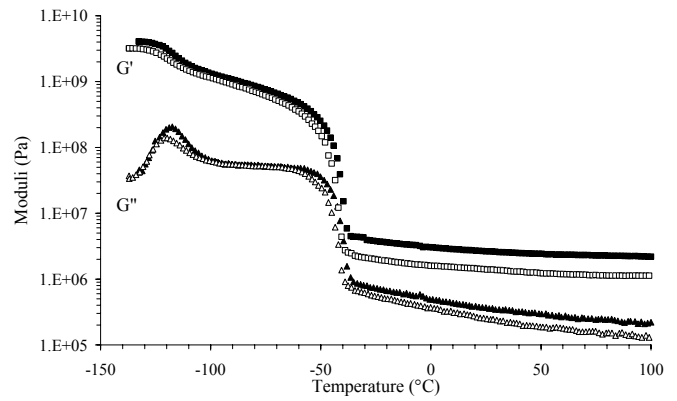
The rheological properties of the initial cured HTV elastomer as a function of temperature are described in Figure 12. The registered thermomechanical profile clearly showed that the polymer had a semi-crystalline morphology. In the low temperature region, the material was found to be quite rigid ($G' > 10^9$ Pa). More precisely, at $T = -115^{\circ}\text{C}$, the curve of the elastic modulus G' showed a deflection while the G'' curve presented a relaxation peak. This latter phenomenon is characteristic of the mechanical relaxation of the amorphous chains during the glass transition of the polymer. The decrease of the shear modulus with temperature remained limited up to $T = -50^{\circ}\text{C}$ due to the persistence of the crystalline regions. Above this critical temperature, the softening of the crystalline phase was observed, giving the material a rubbery state. The elastomeric character then became predominant and the rheological properties remained temperature independent up to 150°C . It has to be noted that the latter temperature widely exceeds the thermal range of the hollow insulator system in normal service conditions.

The thermomechanical behavior of the discolored HTV liner recovered from a failed hollow insulator after service conditions is also presented in Figure 12. It slightly differed from the previous results on a fresh polymer. In particular, the magnitude of the relaxation peak (G''), associated with the glass transition, was smaller and its maximum shifted to a lower temperature. Moreover, the polymer rigidity in the elastomeric state was significantly lower.

Figure 12. Thermomechanical behaviour of HTV silicone liner: new sample (full symbols) and after service conditions (empty symbols).

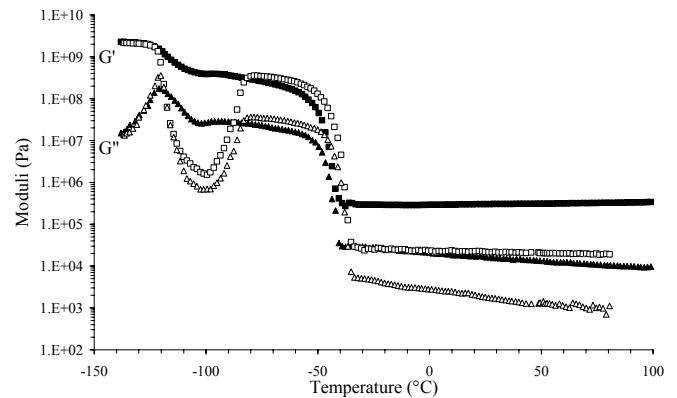
Similar changes were observed with the RTV silicone elastomer used in the hollow insulator as a flexible gasket. Figure 13 shows that the initial thermomechanical properties of the RTV silicone resemble that of the new HTV liner (full symbols). However, although the glass transition temperature and softening point were almost identical between both materials, the elastomeric rigidity of the RTV silicone at room temperature was about a decade lower.

Figure 13. Thermomechanical responses of RTV silicone gasket: new sample (full symbols) and after eight months in service (empty symbols).

Figure 13 also reveals that the rheological properties of the aged RTV significantly differ from the characteristics of new samples. In particular, the rubber elasticity measured at temperatures $T > -50^{\circ}\text{C}$ was reduced from 3×10^5 Pa to 2.2×10^4 Pa. But, according the classical theory of rubber elasticity, the mesh size of the polymer network is inversely proportional to the rubbery elasticity G_e' according the following equation:

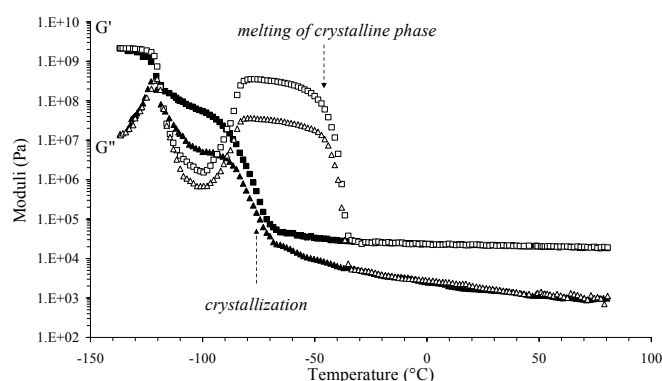
Further observation of thermomechanical analyses seemed to validate the degradation of RTV and, to a lower extent, of HTV silicone. For instance, the decrease of the glass transition temperature was found coherent with the reduction of the crosslinking density as predicted by DiMarzio [27]. But, the most noticeable phenomenon was surely the presence of a depression in the rheological curves of aged RTV sample, just above the glass transition zone (Figure 13). Subsequently, both viscoelastic moduli newly increased to reach the crystalline plateau ($-80\text{ }^{\circ}\text{C} < T < -50\text{ }^{\circ}\text{C}$). This latter evolution resembled that classically observed during a recrystallization. To go further in the understanding of this unexpected rheological behavior, a new thermomechanical analysis was undertaken on the same aged polymer but with decreasing temperature ramp. The results are described in Figure 14 that also reminds the data obtained with increasing temperature for easier discussion.

Figure 14. Thermomechanical analyses of aged RTV silicone: decreasing ramp $-3\text{ }^{\circ}\text{C}/\text{min}$ (full symbols), increasing mode $+3\text{ }^{\circ}\text{C}/\text{min}$ (open symbols)

Both analyses were perfectly superposed above the melting temperature of the RTV silicone ($T > -50\text{ }^{\circ}\text{C}$) where the polymer was in the rubbery state. For lower temperatures, the thermomechanical profiles were quite different due to the classical hysteresis between melting and crystallization temperatures: in decreasing mode the crystalline plateau was observed for $T < -90\text{ }^{\circ}\text{C}$. Moreover, it presented a lower value than that observed in the analysis carried out with increasing temperature. This discrepancy suggested that the RTV silicone has been unable to fully crystallize with a temperature ramp fixed at $-3\text{ }^{\circ}\text{C}/\text{min}$. To observe a more complete crystallization, a smaller temperature ramp should have to be used in the decreasing mode to fit with the slow kinetic of the spatial organization of macromolecular chains. These latter results were judged as helpful to understand the origin of the depression observed in the rheological curves of the aged RTV silicone. During a temperature increase, the crystallization process should restart when the molecular mobility becomes sufficient (that is to say above the glass transition temperature). In other words, the depressions observed in Figures 13 and 14 can be interpreted as being representative of the chains' recrystallization provoked by an insufficient crystallization rate during the initial cooling of the polymer. This phenomenon could not be detected by calorimetry due to its weak exothermicity. As it mainly appeared with the aged RTV sample, it seemed to confirm that the degradation of this class of polymer was much more advanced than that observed with HTV aged sample: if the structural changes in

case of the HTV silicone, less pronounced effects were obtained, which seems consistent with the limited changes in rheological properties observed after service conditions. However, the structural changes only related to the amorphous phase of the polymeric network as described before with silicones aged in commercial conditions. One could be tempted to interpret this result as being the demonstration that the crystalline regions are insensitive to ozone. The more reduced intermolecular space could also be used to justify that ozone diffusion is harder in crystalline phase. But, this analysis would be incorrect. Indeed, it is important to note that in the present industrial appliance, HTV and RTV silicones were always used for temperatures higher than -40°C . In the elastomeric state, the crystalline morphology did not exist anymore. As a consequence, our results showed that ozone was able to produce local degradations in the polymer network that induced an increase of the average mesh size. In the same time, these alterations were sufficiently important to affect the crystallization kinetic of RTV silicone chains as previously shown in Figure 14.

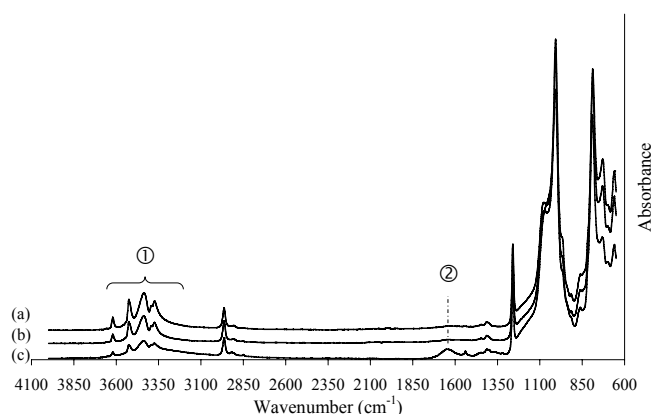
To investigate the structural origin of the rheological changes previously described, three different HTV silicone liners were analyzed by FTIR spectroscopy. The first sample was from a failed insulator which had been exposed to corona discharges, with an inception voltage (DIV) of 12 kV. The other samples were taken from HTV liners of new equipments but presented two distinct corona inception voltages (respectively 50 kV and 10 kV). Figure 15 shows the different spectra obtained and translated along a vertical axis for clarity. As precised in the presentation of the experimental procedure, each spectral zone is specific of precise chemical groups. The first noticeable difference between all spectra was situated in the region ($3200\text{--}3700\text{ cm}^{-1}$ – zone ①) that is characteristic of OH groups. As these units were not present in the chemical structure of silicone, they could be attributed to the only presence of alumina trihydrate $\text{Al}(\text{OH})_3$. This compound currently named ATH is used in the formulation of silicone to improve certain properties such as lower leakage currents, erosion-resistance or fire-retardancy [28], [29]. Indeed, at temperatures exceeding $200\text{ }^{\circ}\text{C}$, the breaking of ATH molecules generates new chemical species such as water and alumina [30]. The comparison of the different FTIR analyses showed that the intensity of the OH bands was much smaller in the case of HTV liner after service conditions. In other words, the ATH concentration was the most reduced for aged HTV elastomer. This ATH defect could be interpreted as being at the origin of the low value of the corona inception voltage as already proposed by Pradeep [33]. But, at the same time, one of the liners taken from new production presented an ATH concentration higher than that of the used liner whereas the respective insulator inception corona voltage was slightly lower (10 kV against 12 kV). From the above results, it is believed that the ATH concentration in the HTV silicone liner could be influenced by the surface discharge activity. This interpretation agreed with conclusions that have already been proposed in the literature by several authors [28-32].

Figure 15. FTIR analyses of HTV liners. (a): liner DIV 50 kV (new), (b): liner DIV 10 kV (new) and (c): liner DIV 12 kV (after service conditions). The spectra were arbitrarily shifted along vertical axis for clarity.

The FTIR analysis of the HTV liner extracted from a failed insulator also exhibited the formation of carbonyl units as revealed by the increase of the absorbance band centered at 1628 cm^{-1} (Figure 15 - zone ②). It is important to be reminded that these chemical species were not present in the initial HTV silicone structure. Additionally, their presence could not be explained by the ATH thermal transformation.

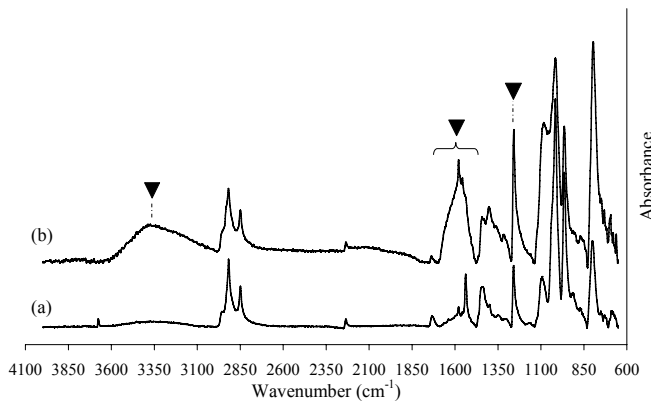
Such structural changes were also observed in the FTIR analyses of the nitrile piston seal which was found to be excessively brittle after service conditions (Figure 16). Indeed, the FTIR spectrum of the aged sample presented new absorbance bands located at 1257 , 1605 and 3350 cm^{-1} which were respectively representative of C-O bonds, carbonyl C=O groups and OH units.

Figure 16. FTIR analyses of the nitrile piston seal. (a): new sample, (b): after failure in service. One spectrum was translated along a vertical axis for clarity.

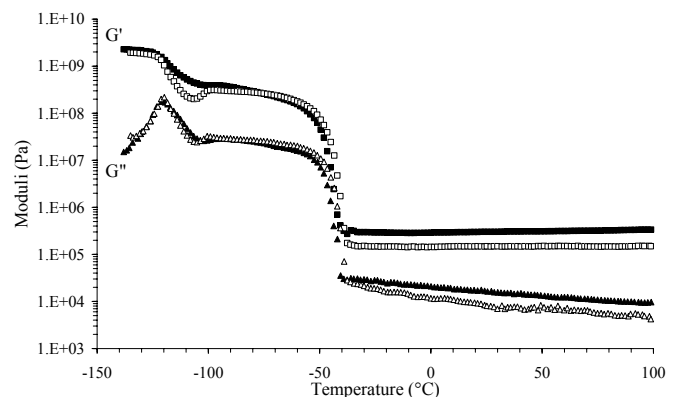
To confirm or invalidate the influence of ozone on the properties of silicone samples studied, we carried out accelerated chemical aging of virgin RTV and HTV samples. The experimental procedure based on a laboratory ozone chamber has been previously described in part 3.5. The thermomechanical analysis of the exposed RTV silicone was worth noting since the rheological results showed a slight depression beyond the glass transition whilst the value of elastomeric elasticity decreased in comparison with the properties of the initial compound (Figure 17).

Figure 17. Thermomechanical analysis of RTV silicone: new sample (full symbols) and after artificial exposure to ozone (1000 ppm – 200 h - empty symbols)

As described previously, all these changes were also observed in samples taken from failed hollow insulators after service conditions. This result shows that the properties of RTV silicone can be affected by ozone exposure. In the

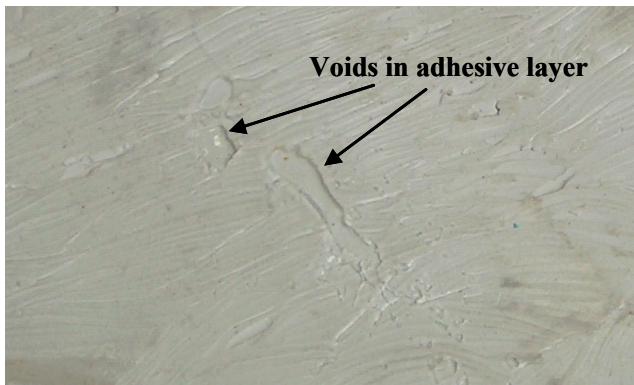
Although the origin of the corona discharges and their consequences on the materials inside the hollow insulator seem to be defined now, the electrical discrepancies between hollow insulators of the same design were thought to be significant. As a consequence, it was thought that another parameter was likely to be contributing. Further electrical experiments conducted on empty hollow insulators (i.e. not fitted with internal parts) enabled the detection of internal partial discharges. Additional structural examinations were undertaken and identified structural bulk defects that could explain the origin of the internal PD activity. Voids were detected in the adhesive used to bond the HTV liner to the composite GRP tube (Figure 18).

Figure 18. Presence of defects in the adhesive interface between the liner and the inner GRP tube.

Their influence on the electrical performances of the hollow insulator was considered to be significant. Internal PD activity was allowed to take place within the defects, thus affecting the electric field distribution along the internal length of the hollow insulator. This could also contribute to the generation of surface PD activity, reinforcing the production of ozone and UV emissions. These parasitic electrical activities
