## **In-situ X-ray microtomography characterization of damage in SiC/SiC minicomposites**

Camille Chateau, Lionel Gélébart, Michel Bornert, Jérôme Crépin, Elodie Boller, C. Sauder, Wolfgang Ludwig

Camille Chateau, Lionel Gélébart, Michel Bornert, Jérôme Crépin, Elodie Boller, et al.. In-situ X-ray microtomography characterization of damage in SiC/SiC minicomposites. *Composites Science and Technology*, 2011, 71 (6), pp.916-924. 10.1016/j.compscitech.2011.02.008 . hal-00736300

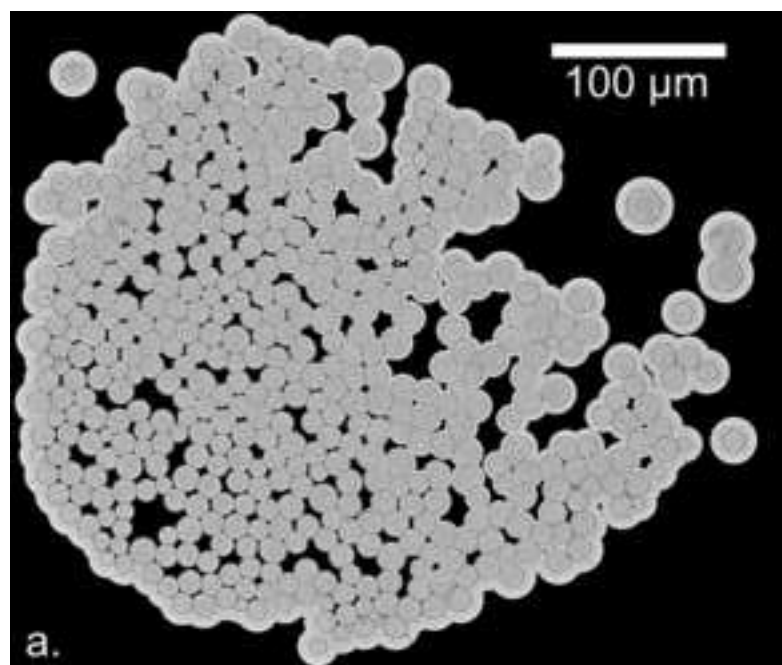
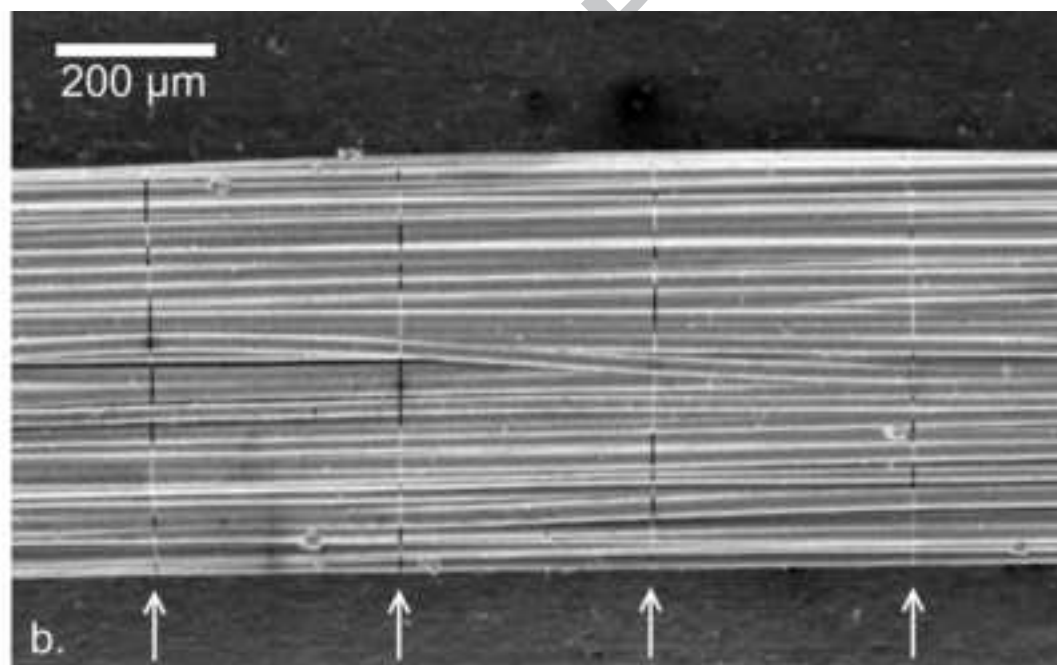
Figure 1: SEM micrographs of (a) minicomposite polished cross section; (b) cracked minicomposite under tension (75 N), arrows point out matrix cracks.

The residual porosity due to the CVI process, and fiber fractions were estimated at 0.12 ( $\pm 0.04$ ) and 0.58 ( $\pm 0.09$ ) from polished cross-section pictures (figure 1a).

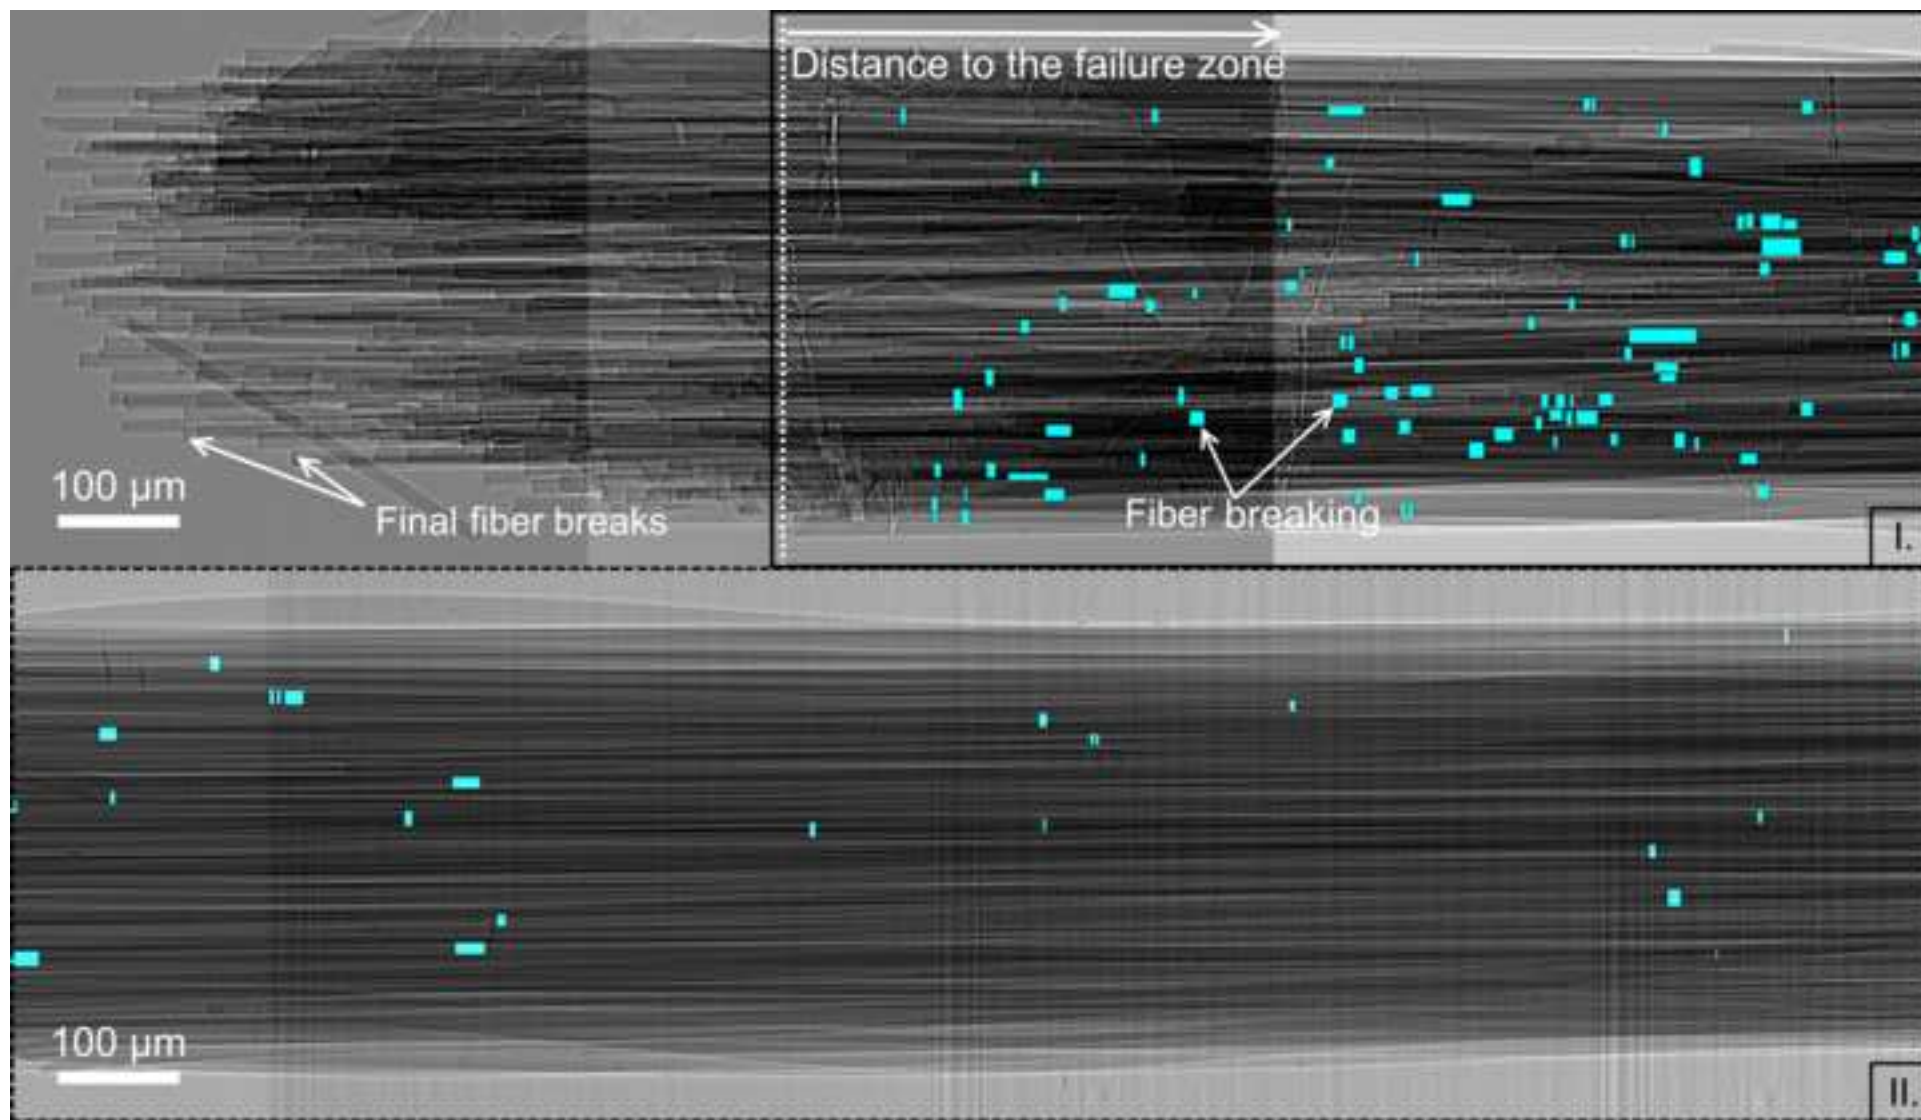
Figure 12: Fiber break local density and opening as a function of the distance to the ultimate failure zone. The local density was computed over a 1 mm moving window.

Regions I. and II. designate radiograph locations presented in figure 11. Region III. is the minicomposite part far from the failure zone when crack density appears uniform.

Considering post-failure observations without counting final breaks (figure 11), approximately 220 fiber breaks were observed in the 12 mm long half minicomposite. The break density is far less homogeneous (figure 12). In fact, most fiber breaks are located within 2 mm of the failure zone. On the other hand, the fiber break distribution is quite homogeneous at other locations. It has a density of approximately 5 breaks per mm (calculated on region III in figure 12), very similar to the density at 92 N. Additionally, observation A shows that the first fiber breaks observed with 3D tomography appeared at 80 N (figure 8). This load matches the final stage of matrix crack propagation inside the minicomposite.

In agreement with these observations, two different scenarios could be proposed. On the one hand, a random uniform fiber breaking develops slowly as the stress increases and the localization of the fiber density observed on figure 12 is the consequence of dynamic effects during failure. On the other hand, the random fiber breaking starts with a uniform distribution, then a localization of the break density occurs and leads to the ultimate failure. This second scenario is in better agreement with the final slight non-linearity observed on macroscopic curves, but additional experiments are required to
