Effect of Corrosion on the High Cycle Fatigue Strength of Martensitic Stainless Steel X12CrNiMoV12-3

To appear in: *International Journal of Fatigue*

This paper addresses the effects of corrosion on the high cycle fatigue (HCF) strength of a high mechanical strength martensitic stainless steel (X12CrNiMoV12-3) that is used in aeronautic applications. HCF tests (between 10^5 and 10^7 cycles) were carried out in two environments: (i) in air and (ii) in an aqueous solution (pH = 6) of 0.1 M NaCl + 0.044 M Na₂SO₄ at a loading frequency of 120 Hz. Surface crack initiation is observed in air, whereas in solution, the crack initiated at corrosion defects. The decrease observed in the corrosion fatigue strength of specimens at 10^7 cycles was 33% of that of similar specimens tested in air. The electrochemical behaviour of the passive film was investigated during fatigue testing in a NaCl aqueous solution by monitoring the free potential and through electrochemical impedance spectroscopy (EIS). Based on fractography analysis and the EIS tests results, fatigue crack initiation mechanisms in air and in the NaCl aqueous solution were identified. A scenario for fatigue crack initiation is pro

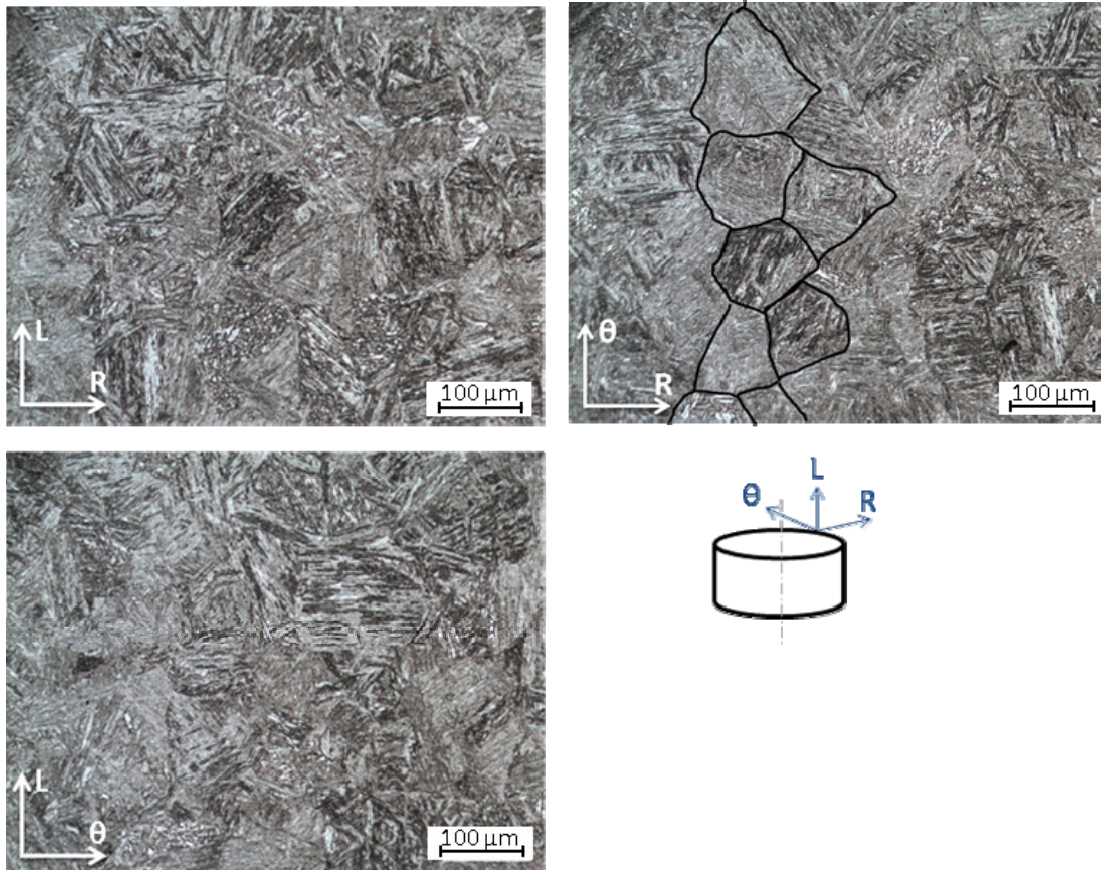
Figure 1: X12CrNiMoV12-3 stainless steel microstructure after heat treatment

The material being investigated is a high strength rolled martensitic stainless steel (X12CrNiMoV12-3) developed for aeronautic applications. Its chemical composition and mechanical properties under quasi-static monotonic tension are shown in Tables 1 and 2. The microstructure of this steel is completely martensitic, as shown in Figure 1 (residual austenite content is less than 1%). Austenitic grains have an equiaxed structure and the grain size is approximately 100 μm (class 5, according to the ASTM standard).

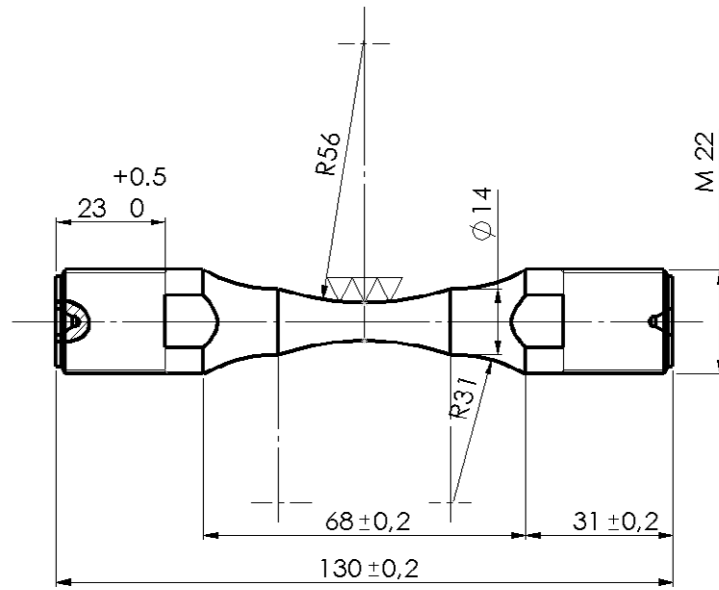
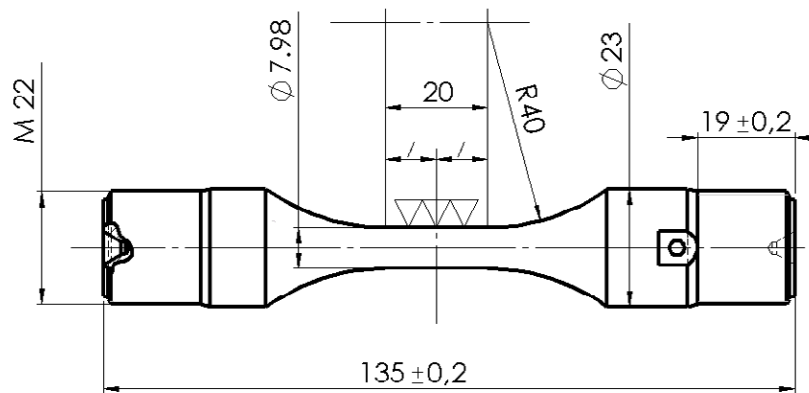
- $\nabla\nabla\nabla$ $R_a \leq 0,1 \mu\text{m}$
 $R_{t\text{max}} \leq 2 \mu\text{m}$
- $K_t = 1.04$

- $\nabla\nabla\nabla$ $R_a \leq 0,1 \mu\text{m}$
 $R_{t\text{max}} \leq 2 \mu\text{m}$
- $K_t : 1.04$

Figure 2: Specimen geometry for (a) fatigue tests in air and (b) corrosion fatigue tests

Fatigue tests were carried out in air and in a corrosive 0.1 M NaCl + 0.044 M Na₂SO₄ aqueous solution. The fatigue tests in air were performed using 8 mm diameter cylindrical specimens with a theoretical stress concentration factor in tension of $K_t = 1.04$ (Figure 2.a). The corrosion fatigue tests in aqueous solution were also carried out using 8 mm diameter cylindrical specimens ($K_t = 1.04$) (Figure 2.b). The arithmetic roughness of the area of interest was less than or equal to $R_a = 0.1 \mu\text{m}$ for all the specimens.

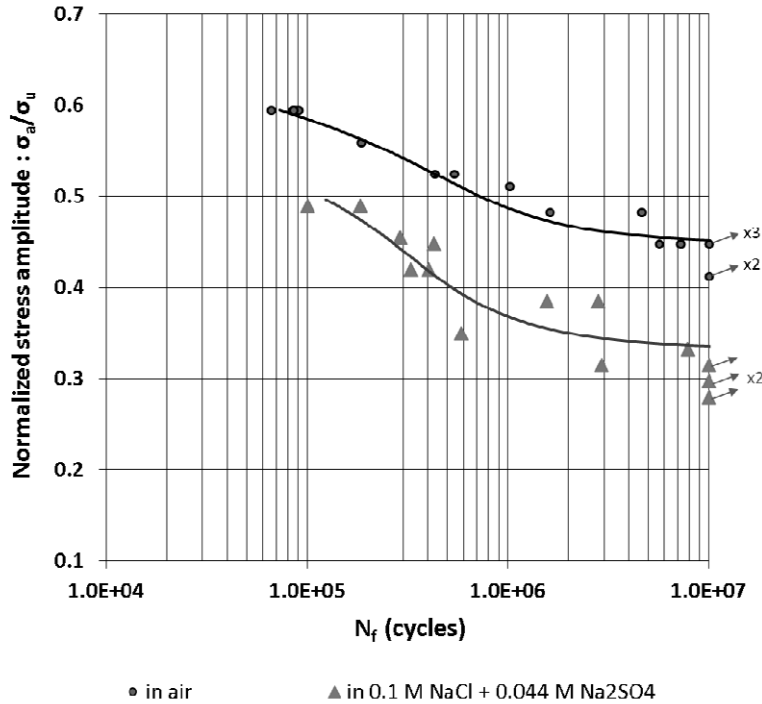
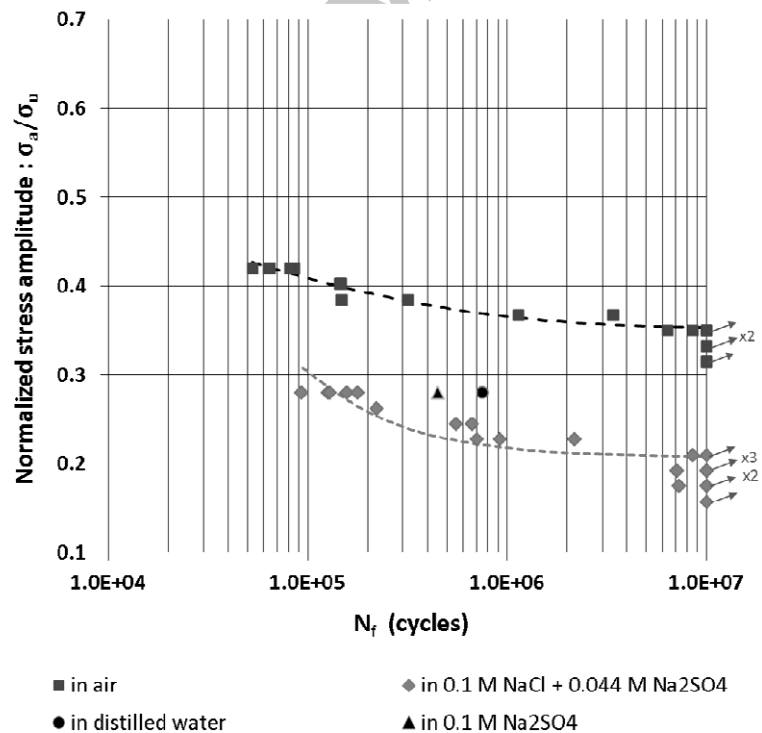
(a) under fully reversed tension ($R = -1$)

(b) under tension-tension ($R = 0.1$)

Figure 4: Median S-N curves (survival probability $P_s = 0.5$) in air and in the aqueous solutions at 120 Hz

The S-N curves of the X12CrNiMoV12-3 stainless steel under fully reversed tension in air and in the aqueous solution are shown in Figure 4 for two loading ratios, $R = -1$ and $R = 0.1$. These curves are normalised by the ultimate tensile strength (σ_u). The results show a significant decrease in the fatigue strength for the specimens in the corrosive aqueous 0.1 M NaCl solution compared to those in air. The median fatigue strength at 10^7 cycles of the specimens in the aqueous solution decreases by 33% compared to those tested in air. Some corrosion fatigue tests in the aqueous solution without NaCl were performed to understand the role of the chloride ions. Similar to the corrosion fatigue test in the (0.1 M NaCl + 0.044 M Na_2SO_4) aqueous solution, the results show a significant decrease in the corrosion fatigue strength in the 0.1 M Na_2SO_4 aqueous solution and in distilled water compared to air (Figure 4.b). The SEM observations show that the fatigue cracks initiated at surface corrosion defects (indicated by arrows on Figures 5.c to 5.f) in all the aqueous testing solutions (0.1 M NaCl + 0.044 M Na_2SO_4 , 0.1 M Na_2SO_4 and distilled water). For the fatigue test in air, fatigue crack initiation sites are located on the specimen surface (indicated by arrows on Figures 5.a and

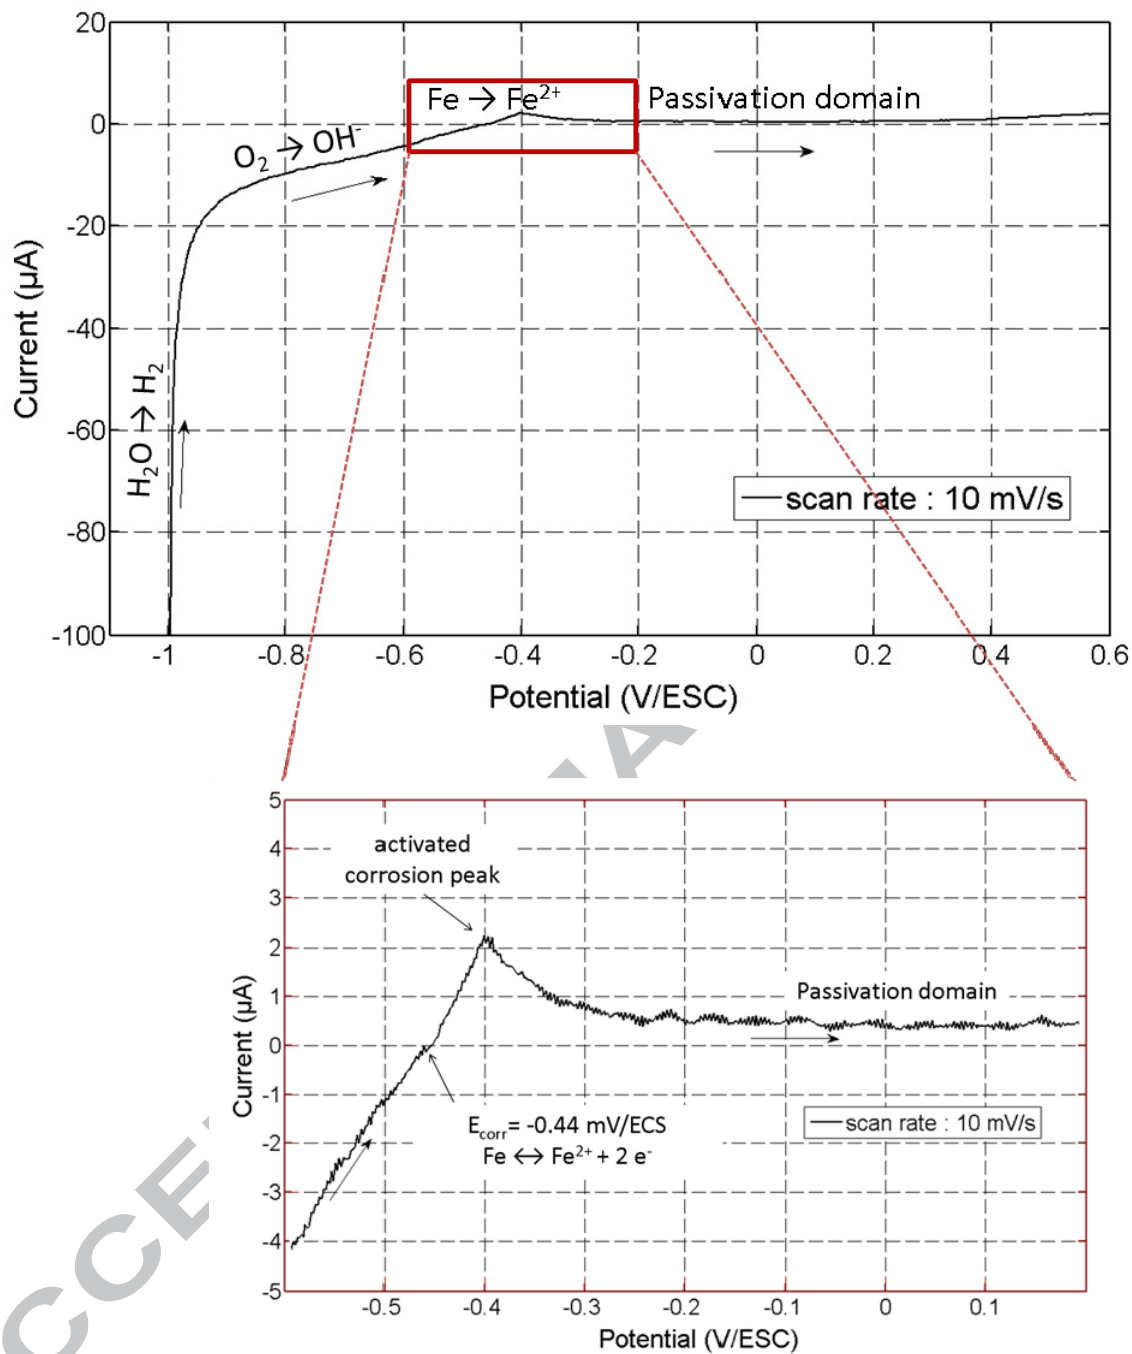
Figure 6: Linear scan voltammetry test on a specimen without cyclic stress in 0.1 M NaCl + 0.044 M Na_2SO_4

The potential was applied from -1 V/SCE up to +0.6 V/SCE at a scanning rate of 0.01V/s (Figure 6). The cathodic potential corresponding to the water reduction was chosen to reduce the passive oxide layer. Thus, an activation corrosion peak was observed around -0.4 V/SCE due to the iron oxidation involved as a result of the passive layer dissolution. A well defined corrosion potential E_{corr} was measured at -0.44 V/SCE. When the potential was shifted to be more anodic, the current decreased until becoming slightly positive. This potential range corresponds to the passivation domain, extending from -0.25 to +0.3 V/SCE.

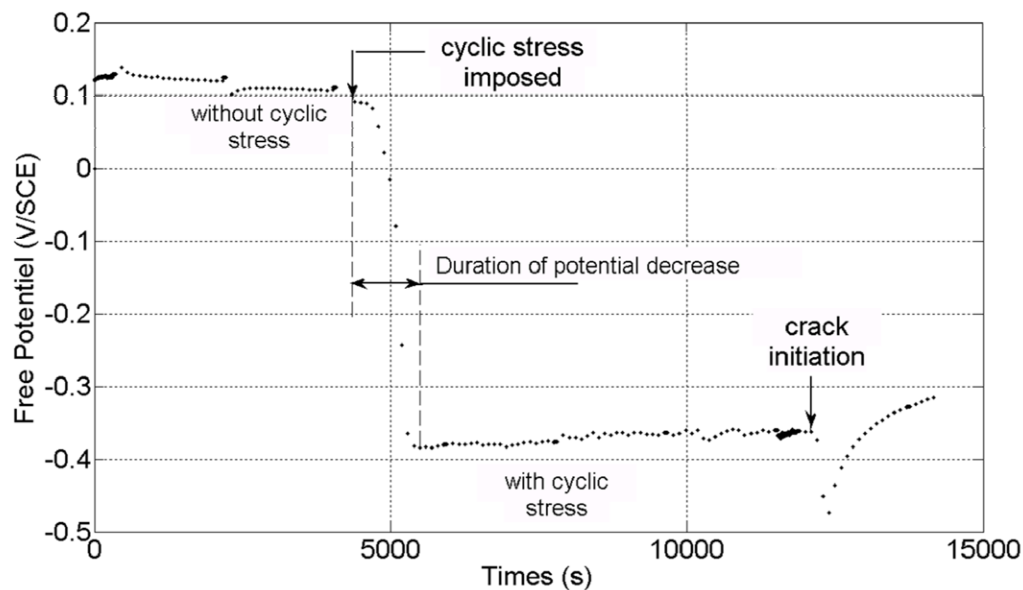
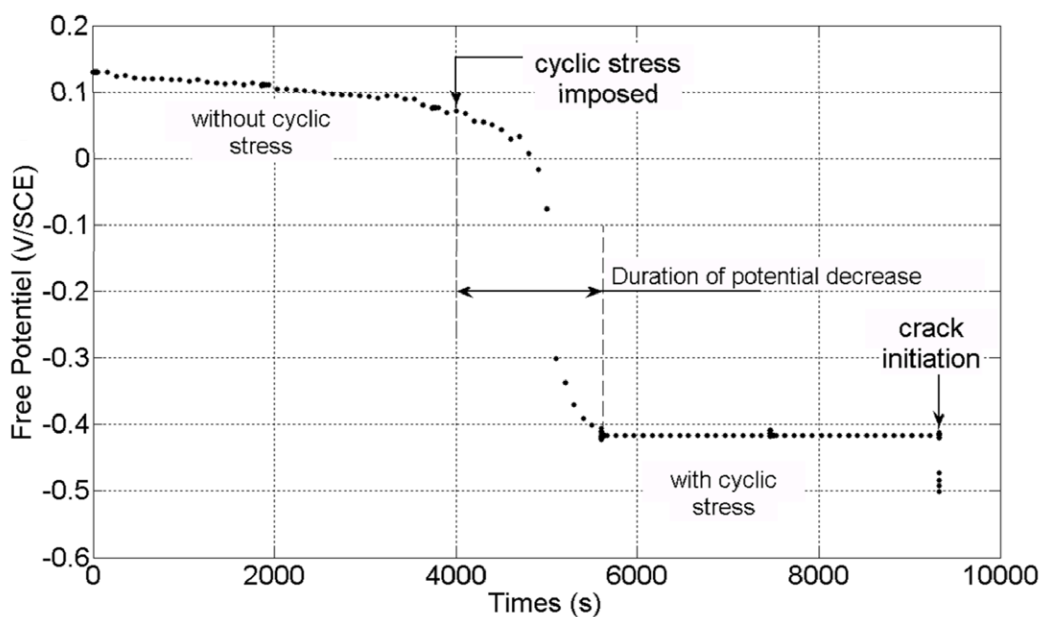
(a) Test at $R = 0.1$; in $0.1 \text{ M NaCl} + 0.044 \text{ M Na}_2\text{SO}_4$; under $\sigma_a/\sigma_u = 0.23$; $f = 120 \text{ Hz}$;
 $N_f = 9.2 \times 10^5$ cycles

(b) Test at $R = -1$; in $0.1 \text{ M NaCl} + 0.044 \text{ M Na}_2\text{SO}_4$; $\sigma_a/\sigma_u = 0.45$; $f = 120 \text{ Hz}$;
 $N_f = 4.3 \times 10^5$ cycles

Figure 7: Free corrosion potential evolution during corrosion fatigue testing of specimen at (a) $R = 0.1$ and (b) $R = -1$

The free potential was recorded during cyclic loading (corrosion fatigue tests) in the same environment (0.1 M NaCl + 0.044 M Na₂SO₄ aqueous solution). Under cyclic loading, the free potential decreased to approximately -0.4 V/SCE (Figure 7). As shown in Figure 6, this value corresponds to the activated corrosion peak observed in the linear scan voltammetry, showing a rupture of the passive film. For the corrosion fatigue test in the 0.1 M Na₂SO₄ aqueous solution without chlorides, the free potential also decreased to around -0.4 V/SCE under cyclic loading. Note that the concentration of Na₂SO₄ (0.1 M) was chosen to have the same ionic strength as in the (0.1 M NaCl + 0.044 M Na₂SO₄) aqueous solution.

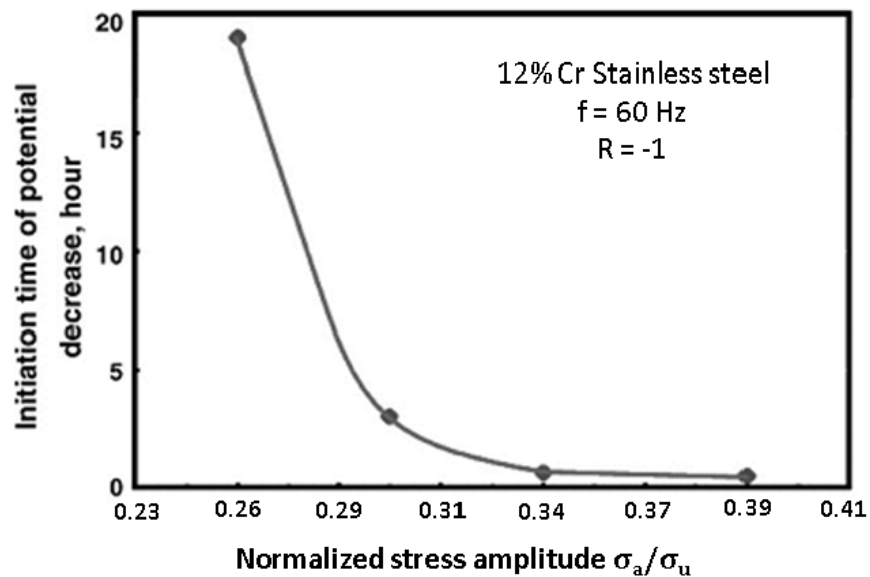
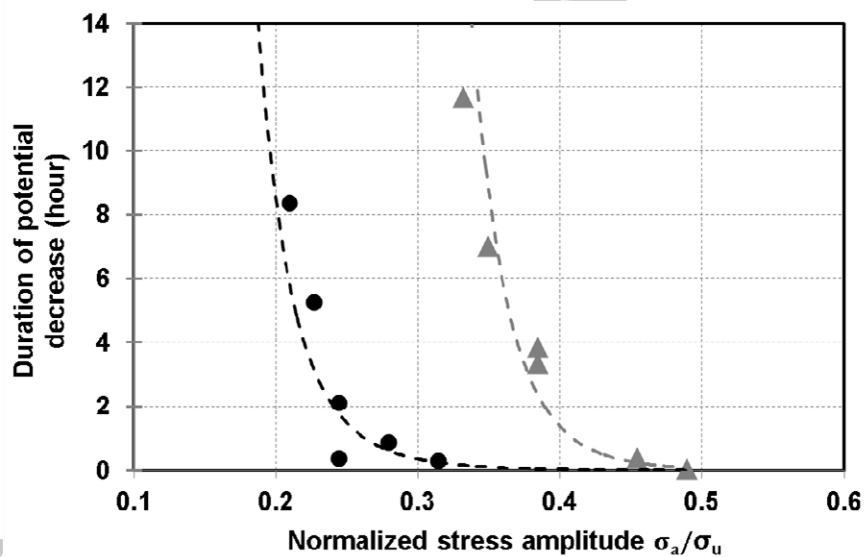
- ▲ corrosion fatigue tests at R = -1 in (0.1 M NaCl + 0.044 M Na₂SO₄)
- corrosion fatigue tests at R = 0.1 in (0.1 M NaCl + 0.044 M Na₂SO₄)

Figure 8: Relation between normalized stress amplitude and (a) initiation time of potential decrease from Ebara [9] and (b) duration of the potential decrease for our corrosion fatigue tests

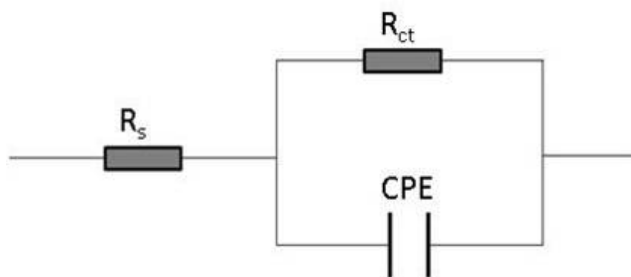
Figure 9: Equivalent circuit of impedance diagram (R_s is the solution resistance, R_{ct} is the charge-transfer resistance and CPE is the constant phase element)

Usually equivalent circuit modelling of the EIS data is used to extract physical properties of the electrochemical system by modelling the impedance data in terms of an equivalent electrical circuit. A resistance in parallel with a capacitance was classically considered, in particular to investigate the high frequency domain of electrochemical impedance measurements. The low frequencies of EIS were investigated by such mechanisms as adsorption or diffusion processes with low time constants. Because we are dealing with a real system that does not behave ideally (processes that occur are distributed in time and space), specialised circuit elements are usually considered. These include a constant phase element (CPE) that accounts for the spatial distribution of the capacitances on the electrode surface [8, 11]. The equivalent circuit chosen for modelling the electrochemical process occurring in the investigated frequency range is shown in Figure 9. The impedance model consists of a solution resistance " R_s " in series with a capacitance "CPE" in parallel with a charge-transfer resistance " R_{ct} " (Figure 9). The EIS data are most often represented in Nyquist or Bode diagrams. A complex plane or Nyquist plot depicts the imaginary impedance, which indicates the capacitive and inductive characteristics of the cell versus the real impedance of the cell. In Nyquist plots, the time-constant appears as an impedance arc in the relatively high frequency domain of the imposed alternative current (100 Hz to 0.1 Hz). The curve provides insight into the governing phenomena of the Faraday's reaction, or redox reaction, in this frequency domain (Figure 10).

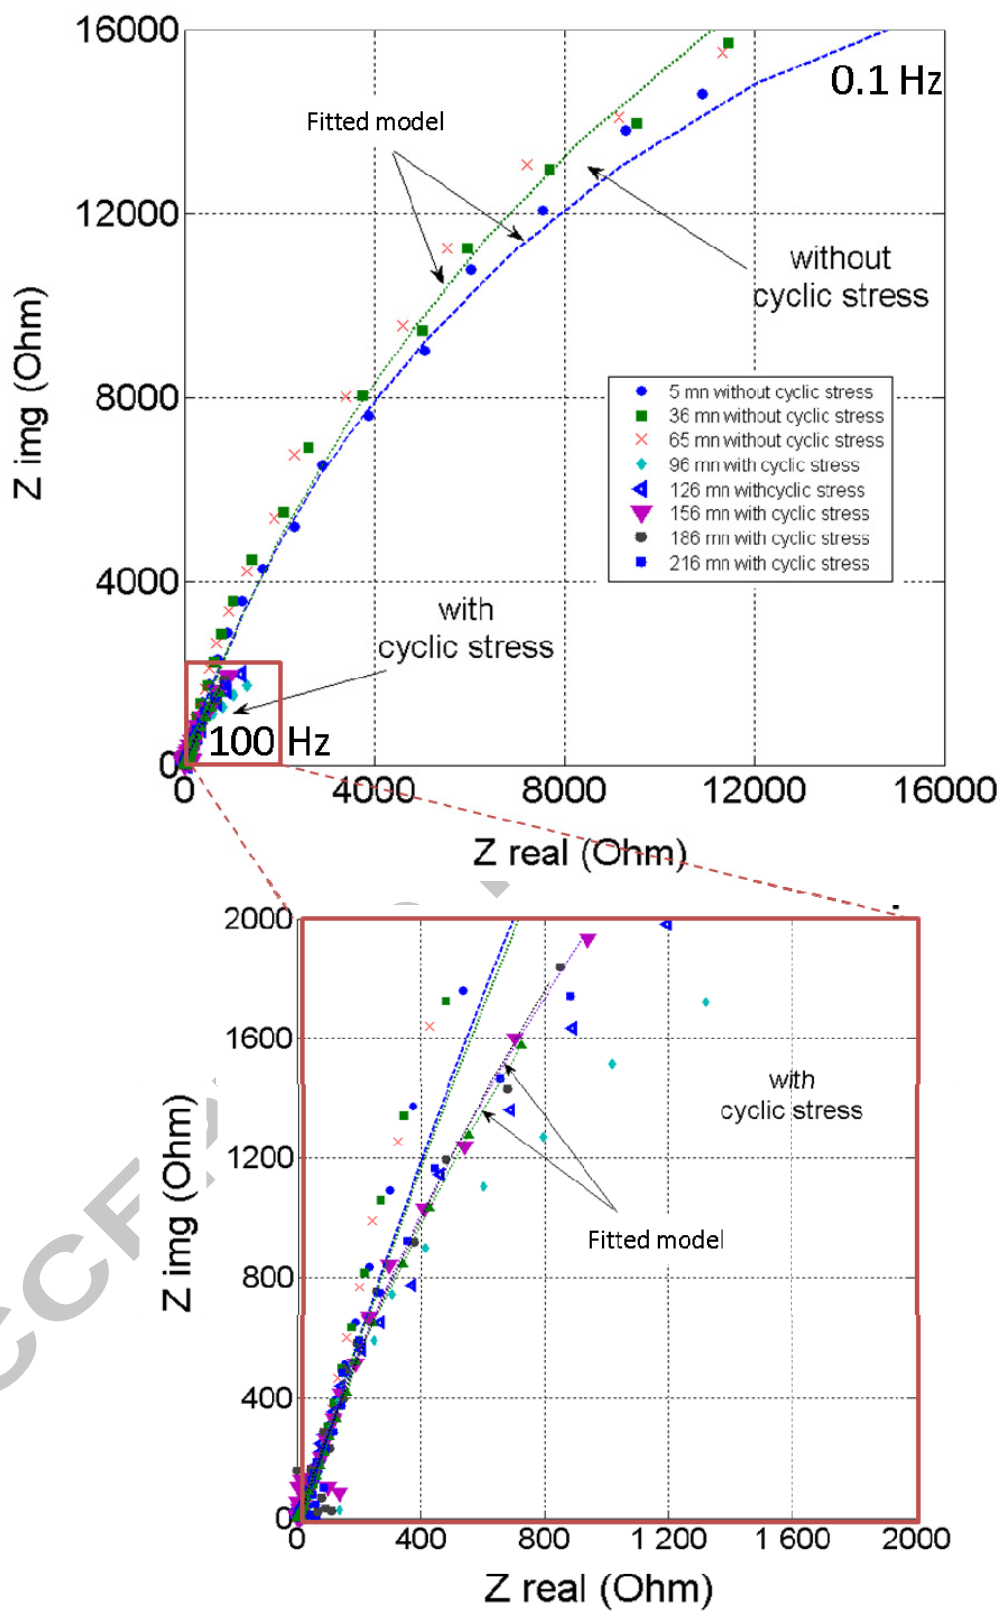
Figure 10: Evolution of the Nyquist plots versus time during corrosion for several durations in 0.1 M NaCl + 0.044 M Na₂SO₄; $\sigma_a/\sigma_u = 0.23$; $R = 0.1$; $f = 120$ Hz; $N_f = 9.2 \times 10^5$ cycles

During the corrosion fatigue tests, electrochemical impedance spectroscopy analyses were carried out every 30 min (2.16×10^5 cycles at 120 Hz). The EIS investigation was performed at a zero current value corresponding to the free potential. The Nyquist plots are reported in Figure 10. All diagrams exhibit a capacitive response characterised by the first part of a half circle. A fitting program (Zsimwin) was used to provide the coefficient values of the CPE, R_{ct} and R_s . Figure 10 shows that the calculated curves agree with the experimental values in the investigated frequency range. To understand such behaviour, the fitted values of the resistances and the capacitance are plotted in Figure 11. Two regimes were clearly observed: one without cyclic stress and one with cyclic stress. In the regime without cyclic stress, a very high resistance and a weak capacitance were measured. This result denotes the presence of resistance from a protective passive film. After the cyclic stress is applied, the resistance strongly decreases and the capacitance increases. This result shows that the material is more conductive due to a local rupture of the passive film. In this case, the measured resistance corresponds to the electronic charge transfer process of the metal dissolution [12, 13]. Additionally, the corrosive attack on the surface of all the specimens tested in corrosion fatigue was observed in small areas scattered all over the specimen surface. There was no generalised corrosion.

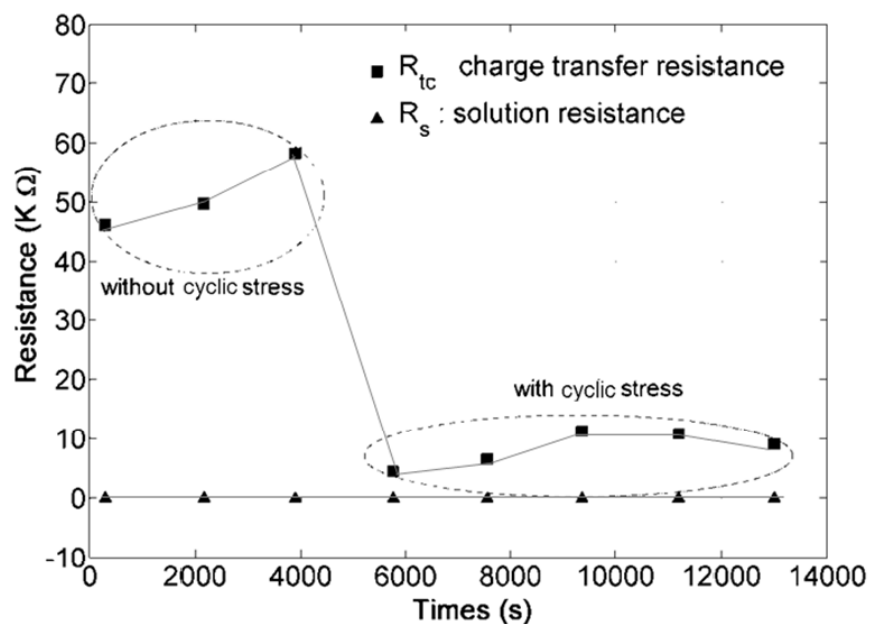
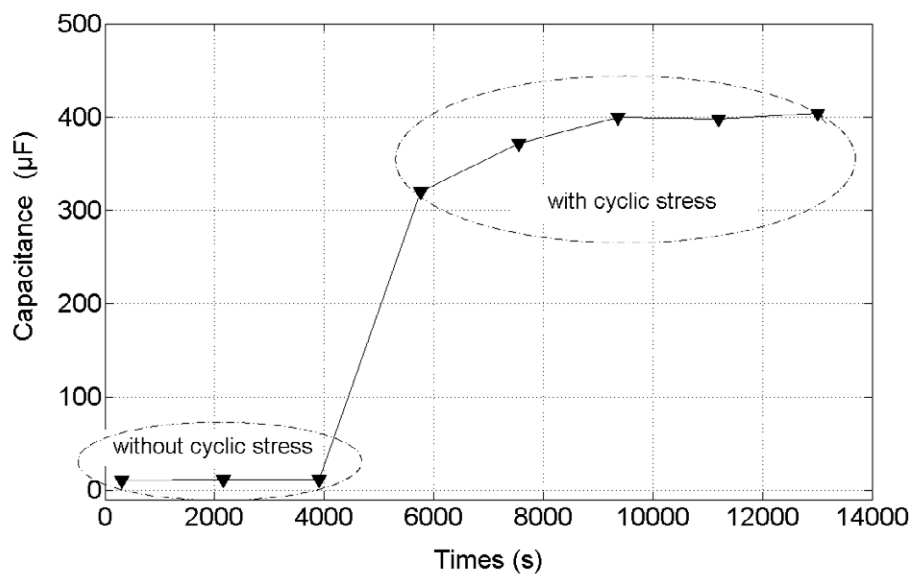
Figure 11: Evolution of (a) the charge-transfer resistance and (b) the capacitance (CPE) of the model in Figure 9 prior to cyclic loading and during cyclic loading (the exposed surface is 5 cm^2) in $0.1 \text{ M NaCl} + 0.044 \text{ M Na}_2\text{SO}_4$; $\sigma_a/\sigma_u = 0.23$; $R = 0.1$; $f = 120 \text{ Hz}$; $N_f = 9.2 \times 10^5$ cycles

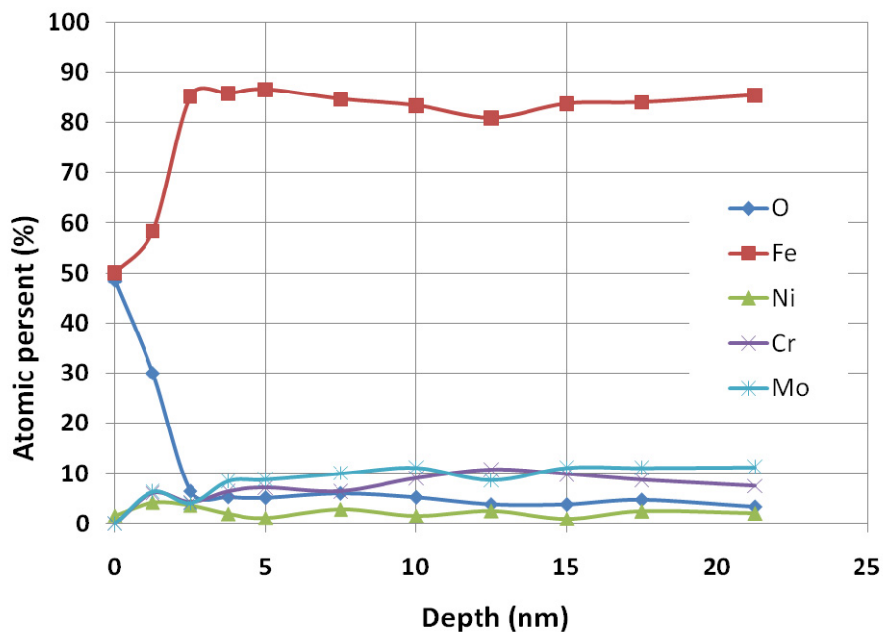
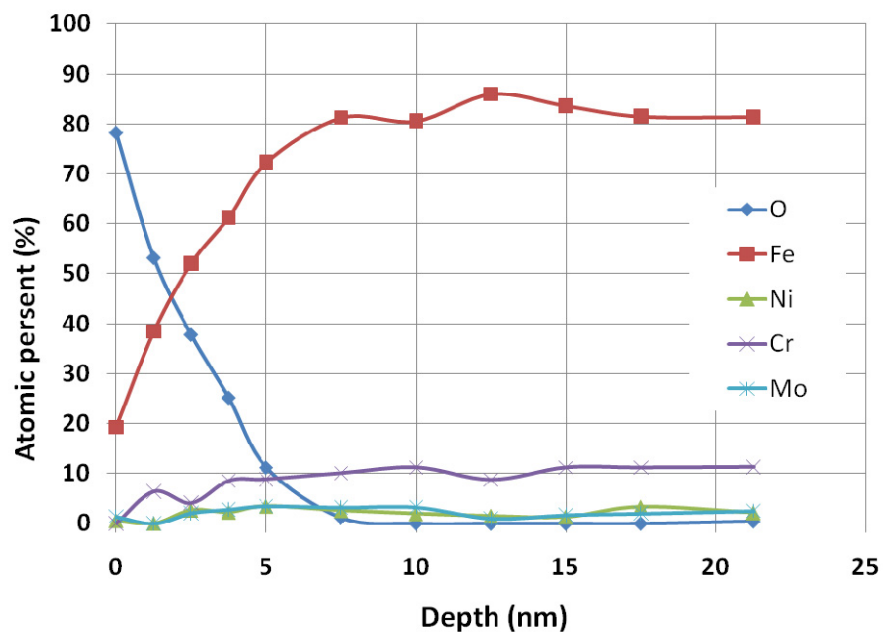
Figure 12: Results of Auger measurements at the surface of the X12CrMoV12-3 stainless steel with (a) passive film formed in air, (b) passive film formed in (0.1 M NaCl + 0.044 M Na₂SO₄)

The previous analysis and observations are physical evidence that corrosion fatigue crack initiation in the X12CrNiMoV12-3 stainless steel is related to the local fracture of the passive film due to strain from the applied cyclic stress. These local ruptures of the passive film and the shift of the free potential in the 0.1 M Na_2SO_4 and (0.1 M NaCl + 0.044 M Na_2SO_4) aqueous solutions can be associate to (i) the variation in the passive film thickness and/or (ii) the appearance of localize deformation features at the surface of the specimens during fatigue testing. Auger probe measurements of the passive film thickness were carried out on the X12CrNiMoV12-3 specimens. Measurements were performed at ten different locations on the specimen surface in order to evaluate the thickness uniformity of the passive film. The thickness of the passive film is deduced from the typical measurement illustrated Figure 12 and was found to be uniform on the specimen surface. Its value is approximately 3 nm for the passive film formed in air and 7 nm for the passive film formed in the (0.1 M NaCl + 0.044 M Na_2SO_4) aqueous solution. This demonstrates that the aqueous media does not dissolve the passive film.

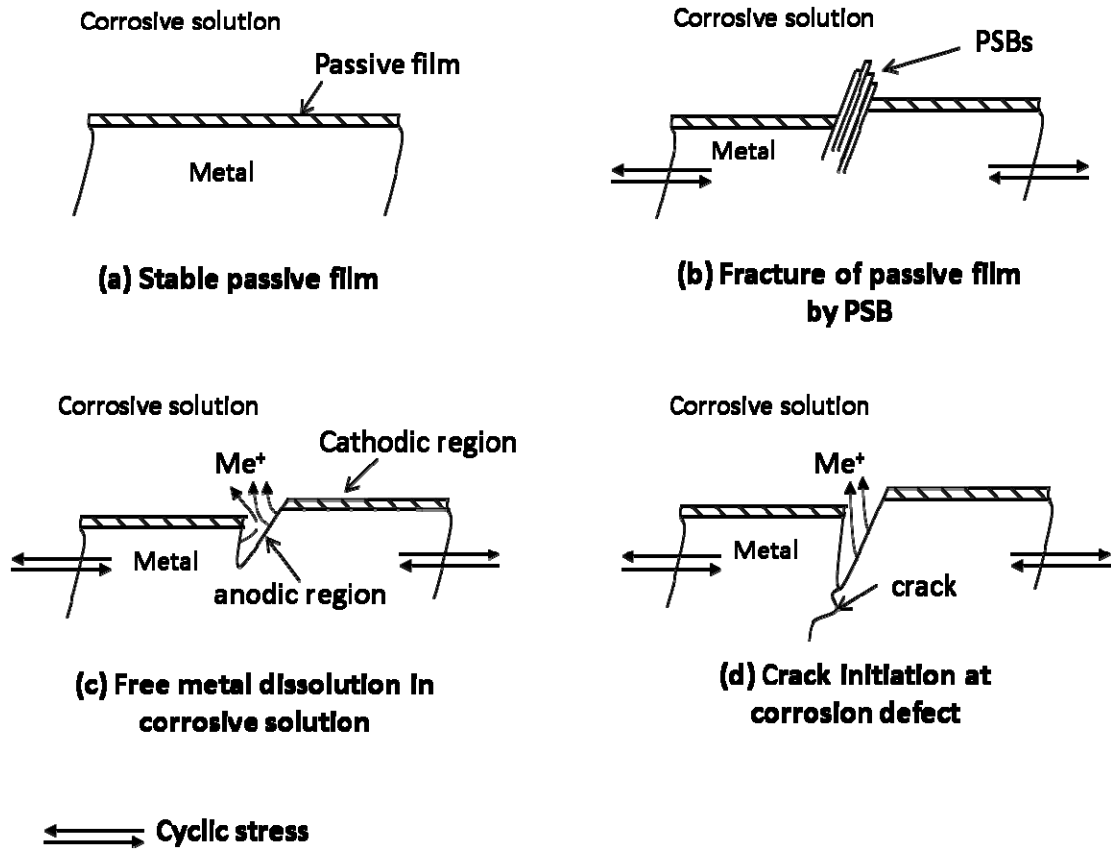
Figure 13: Scenario of corrosion fatigue crack initiation at pits on the X12CrNiMoV12-3 martensitic stainless steel under a 120 Hz loading frequency in the HCF regime (10^5 - 10^7 cycles)

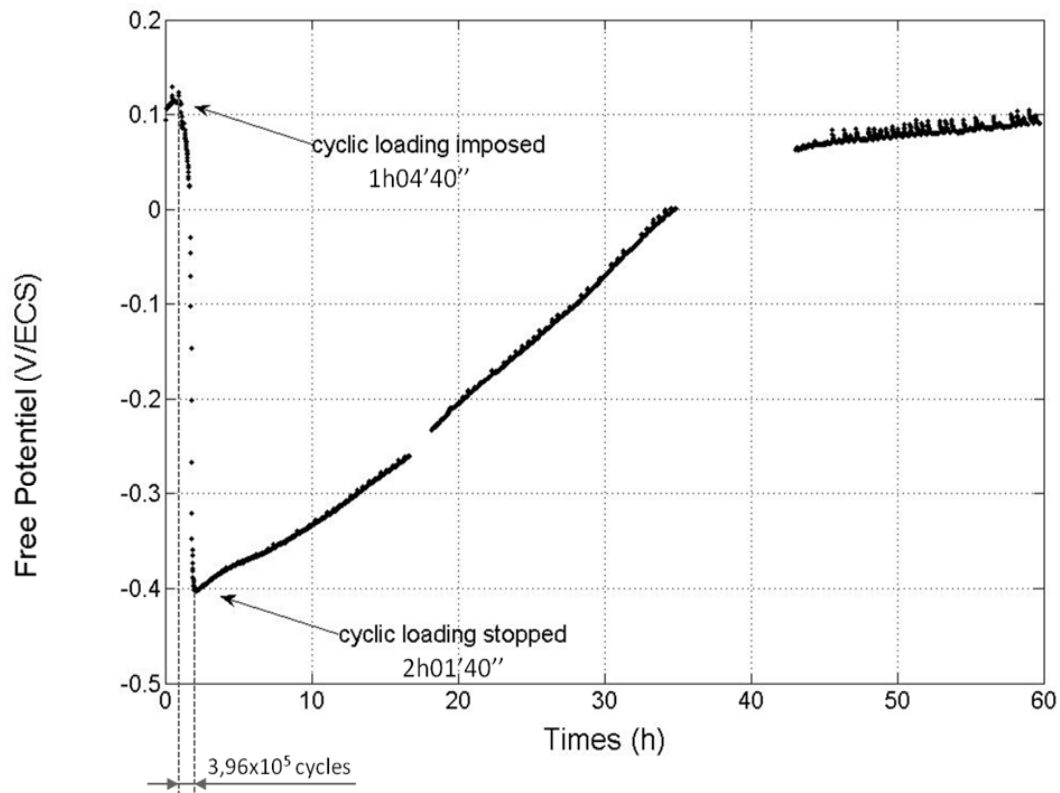
Figure 14: Depassivation by cyclic loading ($\sigma_a/\sigma_u = 0.28$, $R = 0.1$ and $f = 120$ Hz), then repassivation without cyclic loading ($\sigma(t) = 0$ MPa) in corrosion solution (0.1 M NaCl + 0.044 M Na₂SO₄)

The possible effect of the loading frequency in corrosion fatigue is related to the repassivation rate after local ruptures in the passive film. The repassivation rate of the X12CrNiMoV12-3 stainless steel was determined by studying the evolution of the free potential after depassivation under cyclic stress in a corrosive environment with 0.1 M NaCl and 0.044 M Na₂SO₄. Figure 14 shows the evolution of the free potential during the depassivation due to the cyclic loading (under $\sigma_a/\sigma_u = 0.28$, $R = 0.1$ and $f = 120$ Hz) and repassivation without cyclic loading ($\sigma(t) = 0$ MPa) in the aqueous solution (0.1 M NaCl + 0.044 M Na₂SO₄). The free potential needs approximately 3 days to reach +0.1 V/SCE. It is clear that the repassivation rate is significantly lower than the characteristic time of the strain from the applied cyclic stress at a loading frequency of 120 Hz (characteristic time is $1/120 = 8.3$ ms). This finding is in agreement with the S-N curves between 10^5 and 10^7 cycles at 10 Hz and 120 Hz given in Figure 15. This result shows that the loading frequency (at 10 Hz and 120 Hz) has no significant effect in the aqueous solution.

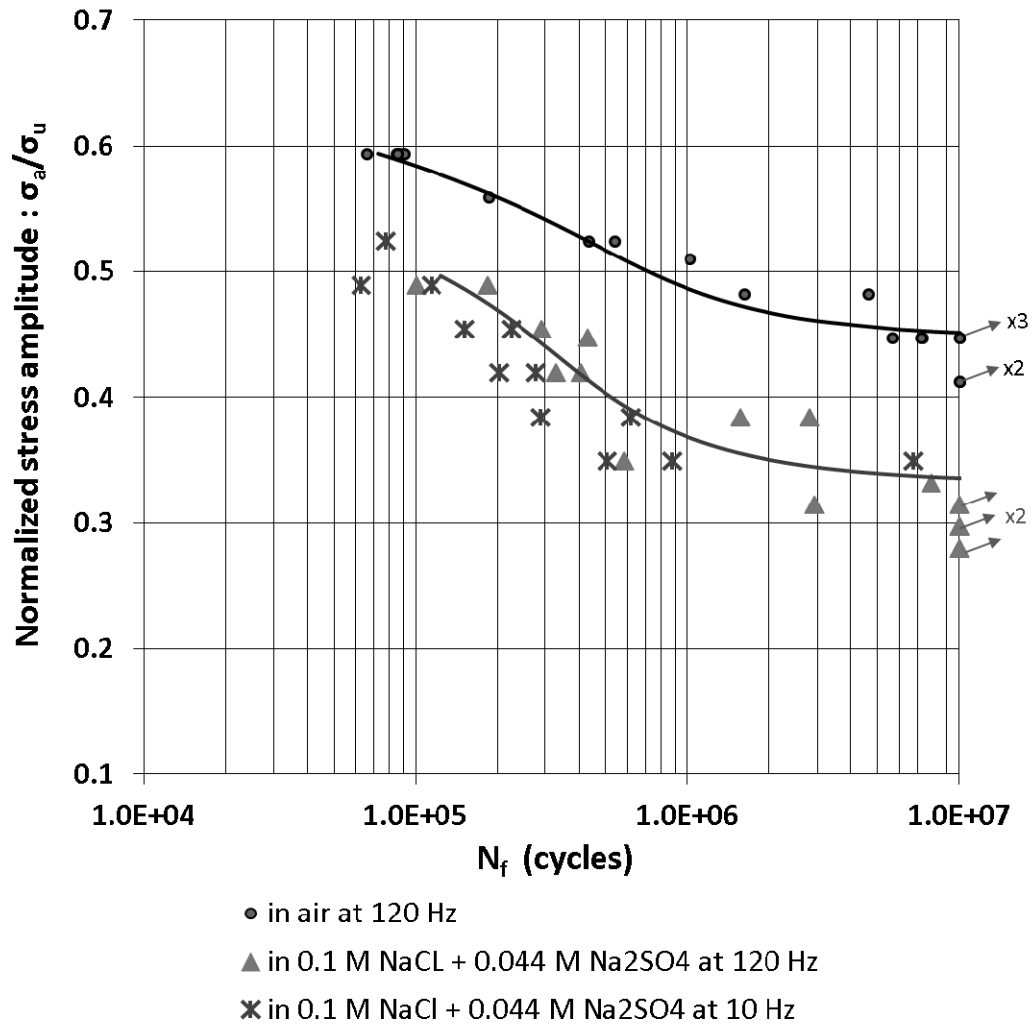
Figure 15: Fatigue test results and S-N curves of corrosion fatigue tests for two different loading frequencies (120 Hz and 10 Hz) at $R = -1$

In this paper, the fatigue crack initiation process of X12CrNiMoV12-3 stainless steel in air at 120 Hz was identified. It was also shown that there is a significant decrease in the fatigue strength (in the HCF regime) under corrosion for all the aqueous environments investigated at 120 Hz (0.1 M NaCl + 0.044 M Na₂SO₄, 0.1 M Na₂SO₄ and distilled water) compared to the fatigue strength under corrosion in the air. The electrochemical behaviour of the X12CrNiMoV12-3 stainless steel was studied to identify the effect of cyclic stress on the passive film. The potential decreased tremendously, by about -0.4 V/SCE, when the strain was applied in all the aqueous environments investigated (0.1 M NaCl + 0.044 M Na₂SO₄ and 1 M Na₂SO₄). This phenomenon was related to the fracture of the surface passive film identified by the EIS measurements. However, at relatively low normalised stress amplitudes ($\sigma_a/\sigma_u = 0.17$ for $R = 0.1$ and $\sigma_a/\sigma_u = 0.31$ for $R = -1$), the potential decrease was not observed and there was no crack initiation after 10^7 cycles. It can be concluded that at very low stress amplitudes, the passive film is stable and protects the material against corrosion (up to 10^7 cycles at least). Based on this physical evidence, a scenario for corrosion fatigue crack initiation mechanisms is proposed. In this process, stress level (amplitude and mean value) and loading frequency have important roles in maintaining the depassivation of the material. Furthermore, it has been shown that for $R = -1$, the loading frequency ranging from 10 Hz to 120 Hz has no appreciable effect on the corrosion fatigue crack initiation life in the (0.1 M NaCl + 0.044 M Na₂SO₄) aqueous solution (Figure 15).
