## Comparative study of three different kinds of geomembranes (PVC-P, HDPE, EPDM) used in the waterproofing of reservoirs

# Comparative study of three different kinds of geomembranes (PVC-P, HDPE, EPDM) used in the waterproofing of reservoirs.

**ABSTRACT.** This work describes the long-term behaviour of three kinds of geomembranes which are constituted by plasticized poly vinyl chloride (PVC-P), high density polyethylene (HDPE) and terpolymer rubber of ethylene-propylene-dienic monomer (EPDM), used as the waterproofing system of the reservoirs “Los Llanos de Mesa”, “San Isidro” and “El Golfo”, respectively.

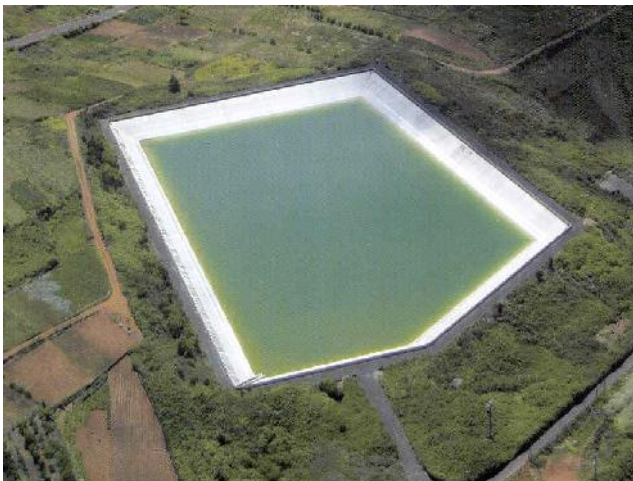
Figure 1. Reservoir of “Los Llanos de Mesa” waterproofed with PVC-P.

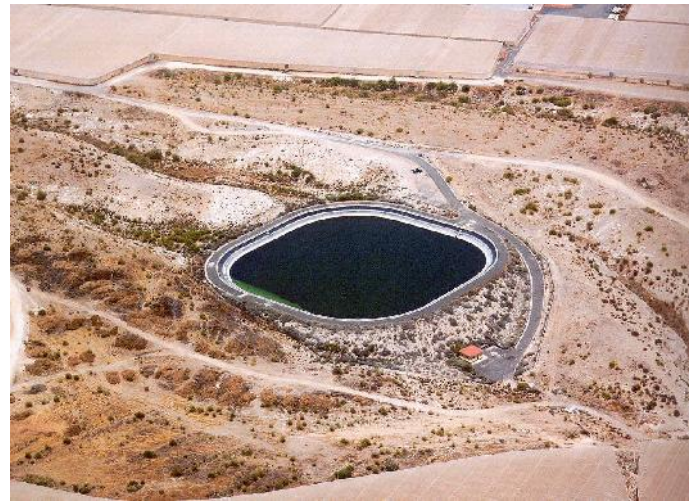
Figure 2. Reservoir of “San Isidro” waterproofed with HDPE.

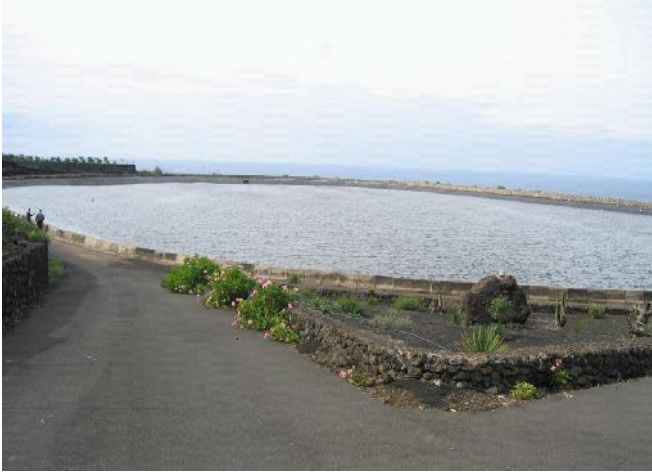
Figure 3. "El Golfo" reservoir which is waterproofed with an EPDM polymeric geosynthetic barrier.

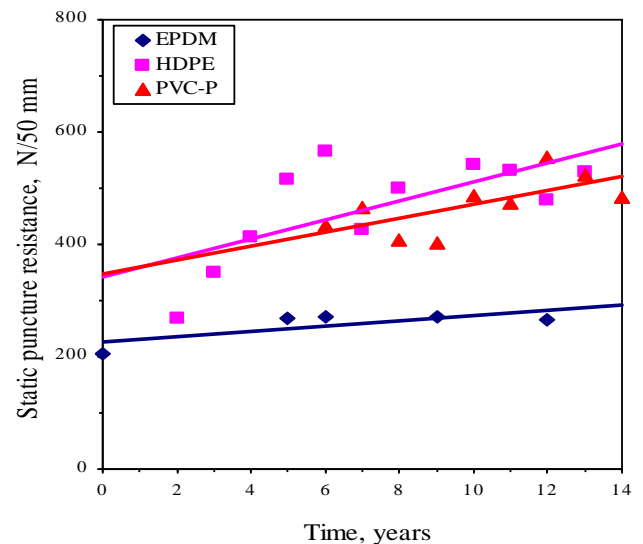
Figure 4. Static puncture resistance evolution, time function.

Figures 4 and 5 represent the variation of resistance to static puncture and the displacement of the plunger before perforation, respectively. In general issues, resistance to static puncture values increased over time in the same way as displacement of the plunger before perforation values decreased. This decrease is more important in the case of EPDM but its value over twelve years is better than the original results of the considered thermoplastic materials.

The behaviour at static impact is considerably better in elastomeric than in thermoplastic materials such as HDPE and PVC-P, while in dynamic impact it happens the other way round.

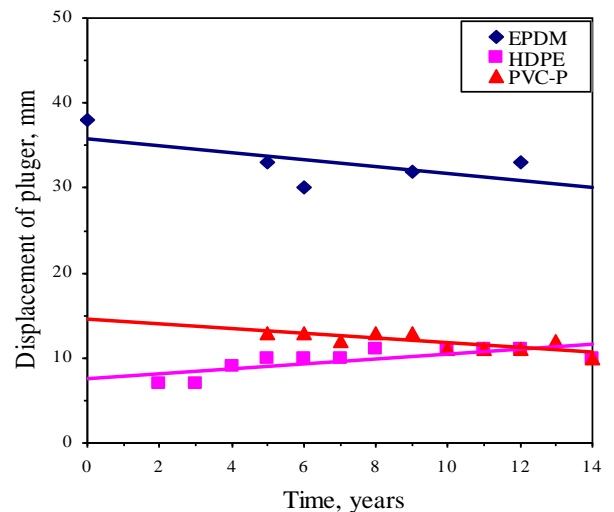
Figure 5. Displacement of plunger before perforation, time function.

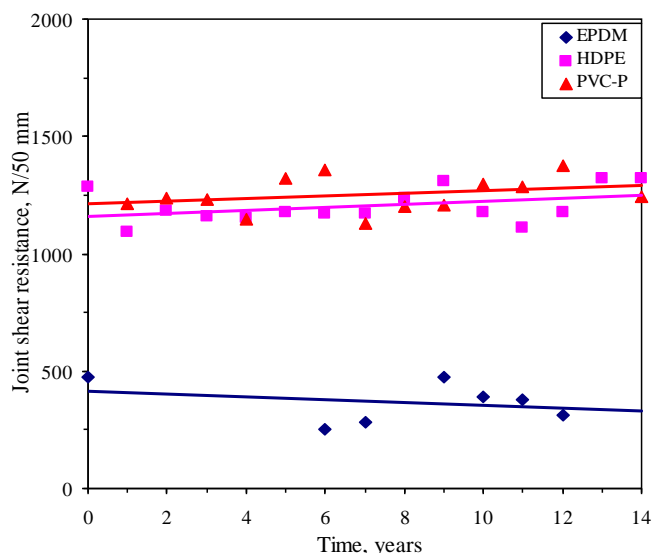
Figure 6. Joint shear resistance evolution, time function.

Seams resistance determined by shear resistance test presented acceptable values as samples broke in the edge or close to the seam, but always outside of it. Values reached are shown in Figure 6.

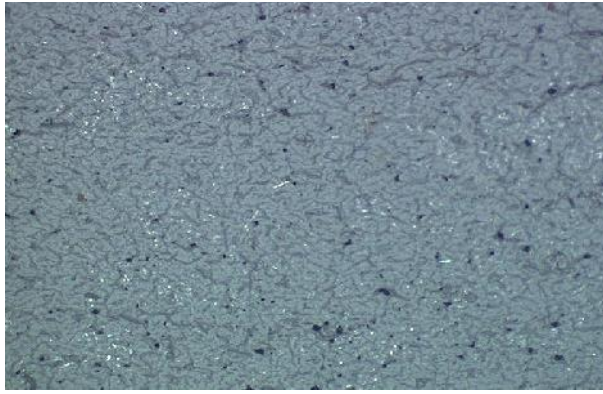
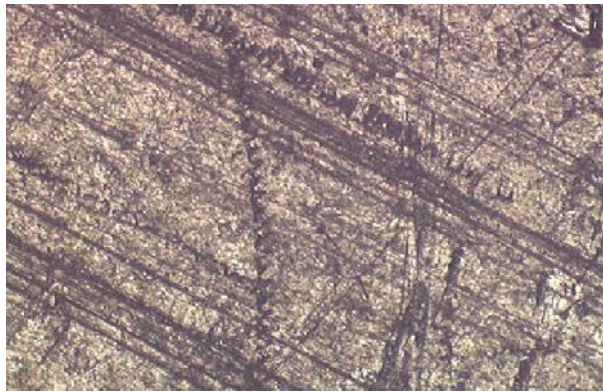
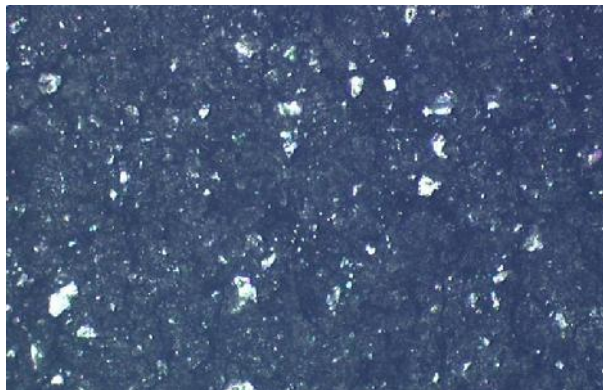
Figure 7. Microphotographs ROM (x 60) of the external face ten years after installation.

and x60 magnifications; the purpose was to see the texture and morphology of the samples. Figure 7 represents the external surface at x60 magnifications of the different geomembranes after ten years of installation. Besides, the behaviour of these geomembranes ten years after installation was also checked by Scanning Electron Microscopy (SEM) at x90 and x900 magnifications, Figure 8 represents the external surface at a x90 magnification of these materials.

Reflection Optical Microscopy shows a PVC-P geomembrane with important ageing symptoms as by the presence of abundant micropores and superficial cracking. The HDPE geomembrane presents grooves of manipulation, although both this material and the rubber show uniform and homogeneous surfaces.

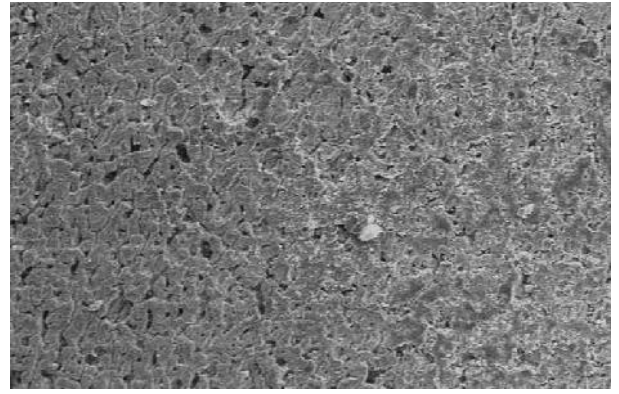
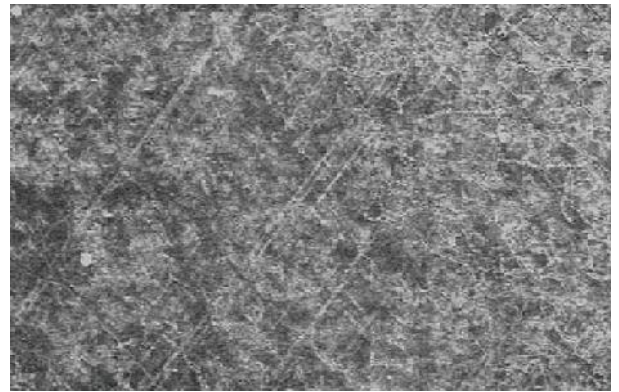
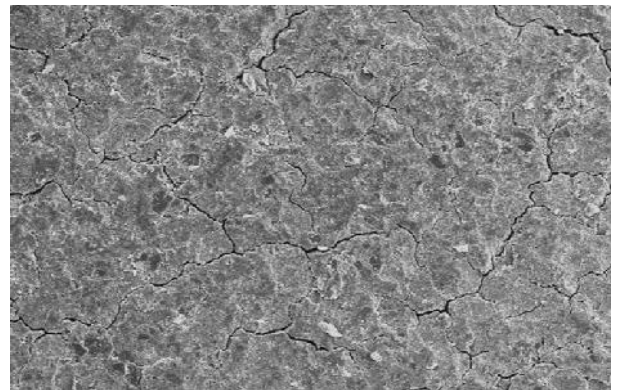
Figure 8. Microphotographs SEM (x 90) of the external face ten years after installation.

Scanning Electron Microscopy (SEM), like Reflection Optical Microscopy confirms the facts cited above and besides, SEM detected microcracks in the elastomeric geomembranes.

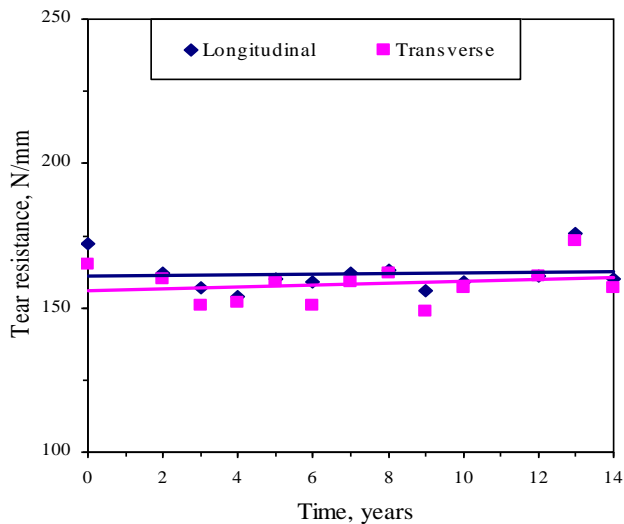
Figure 9. HDPE tear resistance evolution.

The HDPE tear resistance evolution is shown in Figure 9 during the fourteen years of service life of the geomembrane in the reservoir. No appreciable variation is observed during this period. This test was carried out in HDPE for periodic controls because some isolated cases of tearing occurred close to the seams due to the weakening of seam process.

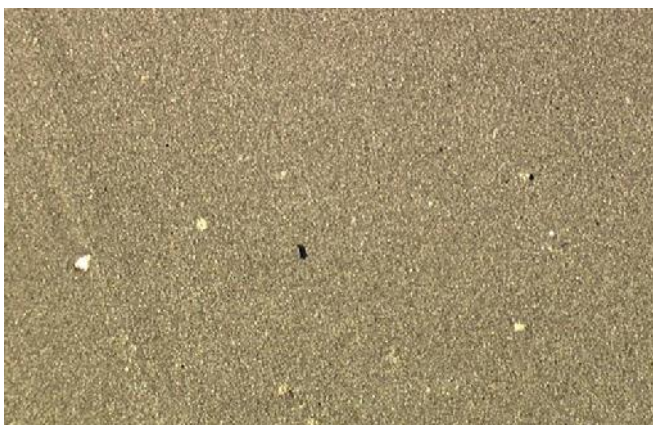
Figure 10. Photograph of carbon black dispersion.

The carbon black content was 2.5% in the HDPE samples, which is a correct value. Indeed a value in the range 2 to 3%, is recommended. Figure 10 presents the way carbon black was dispersed in the geomembrane without accumulation points of this additive. It could be observed that the dispersion of carbon black had a value of 2 on a 1-7 scale, the lower the value, the better the dispersion.

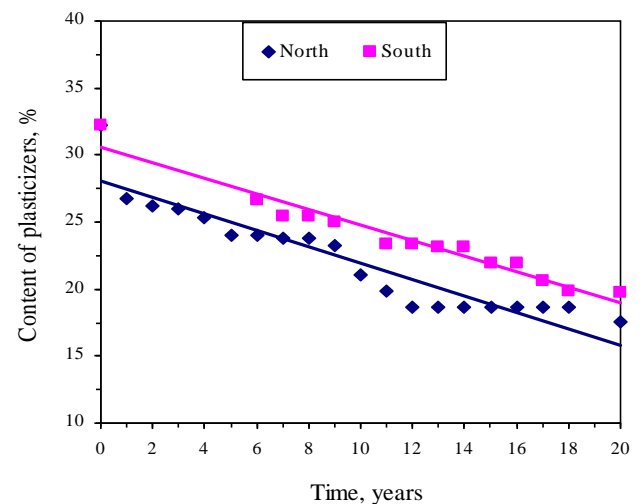
Figure 11. Loss of plasticizers over time.

The initial content of plasticizers determined in the original PVC-P geomembrane was 32.3%. Periodic controls have been carried out for twenty years in order to follow the plasticizers content evolution after installation in the reservoir. Figure 11 shows the loss of this additive in both north and south samples; the loss obtained were 38.8% in south-slope samples and 45.3% in the north ones. North-slope is the area the most affected by radiation proceeding from the sun so it is the most deteriorated zone of the reservoirs' geomembrane.
