# Quantitative linear and nonlinear resonant inspection techniques for characterizing thermal damage in concrete

# ACOUSTICS 2012

## Quantitative linear and nonlinear resonant inspection techniques for characterizing thermal damage in concrete

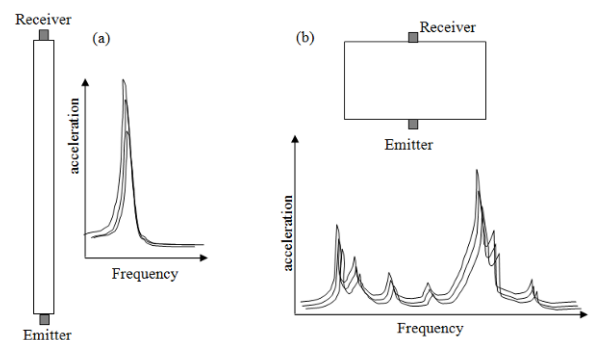
Figure 2: Resonance mode of a cylinder. (a) wavelength compared to the length of the sample. (b) resonance mode

Nonlinear Resonance Ultrasound Spectroscopy (NRUS) was developed at LANL in the 1990's. It exhibits a large sensitivity to damage in a wide range of micro-inhomogeneous materials for various application domains (concrete, rocks, damaged steel or aluminum components, damaged composite, bones, etc.). The nonlinear parameter is usually extracted by the slope of the line (Fig. 2) by

where  $f_0$  is the linear resonance frequency (low amplitude),  $f_i$  the resonance frequency when drive at the  $i$ th amplitude,  $\alpha$  the nonlinear parameter and  $\Delta \varepsilon$  the strain amplitude. Since this method is applied to samples with appropriate geometry (cylinder with large aspect ratio), as the vibration mode along its height is very easy to detect, the measured vibration amplitude of the sample is proportional to the strain. However, for more complex geometry, this assumption does not hold because of the mode shapes complexity (Fig. 6). This is why we make use of numerical simulation that allows identifying a particular mode and so extract the strain values. The input values of numerical simulation are the elastic constants provided by RUS measurements.

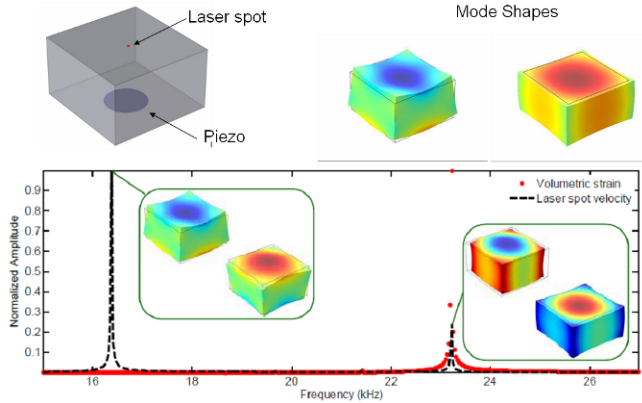
Figure 9: Numerical simulation of experiments.

Most quantitative studies would have chosen the highest amplitude mode, i.e. mode 1. As we have the linear elastic characteristics of the samples (obtained from RUS), we use them as input for numerical simulation using Comsol. We model the experiments with the exact geometry, an additional mass (representing the transducer), and the laser spot that records the out of plane velocity at the top of the sample (Fig. 9).

One can realize that the highest velocity amplitude (black dashed curve) mode is a nearly zero volumetric strain (red dotted curve) amplitude mode because of the symmetry of the mode shape. The second mode, reaches a high strain amplitude with a low velocity at the top of the sample (laser spot location). The study of low volumetric strain mode may be of interest from a basic research point of view because of domination of shear effects, but this is not the purpose of this study. So, we select the "bulk mode" corresponding to an analogous mode as for cylinders (Fig. 1) that will allow obtaining quantitative values of the nonlinearity. Then, the same procedure is applied to each sample to get the absolute value of the volumetric strain so as we are able to link the measured velocity (laser) to the strain inside the sample.
