Dégradation subite des enrobés bitumineux par période de gel/dégel : Analyse de cas de terrain et recherche exploratoire en laboratoire

Sudden degradation of asphalt road mixes during periods of freeze-thaw events: Analysis of field cases and exploratory laboratory research

■ ABSTRACT

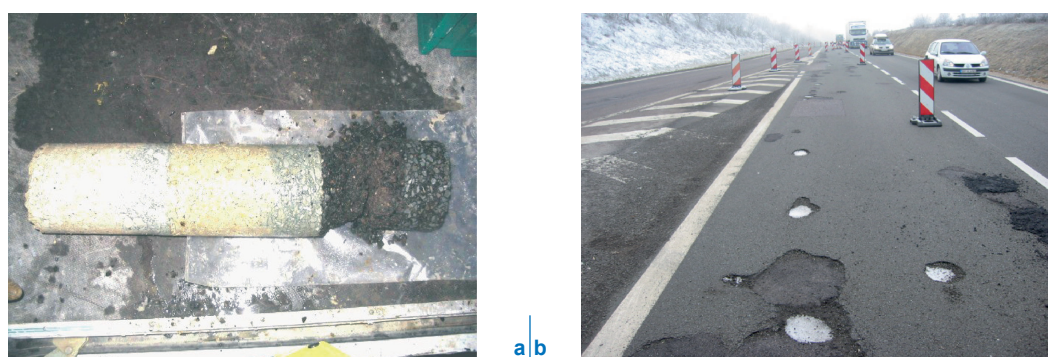
During the winter season 2005/2006, within just a few days, many potholes appeared over the first kilometre of the section (see Fig. 1), requiring emergency repairs, several times a day in some places. These potholes, of a size in the tens of square cm and 5 to 12 cm deep, are plentiful, tightly spaced from one to the next and located in their entirety on the slow-traffic lane, predominantly in the wheel tracks. The borehole samples extracted on this portion of pavement, following these events, reveal that the foundation treated with a hydraulic binder remains in very good condition, with a thin AC bonded to it. The cracked and crazed wearing course lies on two non-cohesive layers, with the presence of hydrocarbon materials that display considerable stripping.

Figure 1
Pavement disorders in
north-eastern France
(a) Pavement structure
borehole sample
(b) Pattern of potholes tens
of cm in size

The visual recording of degradation performed in 2005 shows, over the first kilometre of section not reassessed in 2001, distinct transverse cracks covering 10% of the surface and distinct longitudinal cracks on the traffic lane over 30% of the surface. No indication of any other degradation or stripping was noted.

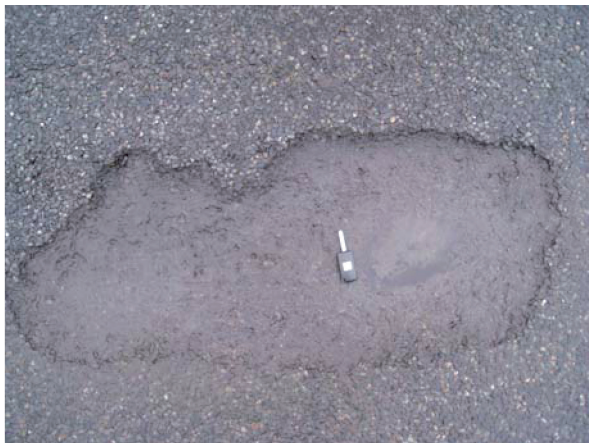
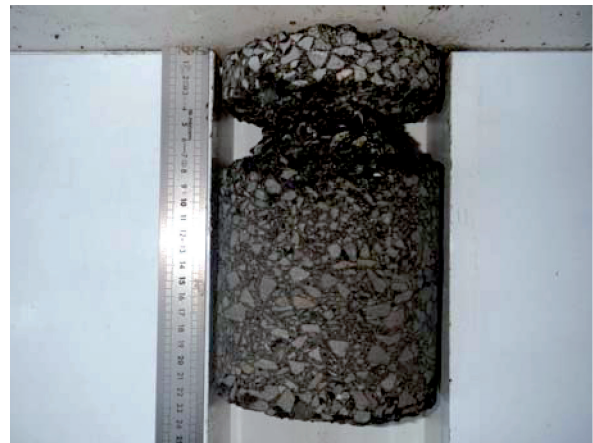
At the end of January 2010, potholes were forming within a very short interval, making it necessary to close the section. The dimensions of these potholes were larger than 10 square cm and their depth in some instances reached 15 cm. These flaws were observed on the wearing course in direction 2, on a length extending more than 500 m, which for the most part corresponds to the low point of the road profile. It could also be observed that the pavement structure was loaded, despite being built as an embankment, since the potholes were filling within a few minutes when empty (Fig. 2a). The onsite borehole coring campaign displayed disaggregation of the asphalt concrete at the level of the first interface (Fig. 4b), in this case at a depth of several cm.

Figure 2
Observations recorded
on test section 2 (central
France specimen)
(a) Rise of a head of water
in a pothole in
the PA layer
(b) Borehole sample with
disaggregated PA
