Microcracking of composites reinforced by stitched multiaxials subjected to cyclical hygrothermal loadings

Pierre-Jacques Liotier ^{a,*}, Alain Vautrin ^a, Jean-Marc Beraud ^b

Microcracking of polymer matrix composites reinforced by multiaxial multi-ply stitched carbon preforms submitted to cyclical purely hygrothermal loading is analyzed. The laminates are manufactured by liquid resin infusion (LRI). The stitching induces deviations in fibre layout and creates openings which become resin-rich regions after the resin infusion. The interaction between resin-rich regions and microcracks induced by the hygrothermal cycles was investigated by 2D metallographic micrography and X-ray mic-rotomography. Specific microcracking process was found to occur in this type of material. The occurrence of cracks was quantified and the morphology of the 3D crack network studied. The nature of the stitching yarn and the size of the diamond-shaped resin-rich regions were identified as having a major influence on laminate microcracking after ageing.

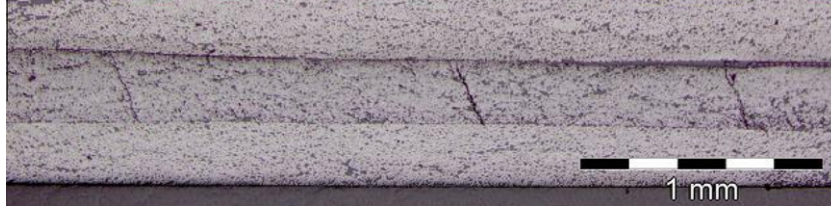
Fig. 6. Cracks at the edge in inner plies in unstitched laminates. (For interpretation of the references to colour in this figure legend, the reader is referred to the web version of this article.)

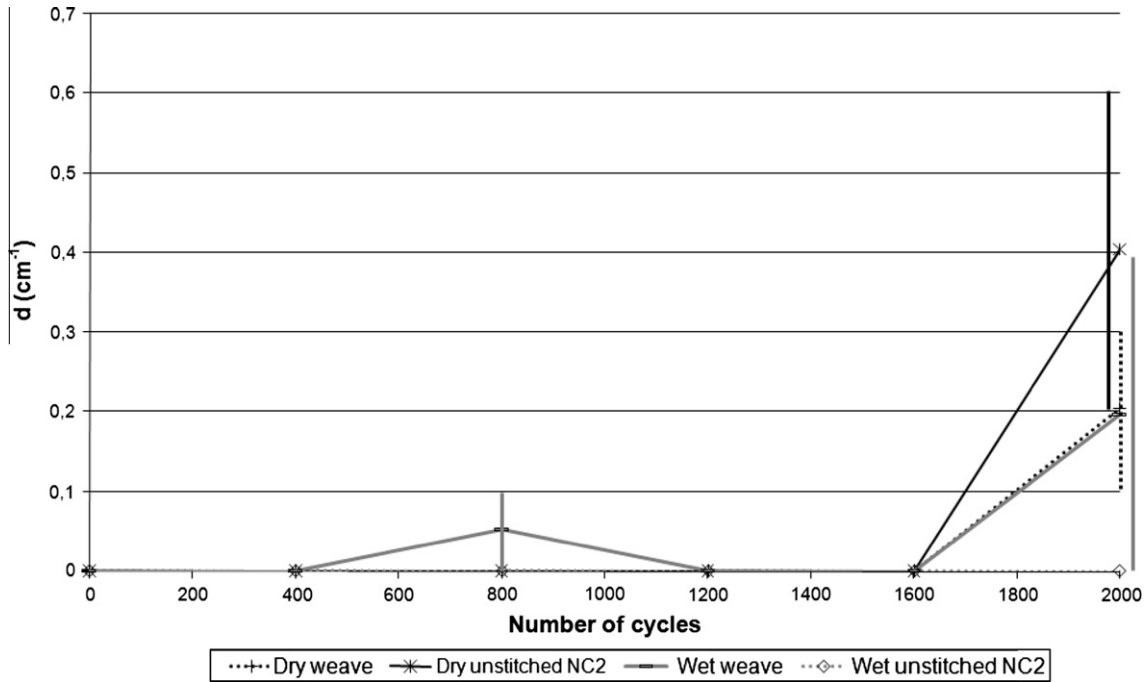
Fig. 8. Crack density d versus the number of cycles for unstitched laminates.

The evolution of the crack density (and the associated dispersion) estimated using the method discussed in Section 4.2 is reported in Table 1. Fig. 8 shows the crack density measured after 400, 800, 1200, 1600 and 2000 cycles. The vertical lines represents the range from maximum to minimum values between the two opposite sections shown in Fig. 3.

Conclusions on the effect of the humid conditioning of the wet specimens can also be drawn from these tests. This effect is weak on the woven material and cannot be detected on unstitched NC2®. The dry sample was expected to show a higher crack density because of the lowering of stress due to hygroscopic swelling in wet samples. However, experimental results do not confirm such a trend for these materials, one reason might be that the water concentration within the material was not sufficient to lead to any detectable changes.

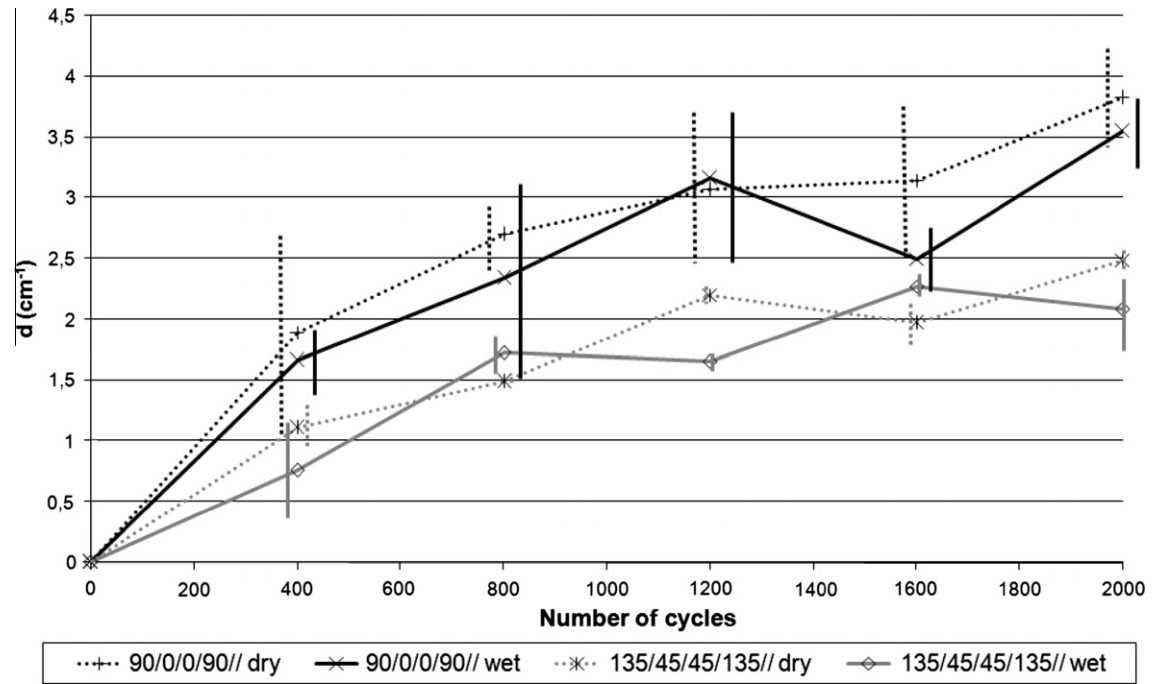
Fig. 9. Crack density d versus the number of cycles for cross ply multiaxial stitched preform.

The choice of focussing first on the specific properties of this material, by achieving large resin-rich regions in the sample tested (Novoloid® 30 Tex yarns, refer to Liotier et al. [20] for the description of the particular morphology due to this yarn), have been made. Moreover, to simplify the characterisation of the cracking paths, two cross-ply laminates have been selected: $[90/0/0/90]_S$ and $[135/45/45/135]_S$ laminates, whose stitching row is oriented at 0° and plies are stitched four by four. The crack density and the associated dispersion at different loading times are shown in Fig. 9 (Table 2). We treated two series of samples: the first was subjected to the full hygrothermal loading and labelled “wet” and the second subjected to the thermal cycles only and labelled “dry” (Fig. 9). Fig. 9 shows the crack density measured after 400, 800, 1200, 1600 and 2000 cycles. No significant difference can be detected between the crack densities of the dry and wet specimens, meaning that the moisture conditioning which has been performed is not so critical. This conclusion is even more obvious from Fig. 9.

If the two materials are compared, it appears that the $[135/45/45/135]_S$ laminate tends to produce a lower crack density than the $[90/0/0/90]_S$ laminate. The second reached around 3.5 cracks/cm/ply while the first reached around 2.5 cracks/cm/ply.

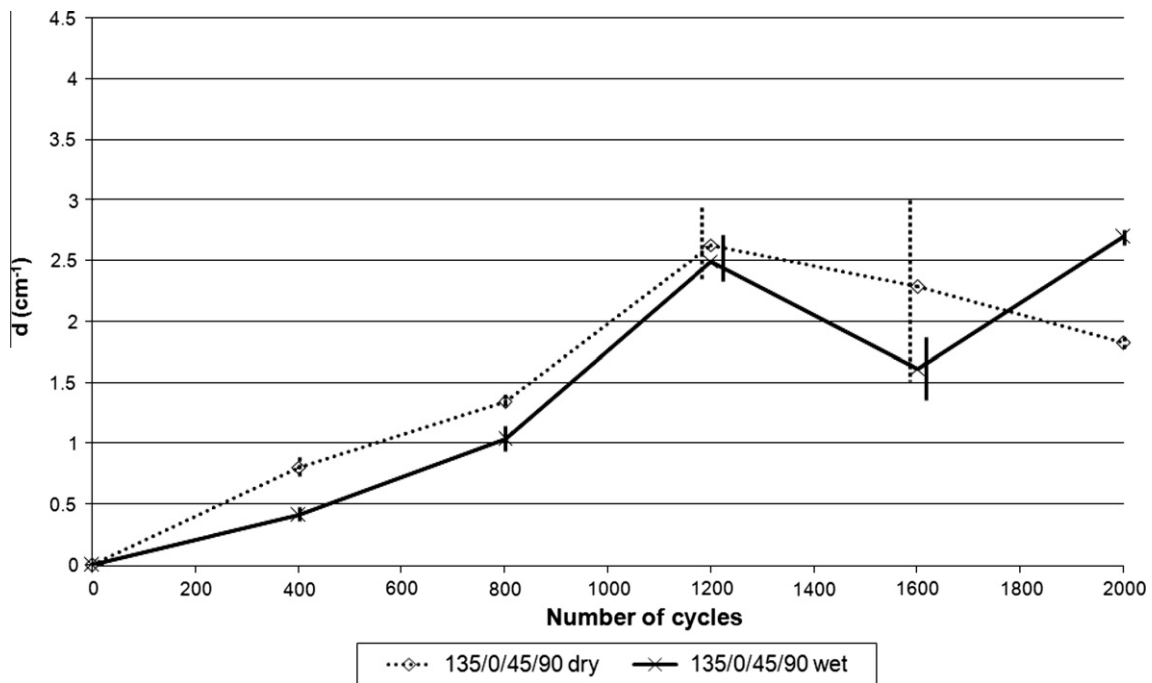
Fig. 12. Crack density versus the number of cycles for quasi-isotropic laminates.

Crack density evolves erratically, as shown in Fig. 12, where the d parameter apparently decreases when the number of cycles increases (Table 3). Fig. 12 shows the crack density measured after 400, 800, 1200, 1600 and 2000 cycles. The scatter could be caused by the uncertainty on the position of the observation plane or by the non-repeatability of crack propagation through a material whose microstructure is highly complex. The first hypothesis has been investigated by 3D characterisation using X-ray microtomography.
