# About the impact behavior of woven-ply carbon fiber-reinforced thermoplastic- and thermosetting-composites: A comparative study

B. Vieille<sup>a,\*</sup>, V.M. Casado<sup>b</sup>, C. Bouvet<sup>b</sup>

This study is aimed at comparing the response of TS-based (epoxy) and TP-based (PPS or PEEK) laminates subjected to low velocity impacts. C-scan inspections showed that impact led to diamond-shaped damage resulting from different failure mechanisms: fiber breakages in warp and weft directions, more or less inter-laminar and intra-ply damage, and extensive delamination in C/PEEK and C/epoxy laminates. The permanent indentation can be ascribed to specific mechanisms which mainly depend on many factors including the ultimate out-of-plane shear strength, and the interlaminar fracture toughness in modes I–II–III. In TP-based laminates, the matrix plasticization seems to play an important role in matrix-rich areas by locally promoting permanent deformations. Fiber-bridging also prevents the plies from opening in mode I, and slows down the propagation of interlaminar and intralaminar cracks in modes II–III. Both mechanisms seem to reduce the extension of damages, in particular, the subs

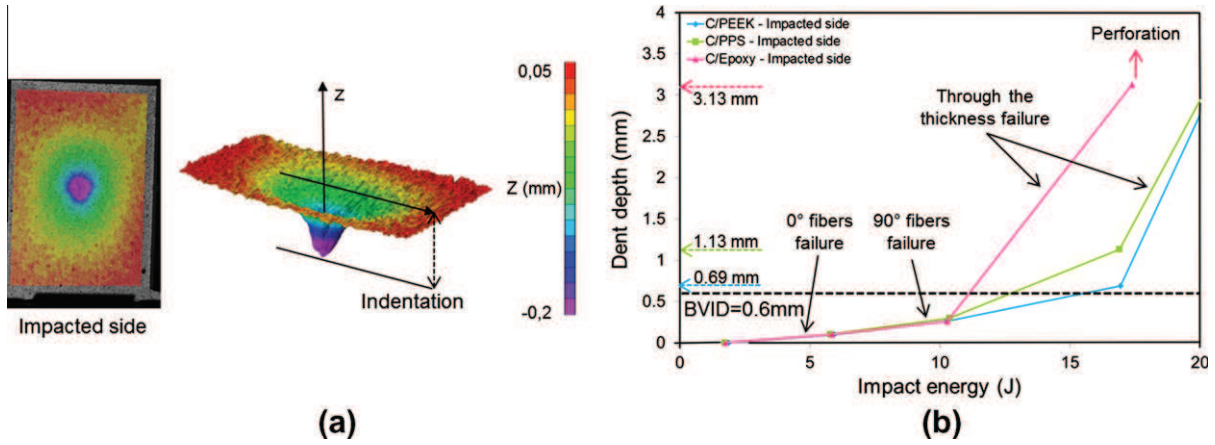
Fig. 2. Dent depth: (a) contour plot and corresponding 3-D image of damaged specimen, and (b) changes in dent depth as a function of the impact energy on the impacted side of specimens.

Laminates can absorb the impact energy by different means including indentation (representative of local matrix crushing and local fiber breakage), delamination (inter-yarn fracture), splitting (intra-yarn fracture) or fibers peeling on the non-impacted side [25,44,45]. For every impact energy, it appears that C/epoxy presents the highest ratio of dissipated energy compared with impact energy, whereas the energy dissipated during impact is virtually the same in C/PPS and C/PEEK (see Table 2). Such a ratio usually increases to reach a maximum value at the onset of perforation, as can be observed in the C/epoxy case [26]. The measurement of the specimen's indentation is typically used to assess the impact damage. In general, the indentation just after the impact (temporary indentation), is always higher than the indentation after relaxation of the impacted composite. Such relaxation effects can be neglected after 48 h to get the permanent indentation [45,46]. The indentation (see Fig. 2a), also called dent depth, is

measured using a dial indicator with an error of  $\pm 0.01$  mm at several locations and according to different directions of the specimen. In TP-based laminates, the BVID (0.6 mm) is reached at about 13 J (C/PPS) and 16 J (C/PEEK), whereas it is reached at about 11 J in C/epoxy (see Fig. 2b).

From the damage mechanisms described above result a permanent indentation (see Fig. 2b). Another factor contributing to the

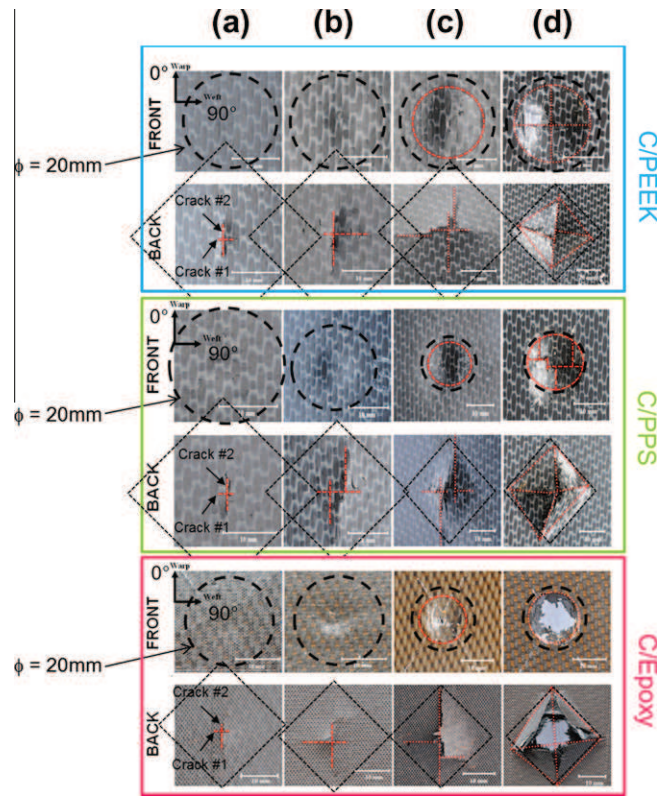
Fig. 5. Observations of impact damage patterns on front and back sides of impacted specimens as a function of the impact energy: (a) 6 J, (b) 10.5 J, (c) 17 J, and (d) 25 J.

Macroscopic views of the front (impacted side) and the back (non-impacted side) of specimens give first information about the onset of damage as a function of the impact energy (see Fig. 5). The hemispherical indenter (impacted side), and the diamond-shaped fracture surface (non-impacted side), each corresponding to the maximum 25 J impact energy, are both represented on each macroscopic view. The scale has been adapted for each view in order to make the observed damages clearer. The 2 J impact does not cause important damage to specimens, whereas the 25 J impact induces the maximum damage in comparison to other energy levels. For the three materials, the onset of cracks along warp/weft directions is observed on the non-impacted side of specimens from 6 J impact energy. On Fig. 5a these cracks are represented by red-dotted lines, and are referenced as transverse crack #1 (along the weft direction) and longitudinal crack #2 (along the warp direction). At 10.5 J, the length of cracks appearing at 6 J along warp/weft directions has increased in all cases, but a new crack along the warp direction can be observed in PPS-based specimens (see Fig. 5b). At 17 J, the hemispherical indentation on the impacted side becomes clear (this is the first energy that creates an indentation over the BVID in TP specimens). In addition, fibers' splitting starts generalizing, and cracks along warp/weft directions significantly developed on the non-impacted side (see Fig. 5c). A 17 J impact importantly

penetrates C/epoxy laminates, and the main 90° crack is longer on the non-impacted side, whereas a new crack has appeared along the warp direction. On the non-impacted side of PEEK-based specimens, there are also new cracks along warp/weft directions, and a cross-shape fracture surface can be observed. Lastly, the 25 J impact importantly penetrates C/PEEK and C/PPS laminates, and perforates C/epoxy laminates (see Fig. 5d). The non-impacted side of all specimens can be characterized by diamond-shaped fracture surfaces.

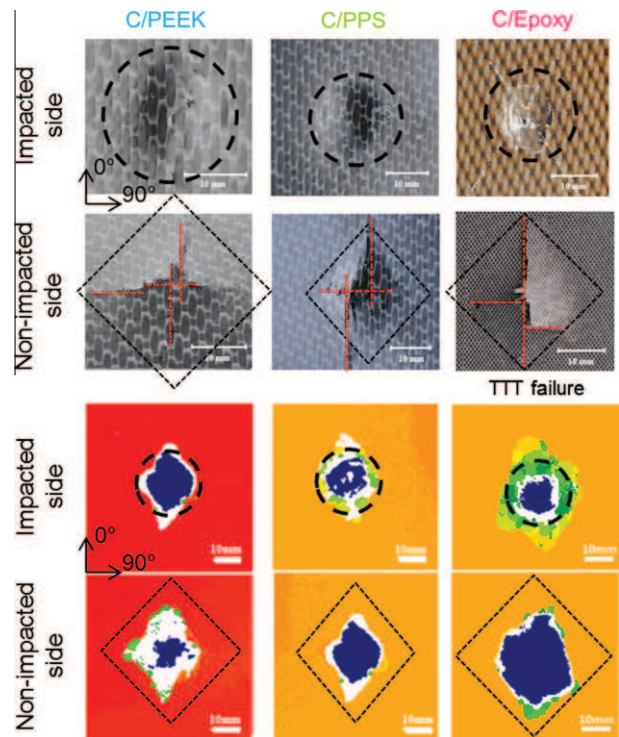
Fig. 7. Comparison of C-scan maps and impact damage patterns on front and back sides of specimens impacted at 17 J: (a) C/PEEK, (b) C/PPS, and (c) C/epoxy.

The impacted specimens have been enrobed by an inclusion resin in order to prevent the relaxation of the damaged parts after cutting them. The microscopic observations of 0° and 90° cuts of impacted specimens have been carried out in order to explain the creation and propagation of the damage during these tests. Only the observations associated with a 17 J impact are presented in this section, because they are representative enough of all the types damages within the impacted laminates, and because the BVID is reached for the three materials at this energy level. In addition, the comparison between macroscopic observations and C-scan maps (see Fig. 7) gives qualitative and quantitative informa-

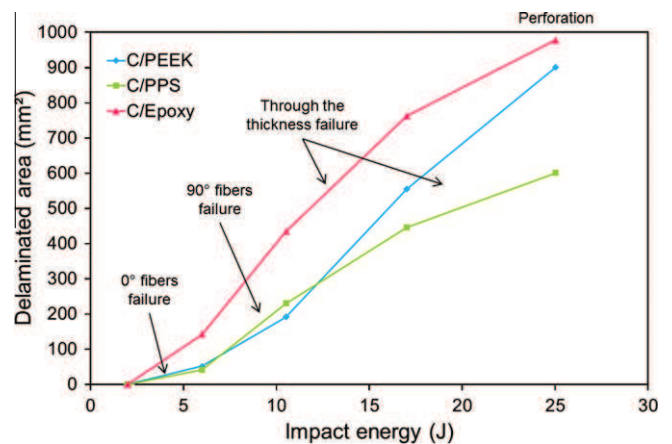
Fig. 8. Changes in the delaminated areas resulting from C-scan results as a function of impact energy.
