## **Nondestructive Evaluation of FRP Strengthening Systems Bonded on RC Structures Using Pulsed Stimulated Infrared Thermography, In : Infrared Thermography, Chapter 9**

# Nondestructive Evaluation of FRP Strengthening Systems Bonded on RC Structures Using Pulsed Stimulated Infrared Thermography

Frédéric Taillade, Marc Quiertant, Karim Benzarti,  
Jean Dumoulin and Christophe Aubagnac  
*Université Paris-Est, IFSTTAR, F-75015 Paris  
France*

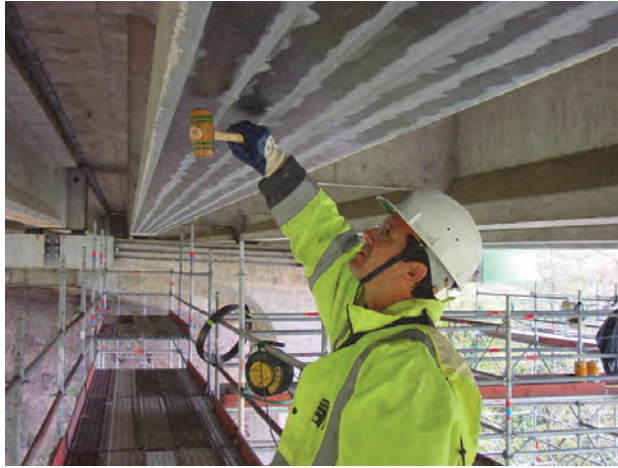
Fig. 1. Inspection with acoustic sounding (hammer tapping).

Visual inspection and acoustic sounding (hammer tapping) are commonly used to detect delaminations (disbonds) (Fig.1). However, these current practices are unable to provide relevant information about the depth (in the case of multilayered FRP systems) and width of debonded areas and they are not capable of evaluating the level of adhesion between the FRP and the substrate (partial delamination, damage or poor mechanical properties of the polymer adhesive). Adherence properties of FRP systems installed on concrete substrates can be evaluated by conducting on site pull-off adhesion tests on witness panels specifically bonded on test zones (Fig.2).

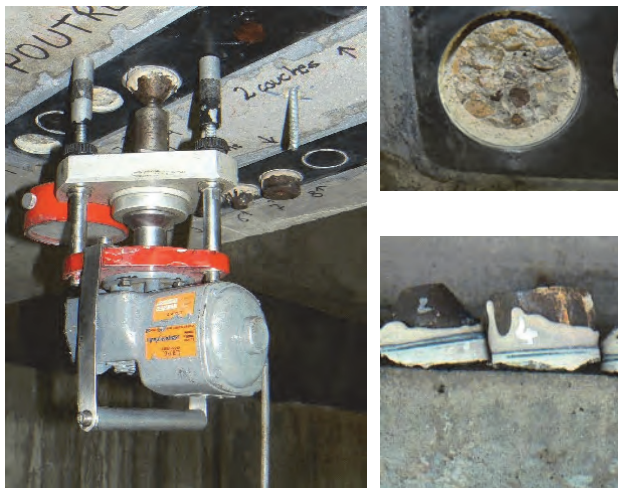
Fig. 2. Pull-off method.

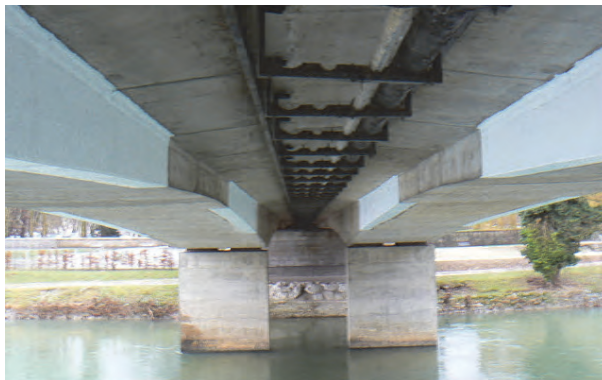
Fig. 17. View of the bridge under consideration; FRP repaired zones correspond to the white parts on the girders.

In order to prevent brittle failure at mid-span, it was decided to repair the cracked box-girders by bonding carbon fibre sheets according to the wet lay-up process (onsite impregnation). A recalculation of the structure was performed in order to optimize the repair design with respect to the shear stress distribution. Finally, composite reinforcements were installed at the outer side of the web of girders as shown in figure 17.

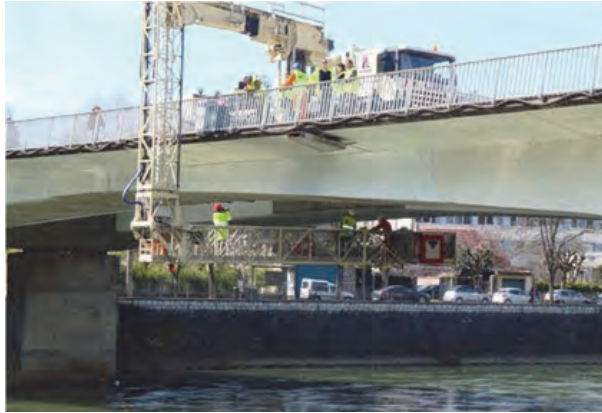
Fig. 18. Inspection operations.

Such a simple set-up offers a fully portable real-time assessment system. The main difficulty of the inspection was the accessibility to the FRP bonded areas, which was resolved by using a truck mounted lift-platform (Fig. 18).

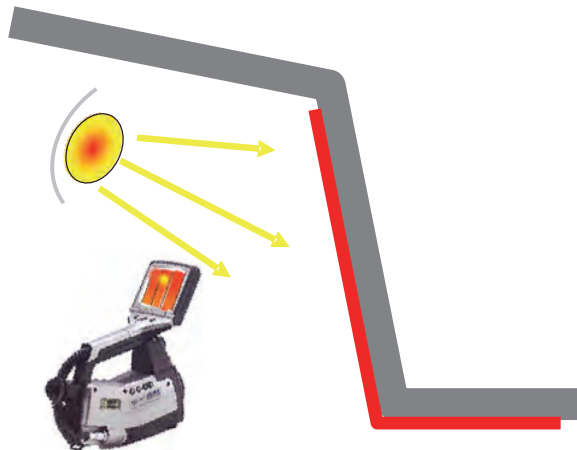
Fig. 19. Schematic representation of the survey area by active infrared thermography.

Figure 19 shows the geometrical configuration of the controlled area. The thermal solicitation is imposed by heating the FRP surface with an infrared lamp. Two examples of detected defects are presented in figure 20. The top image shows a wrapping defect and the bottom
